Discolouration and deterioration of wood in geothermal environments

Wood and wood structures in geothermal areas can quickly discolour and deteriorate, particularly where the wood is treated with preservatives that contain copper. Wood samples were included in a wider BRANZ field test of building materials in geothermal environments to study this effect and look for possible explanations.

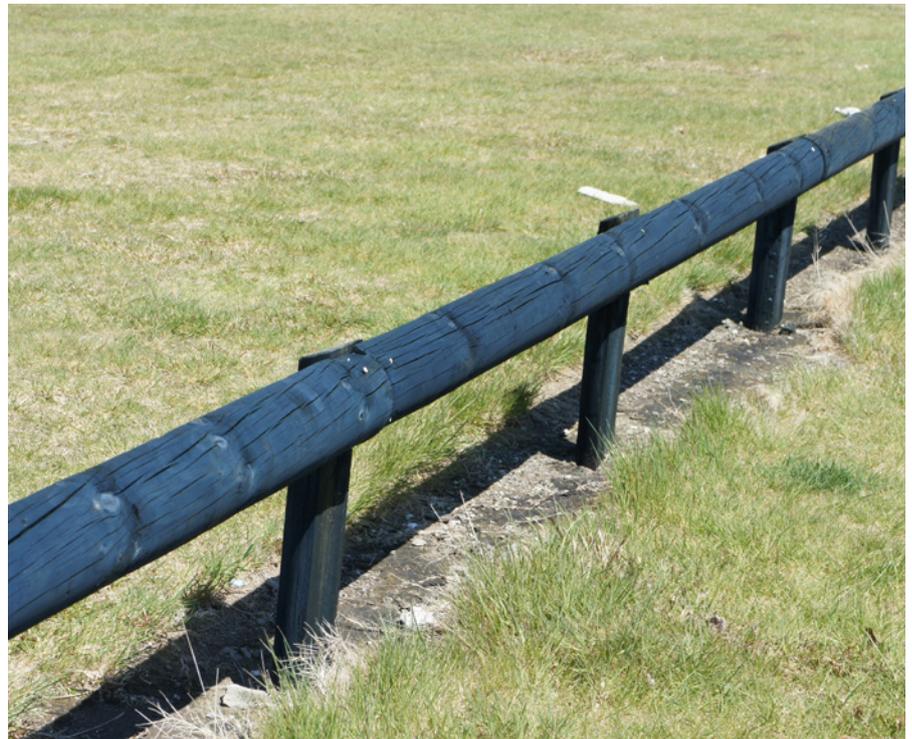
Discolouration of wood, particularly wood treated with copper-containing preservatives, is common in areas with strong geothermal emissions (Figure 1). Although the colour change is mainly cosmetic surface damage, significant reduction of physical and/or structural properties can also happen. Consistent exposure can lead to the formation of deep and large cracks.

Figure 1. Wood discolouration in an area with strong geothermal influences (south of Sulphur Bay, Rotorua).

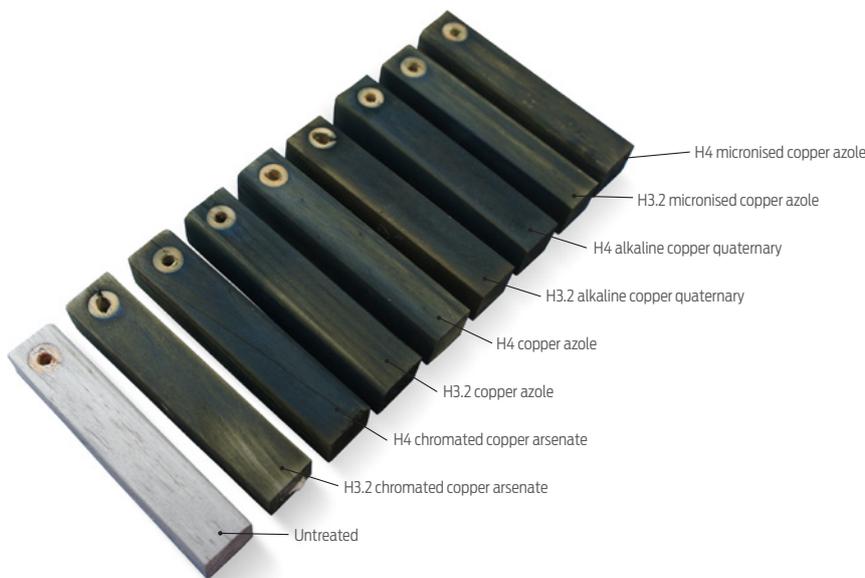
After this 1-year exposure, all wood samples, except the untreated ones, showed surface discolouration and turned blue (Figure 2).

Figure 2. Discolouration of untreated and treated wood blocks exposed at a location approximately 5 m away from a fumarole in Scion campus.

The results of the 1-year exposure indicate that discolouration may be connected to the presence of certain preservation chemicals in the wood, since the untreated wood showed no discolouration. Those treatment chemicals in the test have copper ions in common.

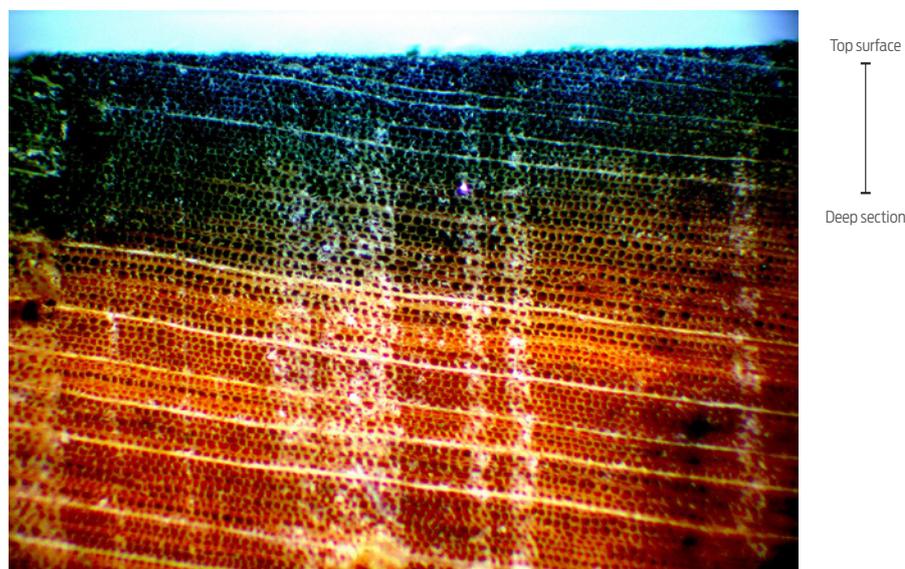
An examination of cross-sections showed that this colour change could affect areas up to around 1 mm deep from the top, directly exposed surface (Figure 3).

Figure 3. Optical microscopic view [32x] of the cross-section of an H4 micronised copper azole-treated wood block. Discolouration is visible after a 1-year exposure at a location about 5 m from a fumarole in Scion campus.
