Discolouration and deterioration of wood in geothermal environments

Wood and wood structures in geothermal areas can quickly discolour and deteriorate, particularly where the wood is treated with preservatives that contain copper. Wood samples were included in a wider BRANZ field test of building materials in geothermal environments to study this effect and look for possible explanations.

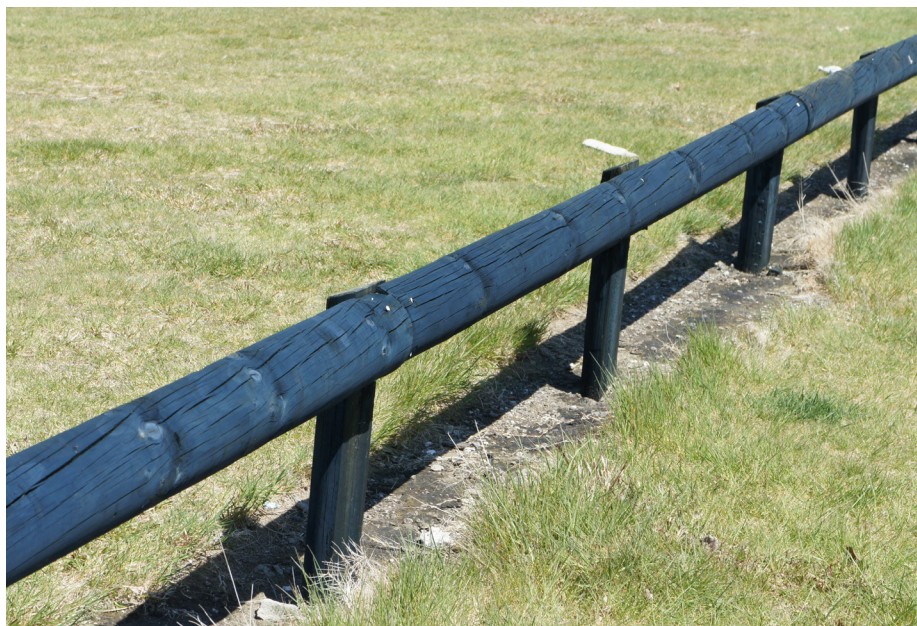
Discolouration of wood, particularly wood treated with copper-containing preservatives, is common in areas with strong geothermal emissions (Figure 1). Although the colour change is mainly cosmetic surface damage, significant reduction of physical and/or structural properties can also happen. Consistent exposure can lead to the formation of deep and large cracks.

Figure 1. Wood discolouration in an area with strong geothermal influences (south of Sulphur Bay, Rotorua).

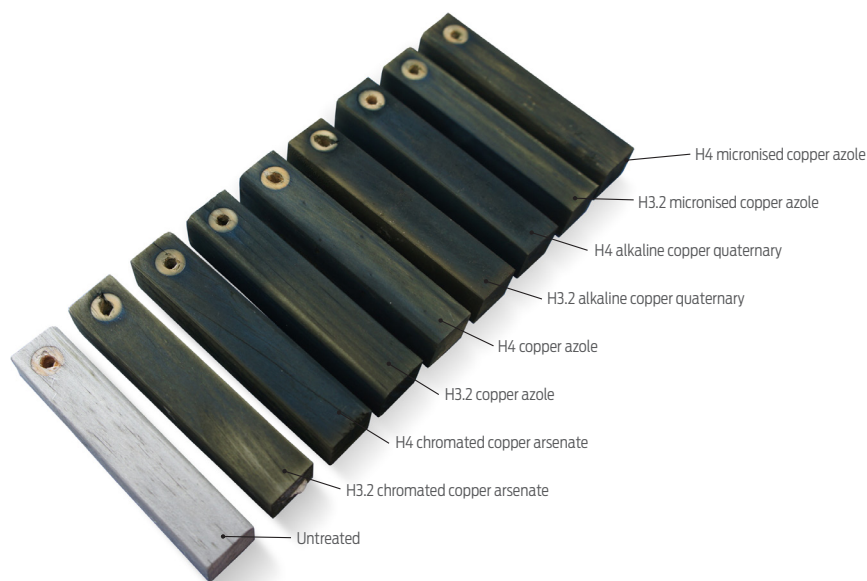
After this 1-year exposure, all wood samples, except the untreated ones, showed surface discolouration and turned blue (Figure 2). An examination of cross-sections showed that this colour change could affect areas up to around 1 mm deep from the top, directly exposed surface (Figure 3).

The results of the 1-year exposure indicate that discolouration may be connected to the presence of certain preservation chemicals in the wood, since the untreated wood showed no discolouration. Those treatment chemicals in the test have copper ions in common.

Based on these results, it is suggested that this type of wood discolouration is caused by the formation of copper sulphide and/or sulphate. This occurs through interactions between copper in the preservative chemicals and geothermal sulphur-containing gases entering the wood structure.

Figure 2. Discolouration of untreated and treated wood blocks exposed at a location approximately 5 m away from a fumarole in Scion campus.

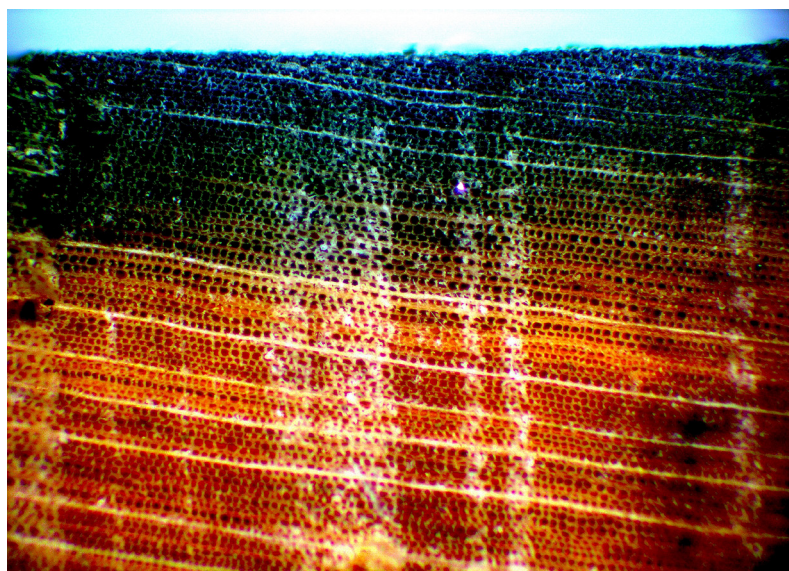
Figure 3. Optical microscopic view (32x) of the cross-section of an H4 micronised copper azole-treated wood block. Discolouration is visible after a 1-year exposure at a location about 5 m from a fumarole in Scion campus.
