BULLETIN

ISSUE 550

DAMAGE FROM WEATHERTIGHTNESS FAILURE

August 2012

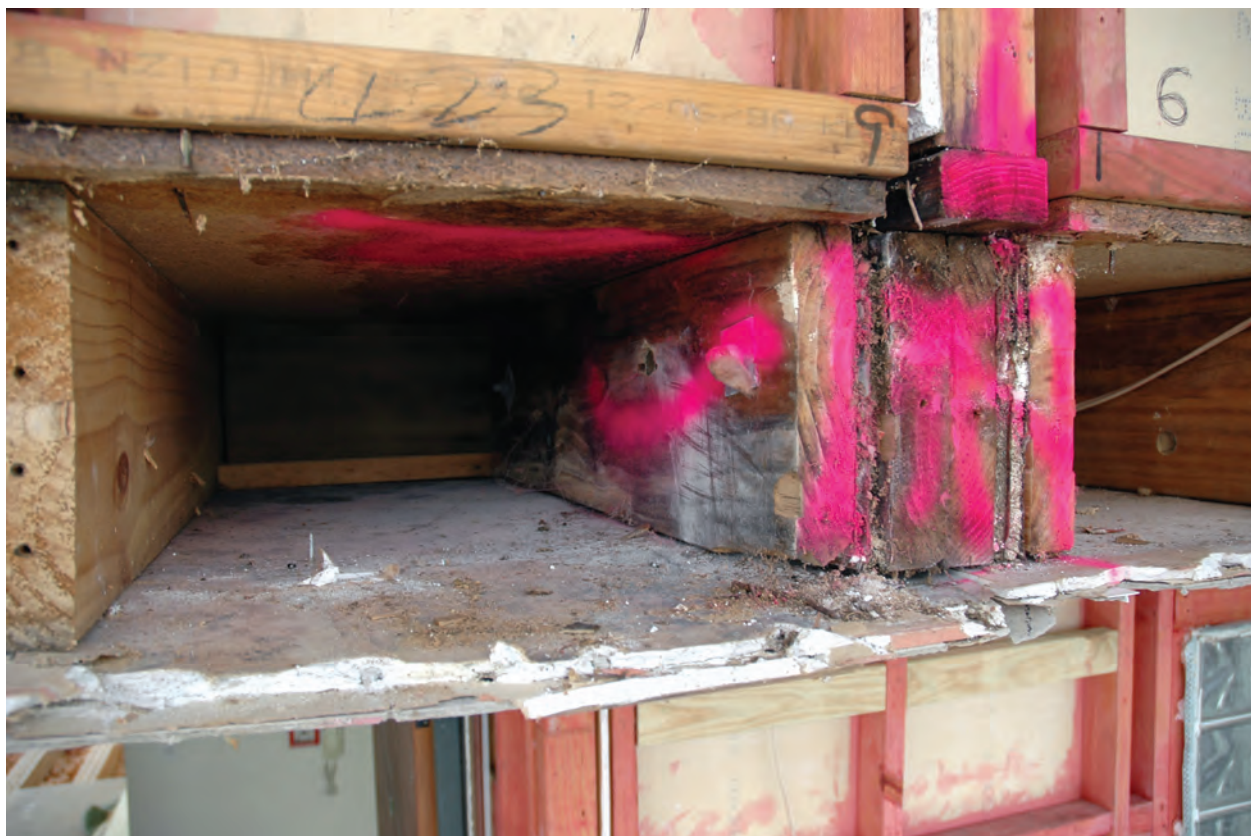
Figure 1 Rot in the ends of intermediate floor joists, with deterioration also visible in the flooring.

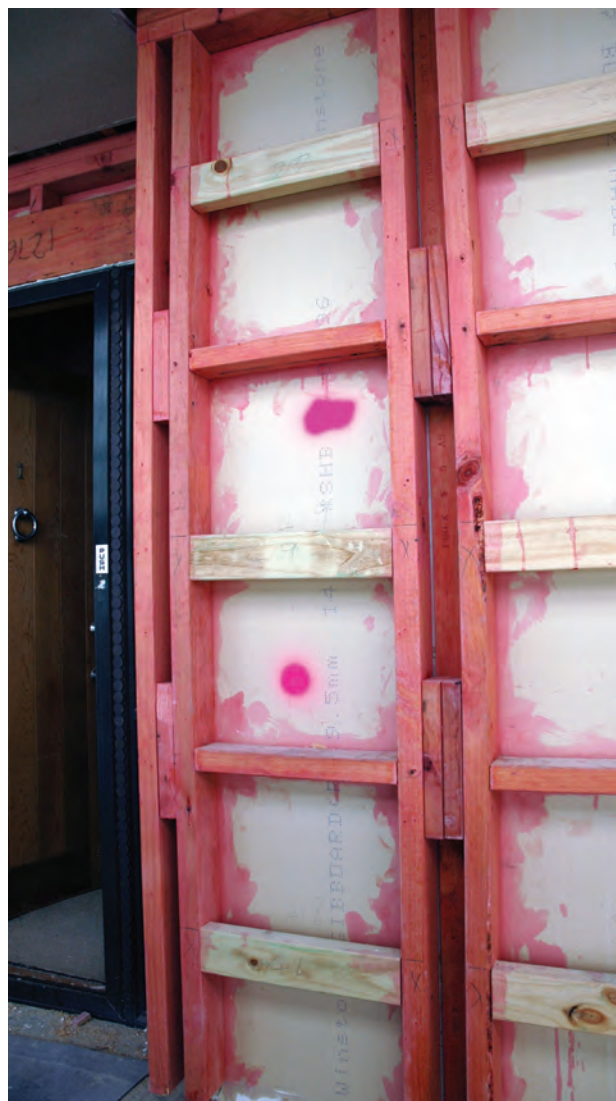
Figure 2 Timber in external walls that is sound but untreated (or not treated to current B2/AS1 requirements) should be given two coats of brush-on boron glycol preservative treatment as part of any remediation work

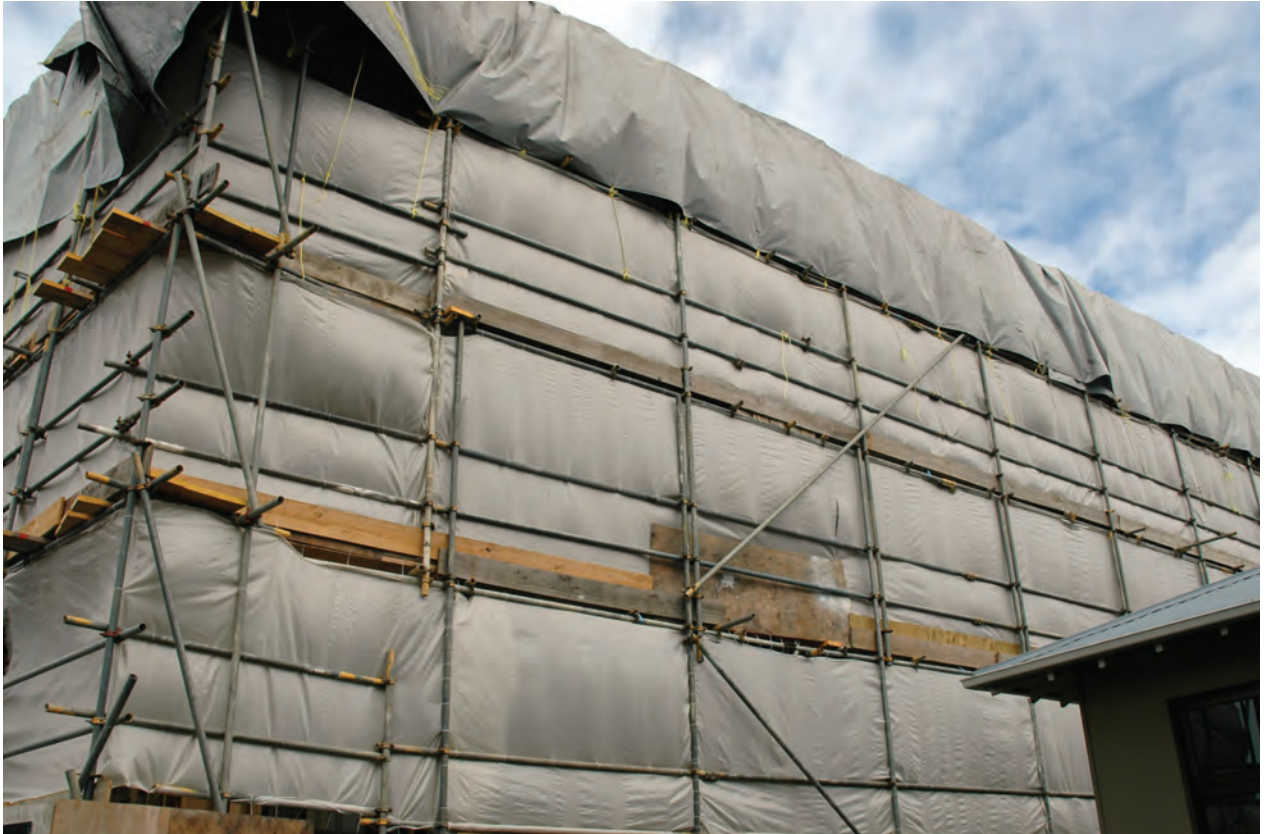
Figure 3 Full cladding replacement allows all faults and decay to be found and exposed timber to be treated.

- a drained and ventilated cavity can be introduced to reduce risk of future failure
- greater confidence can be given to owners
- all faults and decay are more likely to be found
- all exposed timber can be surface treated with a suitable paint-on boron-based fungicide (including injection of the solution into holes drilled into built-up members such as lintels)
- evidence can be uncovered for potential legal action
- there is the opportunity to address other building faults
- there is the opportunity to improve amenity and value, for example, by increasing the level of insulation or changing the building appearance
- there is the opportunity to remove riskier features from the building.
