STUDY REPORT

No. 100 (2001)

Repair and Reinstatement of Earthquake Damaged Houses – Derivation of Repair Techniques

G. J. Beattie

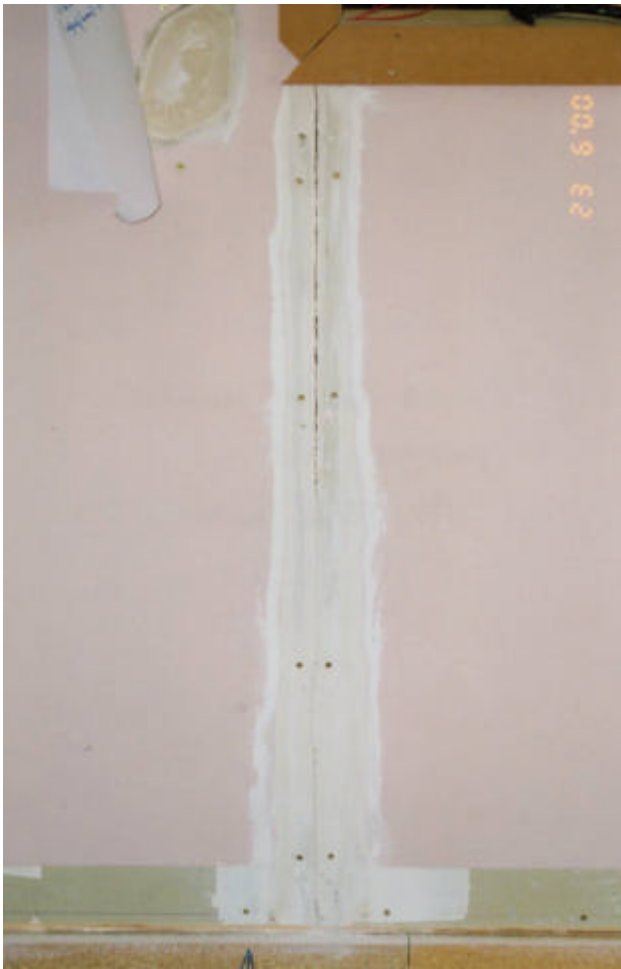
Cycling continued to ± 10 mm and ± 15 mm (3 cycles each). During these cycles the gypsum plasterboard joint adjacent to the window opening on the painted side sheared up to 11 mm and the remaining tape at the bottom of the joint tore. On the opposite side the wallpaper sheared with the joint and repair would require removal of the wallpaper and re-stopping. In accordance with the manufacturer's advice, the plaster surface was scraped back to the paper tape and the tape removed (Figure 7). Then the plaster beneath the tape was slightly V-ed without damaging the paper surface of the board. The joint was then stopped in the normal manner. Extra nails were installed along the edge of the sheets (Figure 7) at the joint adjacent to the damaged ones and the bottom edge of the plasterboard sheets was nailed at 300 mm centres once the skirting board had been removed.

Figure 7: Painted gypsum plasterboard joint prepared for stopping after 15 mm displacement cycles

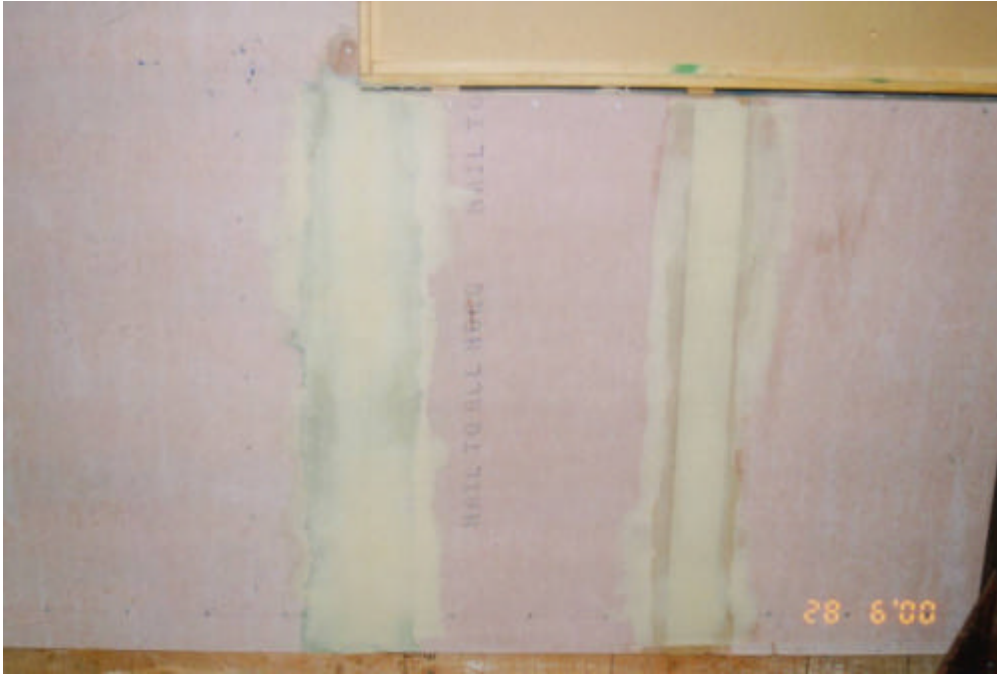
Figure 8: Repaired fibre cement board joints on left side

The left side joint was ground back to original sheet face and the joint V-ed out. The repair involved the application of a water-based primer and then filling with joint filler 3 (Figure 8).

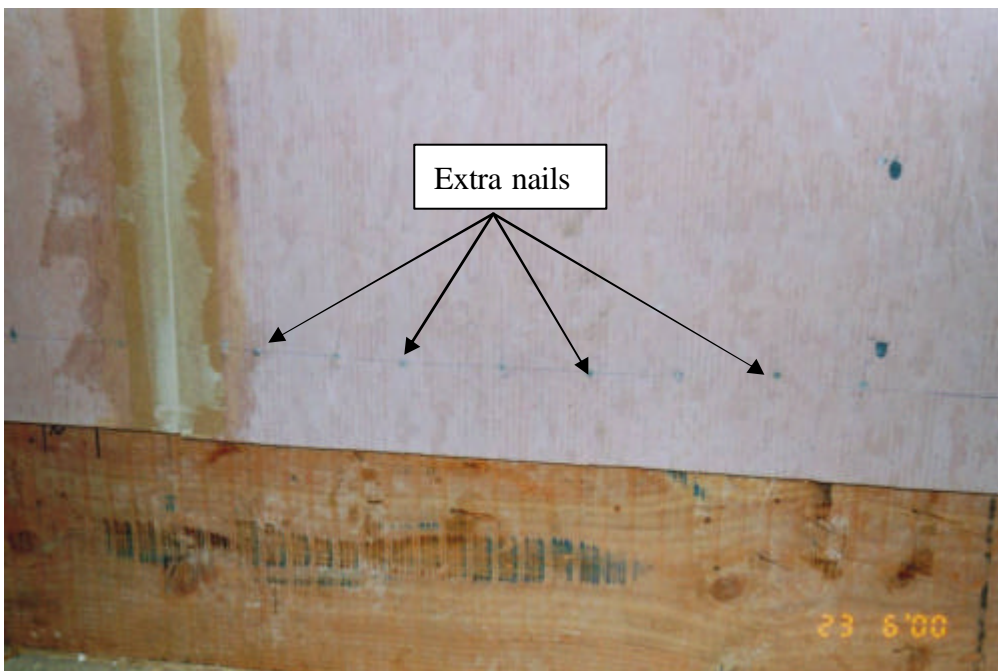
Figure 9: Extra nails added at bottom plate

When the old filler was removed nails were added to the sheet at the joint. An extra nail was added at each gap between the existing nails. Also, the top and bottom corners of the 2.4m long “bracing panel” were nailed to the plates with an extra nail between each of the first four nails in the horizontal row (Figure 9).

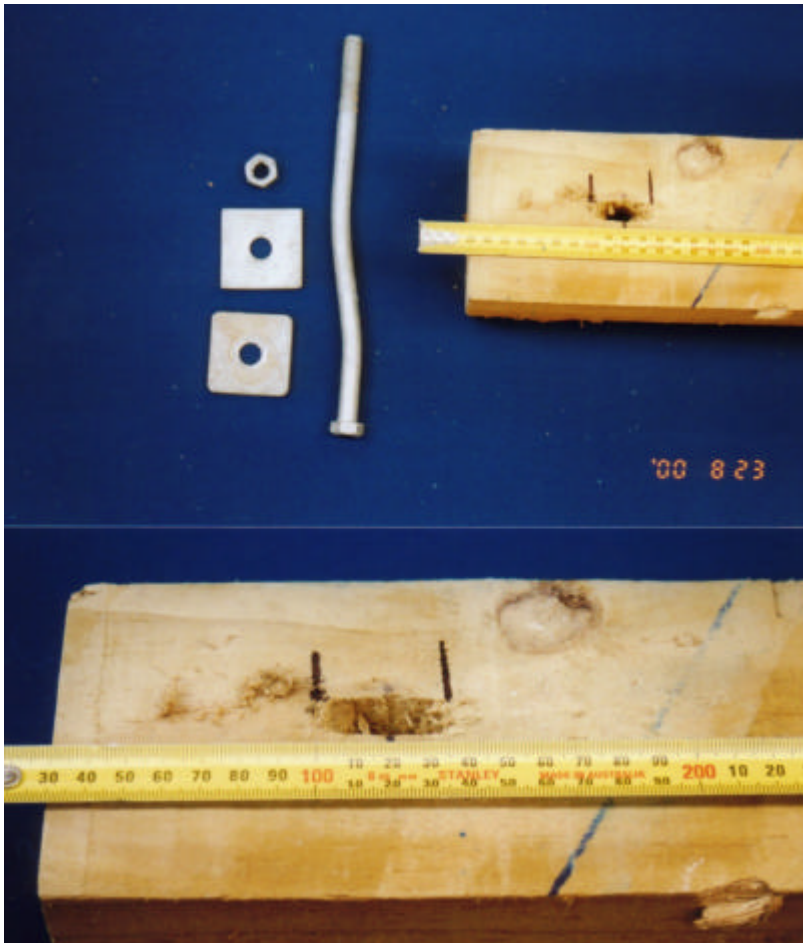
When the bolts were finally removed, there was a large slot in the timber of both members (particularly the brace) and the bolt was significantly bent (Figure 14).

Figure 14: Pile brace after removal showing bent bolt and slot in brace

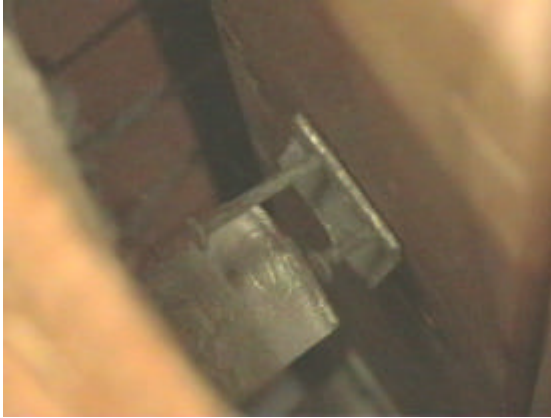
An attempt was then made to dynamically cycle the specimen. This was in an effort to introduce an element of shock loading to the specimen, partially commensurate with real earthquake loading, bearing in mind that the base of the specimen was not able to be excited. Six cycles were applied sinusoidally at 1 Hz at a displacement target of ± 30 mm. There was some evidence of damage to the veneer at this point although only slight. The top tie on the face loaded veneer nearest the corner bent under compression loading and both securing nails were pulled out of the frame (Figure 23). The tie at the same level and on the adjacent stud of the face loaded wall appeared to push the mortar through the joint and a small section of brick fell off the outside face (Figure 24). The nails in this top row of ties pulled part way out of the studs and the top row of ties on the in-plane loaded frame were rotating significantly on the nailed connections to the studs as the studs bent about their weak axis. The veneer continued to remain intact.

Figure 23: Nails pulled from frame and tie broken

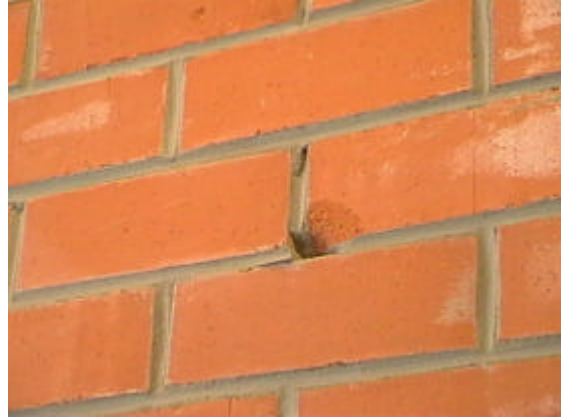
Figure 24: Section of punched brick

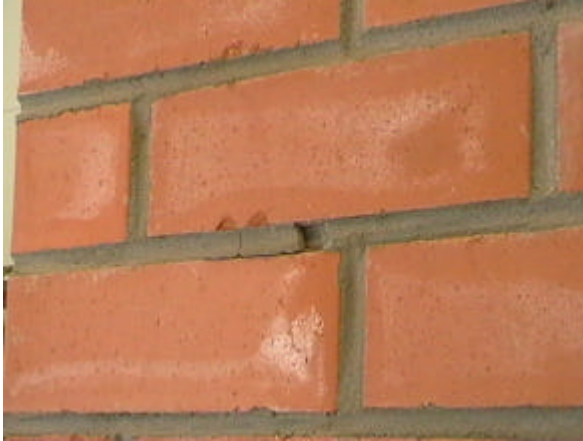
Two sets of six cycles to ± 30 mm at 2 Hz were applied to the wall followed by a set of six cycles with a target displacement of ± 40 mm at 2 Hz. At the completion of these cycles, the second tie down on the corner stud of the face loaded wall had pushed the mortar slightly out of the joint (Figure 25) and a similar situation had appeared at the top tie at the free end of the face loaded wall. The plasterboard had detached from the studs over most of the height of the specimen and there was some damage at the intersection of the two walls. The damage was considered to be repairable with re-nailing and new tape and stopping.

Figure 25: Section of mortar punched out by tie

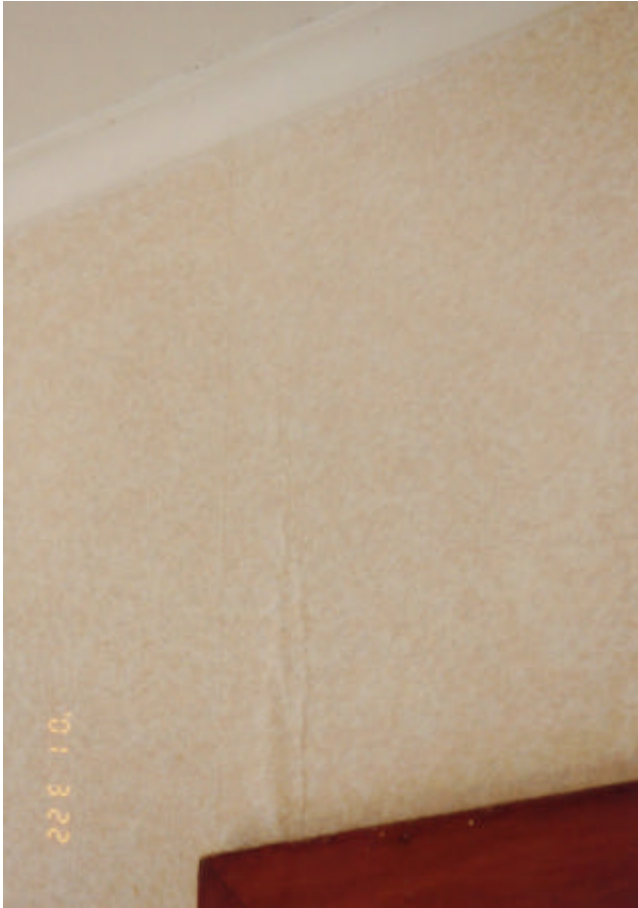
Figure 31: Wallpaper concertinaing under racking load

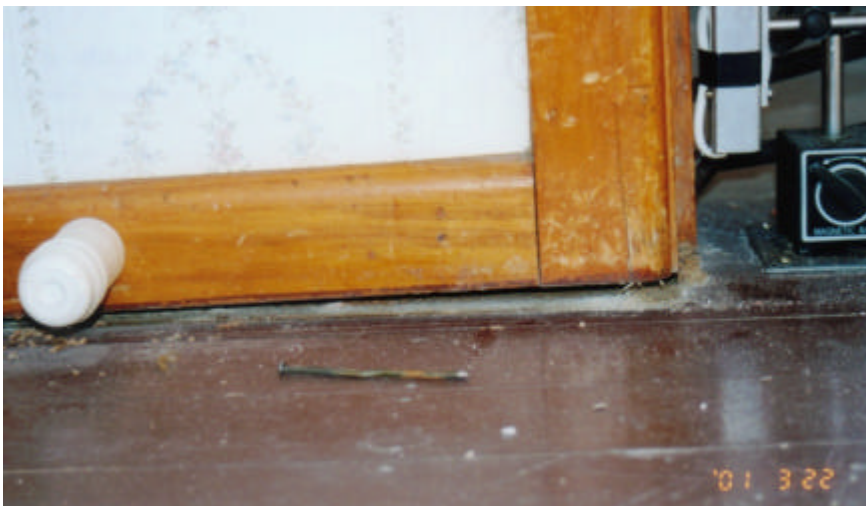
Figure 32: Upper floor skirting board lifting

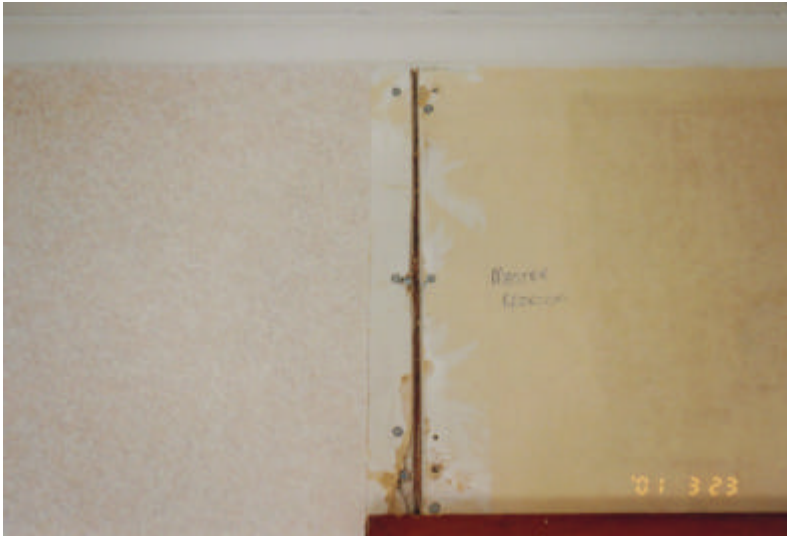
The damage to the wall elements appeared to be mainly cosmetic. There was a 100 mm x 25 mm diagonal brace in the larger of the two elements and this appeared to have sufficient strength to resist the applied load. Because the damage was cosmetic, simple repairs were undertaken. The damaged joints between the gypsum plasterboard sheets were V-ed out, the edges of the sheets were re-nailed with 30 mm x 2.5 mm galvanised clouts at 150 mm centres (Figure 33) and then the joint was re-stopped with paper tape reinforcement included.

Figure 33: Prepared gypsum plasterboard joint ready for re-stopping

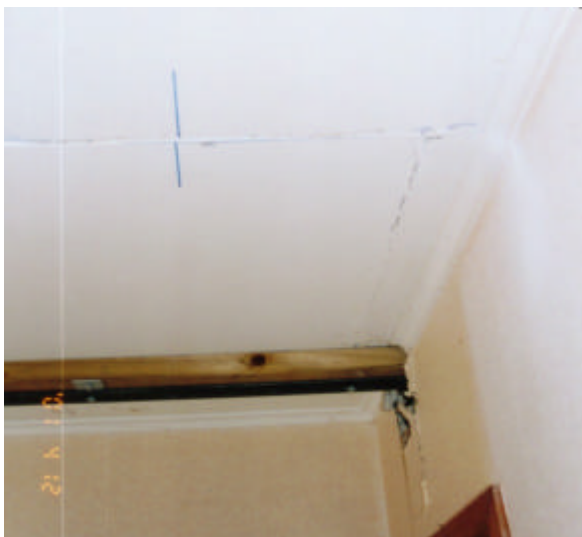
During these cycles a definite misalignment had occurred across the saw cut made in both the lounge and the kitchen ceilings and a stopped joint adjacent to the transverse hallway wall was beginning to open (Figure 38). Bottom plate uplifts and horizontal slippage were negligible.

Figure 38: Ceiling misalignment and joint opening

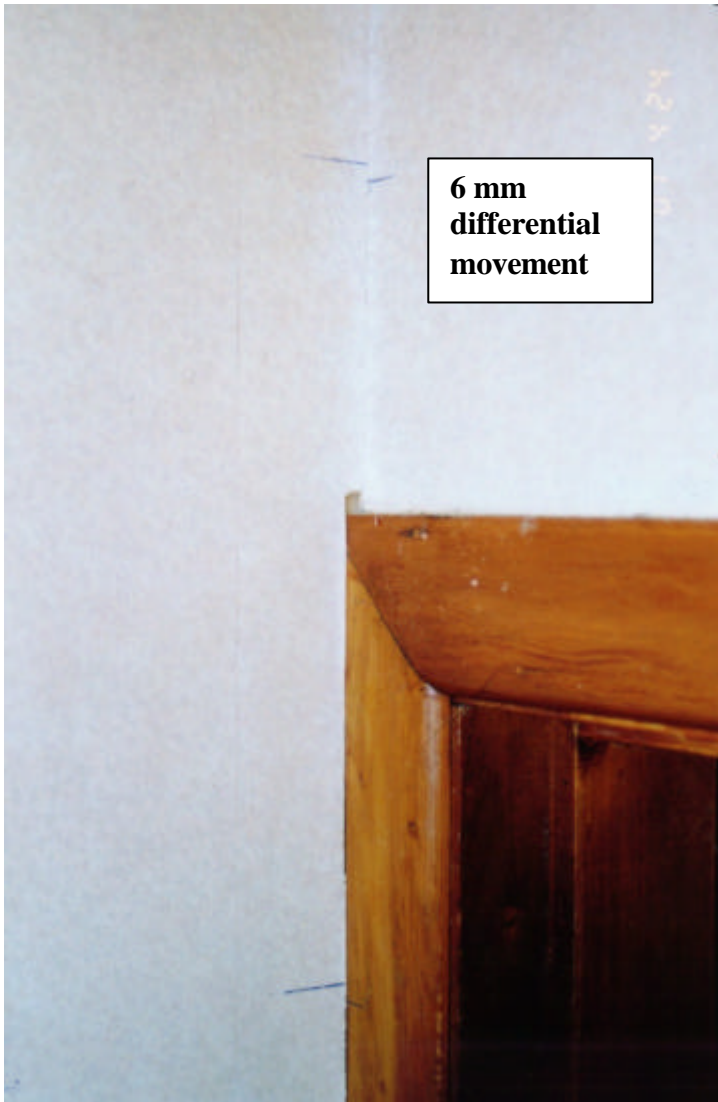
Figure 40: Differential movement between the test wall and the transverse hall wall

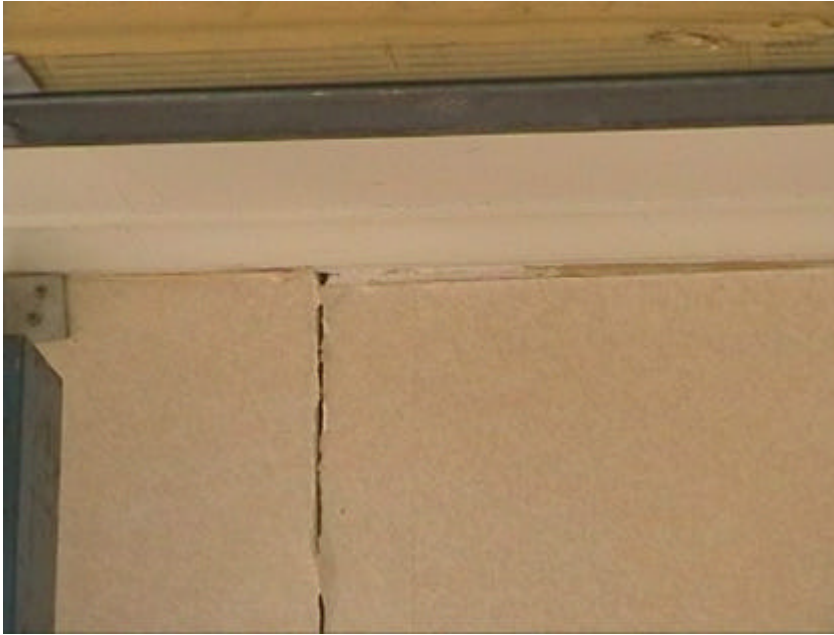
Figure 43: Shear slippage between lining sheets in lounge

Sheet damage was limited to around the perimeter of the individual sheets and could be repaired by removal of the skirting boards and scotias and re-nailing and re-stopping. Replacement of the sheets would not be necessary.
