# STUDY REPORT

No. SR 114 (2002)

## Survey of Nail Plate Corrosion In the Roof Space of Houses Near the Coast

L. R. Jordan

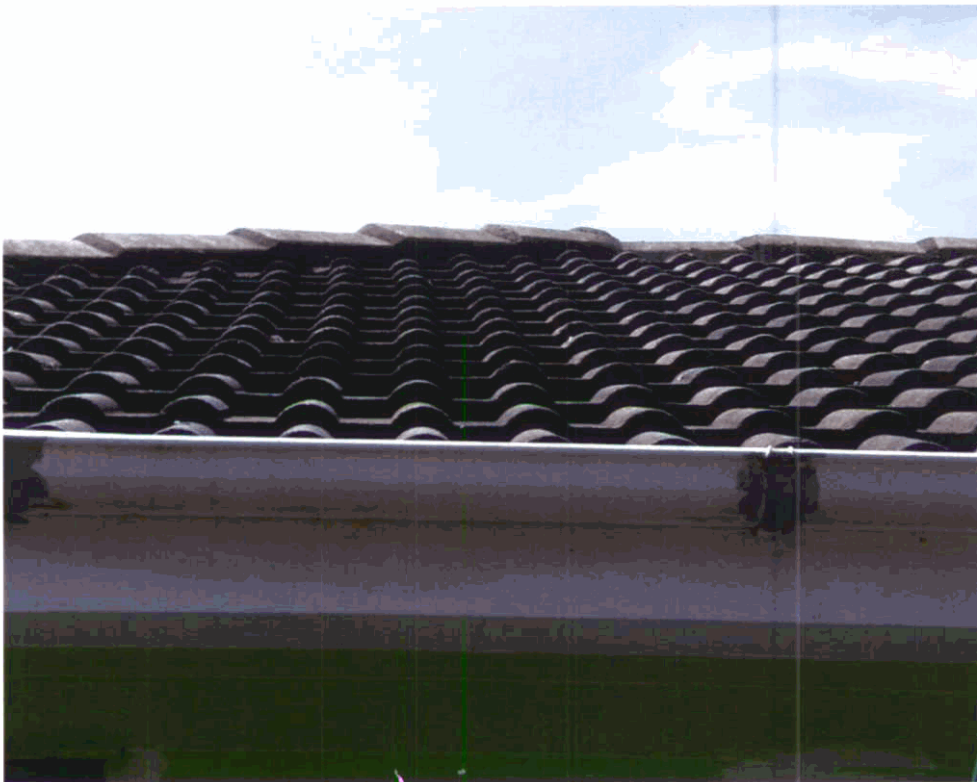
**Figure 2: House 001 Roof.**

The house has a concrete tile roof, (Figure 2), and no building paper underlay. The condition of the nail plates (Figures 3 and 4) was extremely good, having a zinc thickness of approximately 26  $\mu\text{m}$ . The nail plates appear shiny with little dulling due to surface corrosion of the zinc and no white rust evident.

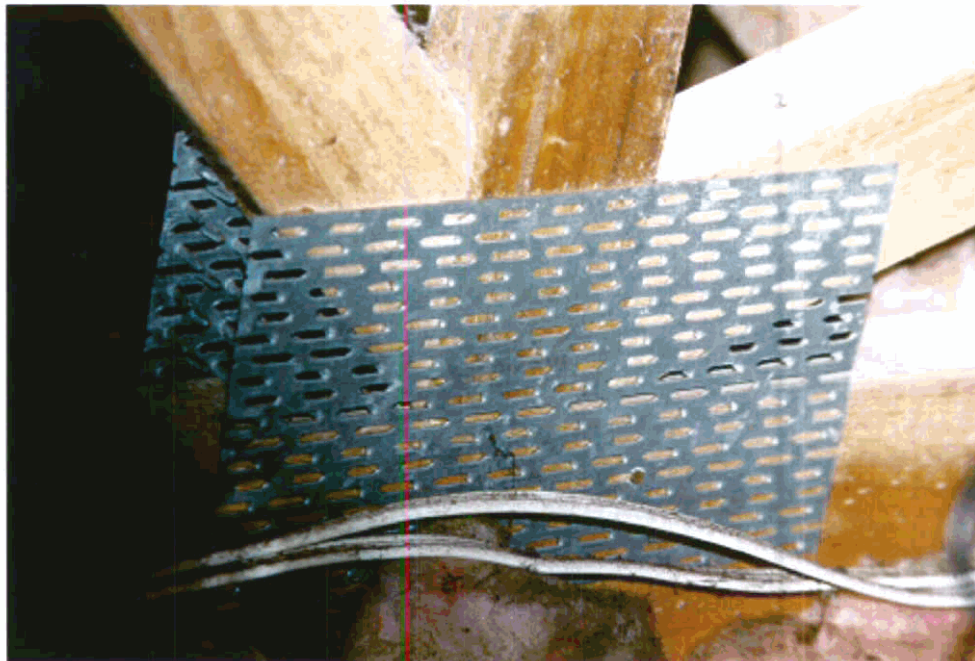
**Figure 6: House 002 Nail plate.**

The house has a concrete tile roof and no building paper underlay. The nail plates in this house were in extremely good condition having a zinc thickness of approximately 24  $\mu\text{m}$  with <1% white rust on the surface. Photographs of the nail plates in Figure 6 show the nail plates to appear shiny with little dulling due to surface corrosion of the zinc and very little white rust evident. The galvanized wire tie shown in Figure 7 is in a more exposed environment in the roof space and shows some white rust on its surface.

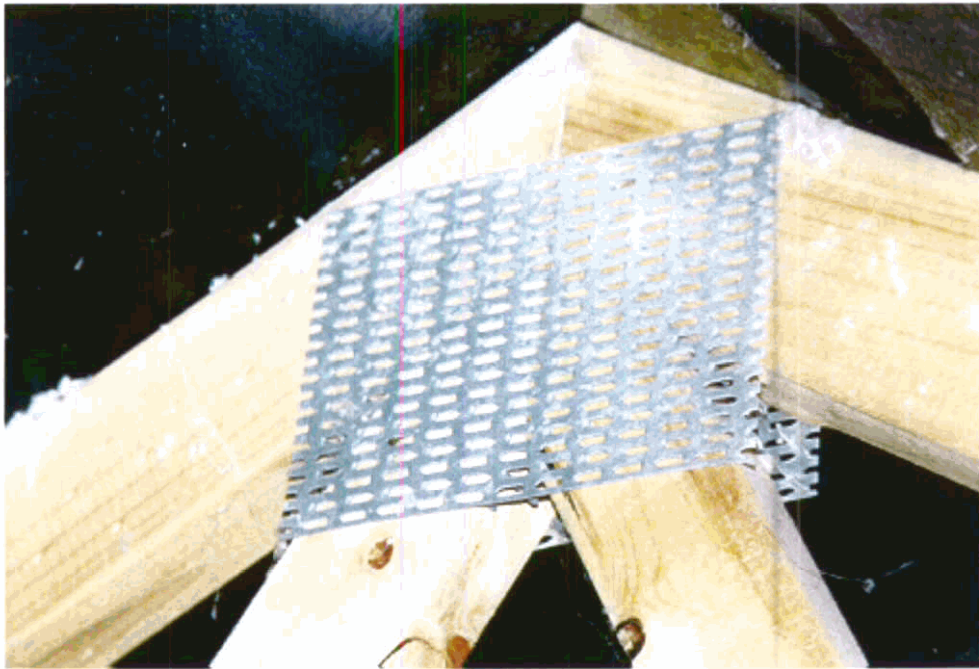
**Figure 9: House 003 Nail plate.**

The house has a concrete tile roof with building paper under the concrete tiles. The nail plates in this house were in extremely good condition having 26  $\mu\text{m}$  of zinc and appearing shiny with little surface dulling as seen in Figure 9. It is not possible to say whether they would be in worse condition had there been no building paper underlay

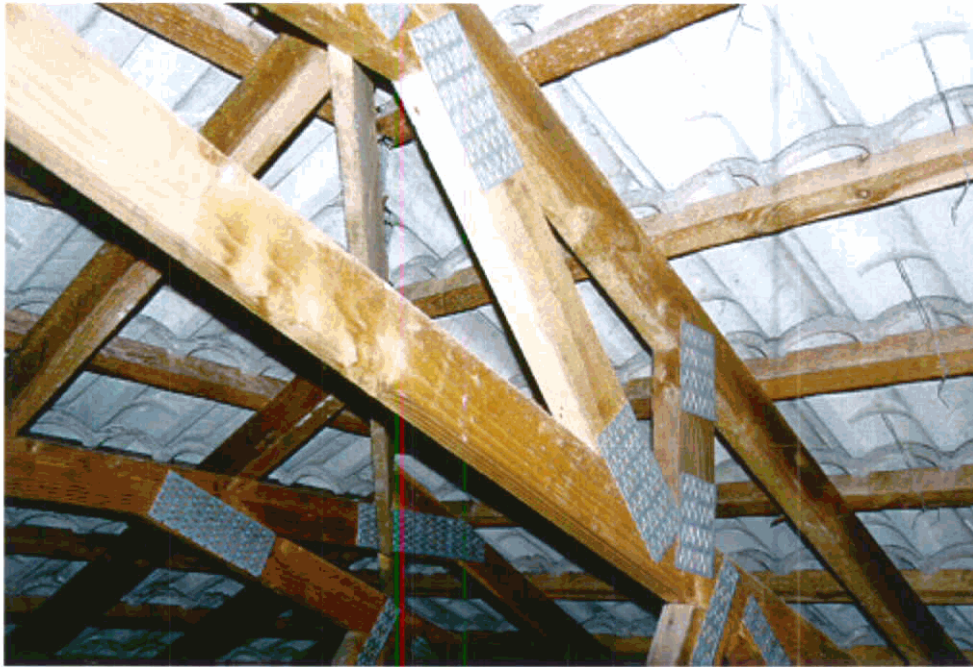
**Figure 11: House Roof space.**

The house had concrete tiles with no building paper underlay. The nail plates in this house were the oldest seen in the survey. The nail plates in this house were in extremely good condition having 20  $\mu\text{m}$  of zinc and very little surface dulling as can be seen in Figures 11 and 12. A wire tie is shown in Figure 13.

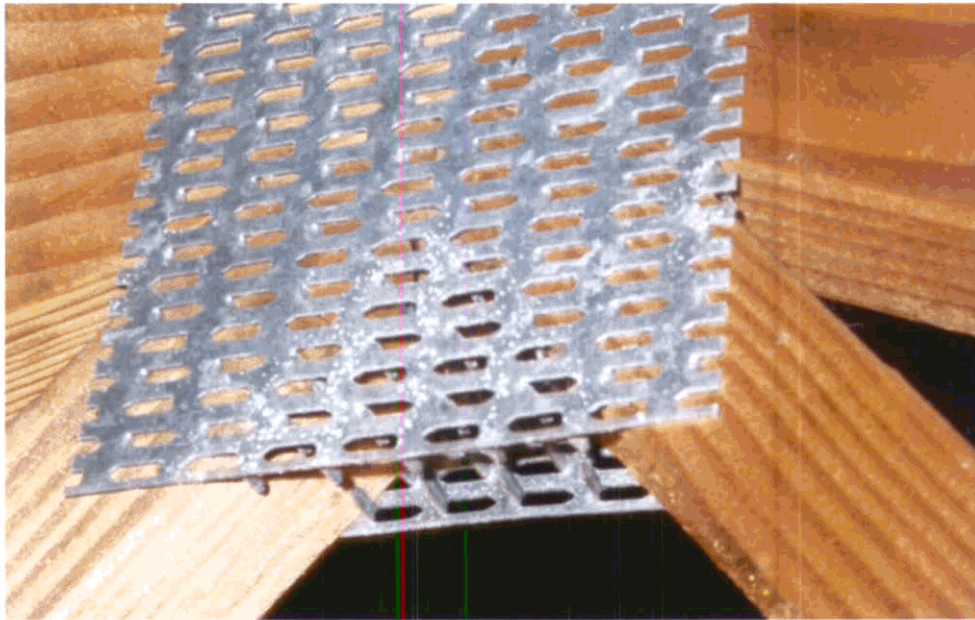
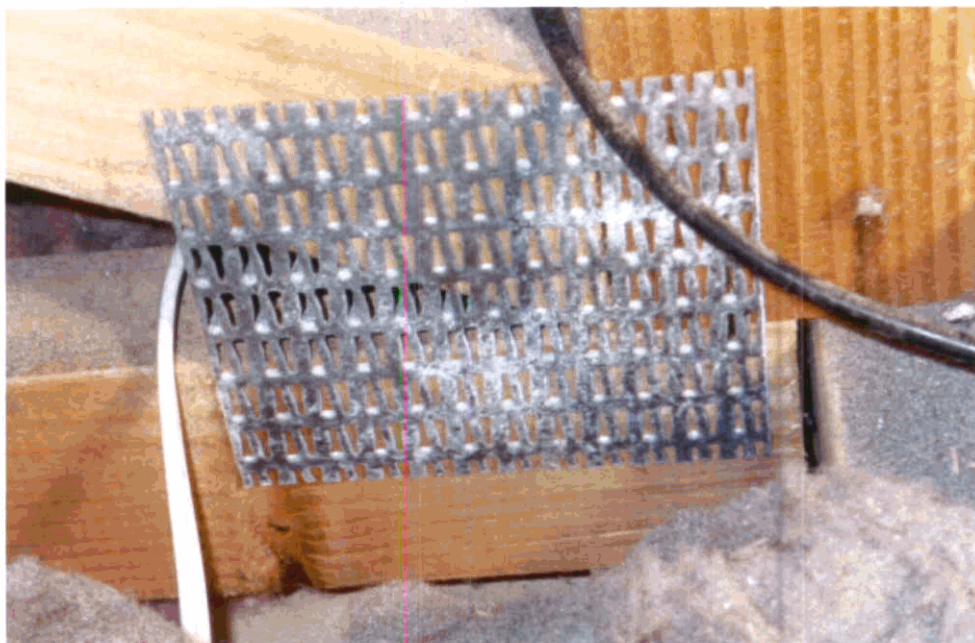
The house has a concrete tile roof with building paper underlay. However there was considerable air leakage and sand deposition into the roof space due to the roof space opening into the garage.

The nail plates, as seen in Figure 15 and 16, had about 19  $\mu\text{m}$  of zinc coating and white rust over approximately 10% of the surface. It is not possible to say whether they would be in worse condition had there been no building paper underlay.

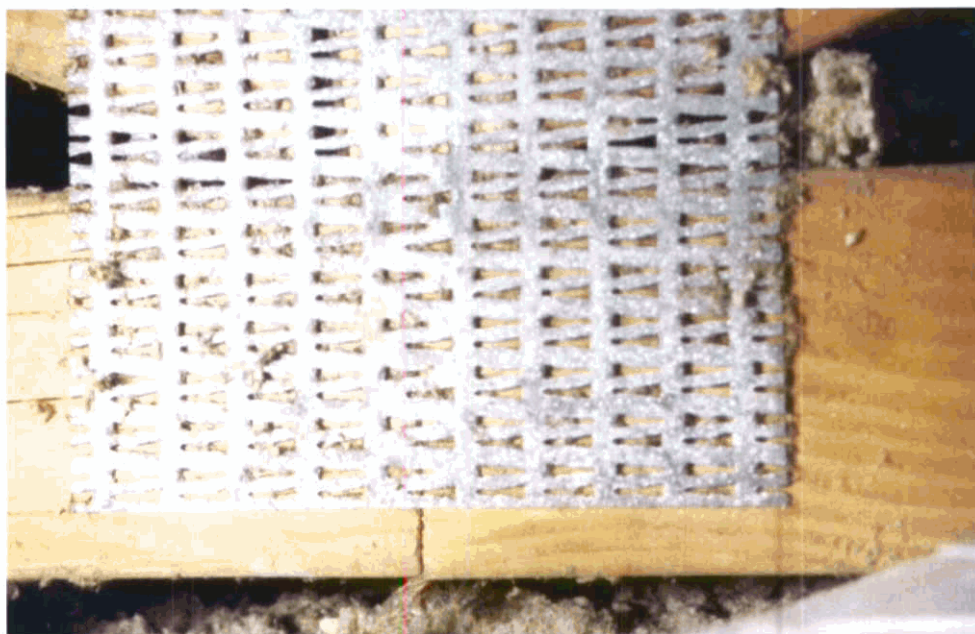
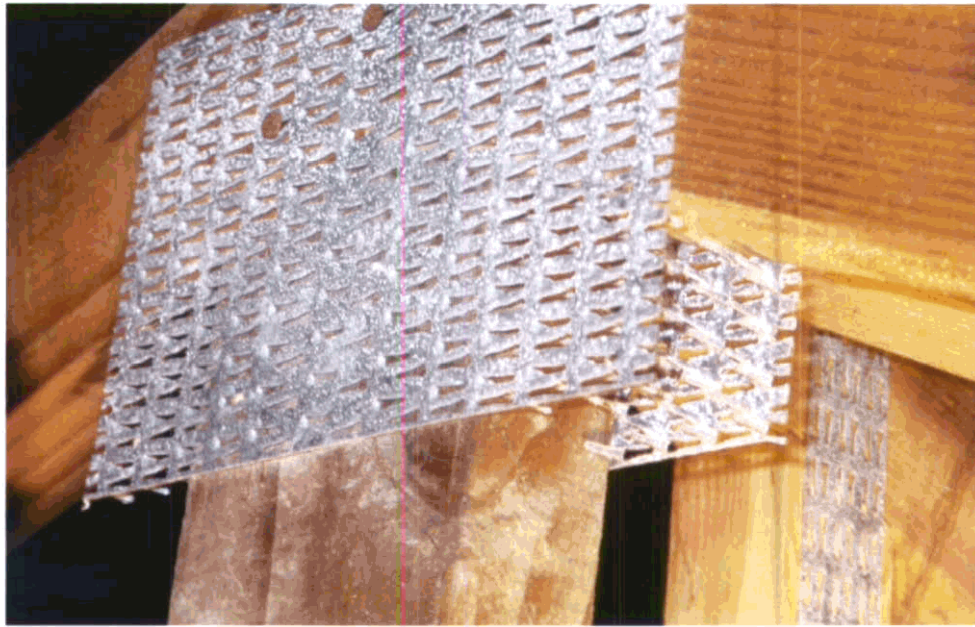
The house has a concrete tile roof with building paper underlay. The nail plates, as seen in Figures 18 and 19, had considerable white rust on the surface.

It is difficult to say whether the cause of corrosion in this case is due to salt deposition on the nail plates before the roof was closed in or due to salt deposition afterwards. However due to the presence of building paper, salt deposition before enclosure is a strong possibility.

The incidence of white rust on one house in the sea spray zone that had building paper underlay raises the question of whether corrosion of nail plates may occur through deposition of salt before the roof space is enclosed. A suggested method to overcome this issue, if found to be a problem, is a peel off coating protecting the nail plates during construction.

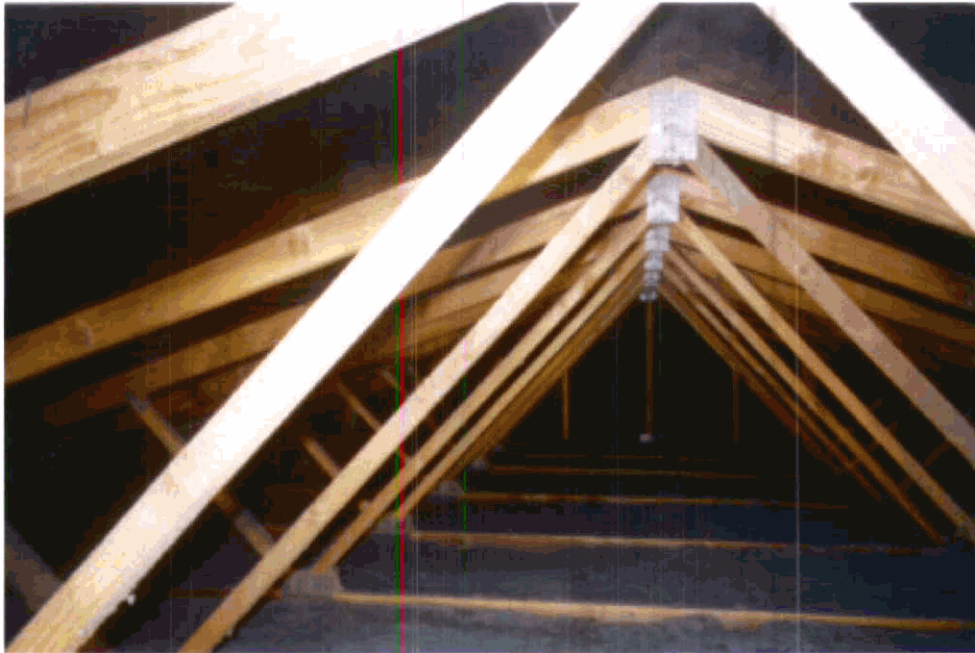
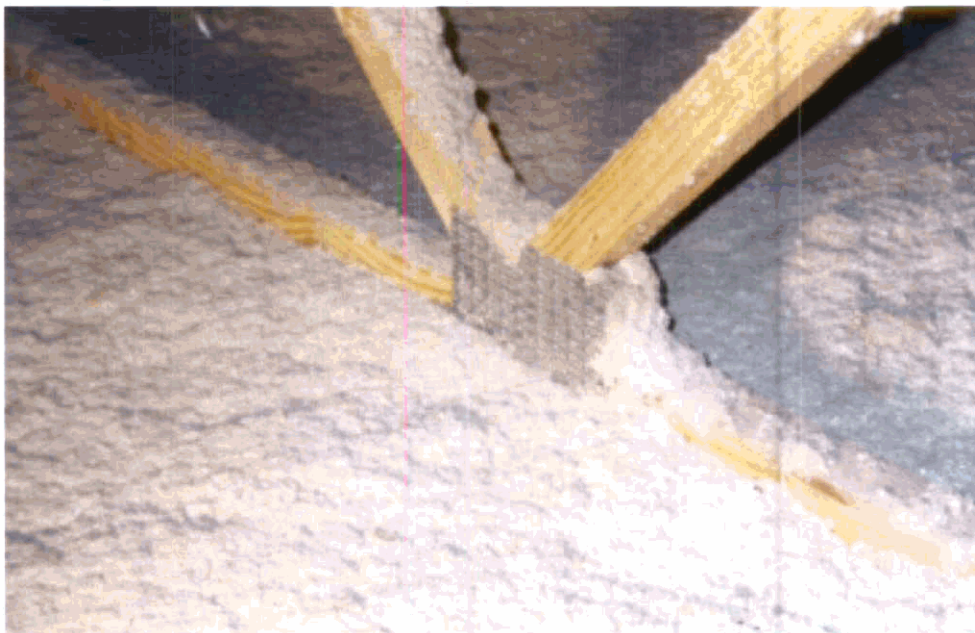
The house has a concrete tile roof and has building paper underlay. Photographs of the nail plates in Figures 21 and 22 show the nail plates to appear shiny with little dulling due to surface corrosion of the zinc and no white rust evident. It is not possible to say whether they would be in worse condition had there been no building paper underlay.
