STUDY REPORT

No. 147 (2005)

Post-earthquake Performance of Passive Fire Protection Systems

P.C.R. Collier

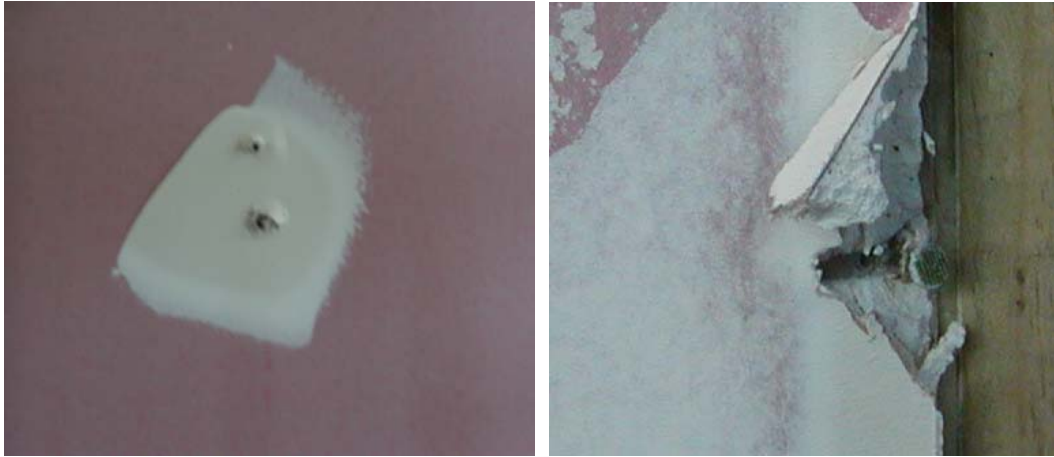
The lining had become detached over the top 600 to 1000 mm of the wall where the nails had torn the lining and it became detached from the framing by up to 7-8 mm on both sides. The nails were also bent proportionately to displacement of the lining relative to the frame. Due to the gap between the wall's timber frame and the concrete fire test frame at the two sides and the top to allow racking movement this meant the lining was relatively free to move over the frame being only restrained by the nails compared with the bottom concrete sill where the lining was also restrained by contact with the concrete. As a result the racking damage to the lining at the bottom was minimal and increased towards the top of the wall to the extent it was loose at the top thus only providing minimal resistance to racking once the higher displacement cycles had been reached as shown in Figure 27. Figure 28 shows popping of nails on an intermediate stud and tearing of the lining on a side stud. In both cases the damage is in the top 600 to 1000 mm of the wall.

Figure 28: Damage to lining in FR3362A

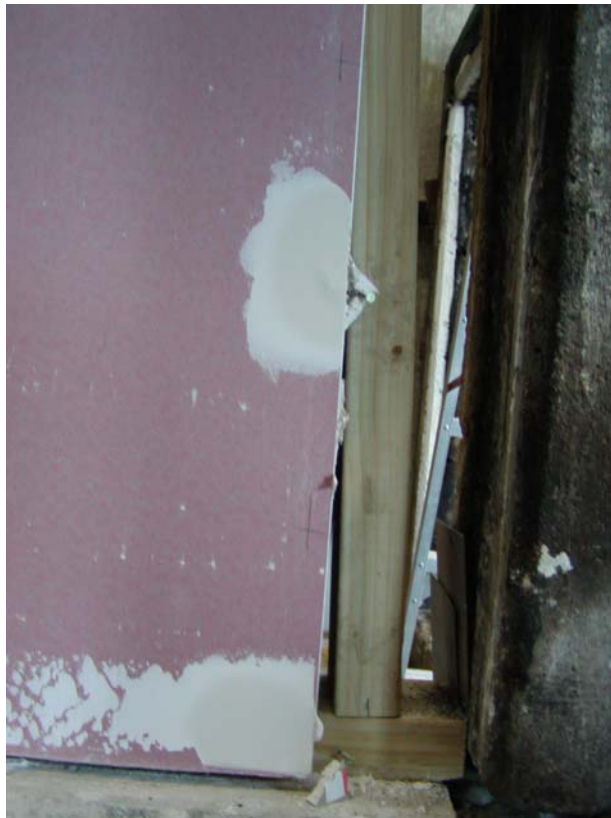
The damage to the lining caused was predominately at the bottom of the wall in FR3362B, as opposed to the top as in FR3362A. The bottom 600 to 1000 mm of the lining was loose and about 6 mm away from the frame on the side studs and along the bottom plate on both faces of the wall. The nails had popped and torn the edges of the lining to some extent around the entire perimeter, but damage was least at the top plate where the lining remained firmly attached to the top plate except at the two top corners. On the intermediate studs up to a height of 600 mm above the bottom the nails had popped where the board was continuous but popping was not so obvious on stopped joints. Figure 30 shows the tearing and detachment of the lining at a bottom corner at 32 mm drift and where there is no other restraint other than the nails.

Figure 30: Racking of wall FR3362B

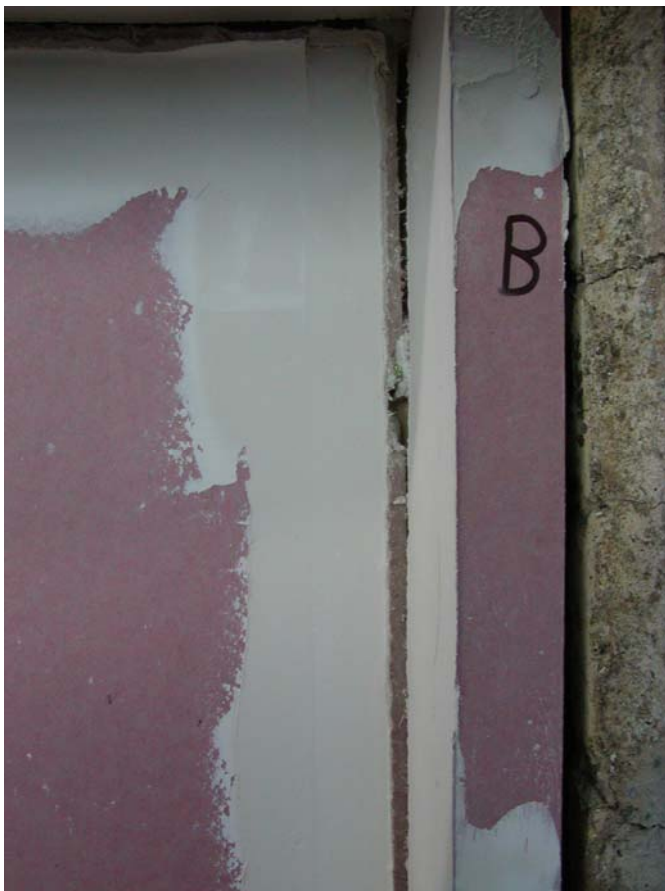
With the additional restraint around the perimeter the resistance to racking increased considerably. Damage was also reduced around the perimeter initially but eventually the taping and stopping on the junctions (wall to wall and wall to ceiling) was torn and gaps opened at the extreme ends of the racking travel as shown in Figure 31 . The skirting board remained attached but movement of the lining relative to it was noted with resultant evidence of nails tearing the plasterboard.

Figure 31: Bending of side plates

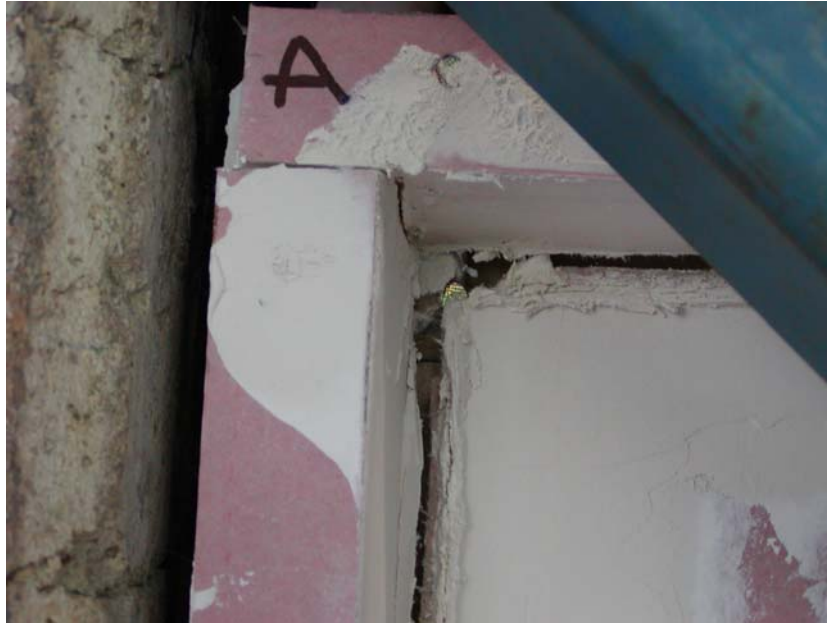
The movement of the lining over the frame was resisted by the edge detail and that required increased racking forces to reach the required 1% drift. In the course of the racking the lining detached around the edges, and although the taping and stopping provided some resistance, cracks and tears did appear at the maximum drifts of the cycles as shown in Figure 33 where a nail is visible.

Figure 33: Lining separation in corner at maximum drift

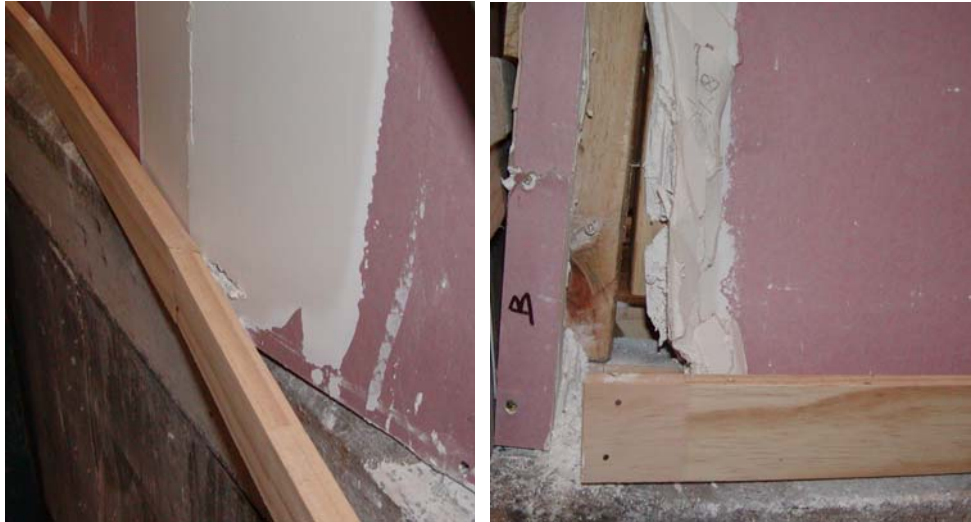
On the fire exposed side the lining joint on the right hand end became detached from the stud and bowed out 135 mm at the full racking displacement with subsequent fracture of the tape and stopping on the joint shown in Figure 35. On the left bottom corner the lining had separated from the side stud.

Figure 35: Detachment of skirting board and opening at bottom corner FR3362D

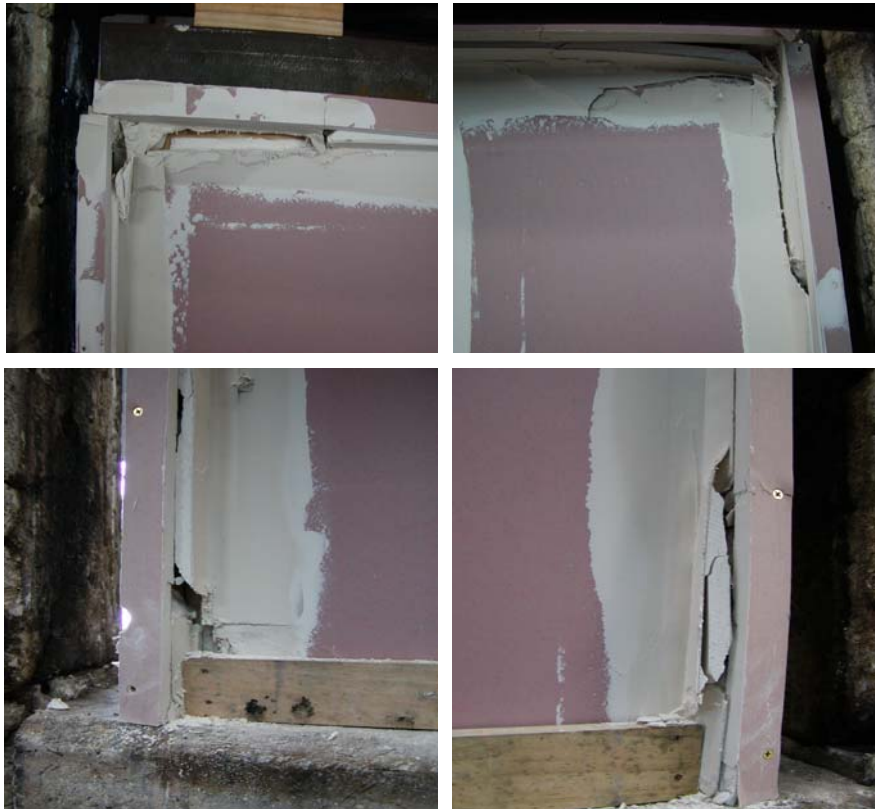
Figure 38: Damage to corners of exposed side of FR3362E

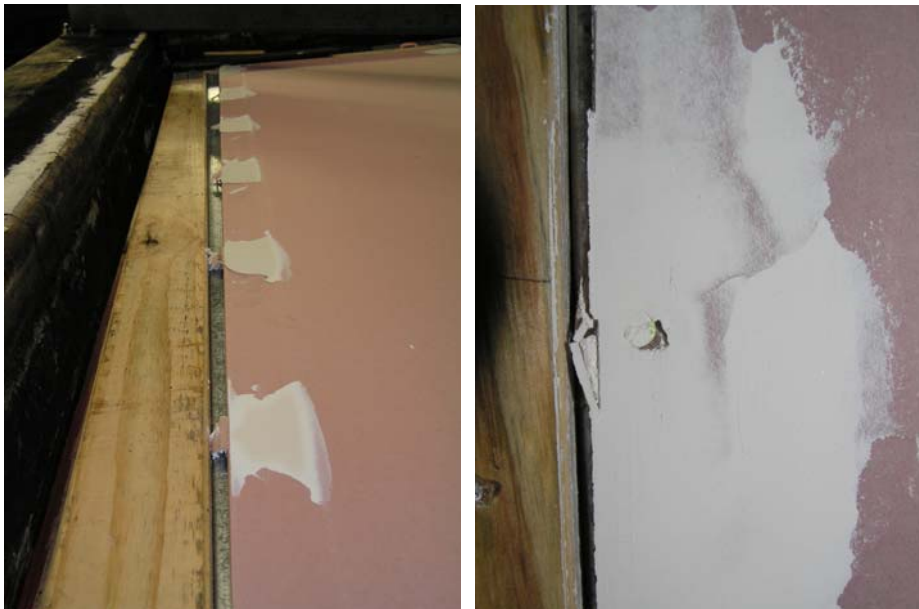
Figure 40: FR3362F displacement of side studs at 40 mm drift

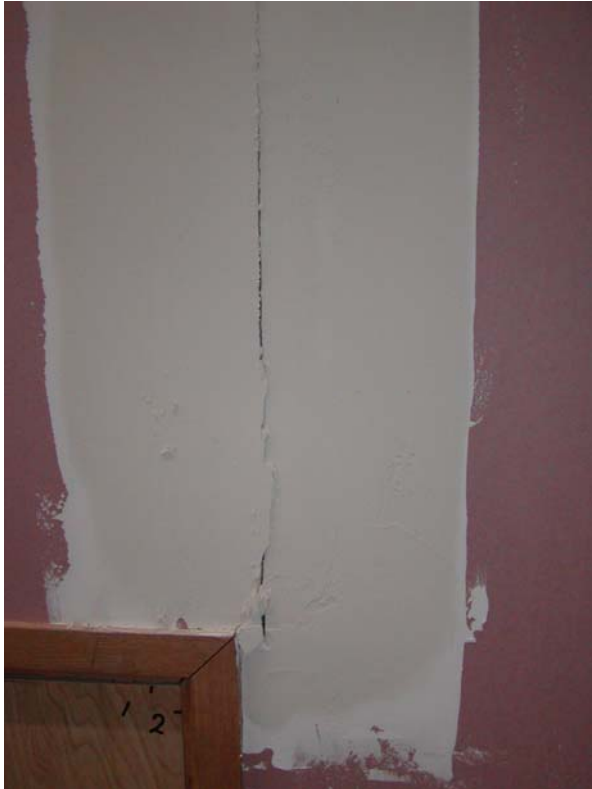
Figure 42: Racking of wall and door FR3362G door frame corner fire exposed side

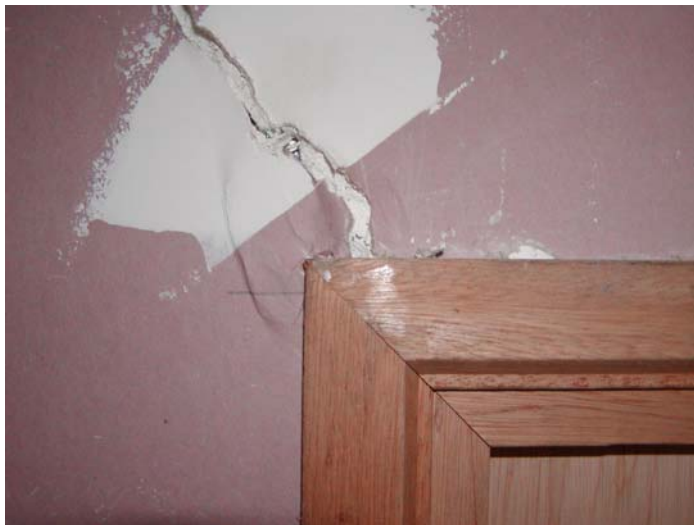
Figure 43: Racking of wall and door FR3362G door frame corner non-fire exposed side

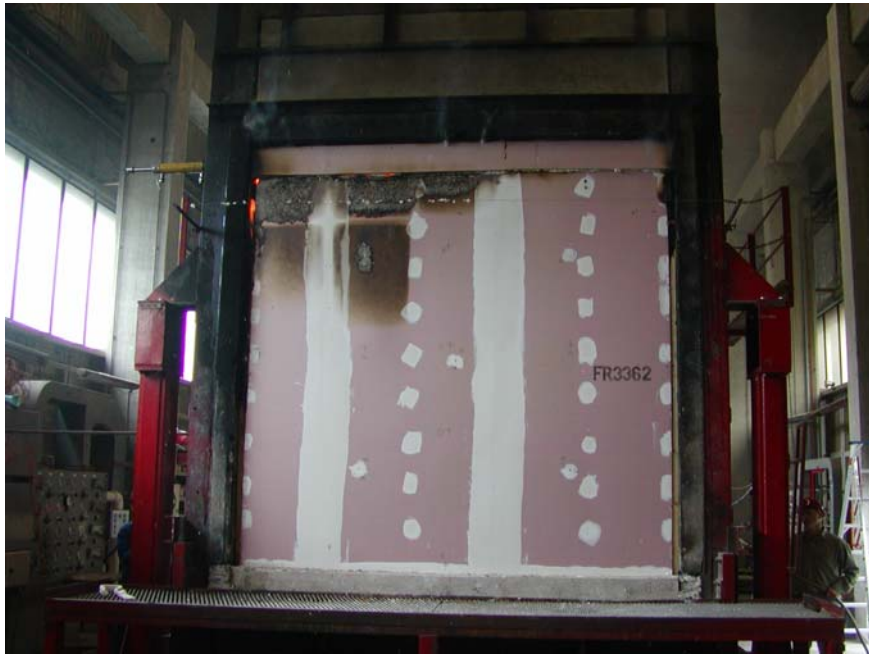
Figure 47: Non-exposed face of FR3362A at conclusion of test 53 minutes

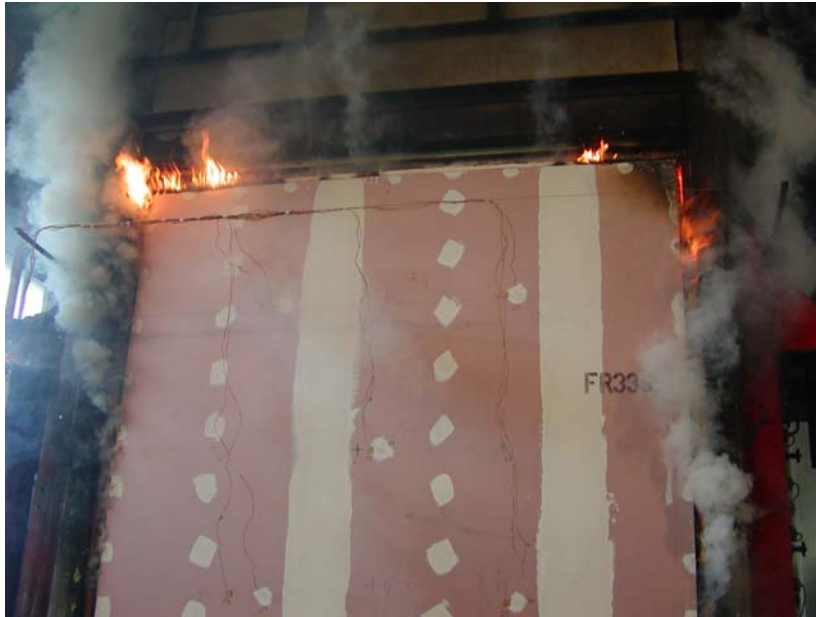
Figure 50: Flaming at top edge FR3362B 60 minutes, previously failed at bottom corner 34 minutes

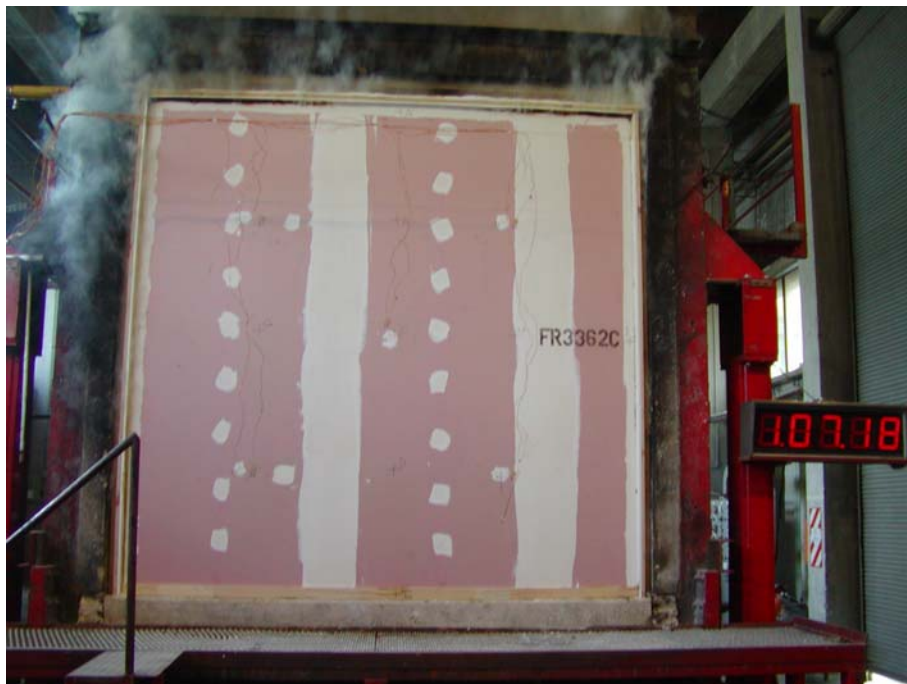
Figure 53: FR3362C at 67 minutes, the time of insulation failure

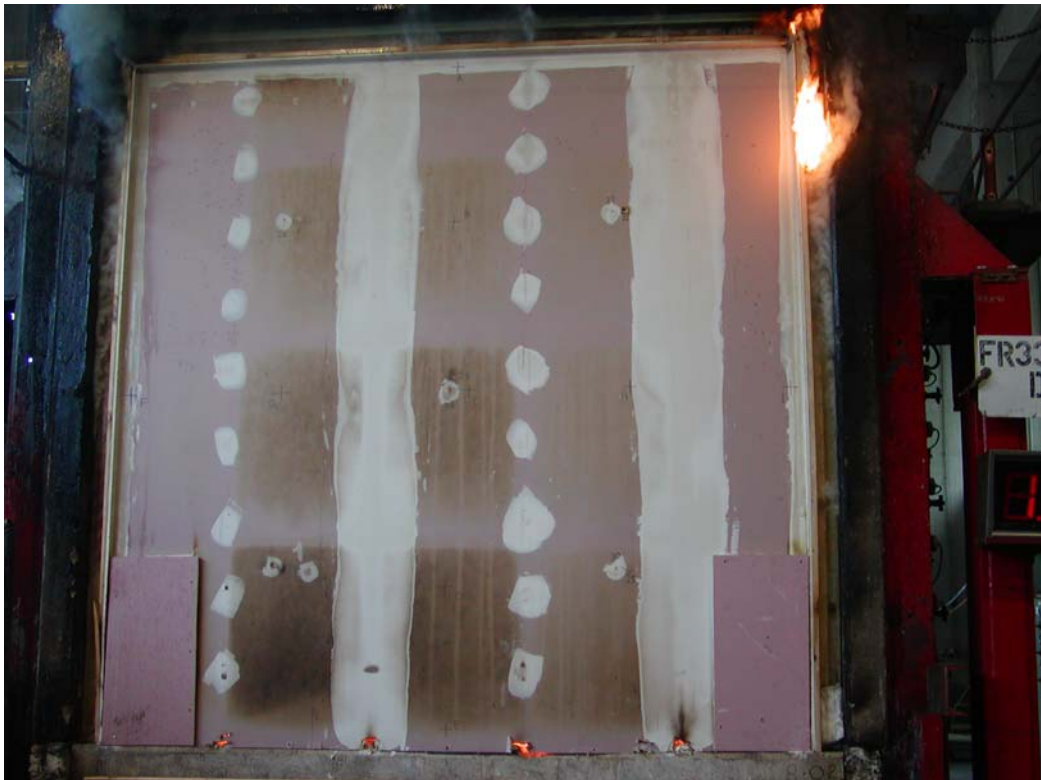
Figure 56: FR3362D at 70 minutes

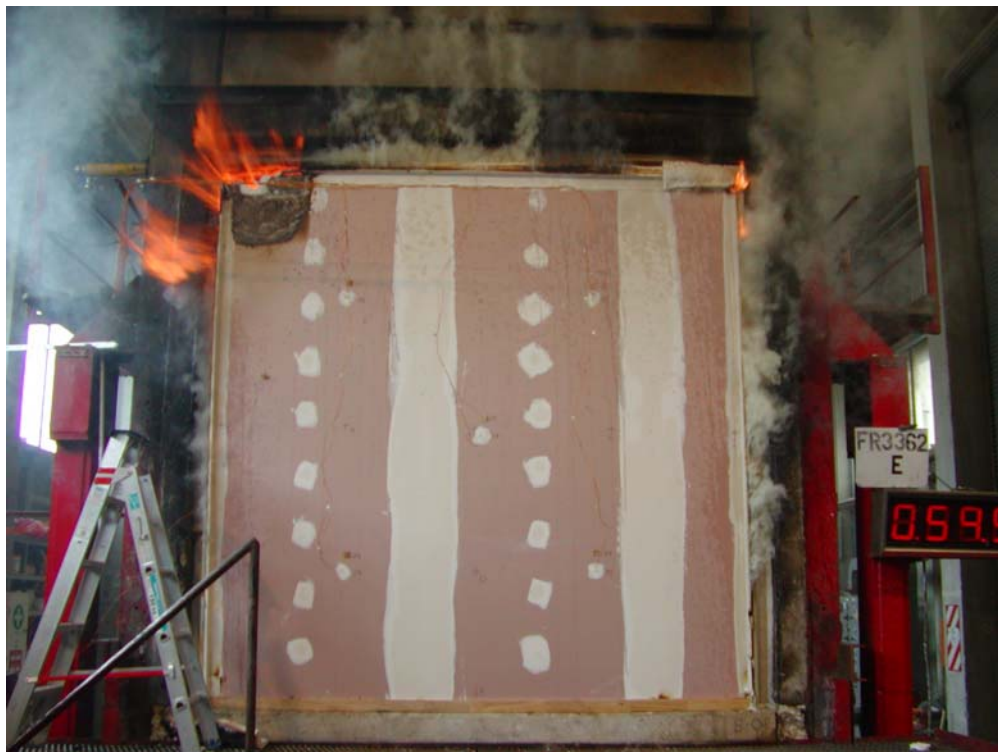
Figure 59: FR3362E end of test

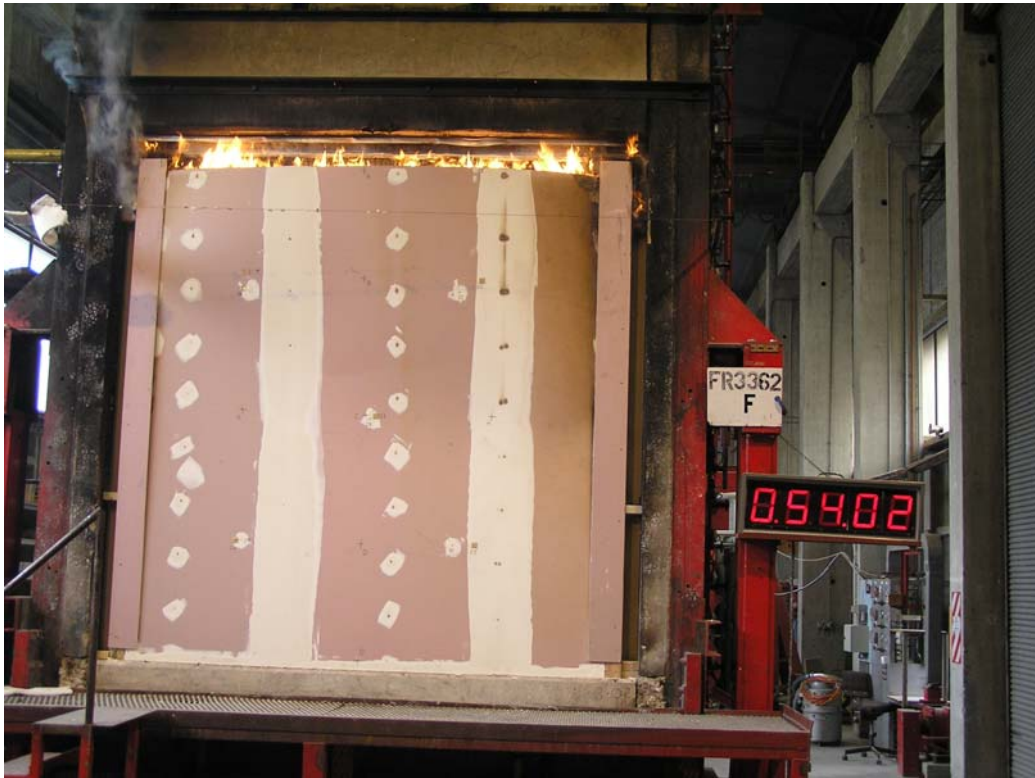
Figure 62: FR3362F at end of test

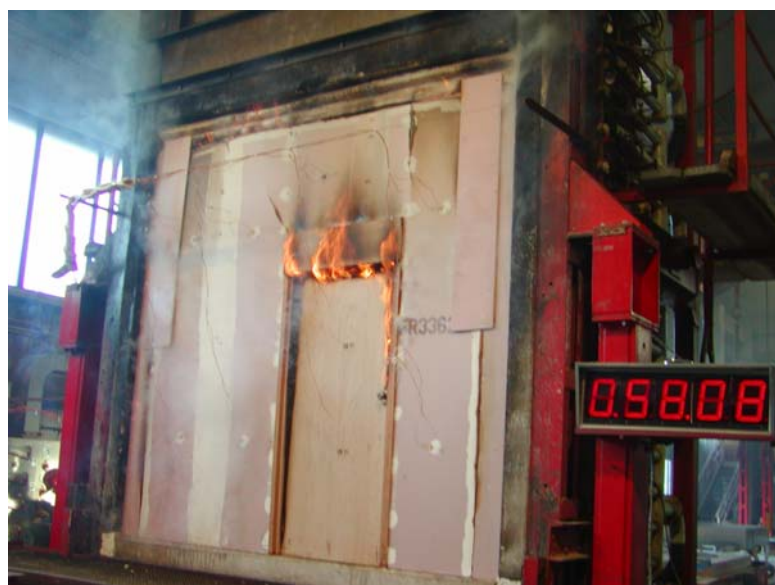
Figure 68: FR3362G at end of test
