STUDY REPORT

SR 233 (2010)

Investigation into the Performance of Urea Formaldehyde Foam Insulation

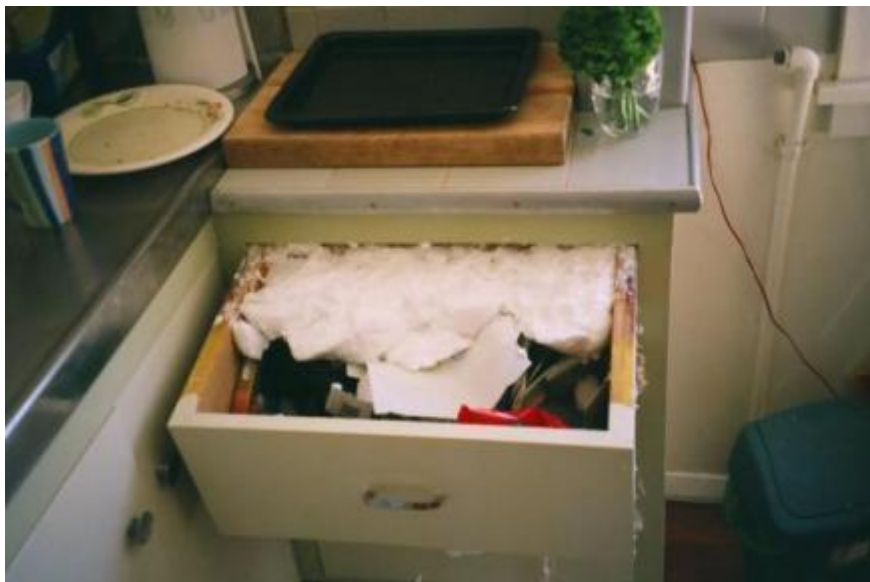
Although there have been a few reported cases where the Airfoam installation process has been problematic, such as in the case observed in Figure 1 and Figure 2, it appears that these cases are relatively rare occurrences. These issues are usually a result of installer error or lack of robust assessments prior to installation.

Figure 1: Example of serious installation problems (House W7)

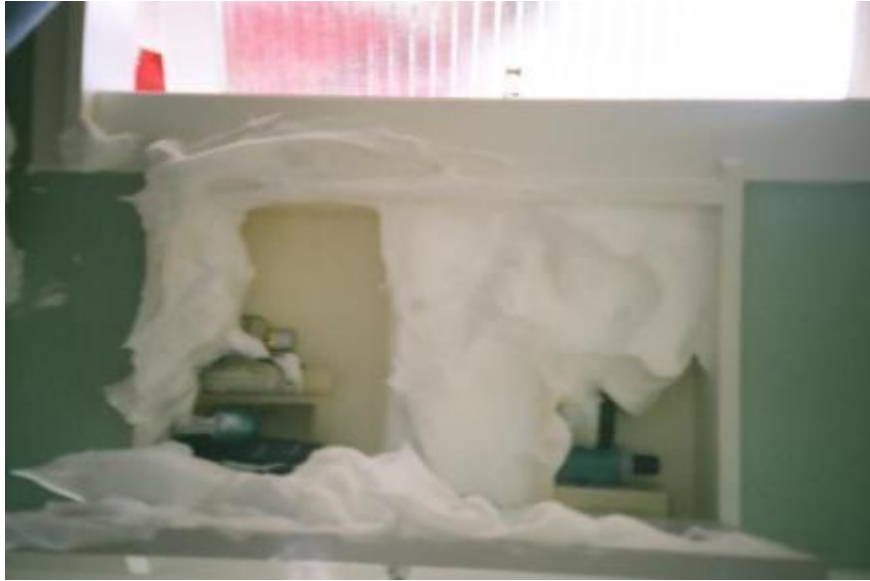
Figure 2: Example of serious installation problems (House W7)

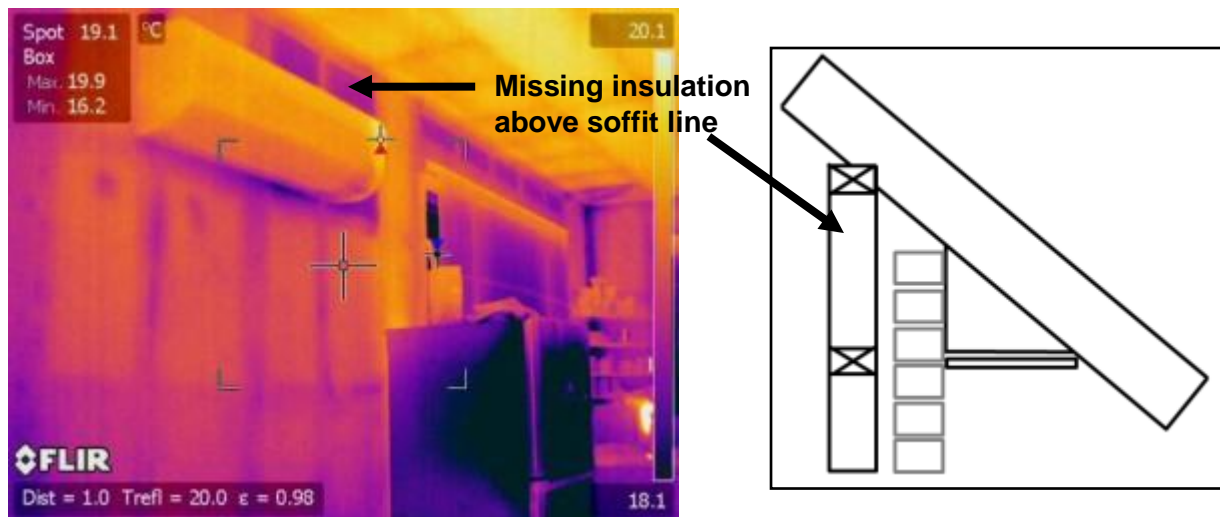
Figure 3: Thermal image identifying missing insulation in an upper wall above the soffit line (House W2)

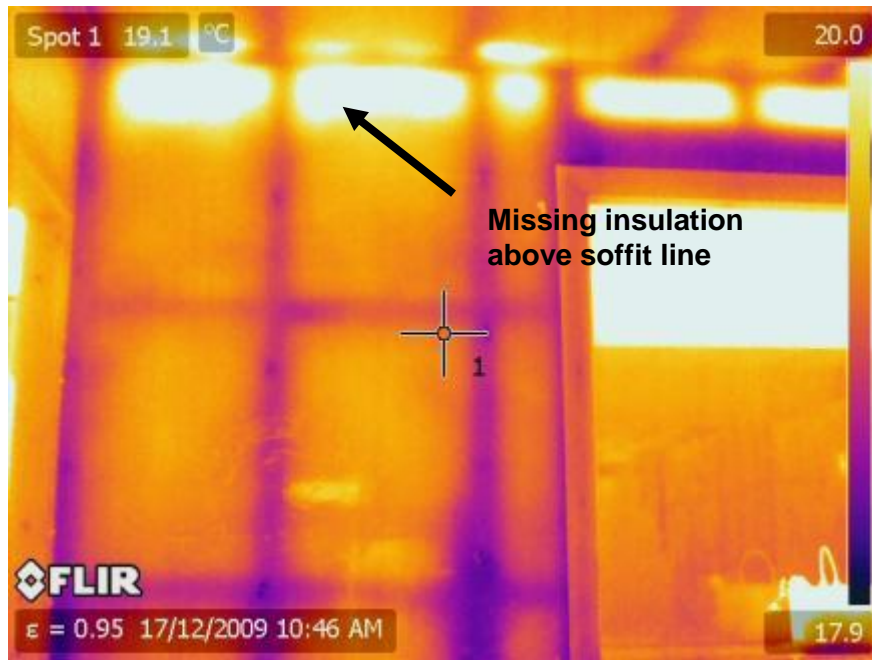
Figure 4: Thermal image identifying missing insulation in another upper wall above the soffit line (House C7)

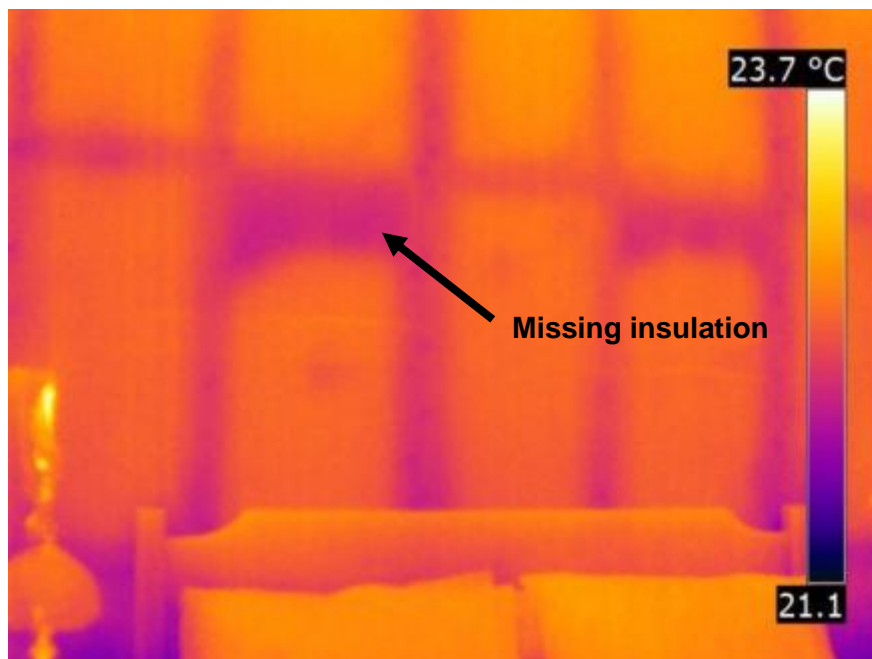
Figure 5: Thermal image identifying poor installation of Airfoam (House C5)

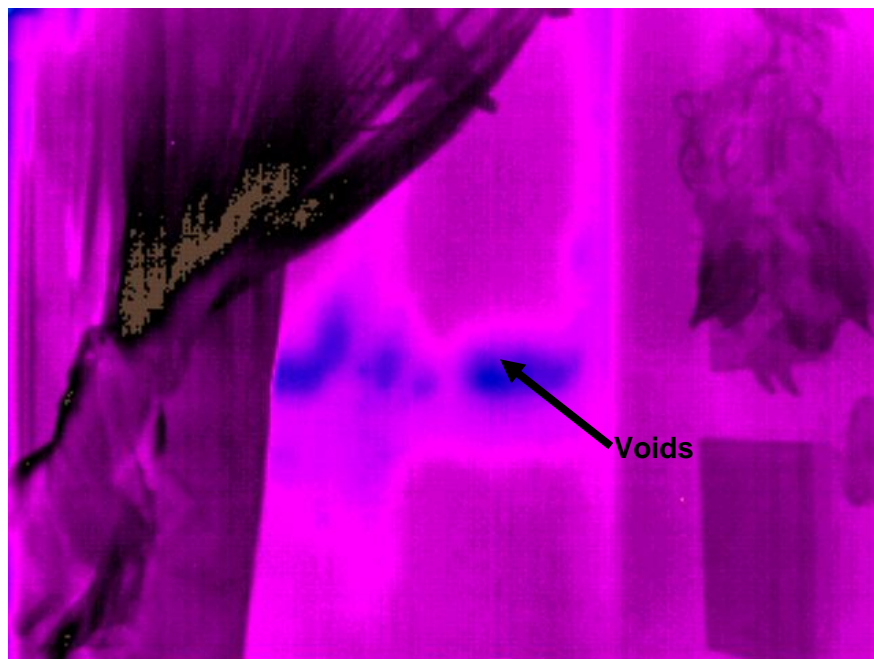
(House W4) *A brick veneer house with building paper, insulated in August 2008.* The thermal imaging showed that the Airfoam installation was inconsistent and poor in many areas of the house. The thermal imaging technique and the use of a videoscope identified some walls where there was very little (if any) urea formaldehyde foam installed at all. This was verified when the wallboards were removed in the living room. The samples collected from the house were poor quality and had many voids throughout the structure of the foam. These samples were used in some of the laboratory tests.

Figure 6: Thermal image showing voids in the Airfoam (House W4)

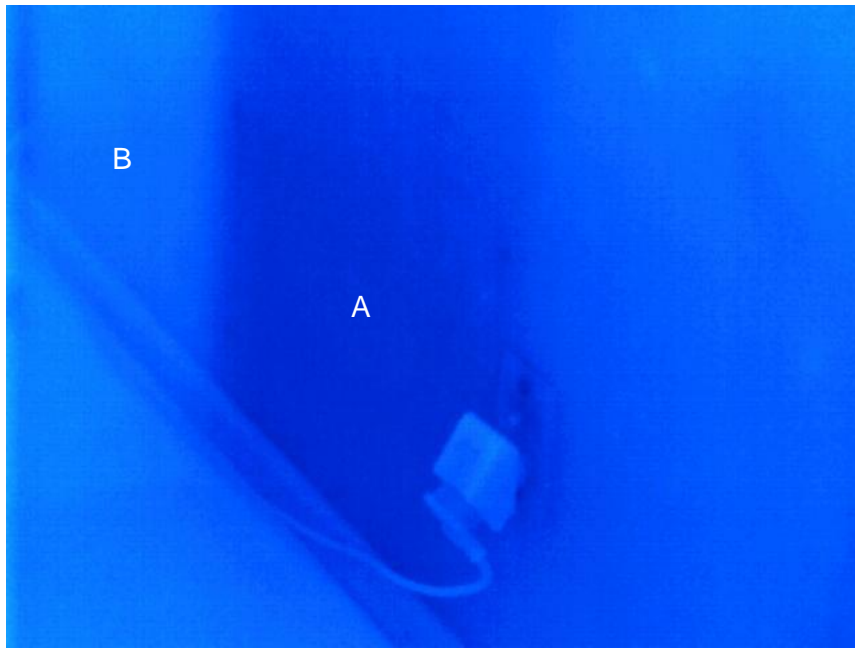
Figure 7: Thermal image indicates no product installed at A compared to B (House W4)

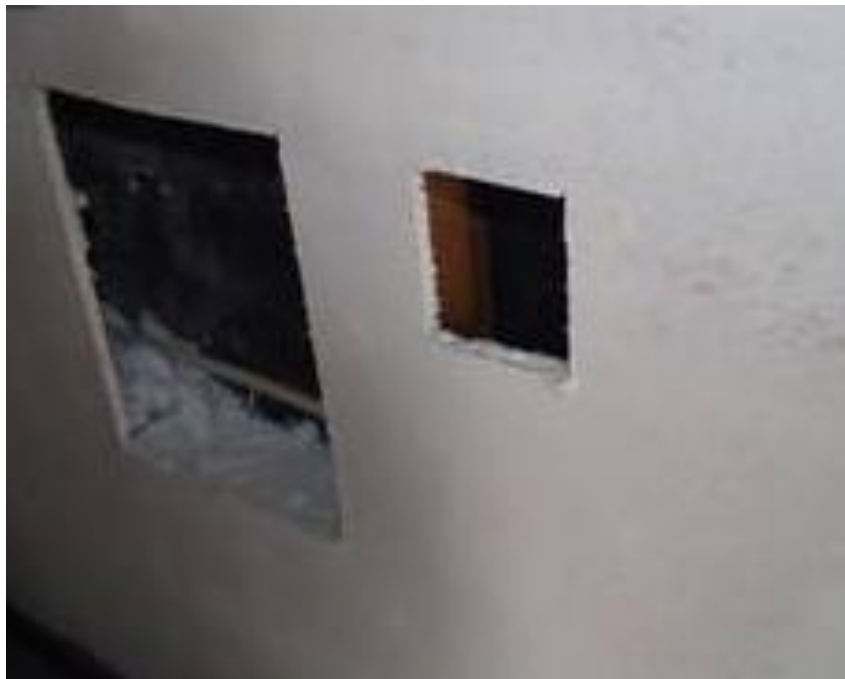
Figure 8: Removal of wallboard confirms missing insulation (House W4)

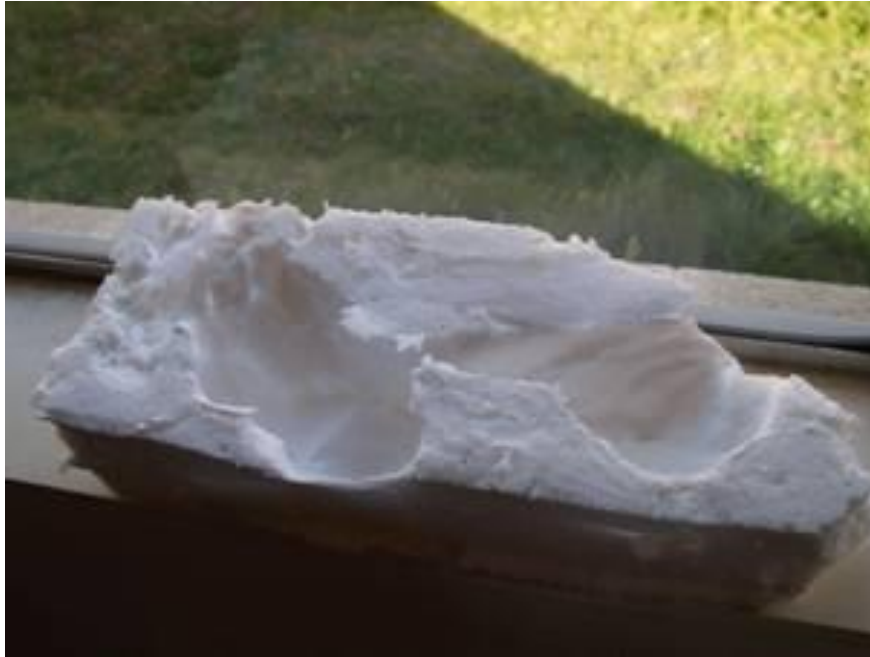
Figure 9: Airfoam sample removed from wall cavity showing voids (House W4)

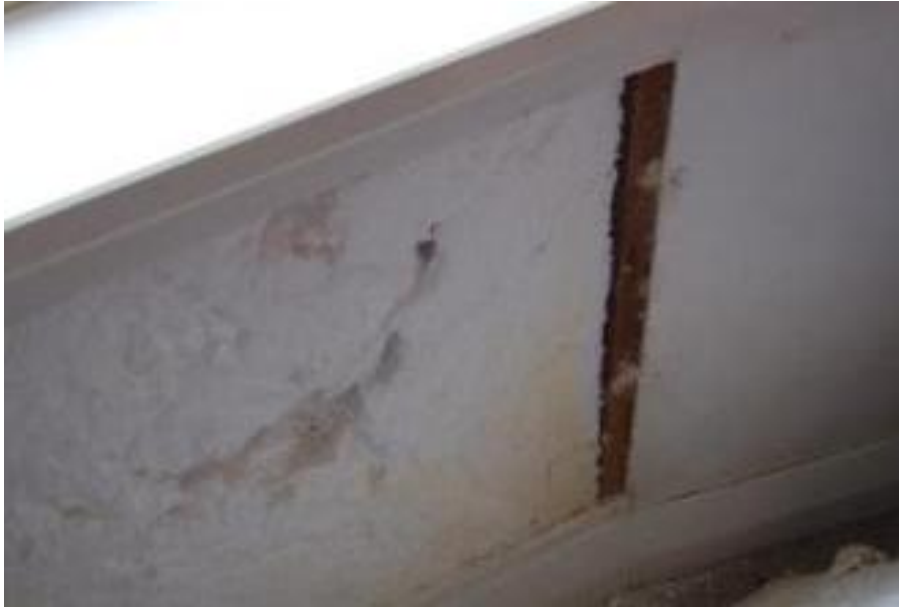
(House W3) *A weatherboard / stucco house with building paper, insulated in August 2008.* The thermal imaging again showed that the Airfoam installation was inconsistent in many areas of the house, which was confirmed when some of the wallboards were removed in the bedroom. The samples showed shrinkage from the framing and voids in some areas, which would undoubtedly compromise the thermal performance of the insulation. These samples were used in some of the laboratory tests.

Figure 10: Removal of wallboard to assess Airfoam installation – note voids present house (House W3)

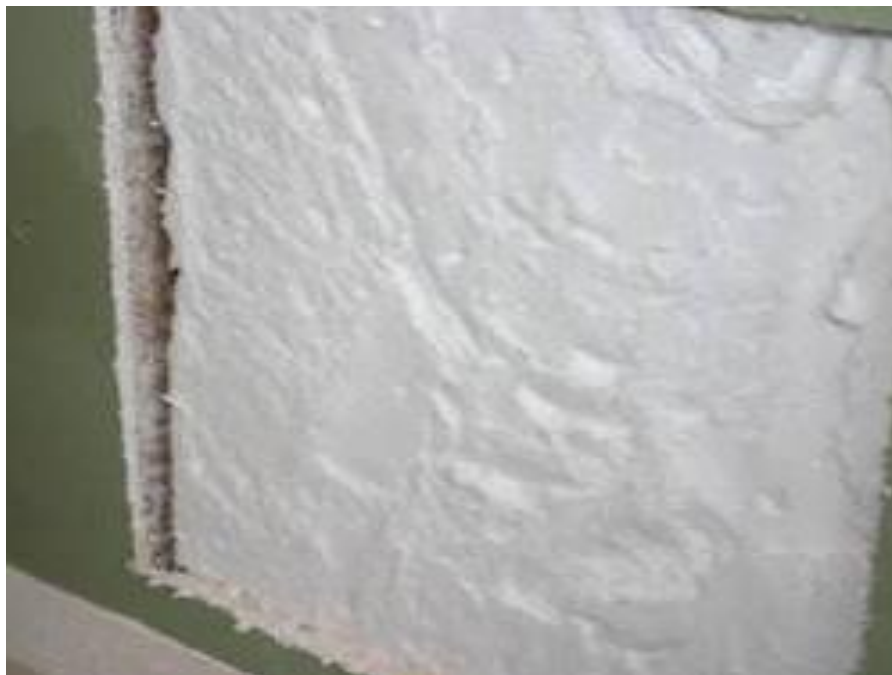
Figure 11: Removal of wallboard to assess Airfoam installation (House W3)

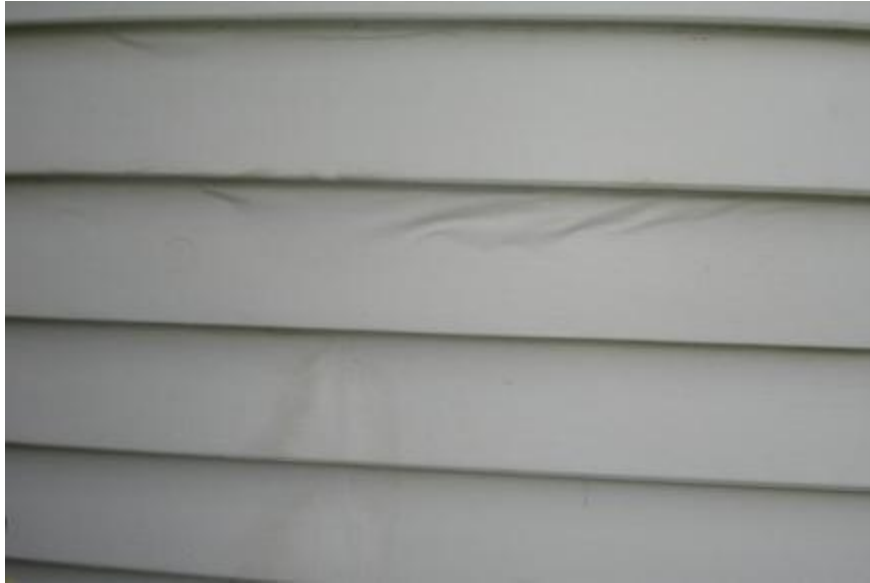
The homeowner stated that the house also had issues with blistering and peeling paint on the weatherboards, as well as a bulging tongue and groove internal lining resulting from the installation of the Airfoam. Some of these issues had since been rectified by the installer. The moisture content of the timber was very high in some places and it was clear the property had some moisture issues unrelated to the installation of the Airfoam insulation. Although the Airfoam was not the main cause of the moisture problems, the high volumes of water evolved during installation processes could have exacerbated the issue.

Figure 12: Blistering paint on weatherboard, evident after Airfoam installation (House W3)

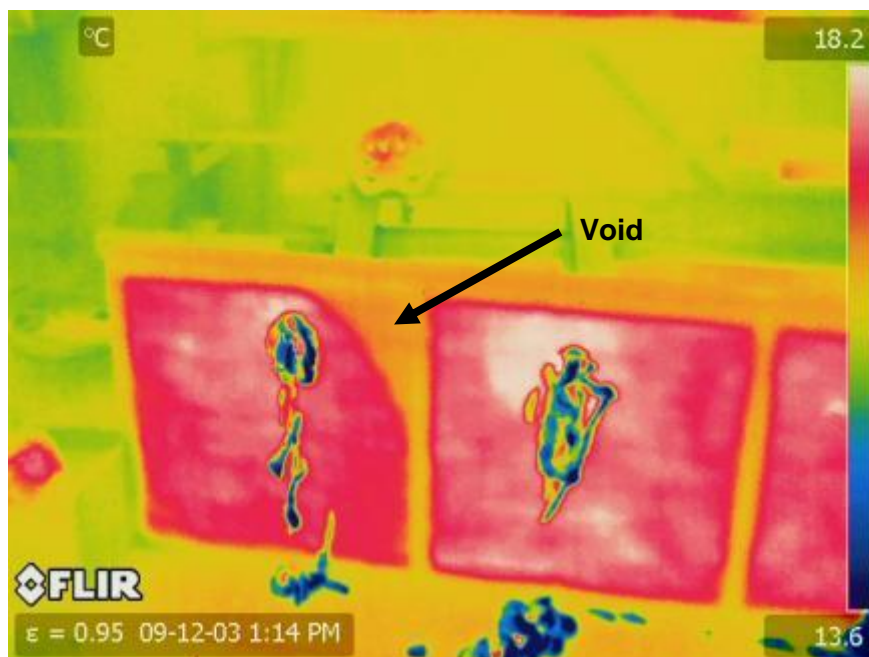
It should be noted that during the Airfoam installation at BRANZ, thermal imaging was used to evaluate the installation process. In some cases the installation of the foam was found to be unsatisfactory. For optimum results the thermal imaging analysis should be carried out post installation of the Airfoam and not during the installation process.

Figure 15: Thermal image indicating poor installation of Airfoam within test samples (D4755A)

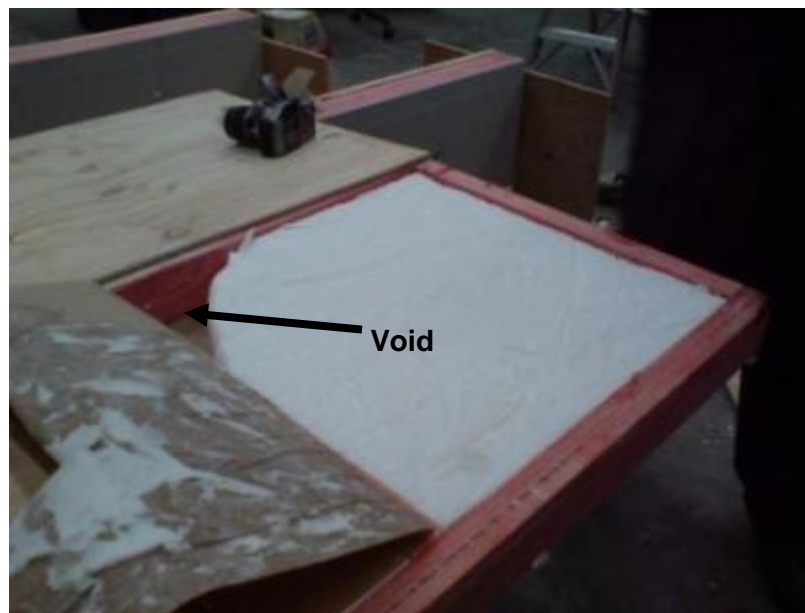
Figure 16: Confirmation of poor installation (D4755A)

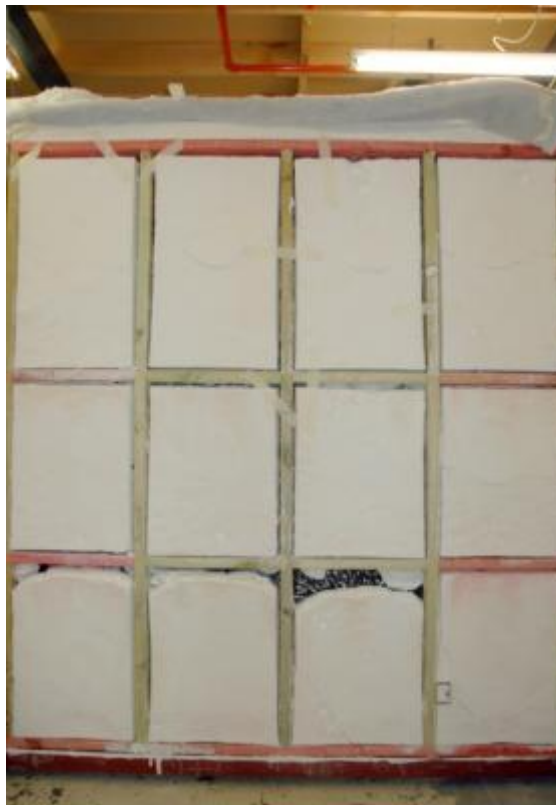
After the thermal testing, the plasterboard lining was removed from the UFFI-insulated brick veneer wall (D4863a). The UFFI insulation was observed to have shrunk approximately 6% (Figure 23). It should also be noted that within one panel the UFFI insulation was incomplete, resulting in a larger void. One further observation was that the installation of the UFFI caused bulging of the kraft paper and in some areas was in contact with the brick veneer.

Figure 23: UFFI-insulated brick veneer wall (D4863a) with plasterboard removed

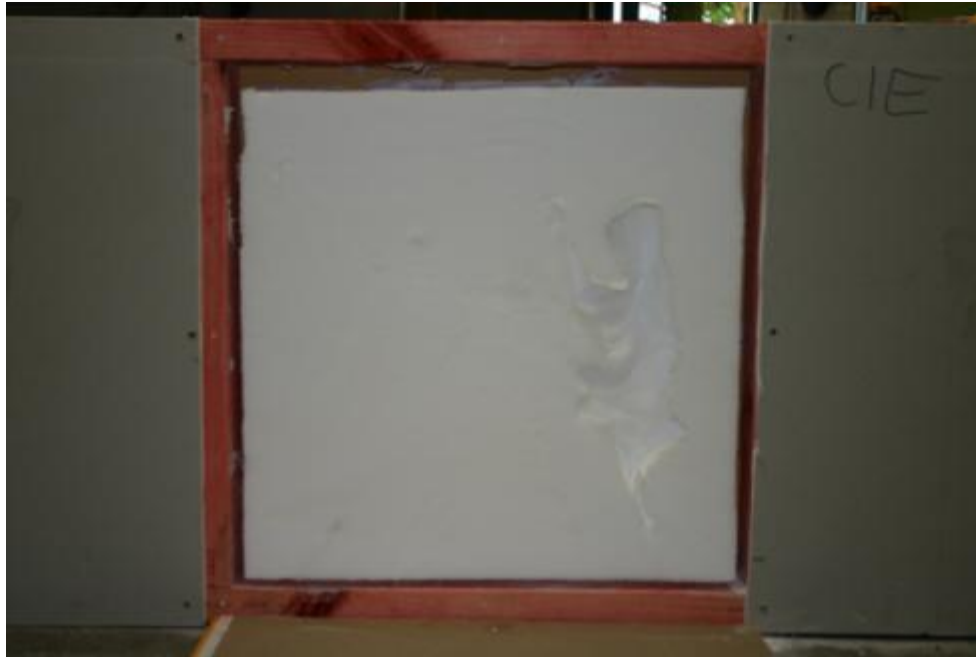
The dimensions of the fully cured UF foam in the cavities of the low walls designated C1 and C2 were also measured. The shrinkage of the samples from the rigid tubes prepared in February 2010 was measured following NZS4235 / BS5617. An average linear shrinkage of 8.97% was obtained on samples with an effective density of 11.86 kg/m³.

Figure 24: : Shrinkage in low wall C1, specimen C1D.

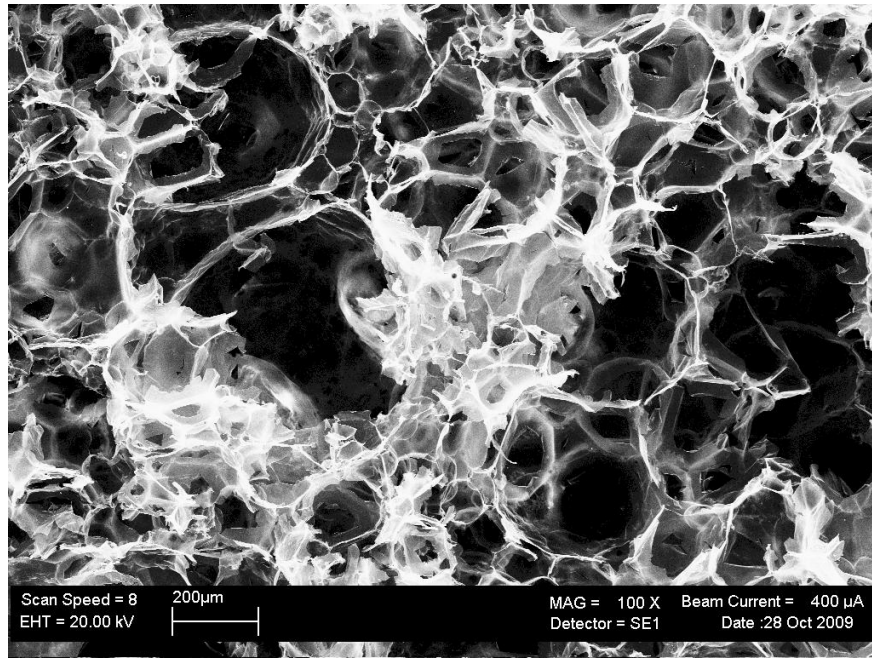
The results indicate that there is potential for further shrinkage of installed and dry UF foam material if subjected to thermal / humidity cycling and that this potential additional shrinkage will vary in the different directions within the wall. Since the results indicate further shrinkage is possible, additional work was completed on Airfoam-prepared samples, as described in Section 5.2.7. Scanning electron microscope (SEM) images of the cell structure of the foam pre- and post aging are shown in Figure 25 and Figure 26

Figure 26:SEM of Airfoam sample from House W3 after accelerated aging, showing collapsing of foam structure

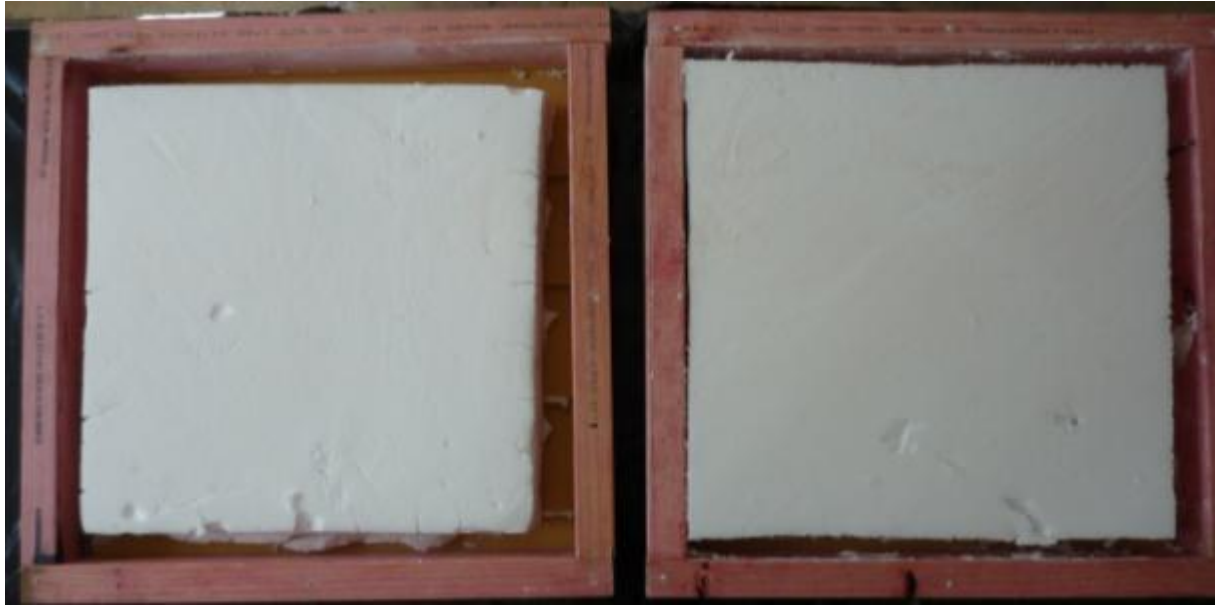
Figure 27: Shrinkage in low wall specimen C1E (left) after aging following 'AS 4073-1993 Appendix H' compared to control specimen C1A

The results confirm that there is potential for further shrinkage of installed and dry UF foam material if subjected to elevated temperatures / humidity during service. The AS4073-1993 Table 1 'Properties of Set Foam' requires a maximum shrinkage of 4% at elevated temperature and humidity. The results for the Airfoam-prepared samples (Table 10) indicate that the product does not satisfy these requirements. Samples were examined using scanning electron microscopy (SEM) to inspect the cell structure of the foam. The results further supported earlier work by CSIRO,¹¹ which demonstrated that the UF foams collapse under high humidity conditions and potentially emit formaldehyde as the foam structure breaks down. Images of a control sample and a sample aged following the procedures of AS 4073-1993 Appendix H are shown in Figure 28 and Figure 29.

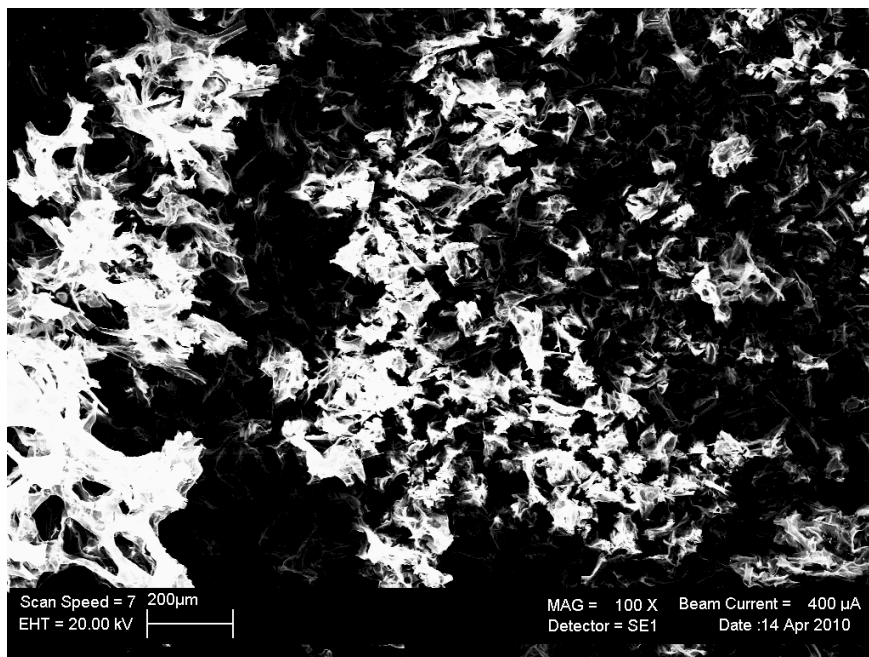
Figure 29: SEM of Airfoam sample C1E after accelerated aging, showing collapsing of foam structure
