STUDY REPORT

SR234 (2010)

Investigation into the Performance of Brick Veneer Walls Installed with Urea Formaldehyde Foam Insulation – A Case Study

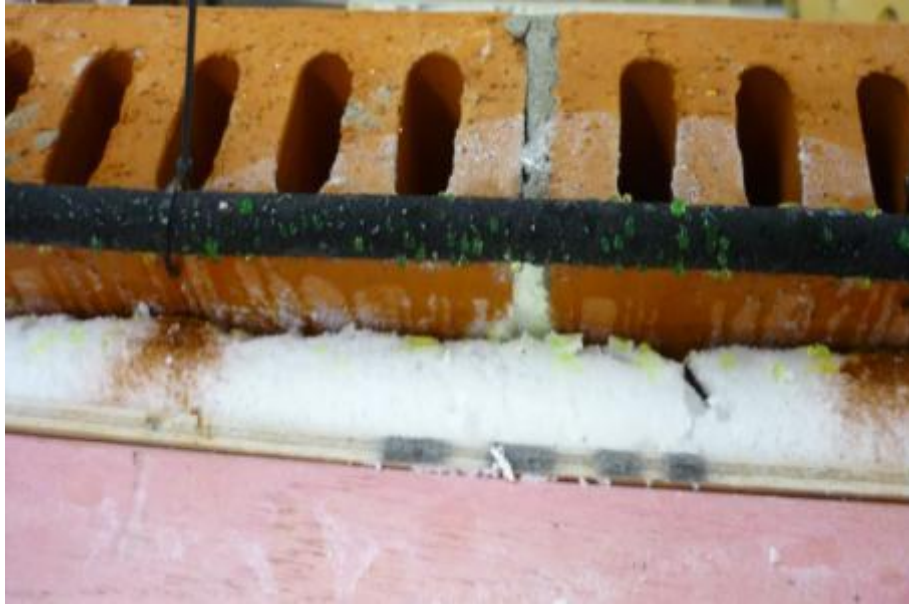
Brick veneer walls are known to be relatively porous and have been designed to include a water managed cavity throughout their history of application in New Zealand. Cladding water leakage studies at BRANZ⁴ have measured leakage rates through brick veneer walls of 0.04 l/m².min. and this rate has been used to calculate a target water application rate of 0.26 l/min for application at the head of the test wall. The test brick wall measuring 2.4 m wide by 2.7 m high was built in the laboratory and fitted with a porous tube (see Figure 1) to feed water to the back of the cladding. The dosing rate was controlled by a peristaltic pump, which was later measured using a catch and weigh method. The wall wrap was replaced in this test wall with a sheet of transparent Perspex to ensure that any water leakage would be seen. It was noted that water tended to initially to flow down the wall in defined trails (see Figure 1) but that in time, the flow spread out as the full surface of the brick wall became wet.

Figure 1: Water applied through a porous tube (D4864)

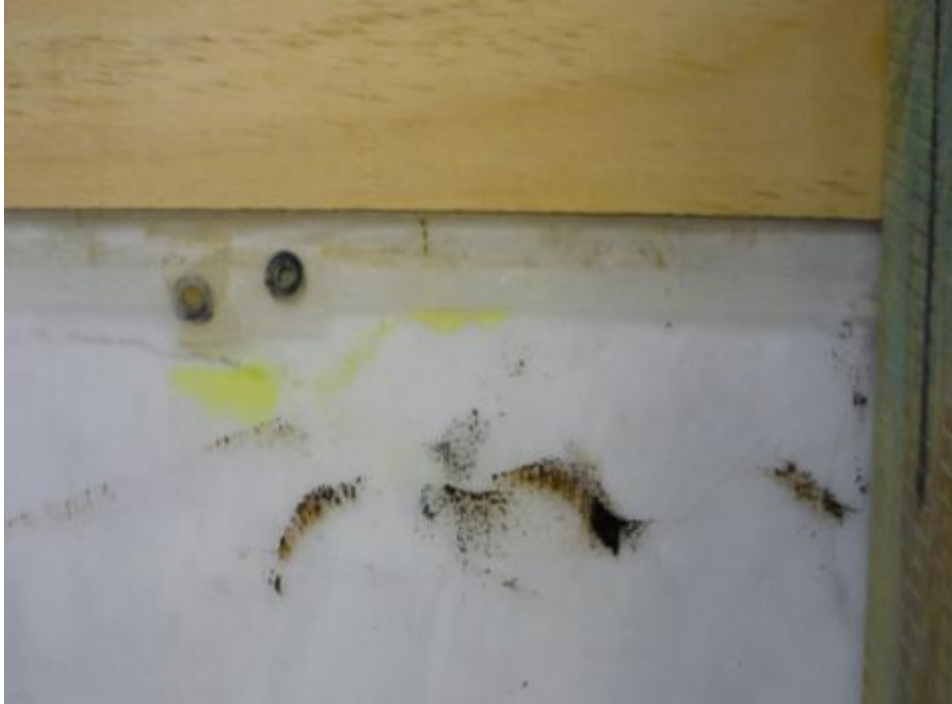
Figure 2 to Figure 4 show water reaching the wall wrap position only minutes after the start of water leakage down the back of the cladding. This is evidence that the foam fill in the water managed cavity has provided drainage paths to the wall wrap position.

Figure 2: Leakage observed 2 minutes after start of test (D4864)

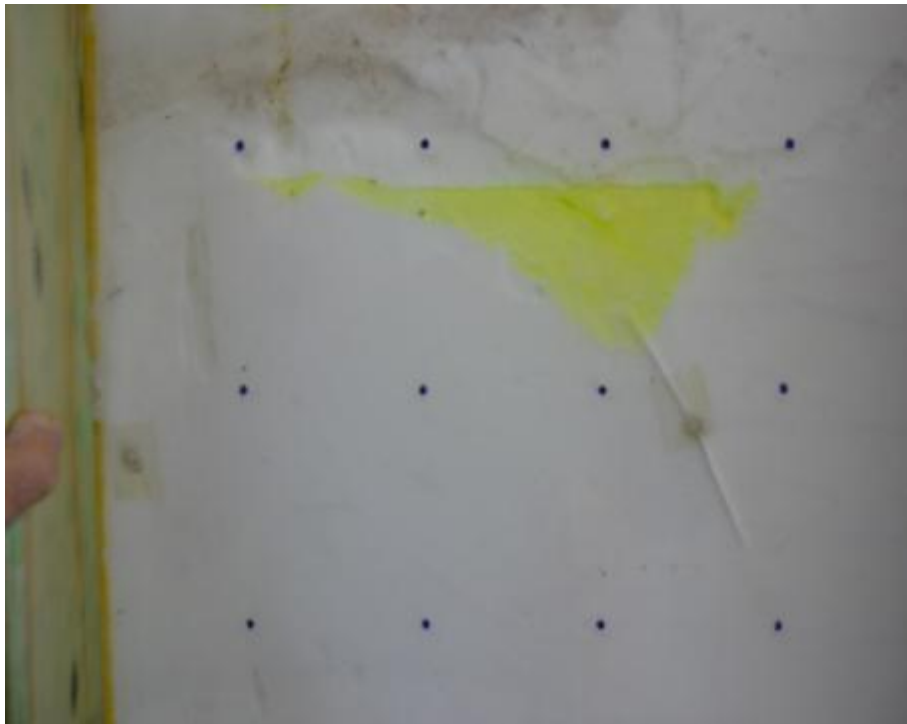
Figure 3: Leakage observed 6 minutes after start of test (D4864)

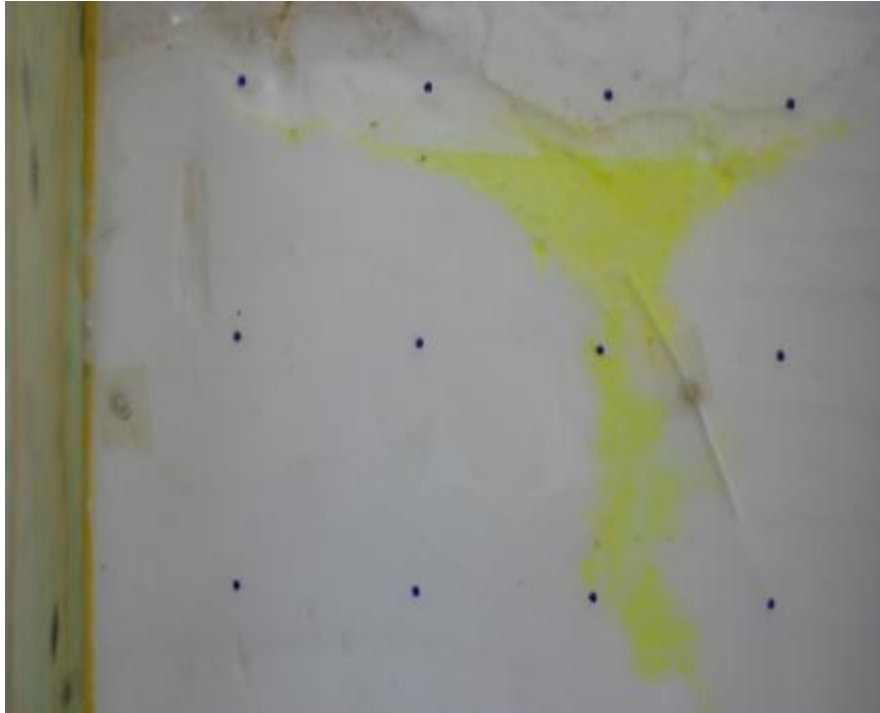
Figure 4: Leakage well established 43 minutes after start of test (D4864)

The measurements described in this report show that the small cavity formed between the brick veneer and insulation by shrinkage was insufficiently continuous to prevent water bridging across to the insulation where it was transported to the building wrap position. The drainage cavity in the test wall did not provide a reliable drainage path for water leakage on the back of the brick veneer cladding.

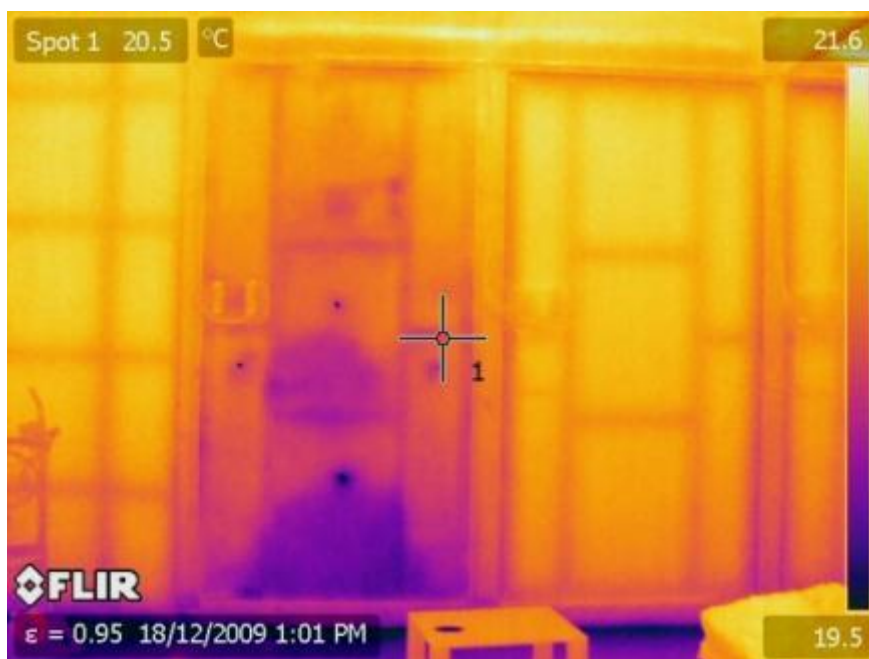
Figure 6: Thermal image of brick veneer test sample during drying stage after Airfoam installation

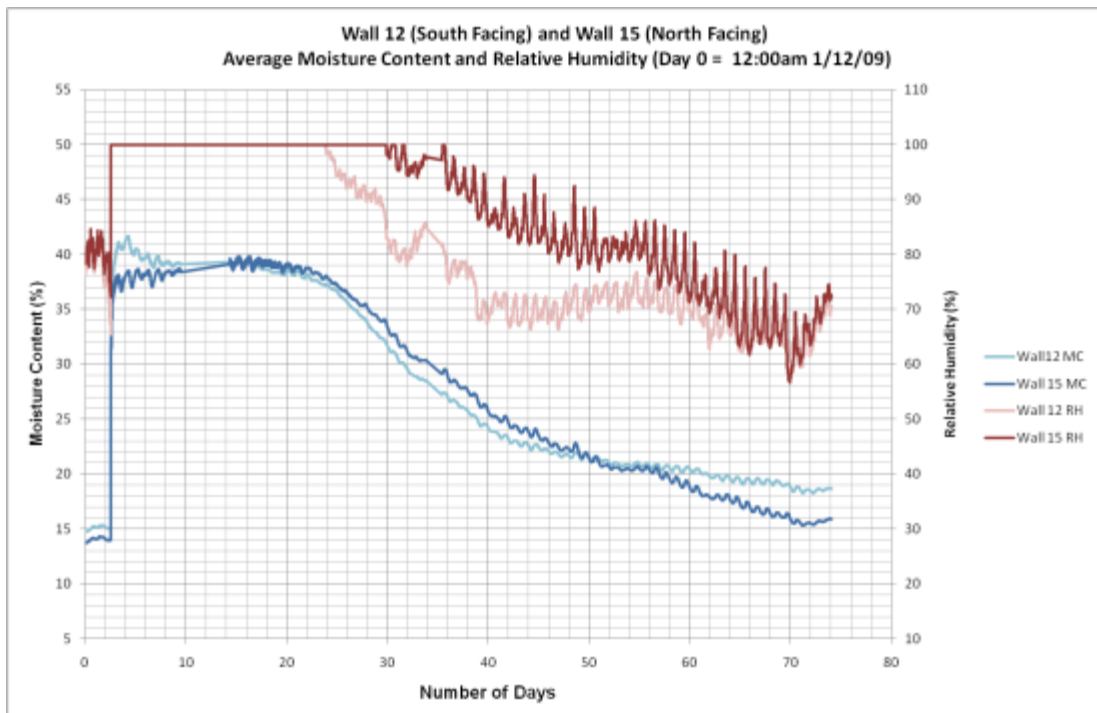
Figure 8: Average Results from Brick Veneer Walls in Test Hut

Figure 8 shows the results from both walls for the period from 1/12/09 to 13/2/10. The installation of the UFF insulation causes a rapid rise in both the relative humidity in the cavity and the moisture content of the framing.

The moisture content of the framing stayed roughly constant for about 2 weeks and then began to slowly dry out. In February 2010, several weeks after installation, the timber was still above the pre-UFFI levels. The results for both walls are similar, but past work indicates that had the UFFI been installed in the winter, the south facing wall would take considerably longer to dry and would be likely to stay wet for the whole of the winter.

The humidity measurements are representative of the moisture in the foam. The results show that the humidity is at 100% (free moisture) for 2-3 weeks before drying out. The foam in the north facing wall dried quicker (about 5 weeks) than its south facing counterpart (about 8 weeks), but in both cases the foam dried at a considerably quicker rate than the framing. Sustained high humidities have the potential to support mould growth and so should be avoided if possible.
