# **STUDY REPORT**

**SR 241 (2011)**

## **Corrosion of Fasteners in Treated Timber**

**Z.W. Li, N.J. Marston and M.S. Jones**

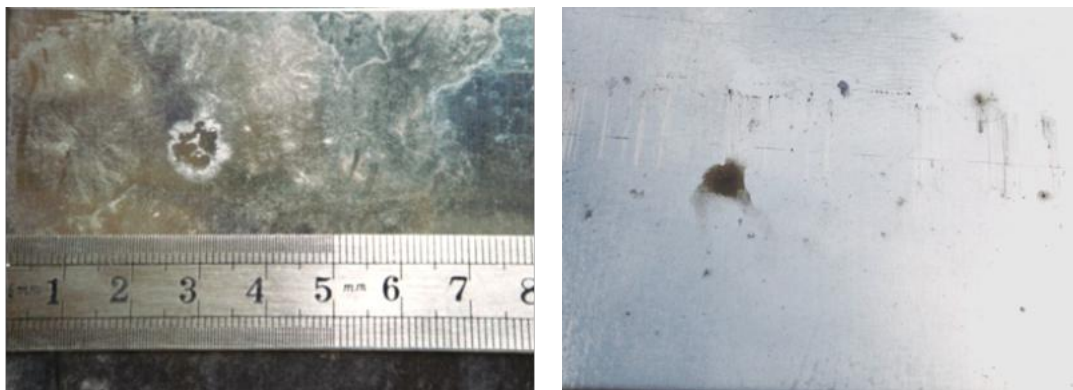
**Figure 12:** Stained (left) and scratch-corroded (right) areas observed on stainless steel flashings attached to H4 CuAz treated timbers and atmospherically exposed at Judgeford site for one year

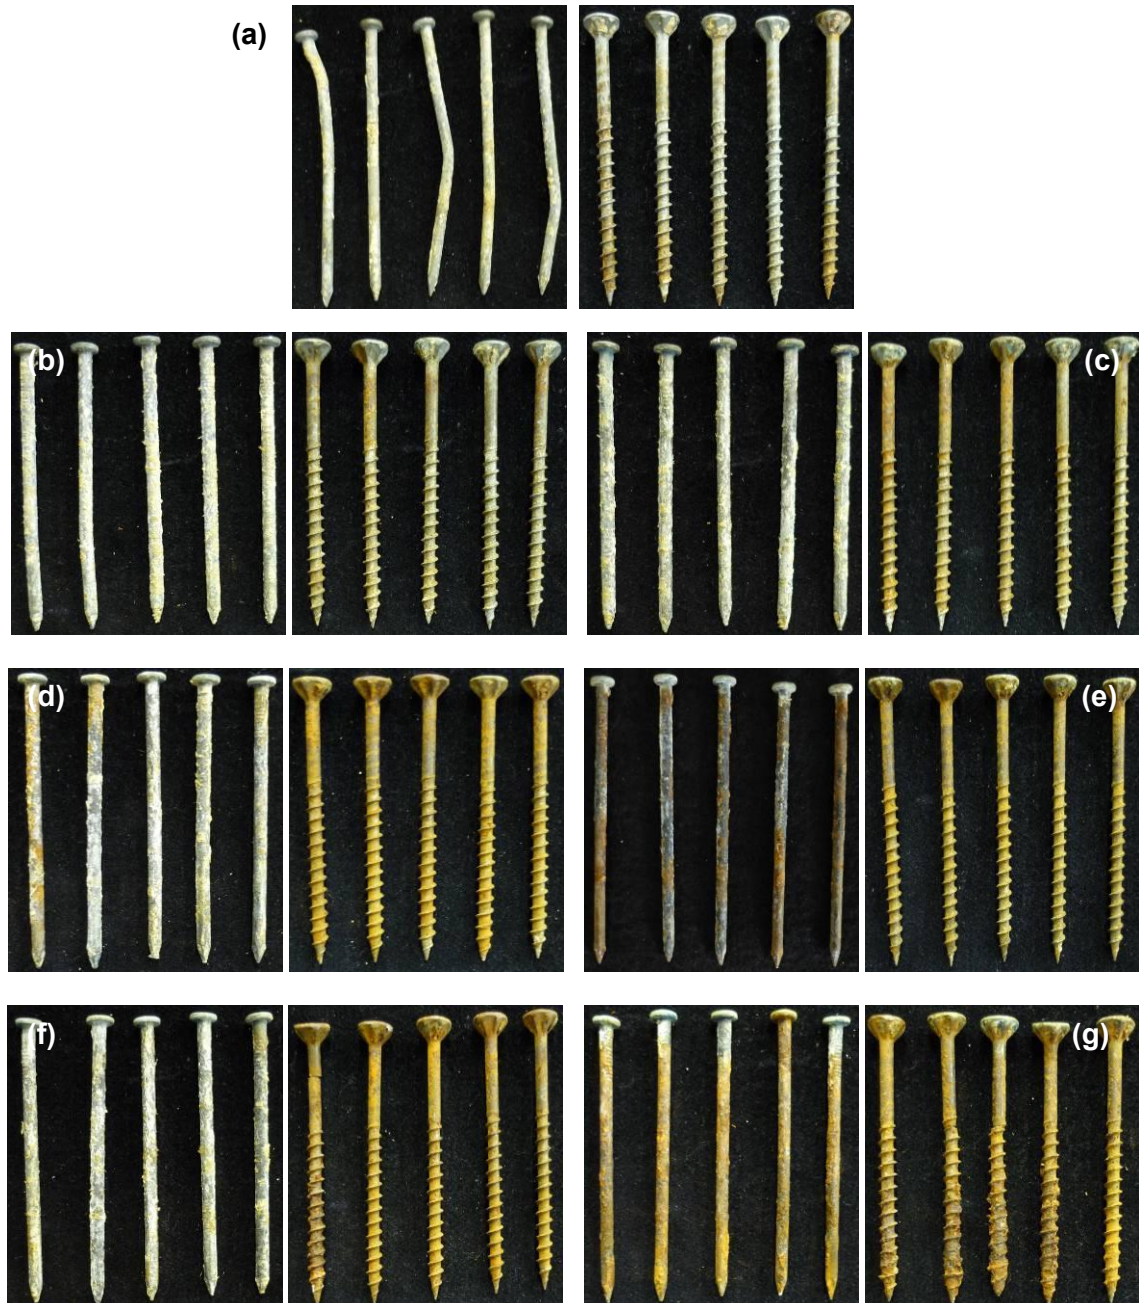
**Figure 18:** Typical surface morphology of stainless steel fasteners retrieved from H4 ACQ treated timbers exposed at Judgeford site for two years (these fasteners were inserted into the timber blocks fixed at the lower (side) part of the gate structure and their longitudinal orientation was parallel to the ground). Very limited iron-rich rust was occasionally found on the head top surface and the body section is free of damage

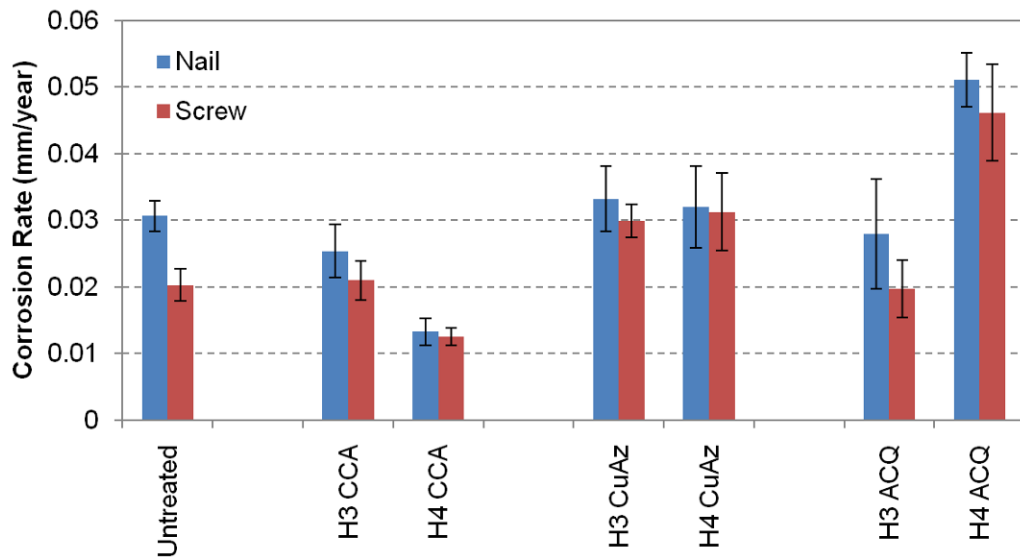
The corrosion acceleration imposed by H4 ACQ can be as high as 3.8 times greater than that of H4 CCA.

**Figure 39:** Corrosion rates of mild steel fasteners embedded into timbers exposed at Oteranga Bay for three years (these fasteners were retrieved from the top part of the gate-shaped timber structure i.e. their longitudinal orientation was vertical to the ground)

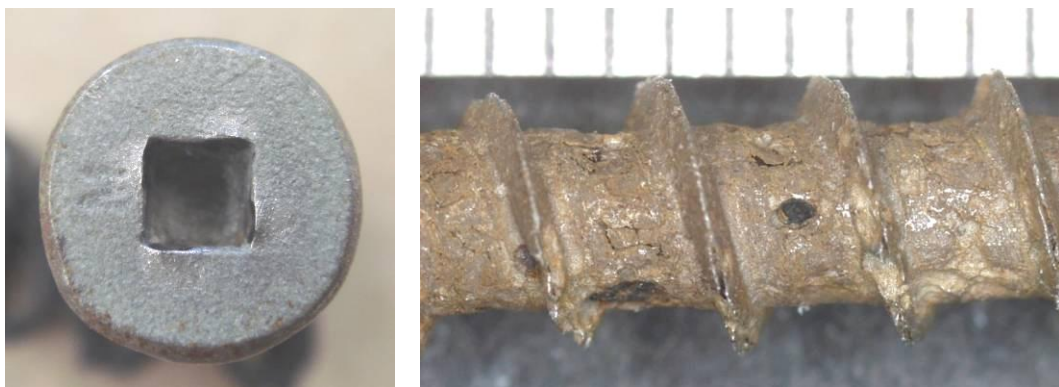
**Figure 53:** Morphologies of head and thread of a mechanically-plated screw retrieved from H4 ACQ treated timber exposed at Judgeford site for two years. The conditions of the zinc coatings on the head and the body were significantly different

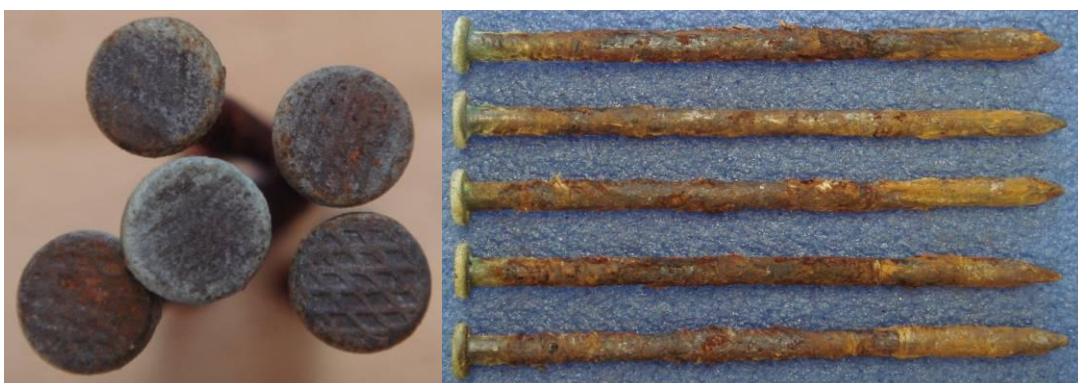
**Figure 54:** Hot dip galvanised steel nails embedded into H4 ACQ treated timbers exposed at Judgeford site for three years. The formation of iron-rich red rust on the top surface of the head is not as severe as on the shaft

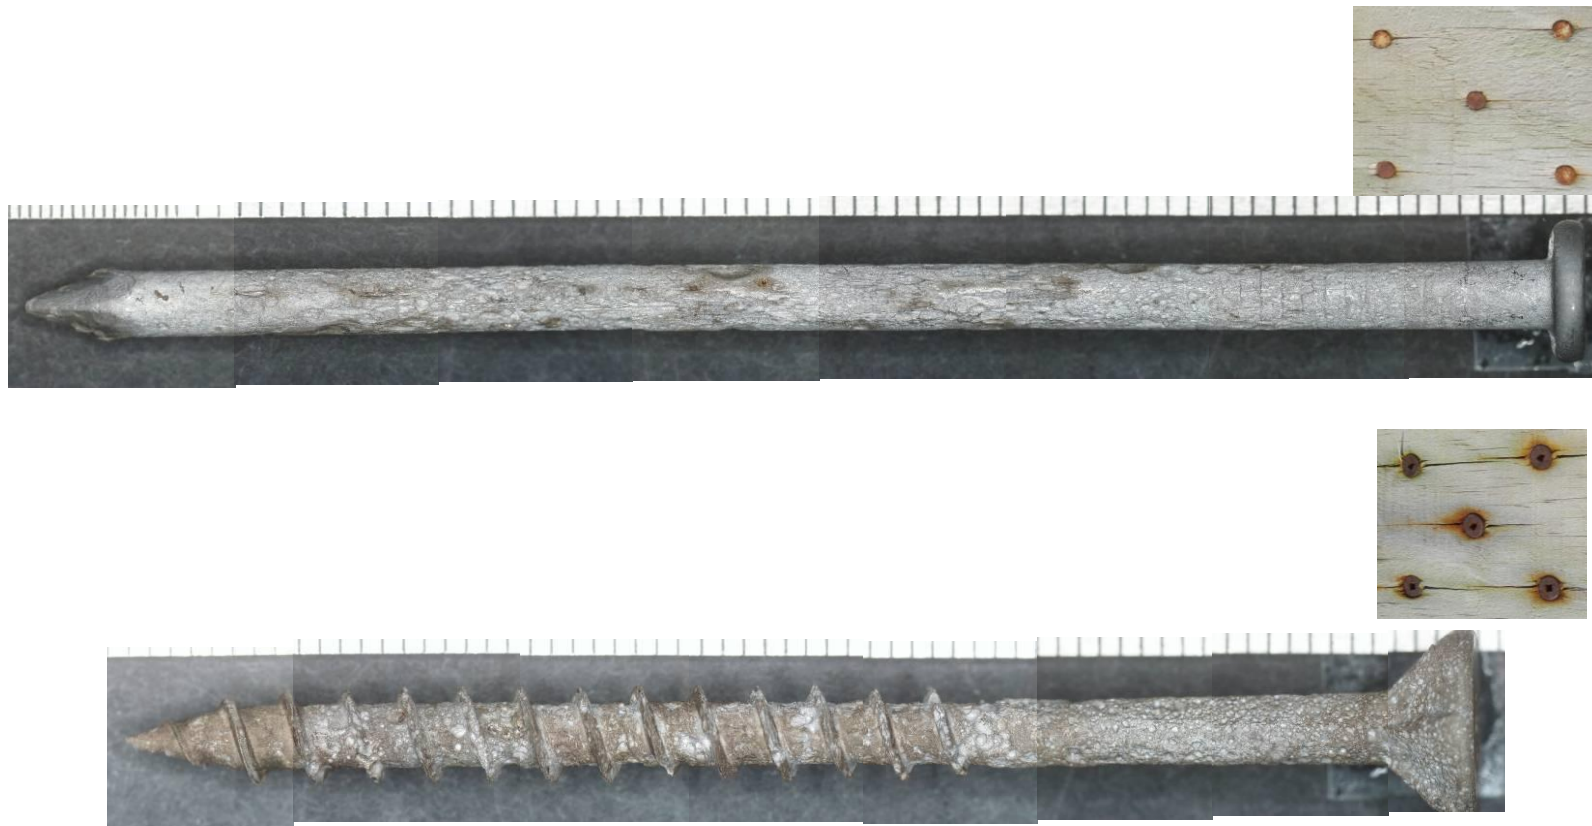
**Figure 55:** Cleaned zinc-coated fasteners retrieved from H4 ACQ treated timbers exposed at Oteranga Bay for three years. The zinc coating on the head was consumed and then iron-rich rust was formed. However, it must be noted that corrosion on the body section was still more severe than on the head

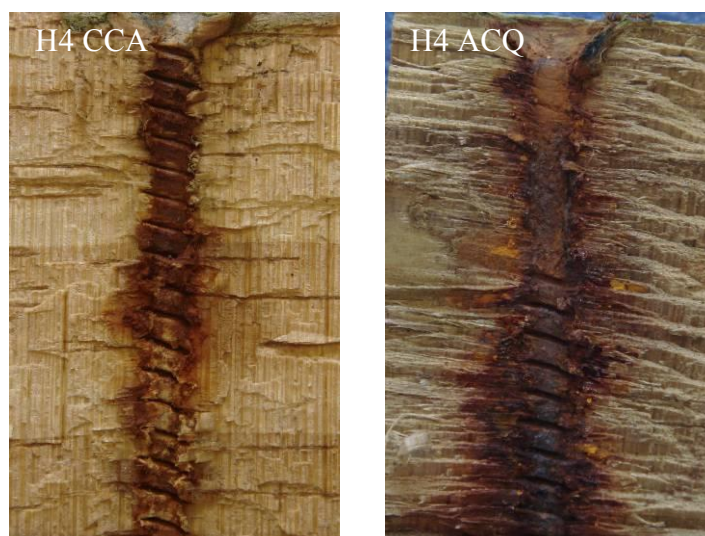
**Figure 56:** Iron stains formed by corrosion of mechanically-plated screws in H4 CCA and H4 ACQ treated timbers exposed at Judgeford for three years
