# **STUDY REPORT**

**SR 327 (2015)**

## **Structural Performance of Houses in the Canterbury Earthquake Series**

**G.J. Beattie, R.H. Shelton and G.C. Thomas**

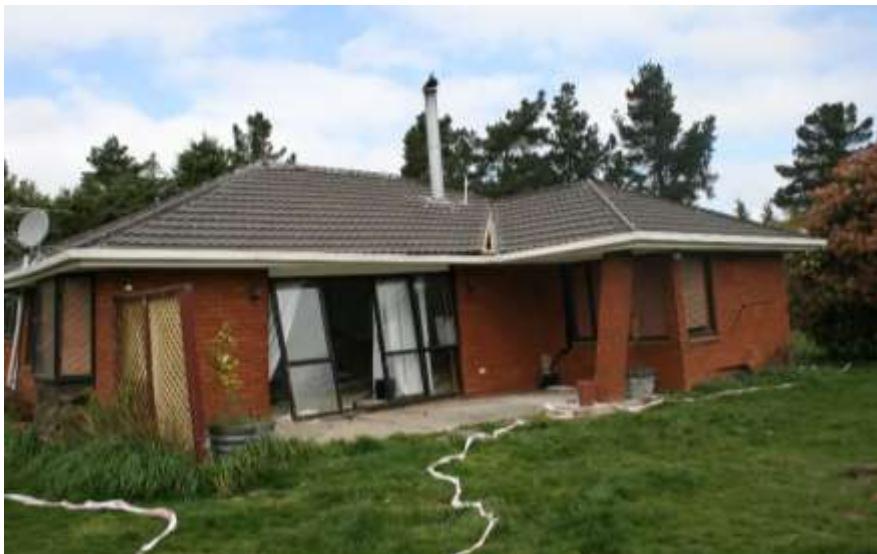
Much of the damage to houses on the flat was due to differential ground settlement and lateral spreading associated with liquefaction and varied from quite minor to major (Figure 9).

**Figure 9. House severely damaged by differential ground settlement and lateral spreading**

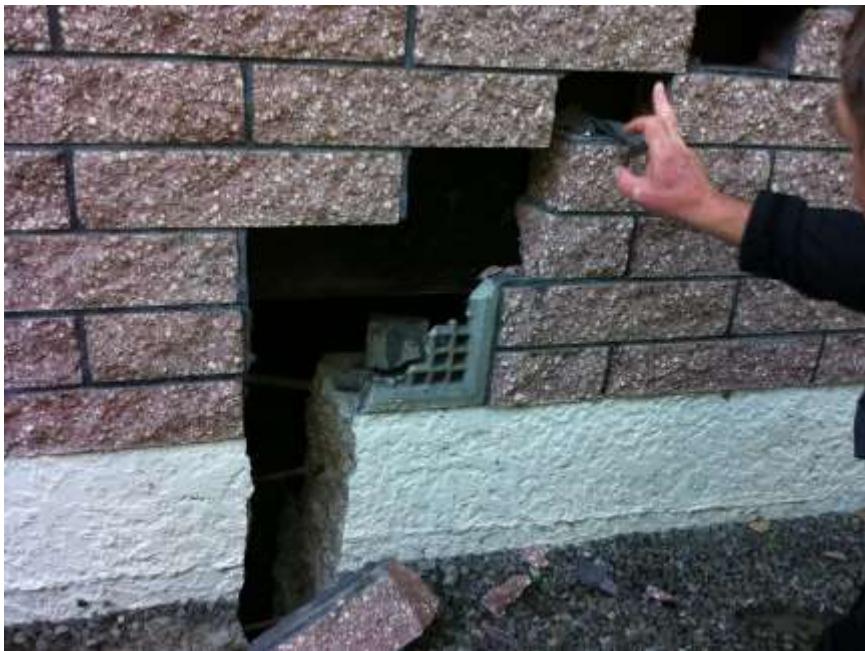
The common perimeter concrete foundation in combination with internal piles also fared well under ground shaking but was affected by varying degrees by the ground movement. It was usual for these perimeter foundations to be unreinforced in the early to mid-20th century houses, but most foundations constructed after this contained at least one 12 mm diameter bar, often plain. Whether reinforced in this way or not, these foundations were unable to resist the ground deformations associated with lateral spreading and severe liquefaction, and they fractured (Figure 10).

**Figure 10. Example of reinforced concrete perimeter foundation pulled apart by spreading ground (note reinforcing bar crossing gap in foundation)**
