Study Report

SR412 [2018]

Medium-density housing construction quality survey

Matthew Curtis and Nick Brunsdon

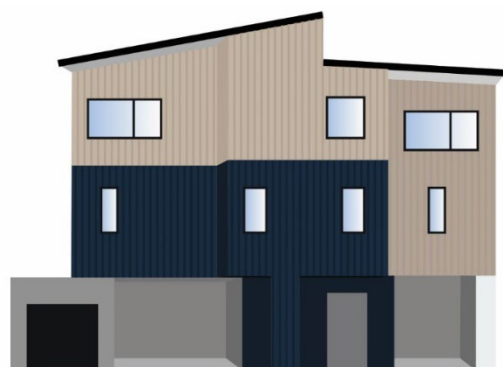
Case study 1 is a two-unit, 3-storey duplex. It was constructed using timber framing with some steel portals and vertical cedar weatherboard. The surveyor's general assessment of the site was that it was accessible, had evident health and safety procedures and was reasonably clean and tidy during the construction of the units. The consented building plans were not on site at the post-underlay inspection carried out by the surveyor.

The post-wall underlay inspection found that the general workmanship on the wall framing, roof framing and joinery was good on both sites. One of the sites was noted to have some bottom plates that had been cut out to run services and required repairs or replacement. However, no further defects were found at the post-underlay inspection.

No poor or incomplete building work was identified during the final inspection. However, poor workmanship and incomplete workmanship was found throughout both units. Internal doors in some bedrooms and a bathroom were found to be poorly installed. Cupboard doors in the bedroom of one of the units were twisted and needed refitting. A strip of daylight could be seen at a roof to fascia junction. However, there were no evident issues from the external inspection. Finally, the inspector found that some of the lower edges of the cladding required sealing to prevent moisture damage from occurring.

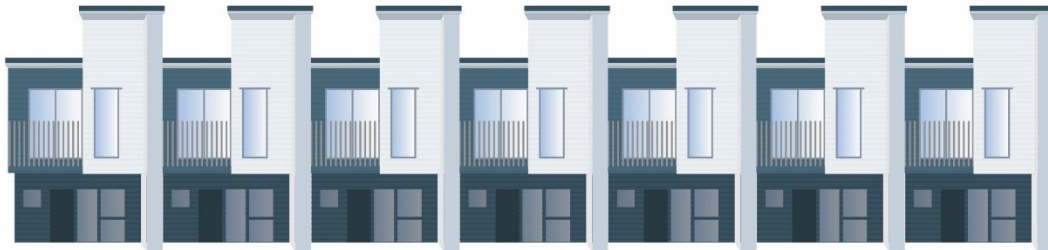
4.1.3 Case study 3 – new MDH

Case study 3 is a seven-unit, 2-storey row of townhouses. It was constructed using timber framing, Speedwall and concrete blocks and clad with timber horizontal bevel-back weatherboards. The surveyor's general assessment of the site was that it was accessible, had evident health and safety procedures and was in good overall condition. The building plans had been placed on all four sites and appeared to have been followed.

General workmanship at the post-wall underlay inspection across the majority of the four sites inspected was found to be good. However, workmanship on one of the sites was found to be average at the post-wall underlay inspection.

There was no poor or incomplete building work found on three of the four units surveyed. On the fourth unit, the metal capping to the fire wall between units was found to be poorly installed and required some reworking.

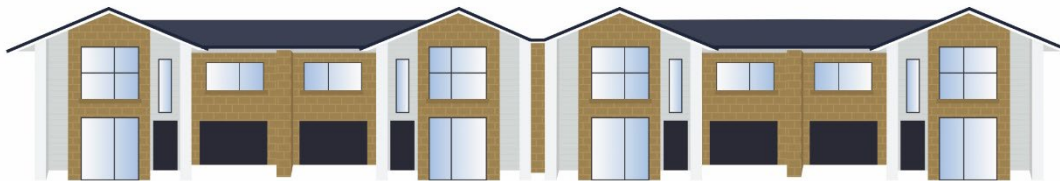
4.1.5 Case study 5 – new MDH

Case study 5 is a four-unit 2-storey row of townhouses. It was constructed using steel framing and clad with brick and fibre-cement bevel-back weatherboards. The surveyor's general assessment of the site was that it was accessible, had evident health and safety procedures and was generally tidy. The building plans were available for all four units. However, they did not appear to have been followed in all respects, particularly the cladding.

The general workmanship of the wall framing was found to be average at the post-wall underlay inspection. Framing and inter-floor connections were incomplete. Bottom plate connections and hold-down bolts were also incomplete. The builders had started installing the roof and cladding despite the structural work not being complete.

The wall underlay was not correctly secured. The fixings should have been at 300 mm centres to each stud, as per the manufacturer's specifications. However, they were only held in place by the cavity battens, some screws and tape. The joinery flashing tape was not installed right over the sill, although it was not required to be according to the consent documents. The penetrations were not taped and sealed, nor were the head flashings. The battens were not installed correctly. They were fixed at 1200 mm centres, and some were loose. The builder advised that they do this as the cladding fixings provide the necessary fixings.

At the final inspection, the surveyor found a number of items that were classed as poor or incomplete building work. They found a screw head on the exterior cladding that had not been filled. This could be repaired to prevent damage to the fixing. The pipes and cables penetrating the exterior cladding were not sealed around to prevent moisture getting in behind the cladding.

The bottom edge of some of the weatherboard cladding had split, which required repairs or replacement to prevent moisture ingress. There was also a gap down the side of some scribes, which required repair to prevent moisture getting in behind the cladding. The bottom edge of the weatherboard had not been painted, although they had the factory seal. The weatherboards were also out of alignment at the join, indicating incorrect installation.

There was paint splatter on the brick cladding, which is not good trade practice and could be removed. The bricks were inside the foundation line in some areas, which can allow water to wick back in behind the bricks. This may also have affected the width of the cavity at these points. There was a large gap in the cladding where the head flashing penetrated above the front exterior door. It was not known by the surveyor if there was a concealed flashing behind this. There were some gaps down the side of the facing boards that could be sealed to prevent moisture getting in behind the cladding. The cladding joins were visible, indicating they had not been correctly prepared. The bottom edge of the box corners had not been sealed and required painting to prevent moisture soaking up the end grain. The join in the scribes was out of alignment.

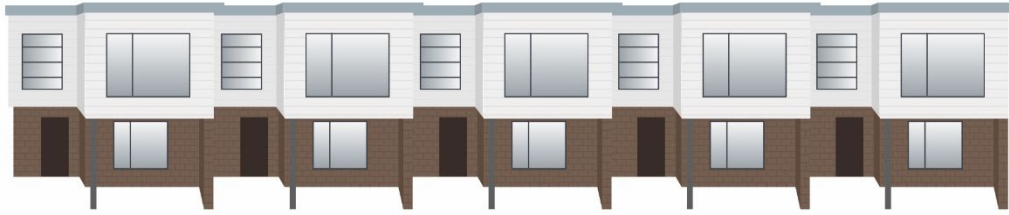
4.1.6 Case study 6 – new MDH

Case study 6 is a six-unit 2-storey row of townhouses. It was constructed using timber framing with clay brick and horizontal fibre-cement weatherboard cladding. The surveyor's general assessment of the site was that it was accessible, had evident health and safety procedures and was in good overall condition. The consented building plans were placed on all four sites and appeared to have been followed.

In general, workmanship was found to be good on the four sites surveyed. However, during the post-wall underlay inspection of one of the sites, the wall wrap had been cut out and required repairs.

In the first unit, there was some cracking in the ceiling lining to wall junction that needed to be repaired. The stairs to the attic were found to be incomplete, requiring the lower section to be cut to allow the stairs to be a straight flight and the spring system to be installed.

The third unit only had some minor repairs needed to the bedroom doors and door frames. In the master bedroom, the repairs to the door frame were in progress. Repairs were yet to commence to the striker plate in the second bedroom, which required adjustment to prevent the door from catching.

In the final unit inspected, there was found to be no seal between the vanity and the adjoining wall. This would have allowed moisture to get behind the vanity. It was also found that the insulation had been disturbed in places and required relaying.

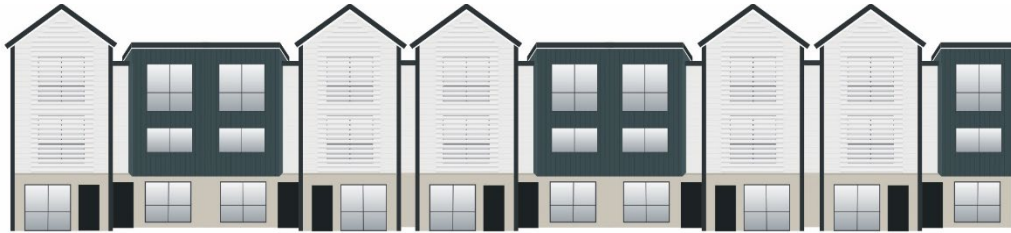
4.1.7 Case study 7 – new MDH

Case study 7 is a five-unit 3-storey row of townhouses. It was constructed using concrete and timber framing and clad in fibre-cement bevel-back weatherboard and aluminium planks. The surveyor's general assessment of the site was that it was accessible, had evident health and safety procedures and was in a good overall condition. The building plans were placed on all four sites and appeared to have been followed.

The post-wall underlay and pre-line inspections did not find anything of concern. The general workmanship was found to be good across all four units surveyed.

At the final inspection stage, the surveyor found some scratch damage to the surface of the aluminium cladding. The cladding would require replacement. No further poor or incomplete building work was found on any of the sites.

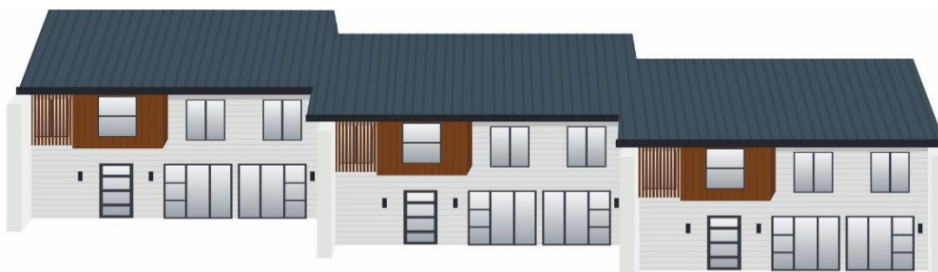
4.1.8 Case study 8 – new MDH

Case study 8 is a three-unit 2-storey row of townhouses. It was constructed using concrete tilt slabs and timber framing and clad in bevel-back timber weatherboard and vertical shiplap cedar weatherboard. The site was found to be accessible but was untidy. No health and safety procedures were evident on any of the sites. The overall condition of the site was found to be poor. The consented building plans were not on site.

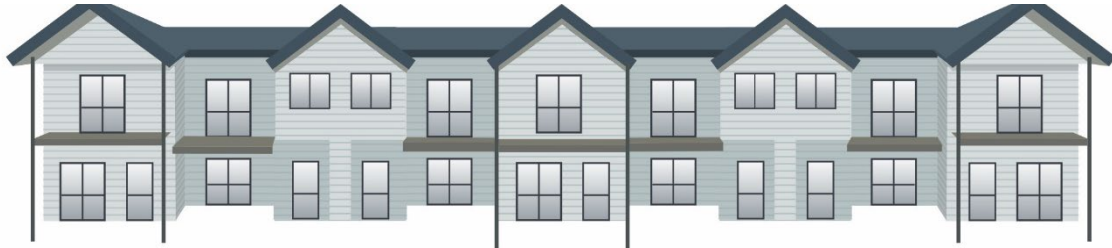
4.1.9 Case study 9 – new MDH

Case study 9 is a seven-unit 3-storey row of townhouses. It was constructed using timber and concrete block framing and clad with fibre-cement bevel-back weatherboards. The surveyor's general assessment of the site was that it was accessible and had evident health and safety procedures but was generally untidy. The consented plans were available on all four sites and appeared to have been followed.

The post-wall underlay and pre-line inspections did not identify anything of concern, and all of the workmanship was found to be good across all four units surveyed.

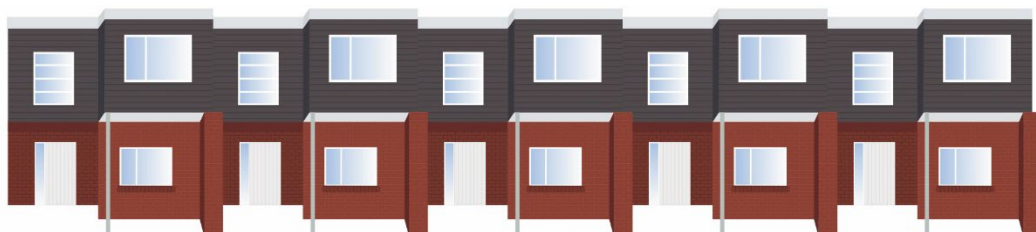
4.1.10 Case study 10 – new MDH

Case study 10 is a five-unit 2-storey row of townhouses. It was constructed using timber framing and clad with brick and fibre-cement bevel-back weatherboard. The surveyor's general assessment of the site was that it was accessible, had evident health and safety procedures and was in good overall condition. The plans were available on all four sites and appeared to have been followed.

The general workmanship across all four units was found to be good during both the post-wrap and pre-line inspections. However, one of the units had ceiling insulation that required replacing in some areas.
