ISSUE 521 BULLETIN

SQUEAKY FLOORS

April 2010

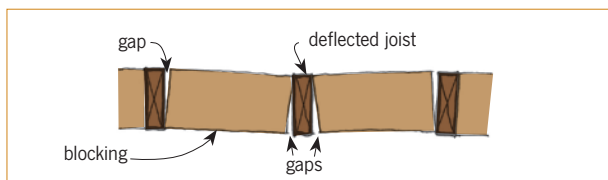
2.0.5 Noise in floors can also result from deflection (more than 1 mm in 300 mm in AS/NZS 1170 *Structural design actions*) of the floor framing (see Figure 1) because of greater flexibility of 'second generation' juvenile timber that has been used more recently. Note: Amendment No 2 to NZS 3604:1999 (May 2006) may have mitigated this problem as it introduced new maximum span tables that take account of the greater flexibility of today's framing timber.

Figure 1: Deflection of subfloor framing.

4.1.5 If the floor itself is springy or bouncy (deflecting excessively) and there is reasonable access to work from underneath, the preferred option is to provide further structural support to the underside of the floor joists by installing additional bearers and/or additional floor joists.

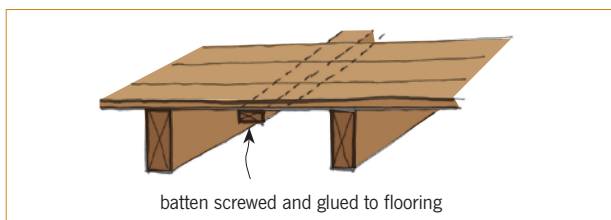
Figure 2: Adding a batten to provide mid-span fixing for strip flooring.

- installing a timber batten (construction adhesive and screw fixed) mid span between the floor joists as shown in Figure 2, or
- installing a timber batten (construction adhesive and screw fixed) to each side of the floor joist as shown in Figure 3, or
- filling any gaps between the framing and the flooring with a polyurethane construction adhesive that expands on application to fill the gap and improve the adhesion of the flooring to the framing.

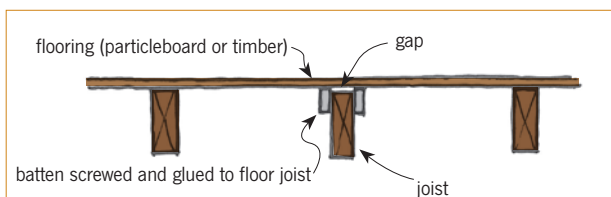
2.0.7 In a number of cases, the floor joists may have never been in direct contact with the sheet flooring (also applicable to strip flooring but less likely) from the time the house was built – the resulting gap between the flooring and the joist allows the flooring to deflect and generate the noise.

Figure 3: Adding battens to take up gaps between the flooring and the joists.

- For solid blocking – insert wedges into any gaps between the blocking and the joists.
- For herringbone strutting – adjust the angle to tighten the junction with the joist and re-nail.
- For gaps – install a timber batten (construction adhesive and screw fix) to each side of the floor joist as shown in Figure 3 and screw fix the flooring to the batten or insert a polyurethane construction adhesive that expands on application to fill the gap and improve the adhesion of the flooring to the framing.
