BRANZ STUDY REPORT

PROTECTED NAILED GUSSET CONNECTIONS FOR GLULAM MEMBERS

**K. Y. S. Lim and
A. B. King**

Study Report SR 29

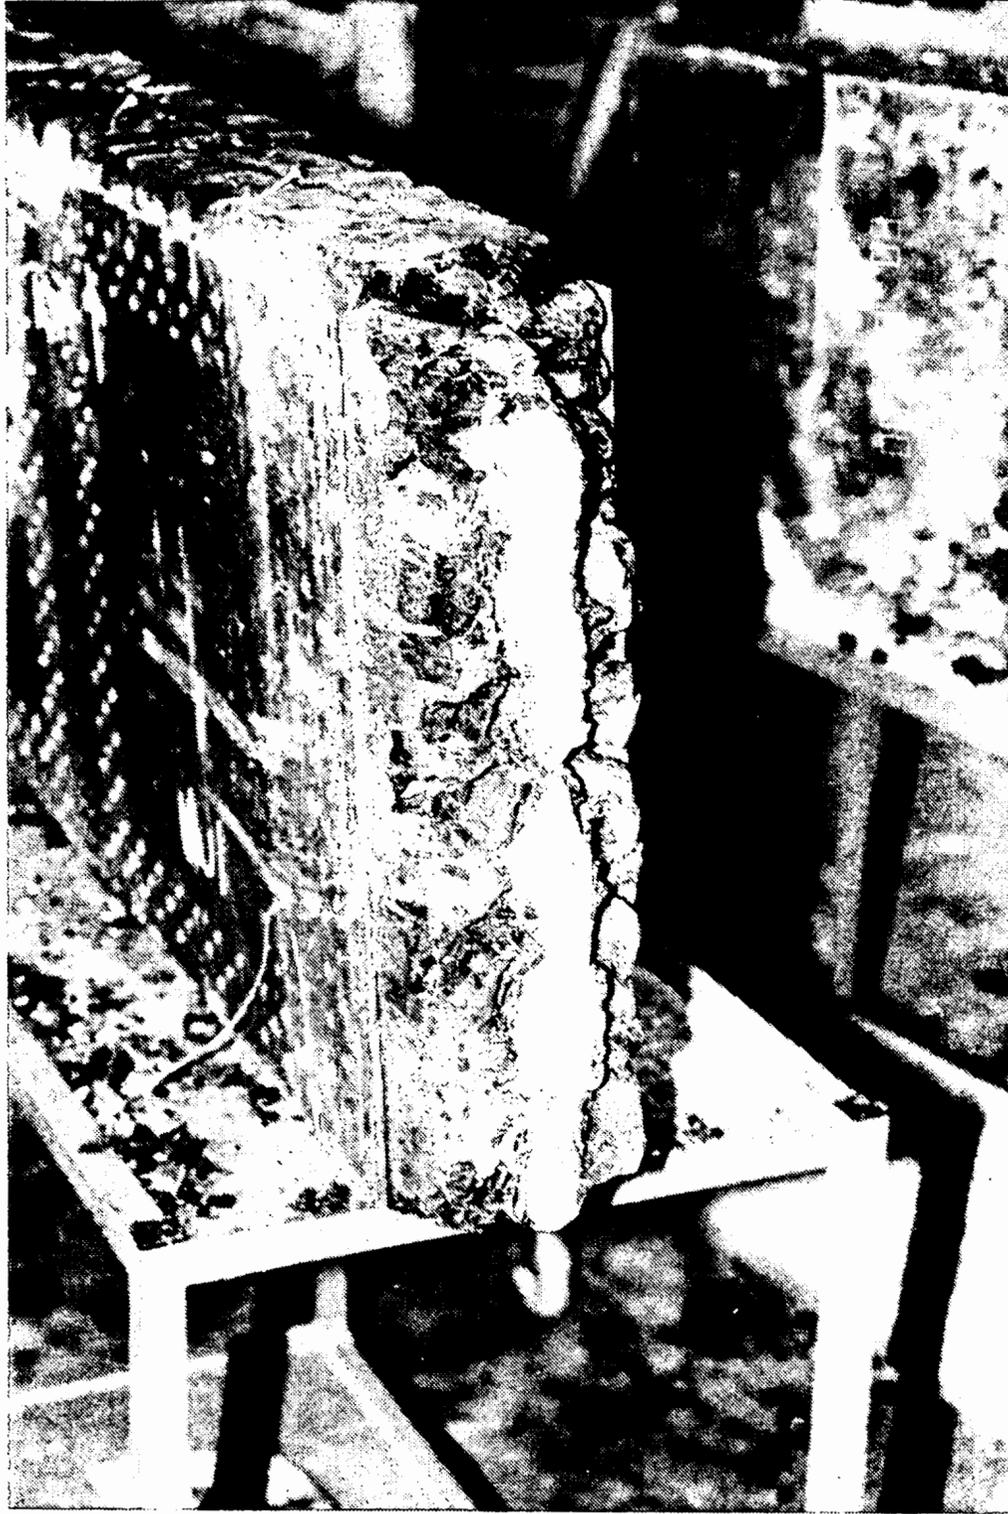
- Joint SG1 (Steel gusset - single layer of 'control' board protection)
 The steel gussets were not damaged and the charring of the joint was predominantly on the top and bottom faces of the beam where the protection had become detached (Figure 8a). When corner sections were cut from the gussets and removed, char had occurred to a depth of 6 mm on the inner face and 1 mm on the outer face of the glulam beneath the gusset. Nail slips of up to 1 mm were also estimated visually in the timber beneath the gussets (Figure 8b).

Figure 8a: Section adjacent to joint SG1.

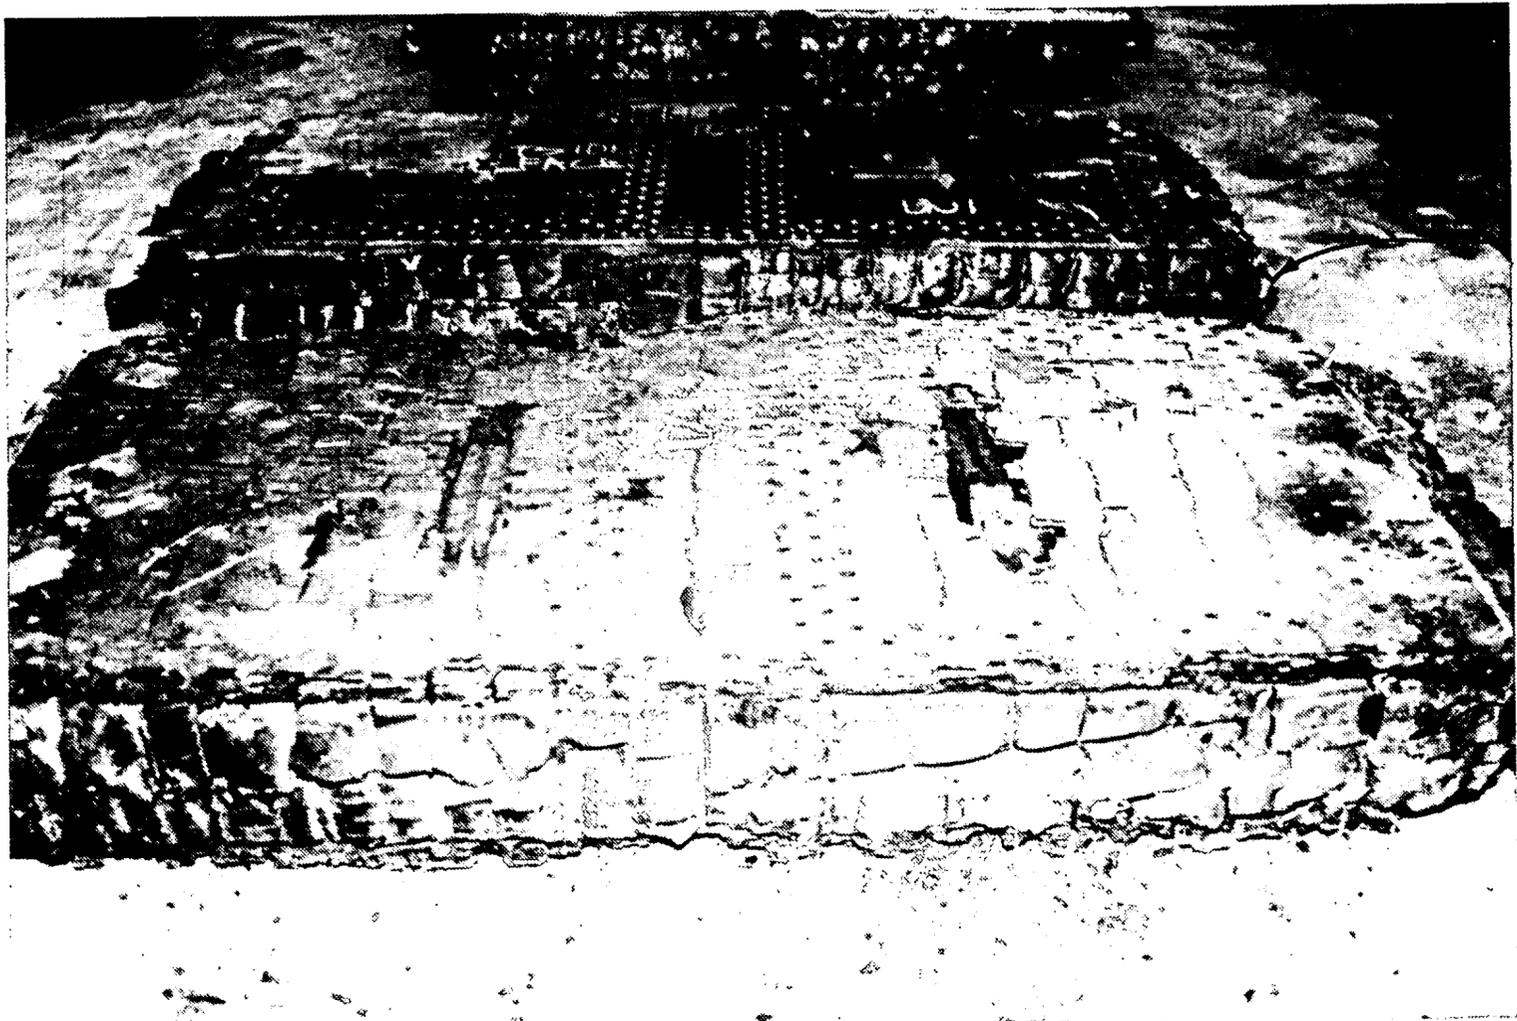
For the two outer beams (SG1 and PG3), measurements indicated that in each case the inner face of the beam had an average of 10 mm greater depth of char than that measured on the outer faces. This was consistent along the length and across the depth of the beam. Although there were variations in depth of char across the depth of the beam, there was no apparent correlation between char depth and the position of gluelines. The condition of the joints and the beams of test FS2 are shown in Figure 9.

Figure 9a: Condition of joints after test FS2.

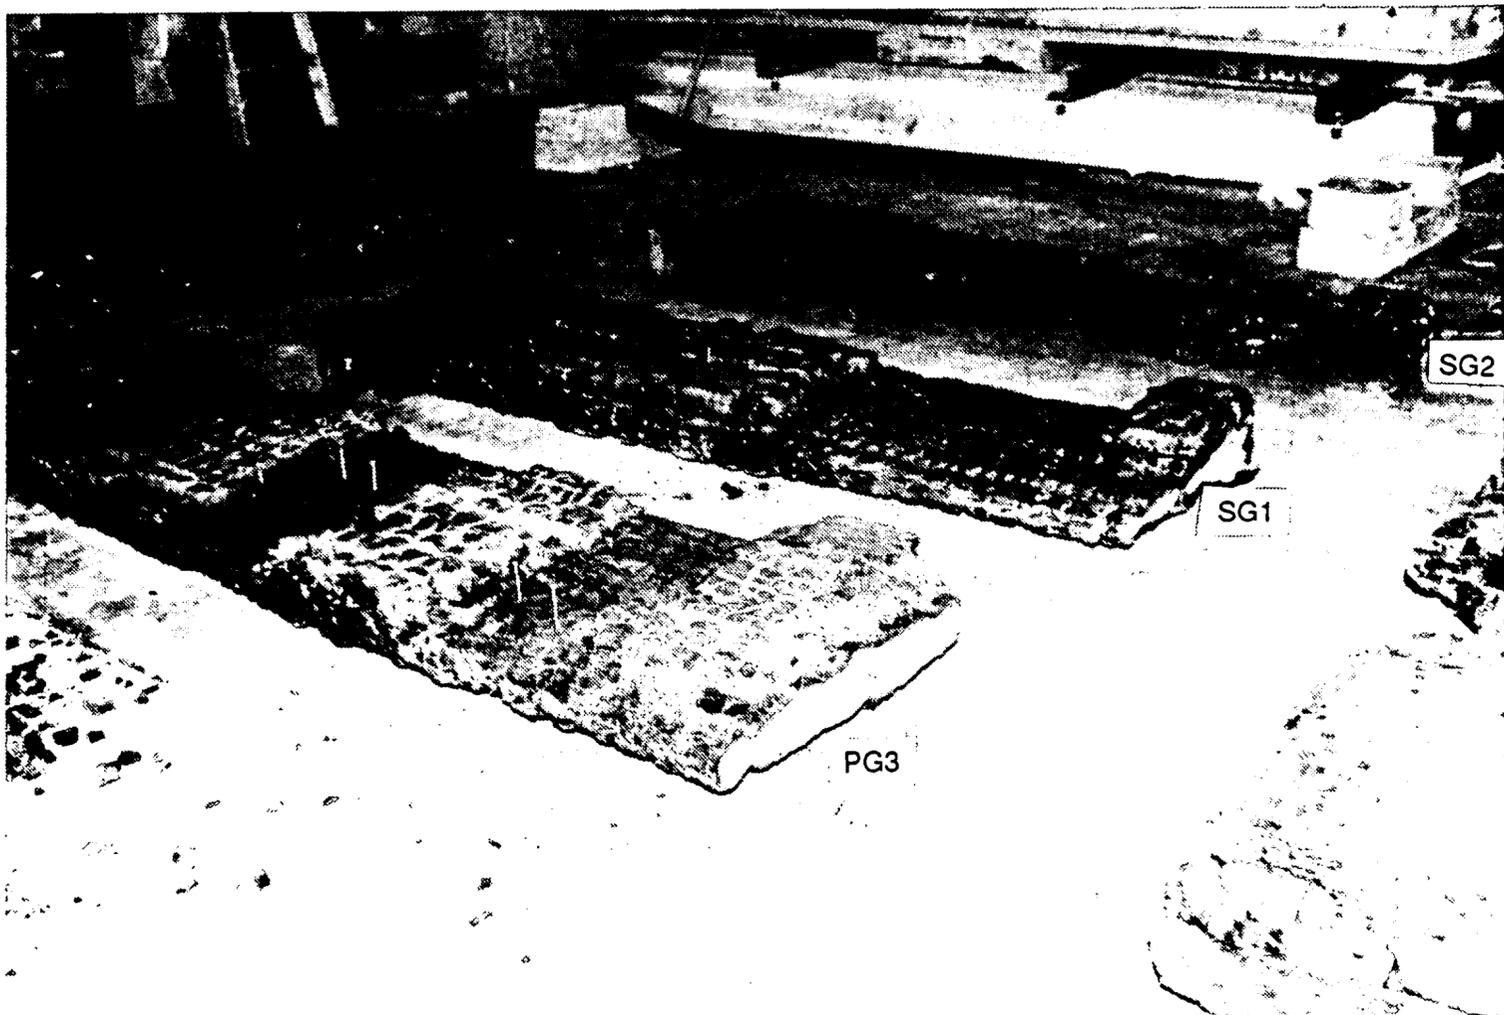
Figure 9b: Condition of beams after test FS2.

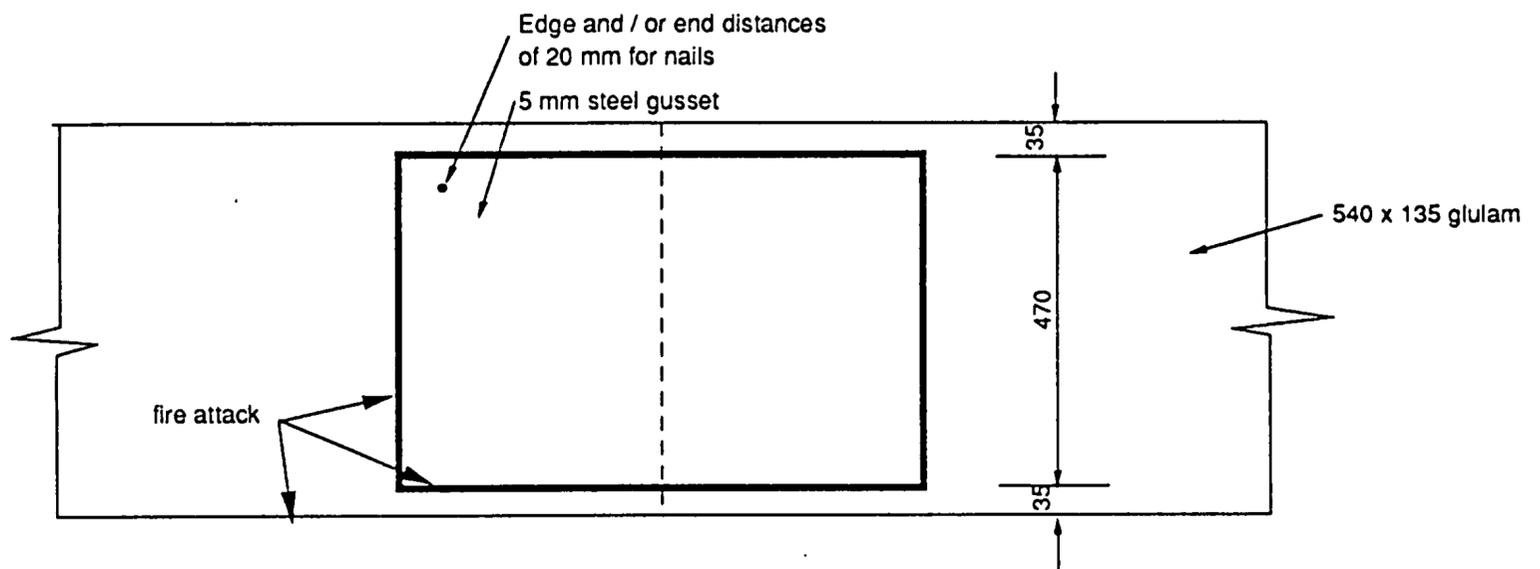
The 35 mm edge distance allowance of charring (above and below the gussets) was inappropriate because the fire attacked the glulam from the faces as well as from the top or bottom surfaces (Figure 16a). This design was not able to prevent the nails from being exposed to furnace conditions with charring penetrating to the second row of nails. Moreover, a path was provided where the fire attacked the glulam beneath the steel gusset as well as the steel gusset itself.

Figure 16a : Detail of joint SG2 Intumescent Coating Applied to Steel Gusset

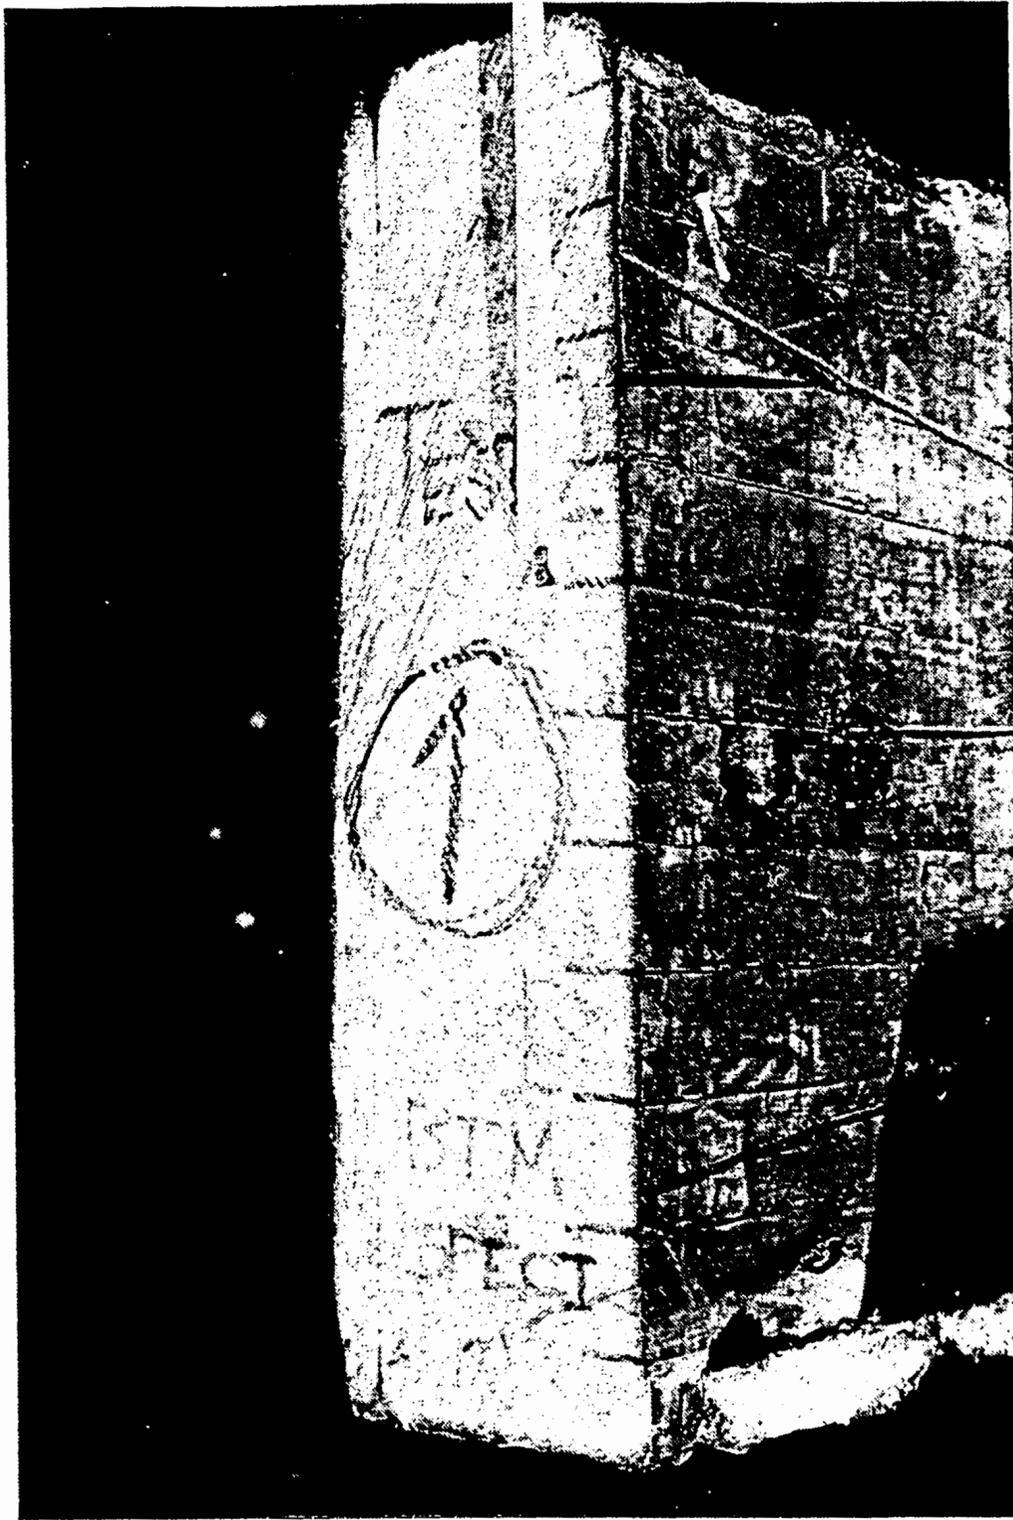
Figure 22a: Glulam beneath steel gusset.
