Which metals are more sensitive to geothermal corrosion?

BRANZ conducted field trials in Rotorua to examine how different metals corrode in geothermal environments. Identical samples were also exposed to a marine environment for comparison. Copper and mild steel suffered serious corrosion in the Rotorua exposure sites, and zinc did too where concentrations of sulphur-containing gases were high. Aluminium and stainless steel corroded more slowly in a geothermal environment than a marine environment.

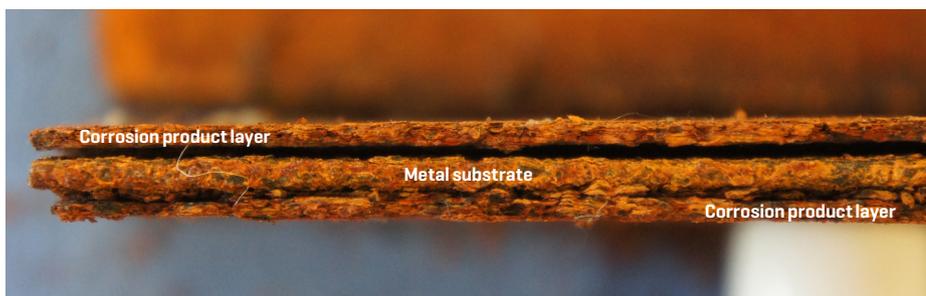
Figure 3. Corrosion products on the mild steel sample exposed at the wastewater treatment plant site for 1 year.

At the wastewater treatment plant site, a thick corrosion product layer formed on the mild steel sample (Figure 3). The sample thickness had increased from 3 mm to around 5-6 mm after a 1-year exposure, leading to a huge volume expansion. This thick corrosion product layer of around 1-2 mm thickness on each side could easily break off from the sample surface.
