Assessing retrofitted external wall insulation techniques

Retrofitting insulation into external timber-framed walls with no underlay brings the risk of water transfer from the back of the cladding to the insulation and/or framing. BRANZ investigated this in direct-fixed weatherboard walls. Using drainage plane mesh together with underlay was found to be the best method of reducing moisture transfer.

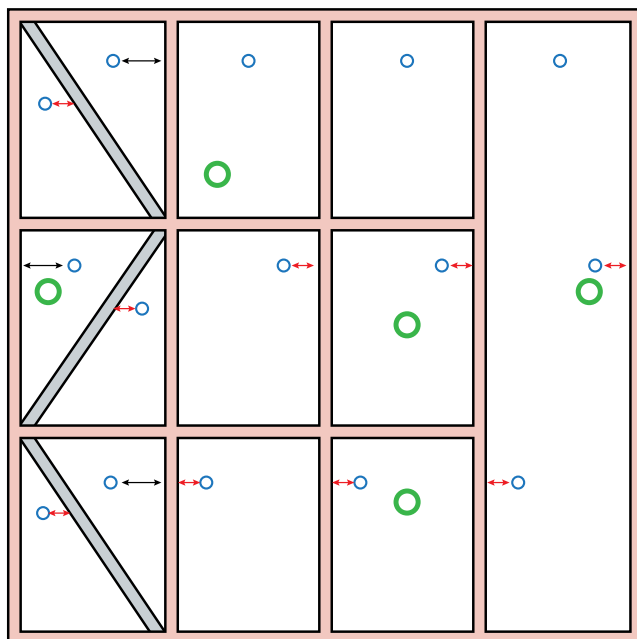
Figure 2. Wall framing layout for test specimen (not to scale). The 15 smaller circles were the water entry points for the first set of tests. The larger circles were the additional water entry points for later tests.

wall specimens (Figure 2) and used a series of leak points (15 holes of 6 mm) to create a significant water load through the cladding (see BRANZ Study Report SR484 for more details).

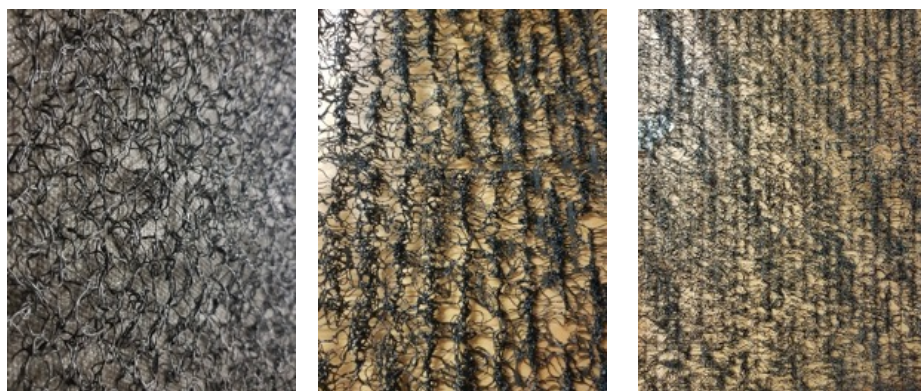
(a) 8 mm, integrated underlay

(b) 7 mm, separate underlay

(c) 7 mm, separate underlay

Figure 3. Drainage plane materials used in this study.

Drainage plane mesh is a material that keeps a drainage path open and protects the installed insulation. Figure 3 shows the products used in this study. One drainage plane mesh product was supplied with an underlay already attached so there was no opportunity to add folds to the edge of the underlay (pan method). For the other two drainage plane meshes, no underlay was attached so it would have been possible to use an oversize underlay and fold the edges. The mesh is approximately 7-8 mm thick.
