# STUDY REPORT

No. SR 128 (2004)

## Fire Protection of New Zealand's Traditional Māori Buildings

**BRANZ Study Report SR 128**

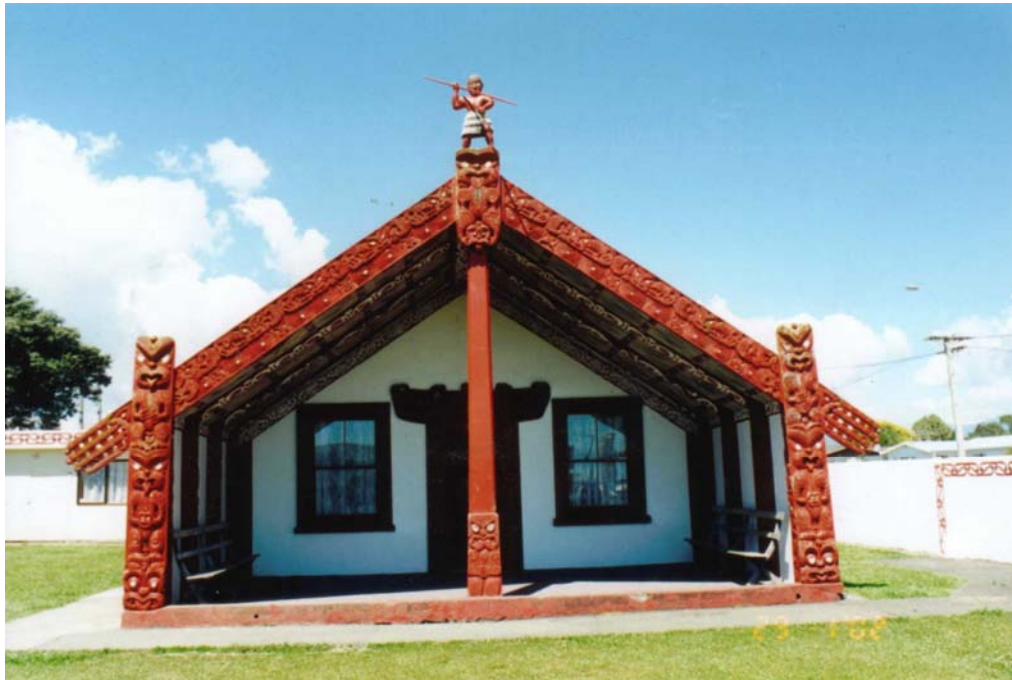
**Figure 8-1: Raukawa Marae – Ōtaki**

Raukawa Marae is in Ōtaki township, on the Kāpiti Coast, on the west coast of the North Island (refer Figure 8-1).

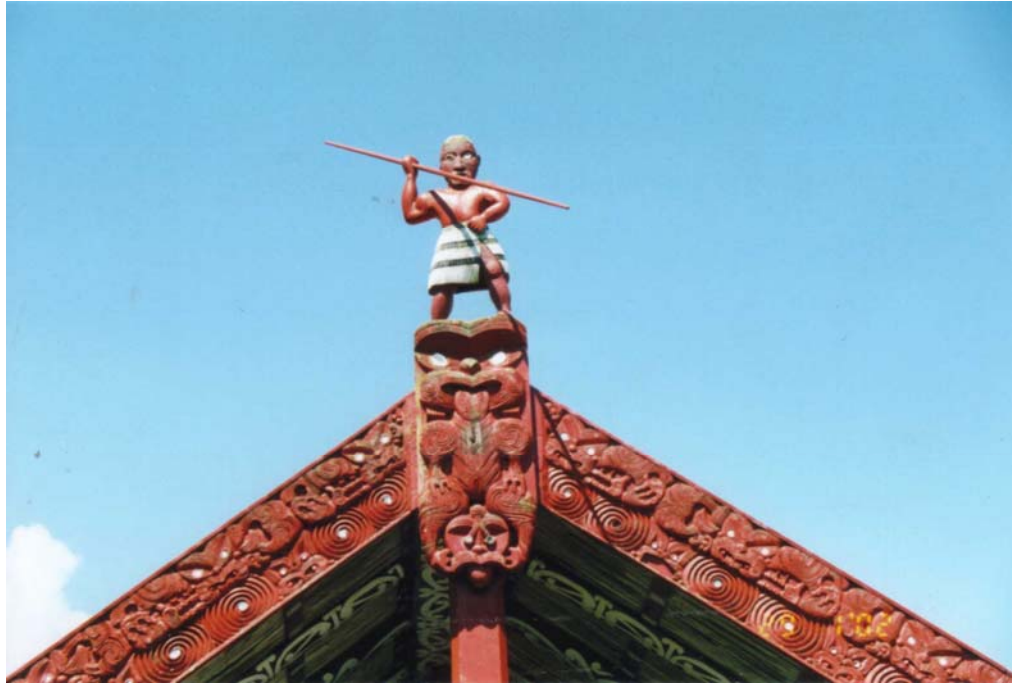
**Figure 8-2: Raukawa Marae – decoration of marae completed in 1936**

Construction of the marae began in 1930 with the fully decorated marae completed in 1936 (refer Figure 8-2). More recently a store room and ablutions block have been linked into the side of the marae (just visible on the left of Figure 8-3).

Construction of the present Raukawa Whareniui began in 1930, with the fully decorated building officially opened on 14 March 1936. The walls and foundations are of concrete and a concrete pillar, supporting the ridgepole, stands in the centre of the porch. Atop the concrete pillar, where one would normally find a koru-carving, there is a full-length figure carved in the round, and above this, crowning the apex of the roof is the tekoteko Motai, an ancestor of Raukawa (refer Figure 8-2).

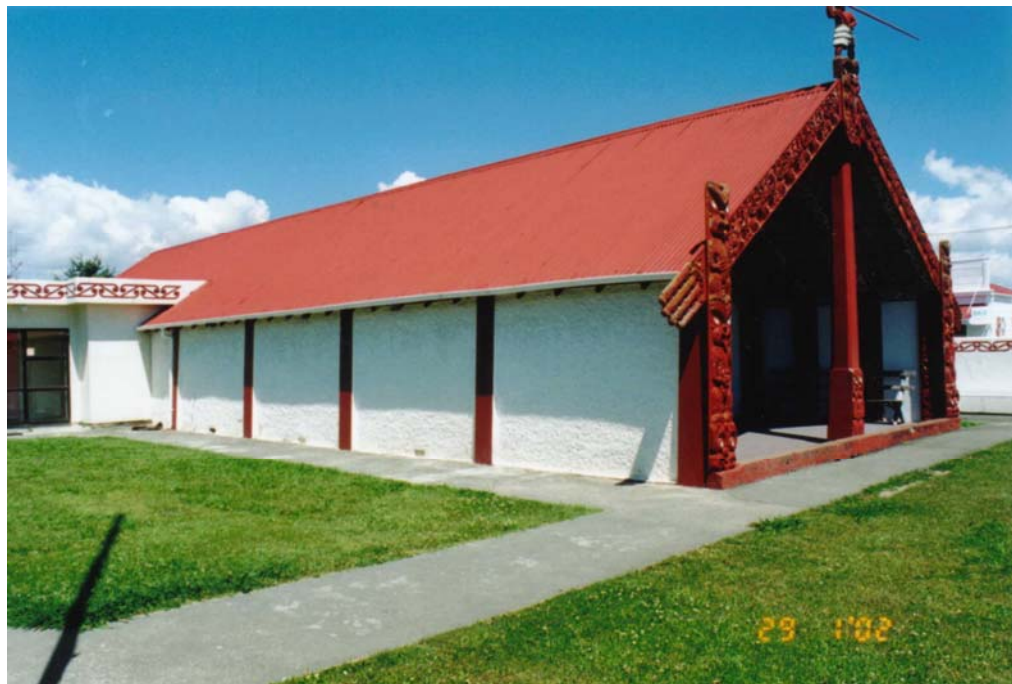
A particular construction feature of this wharenui is the concrete shell which encases the more traditional construction (refer Figure 8-3).

→ Ablutions and store attached

**Figure 8-3: Concrete shell encases traditional construction**

A cross-section of the meeting house wall would reveal a concrete outer shell covering vertically aligned and laced together panels of toetoe, with the interior lined with tukutuku panels of horizontally placed strips of tōtara (timber) woven together.

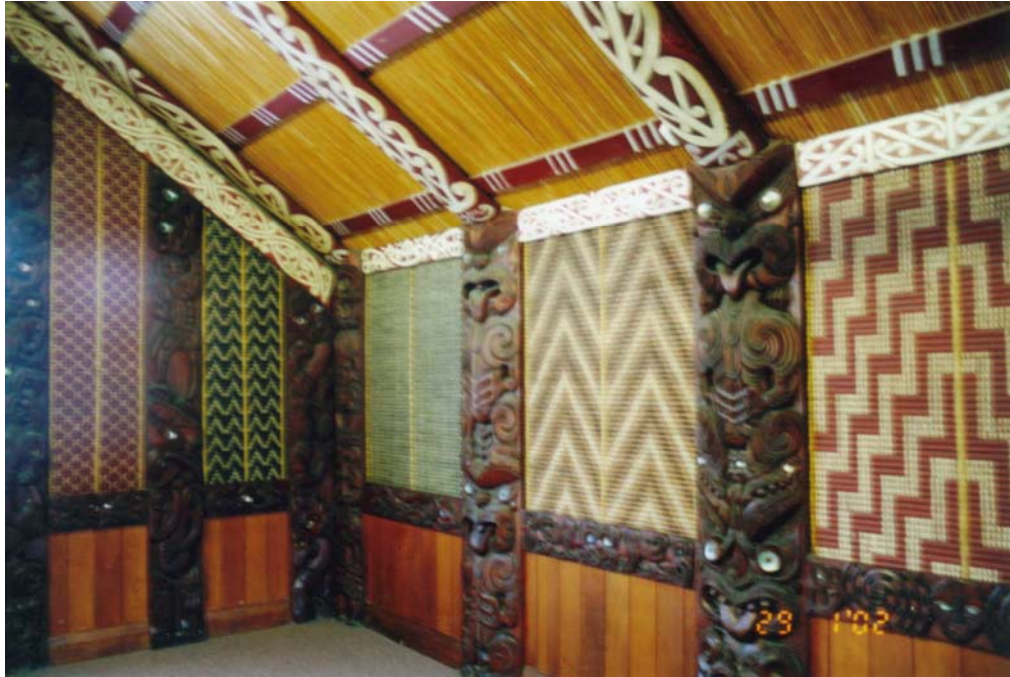
**Figure 8-4: Raukawa Marae – internal surface finishes**

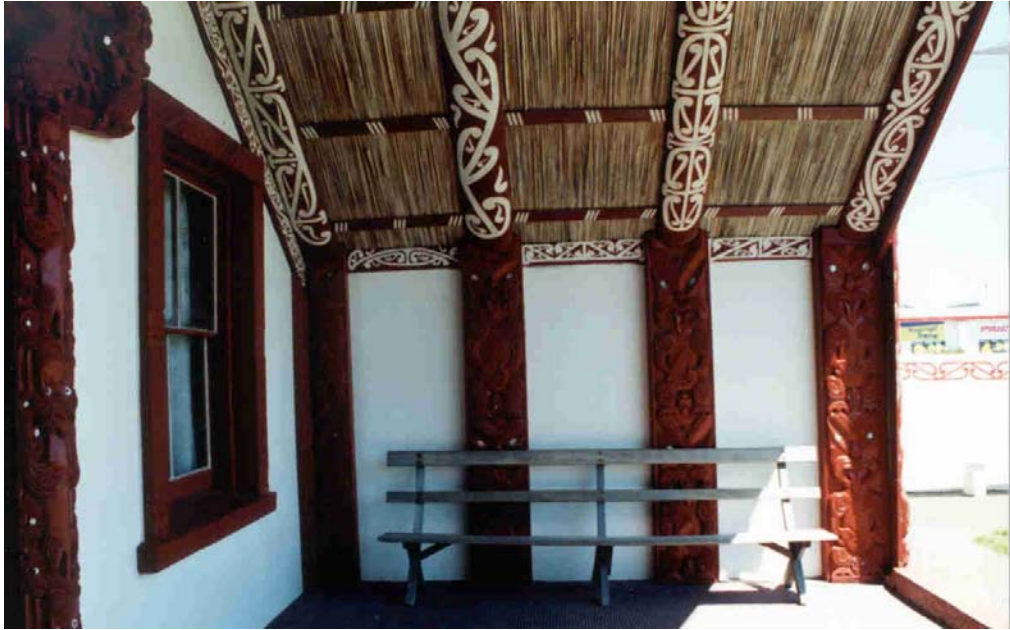
The ceiling is panels of toetoe kakaho stitched together. The toetoe is untreated and Figure 8-5 and Figure 8-6 show the variations in external and internal weathering.

**Figure 8-5: Ceiling lining of porch – toetoe thatched together**

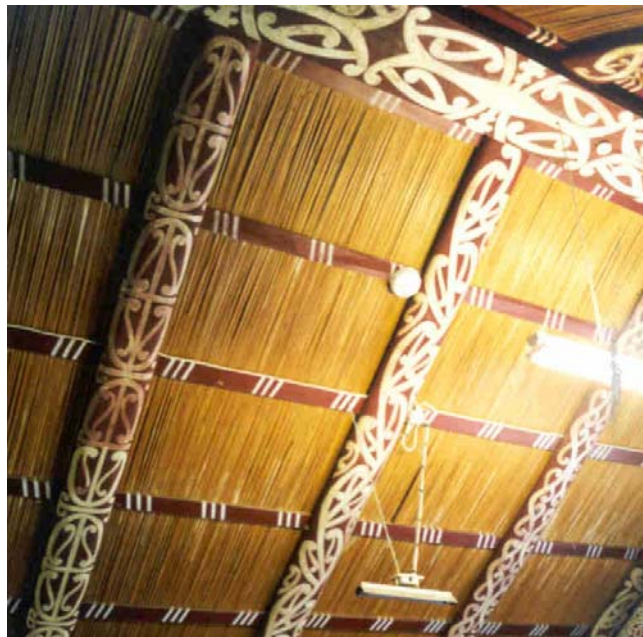
**Figure 8-6: Internal ceiling linings**

Stand alone point-style smoke alarms have been installed in the whareniui and adjoining storage area (refer Figure 8-6). The dining room, kitchen and corridor between them and the whareniui do not have smoke alarms.

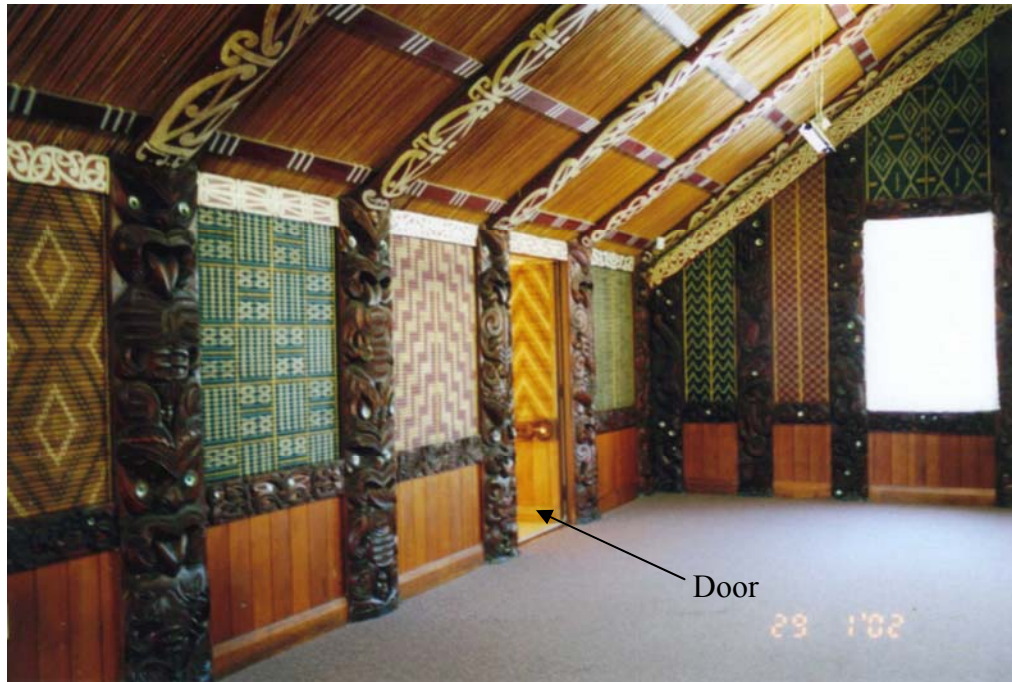
**Figure 8-7: Additional exit sympathetic to internal surface finishes**

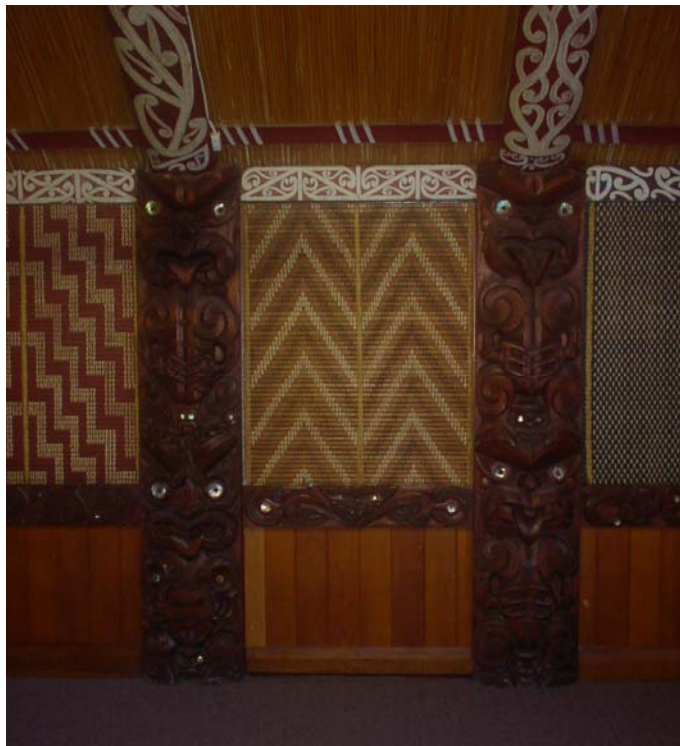
**Figure 8-8: Door lined with tukutuku panelling for camouflage**

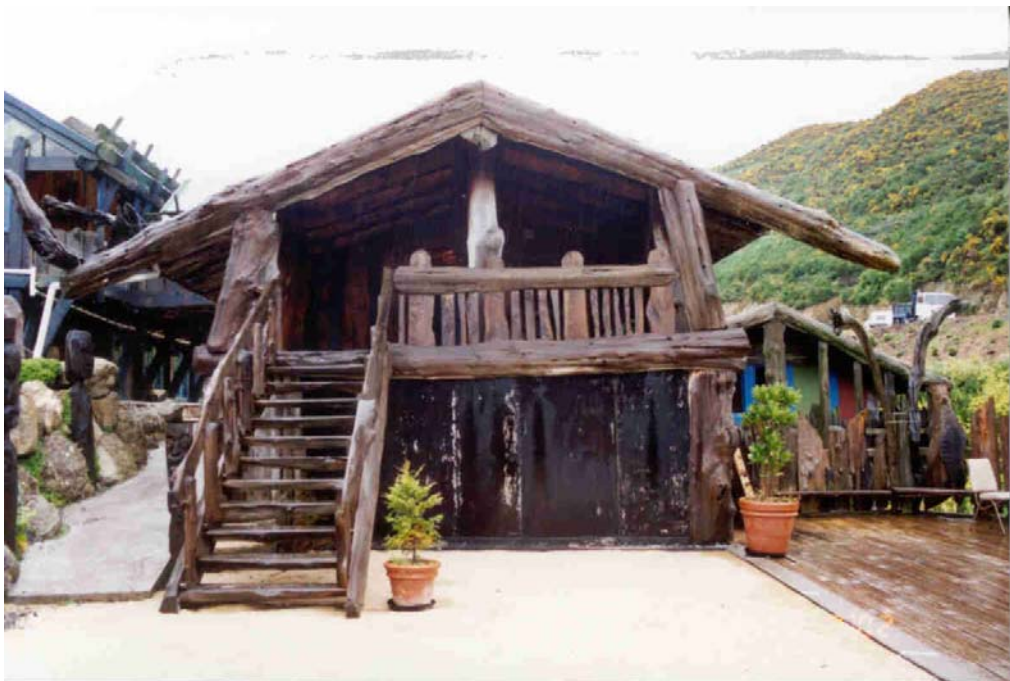
**Figure 8-9: Contemporary style of marae building**

Tapu Te Ranga incorporates a more contemporary design of marae (refer Figure 8-9). The marae buildings at Tapu Te Ranga aim to enforce the idea of sustainable living by using recycled material. The pitched roof and construction style is the same as that of more traditional style marae.

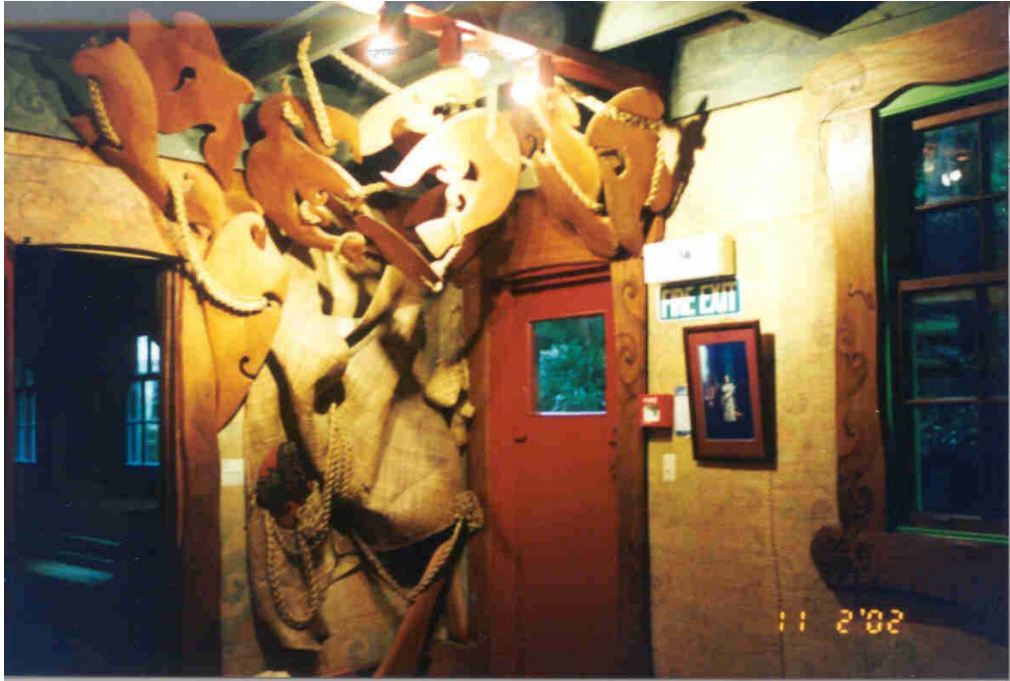
Note the elaborate decorations constructed of flammable material and only one entrance and exit to some of the rooms (refer Figure 8-10).

**Figure 8-10: Artwork and decorations**

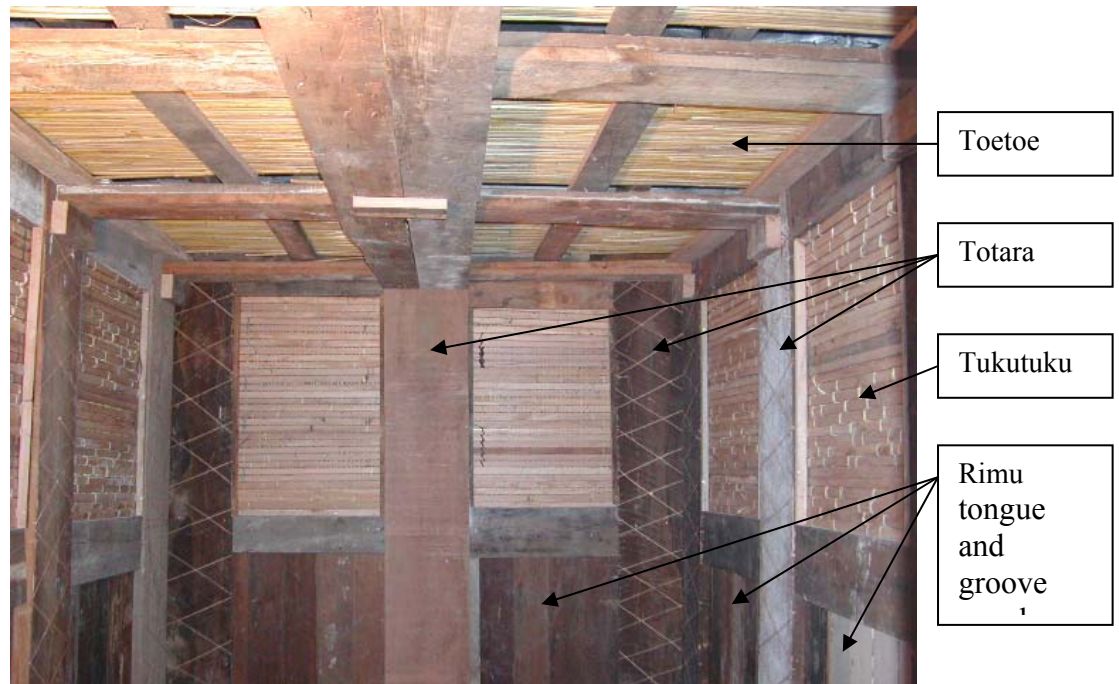
Rimu tongue and groove and woven tukutuku panels lined the walls and the ceiling was lined with kakaho (cut stem of toetoe) suspended on rimu heke (rafters). Posts of totara (300x50) were used to represent carvings (Poupou).

**Figure 10-4: Full-scale fire test construction**

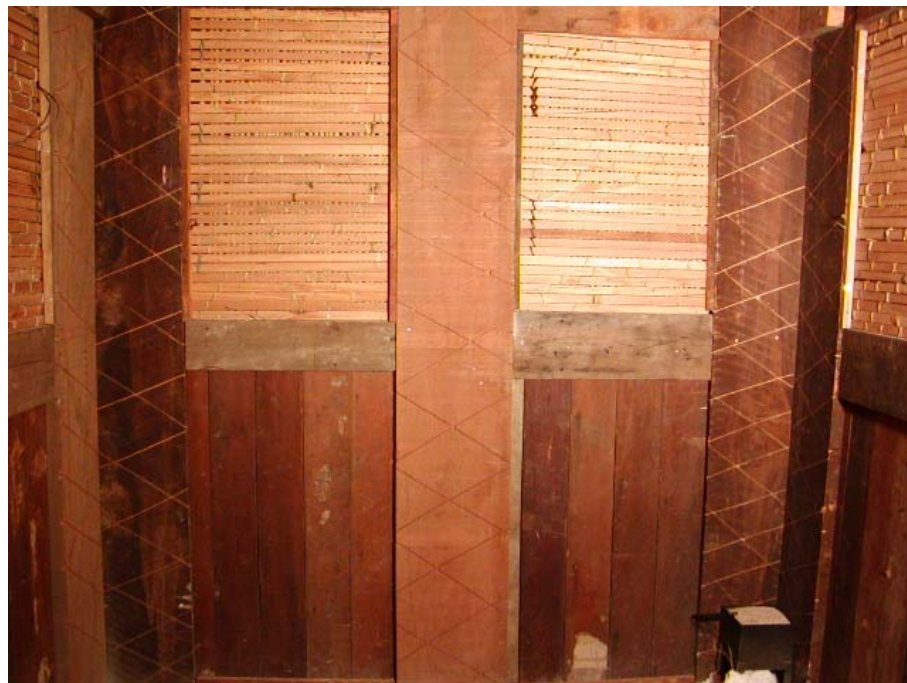
Each of the tukutuku panels (800 mm x1000 mm) were made of rimu slats (30 mm x 5 mm) and thatched horizontally by flax to stems of toetoe.

**Figure 10-5: Traditional wall linings – tongue and groove, tukutuku and replica carvings**

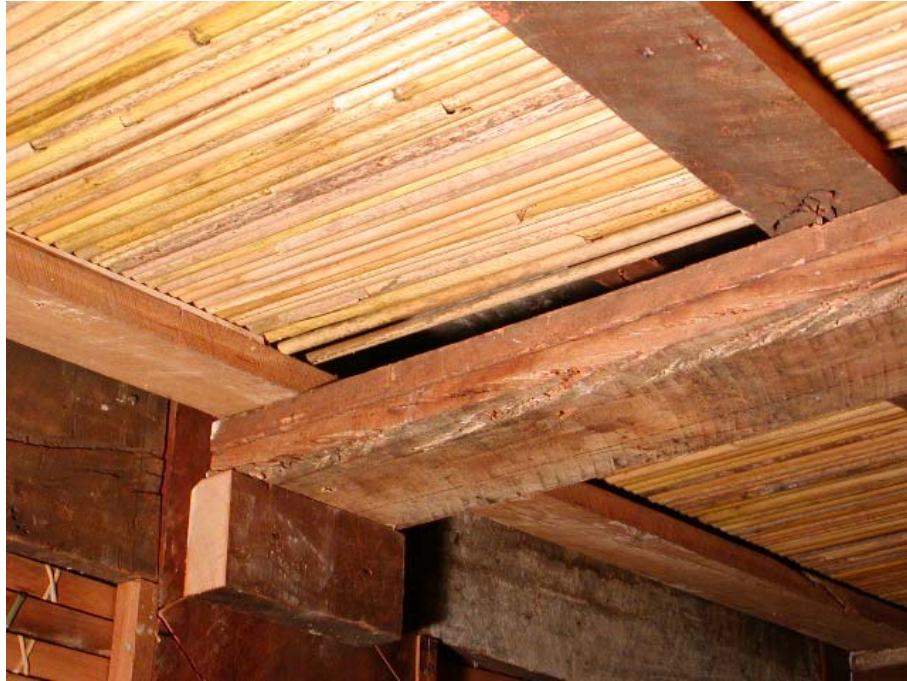
The construction differed from the traditional due to the ceiling being flat, not pitched as fundamental to the basic style of whareniui. Testing with a flat ceiling enables results to be compared to those of other wall and ceiling linings similarly tested.

**Figure 10-6: Ceiling linings - toetoe and rimu rafters**

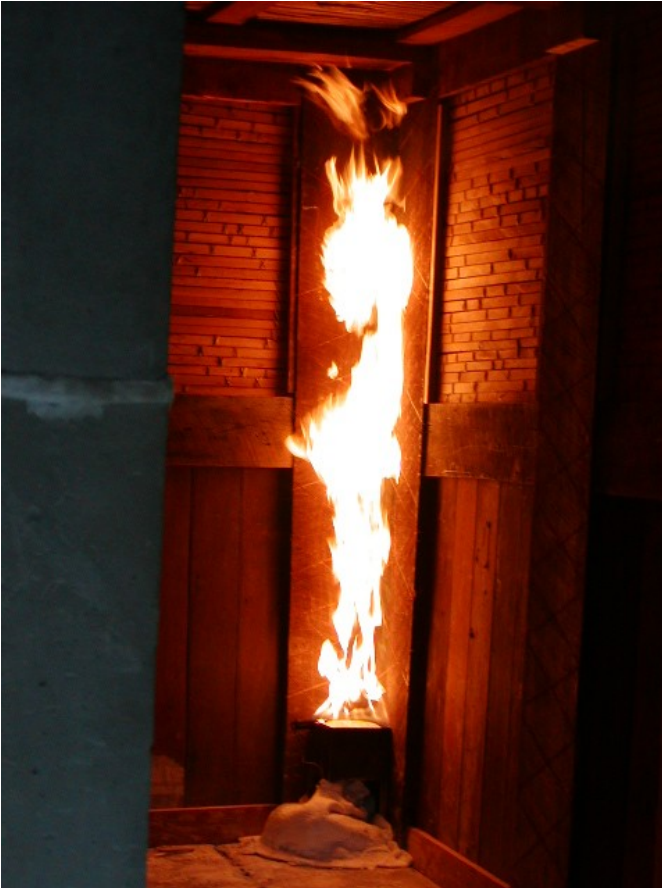
**Figure 10-7: Fire test 20 seconds after ignition**

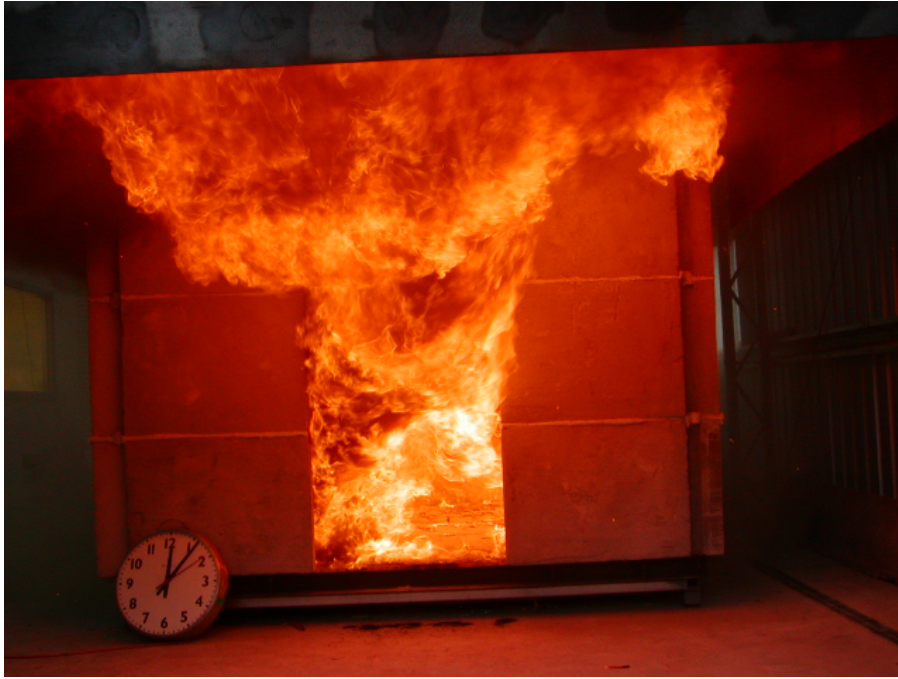
**Figure 10-9: Fire test 370 seconds after ignition**

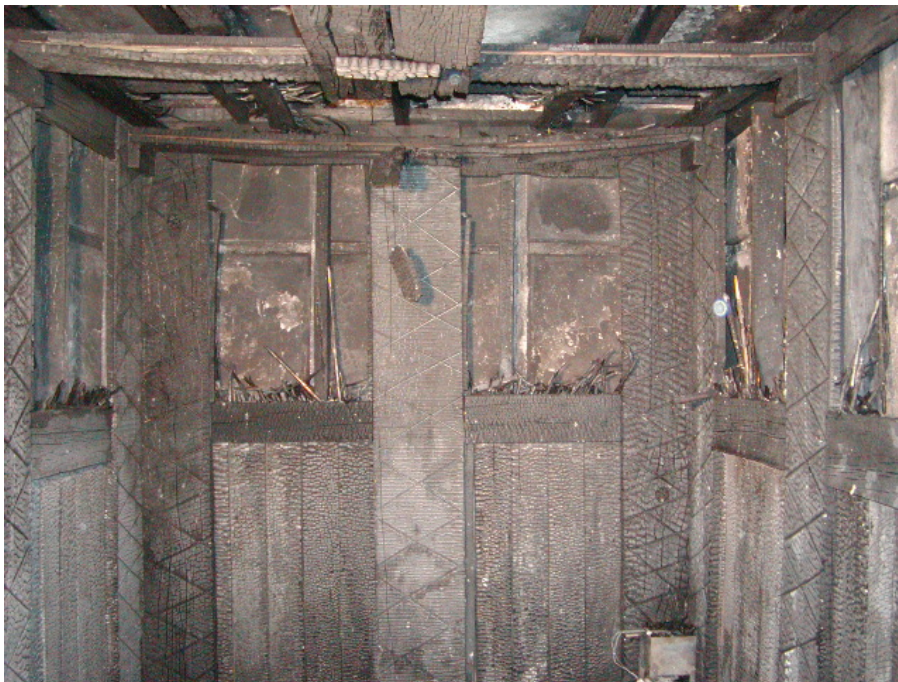
**Figure 10-10: Fire test conclusion**

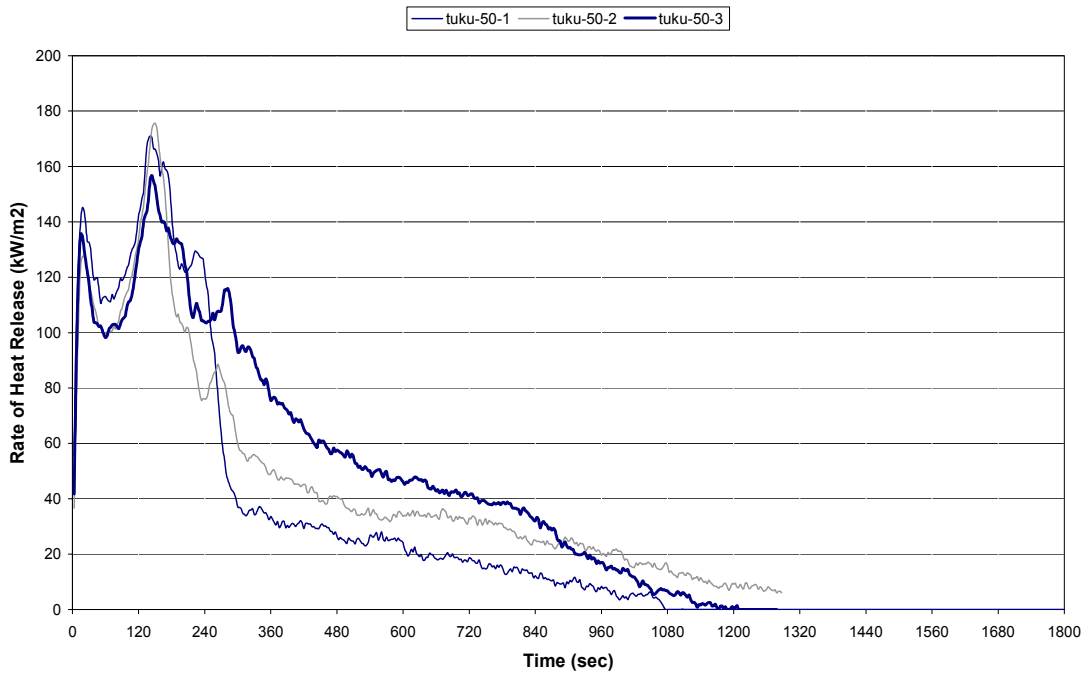
Figure 10-18: Rate of heat release of 50 mm tukutuku (@ 50 kW/m<sup>2</sup>)

A summary of the test results for each cone calorimeter test is given in Table 4 together with the mean and 95% confidence interval for each set of replicates tested at the same irradiance level.

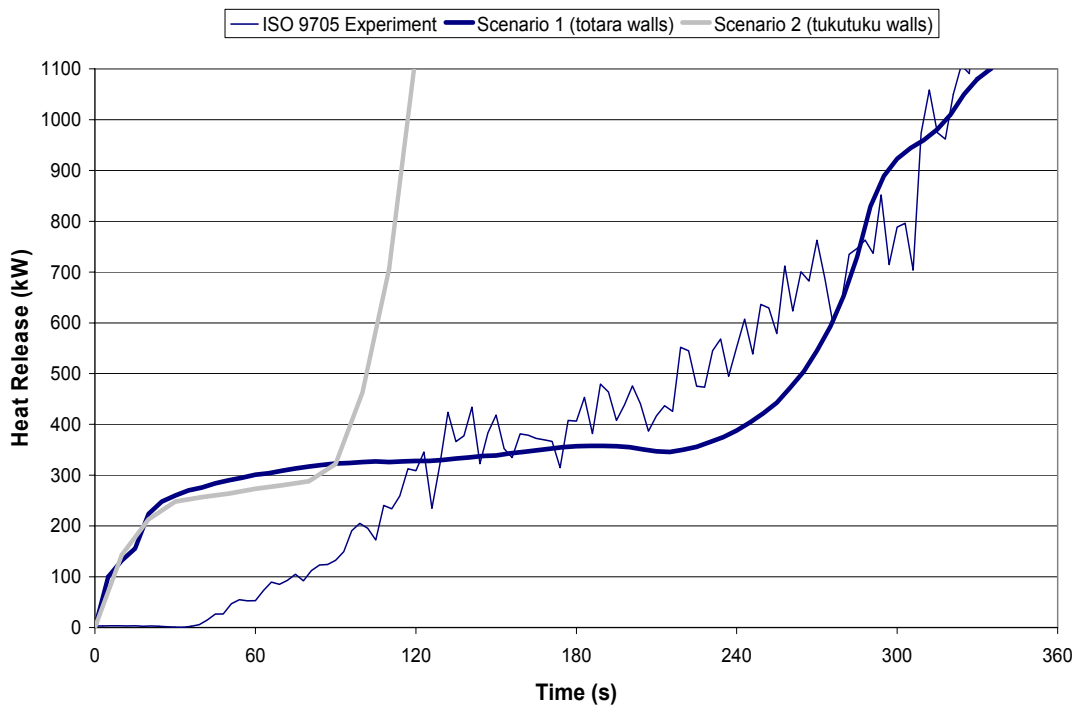
The agreement between the ISO experiment and the all totara-lined walls of Scenario One was found to be relatively good, given that the experiment comprised a mixture of totara and tukutuku on the walls.

**Figure 11-2: Heat release rate curves in the ISO room experiment and the BRANZfire modelled scenarios**

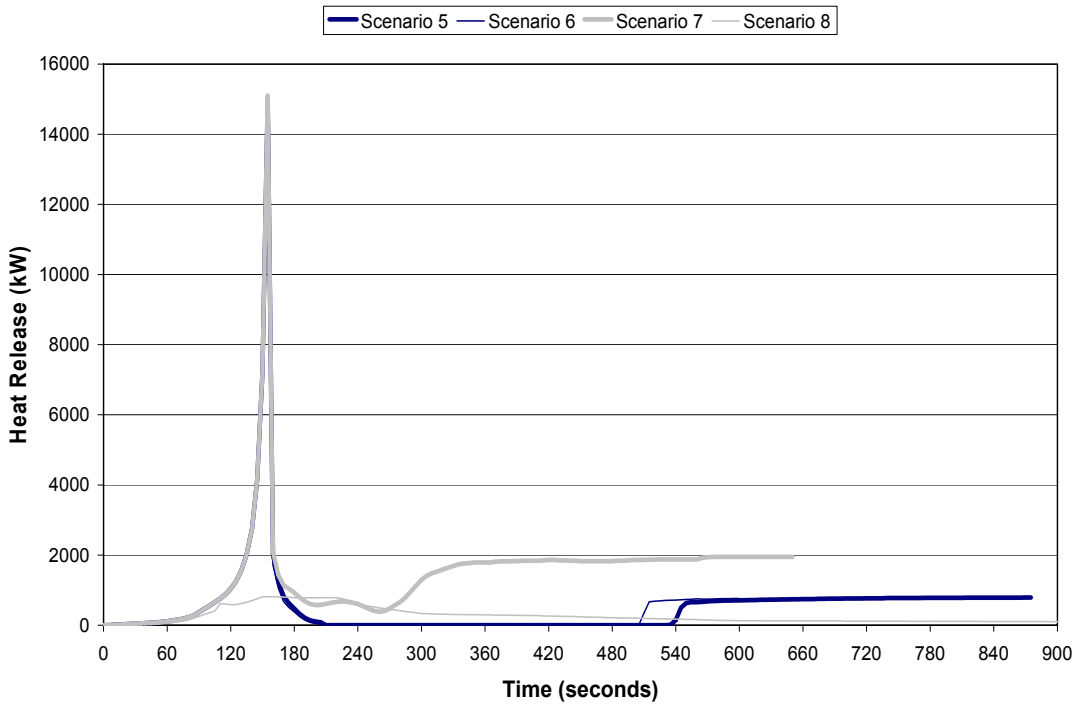
**Figure 11-4: Heat release rate curves from the BRANZfire modelled wharenuui scenarios with a realistic mattress ignition source**

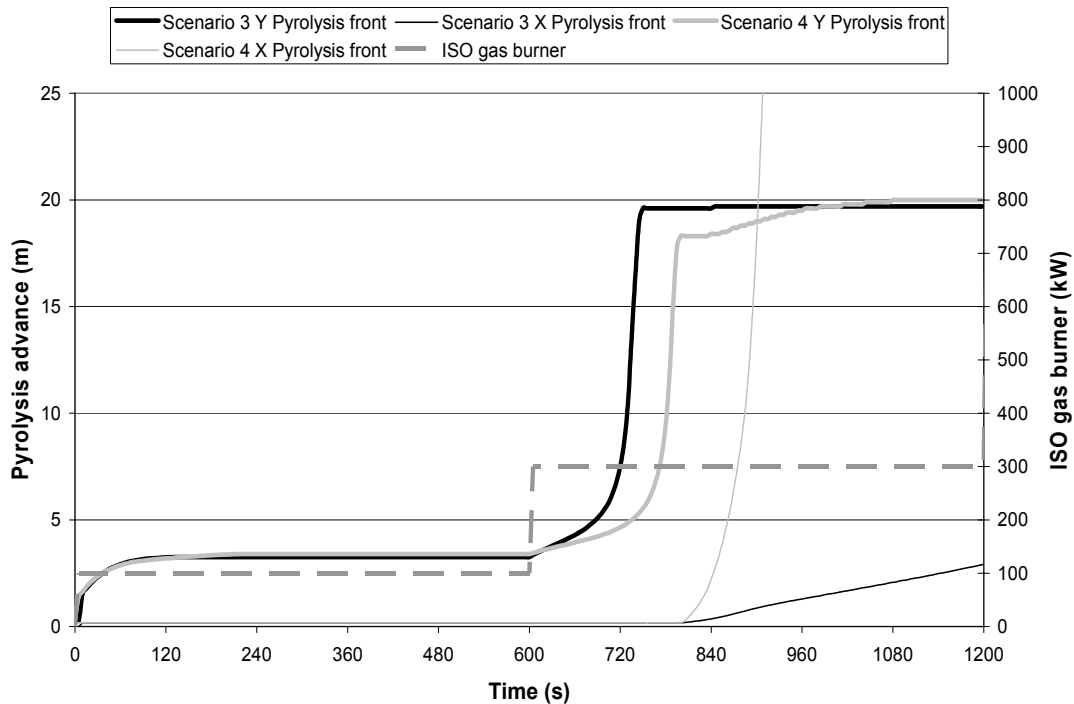
- the totara wall lining results in a worse fire safety scenario with consistently earlier times to both flashover and the tenability limits.

**Figure 11-6: Pyrolysis front development in the X and Y direction for Scenarios Three and Four**

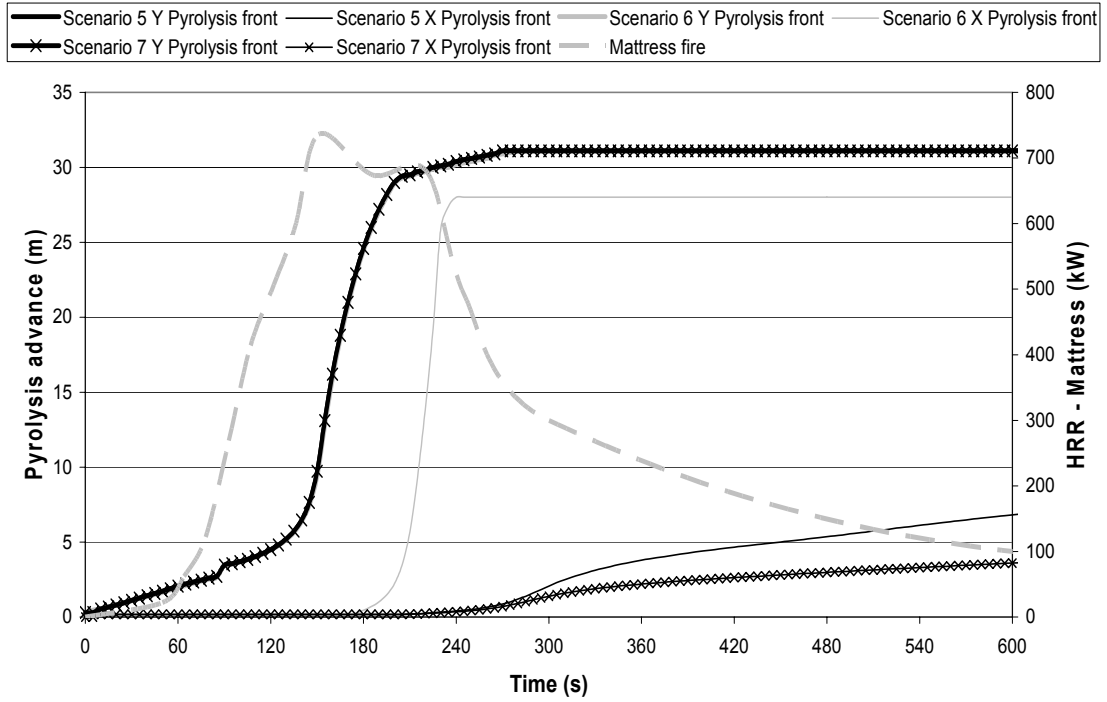
**Figure 11-10: Pyrolysis front development in the X and Y direction for Scenarios Five, Six and Seven**

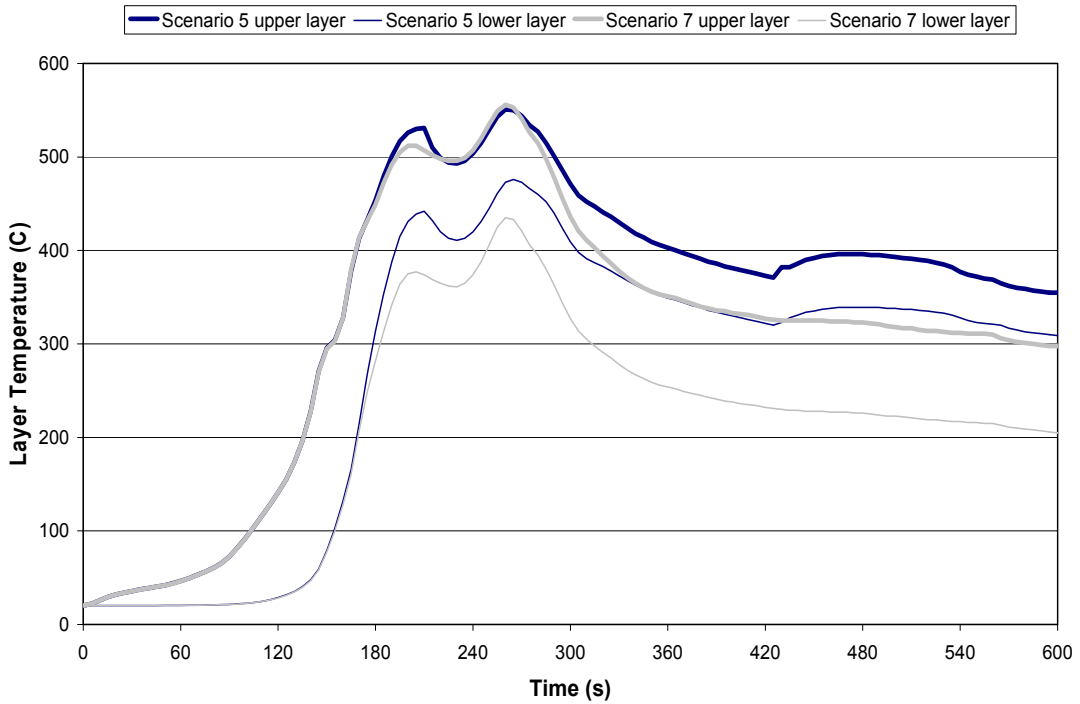
- this difference between Scenario Five and Seven is attributed to the additional ventilation provided in Scenario Seven effectively reducing the temperatures within the wharenuī (refer Figure 11-11). The upper layer temperatures only differ in the decay phase, while in the lower layer the peaks are an average of 50 °C lower.

**Figure 11-11: Upper and lower layer temperatures in Scenarios Five and Seven**

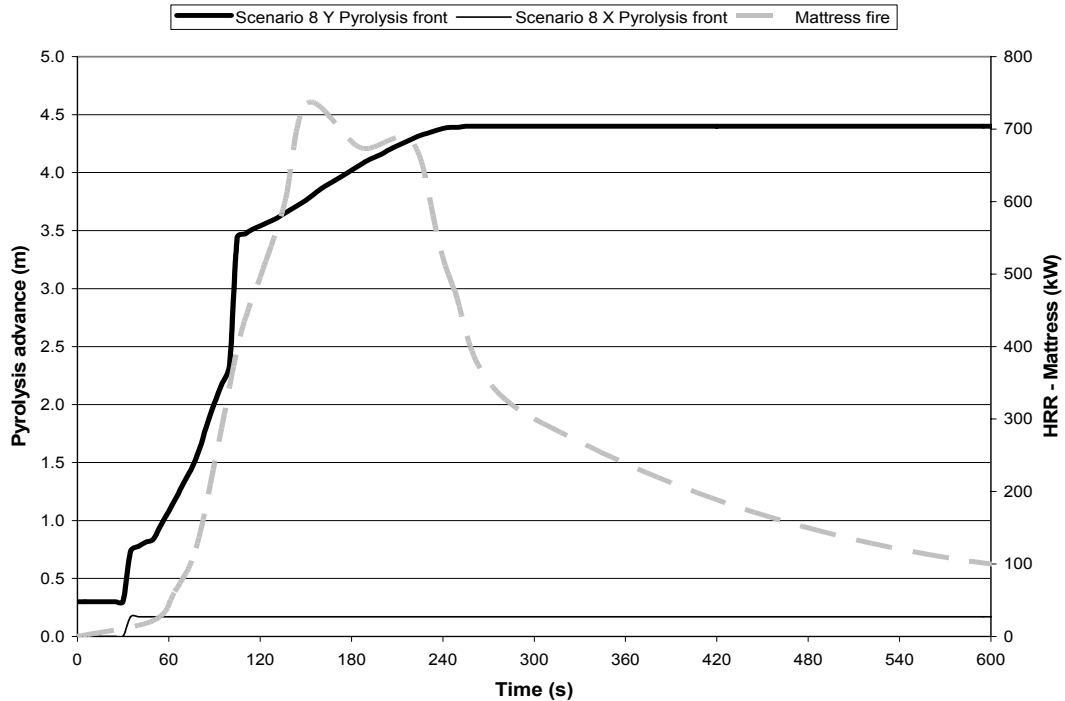
- the development of the pyrolysis front is illustrated in Figure 11-14. The significant feature in this graph is that it exhibits minimal travel of the pyrolysis fronts. The vertical fire spread (Y pyrolysis front) does not exceed 4.4m, and no spread in the lateral X direction. The 4.4m in the Y direction represents the pyrolysis front spreading up the wall reaching ceiling at 3.1m and travelling across the ceiling a distance of 1.3m. No lateral spread indicates there was insufficient fire development for this to occur.

**Figure 11-14: X and Y direction pyrolysis front development for Scenario Eight**
