STUDY REPORT

No. 144 (2005)

Flame Barriers For Foamed Plastics

P.C.R. Collier

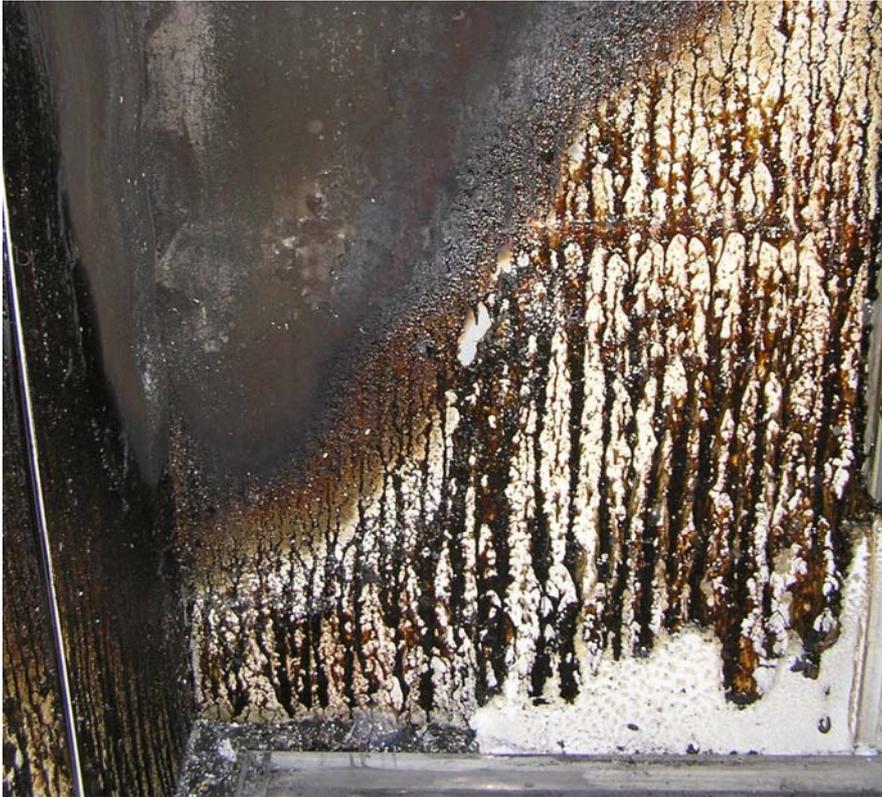
A similar trend is indicated in considering the combustion of the EPS indicated by the temperature exceeding 450°C. Improved security of fixing of the panels results in a delay of the burning of the core, although this is not strictly true considering that the core melts at ~150°C in the walls and it will have a tendency to flow towards the bottom of the cavity where the temperature is lower and therefore does not contribute to the heat release. Similarly in the ceiling, molten EPS will flow to the lower points of the sagging panel skin and either burn within the panel or flow from opened joints and burn within the compartment contributing to the heat release. Figure 11 and Figure 12 show the indicated % burnt for the walls and ceiling respectively. The plateaus reached seem low compared with the quantity of EPS core remaining when the specimens were dismantled, and this can be attributed to the melting and flowing of the core to the bottom of the panels confirmed by observations of pooling when the panels were dismantled as shown in Figure 13.

Figure 13: Ponding of molten EPS at the bottom of cavity

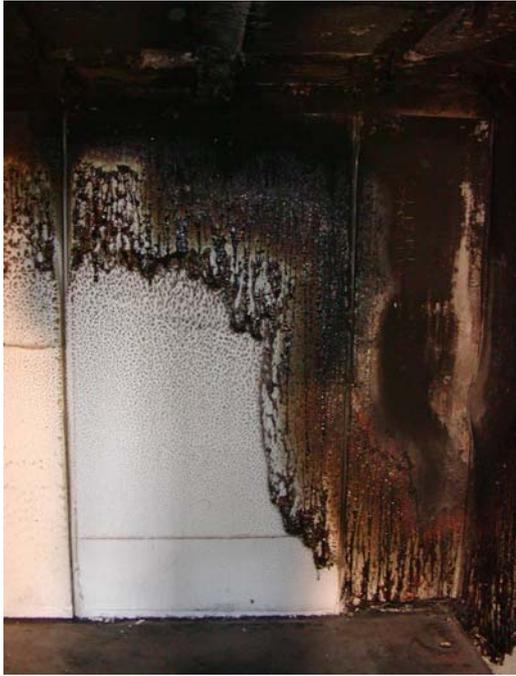
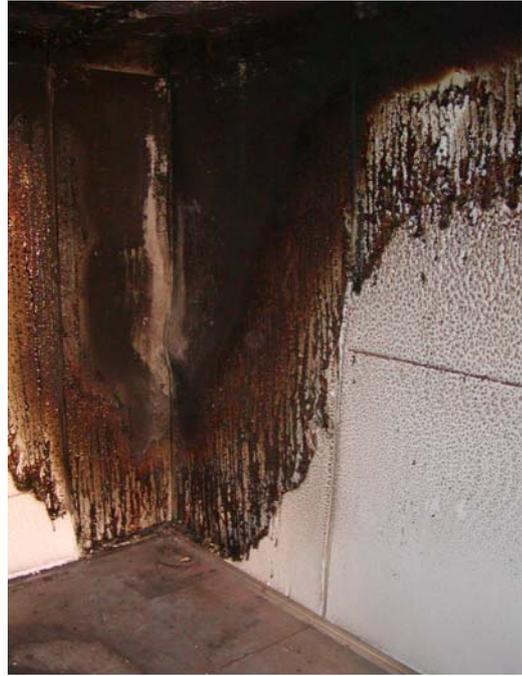
Figure 21: EPS core remaining in the burner corner after test PIP 1, with exposed skins removed

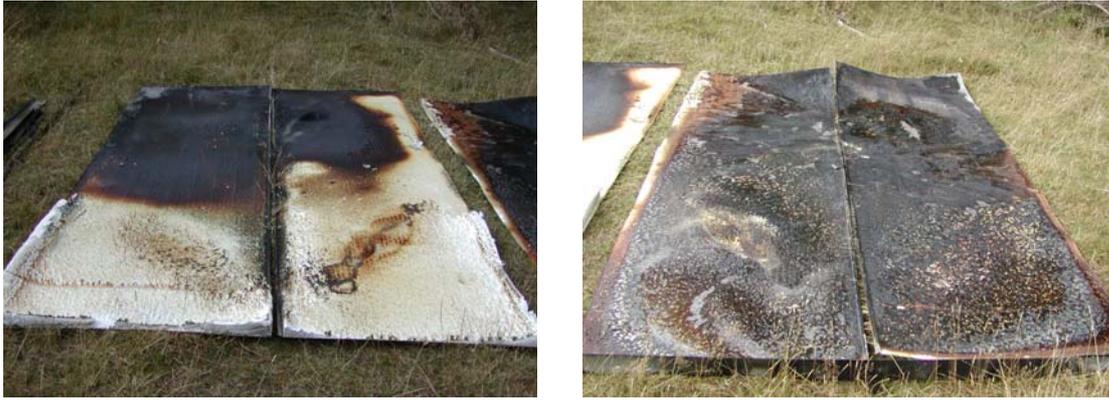
Figure 23: EPS core remaining in the ceiling at end of test PIP 1, upper steel skins on left and lower fire exposed skins on right

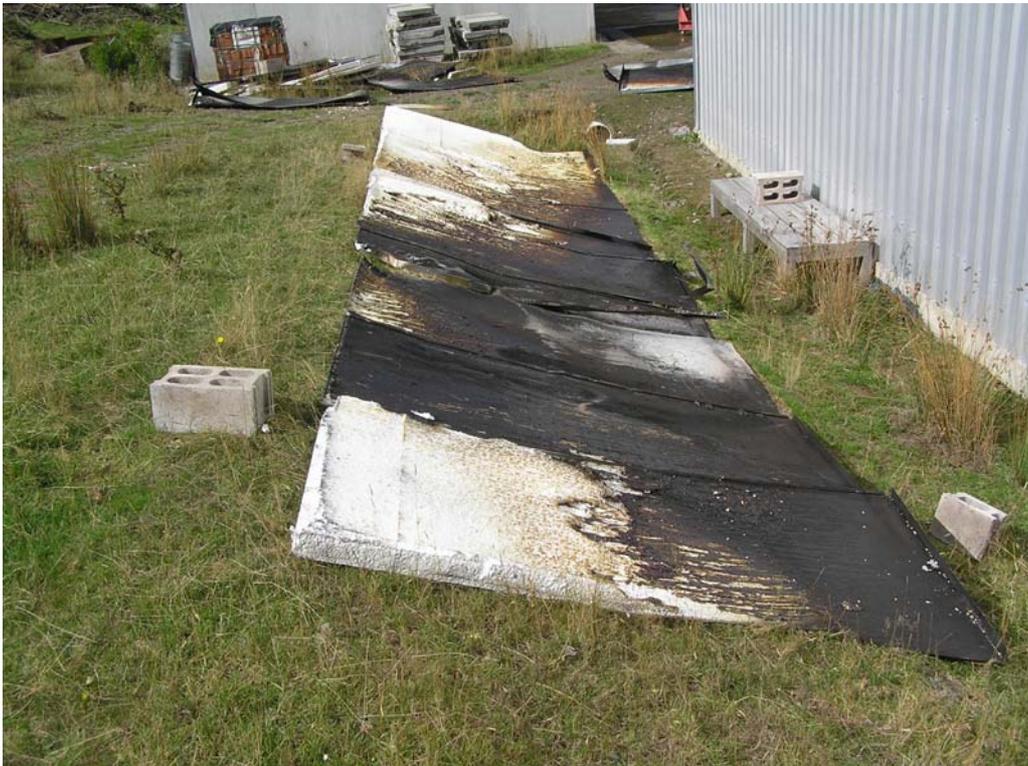
Figure 27: EPS core in walls remaining at the end of test PIP 2

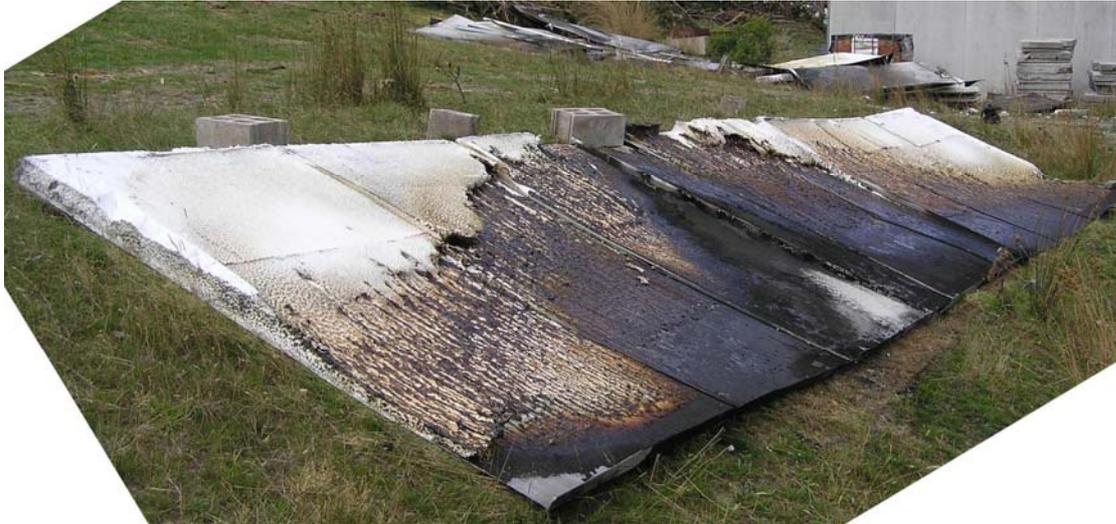
Figure 32: EPS core in walls remaining at the end of test PIP 3

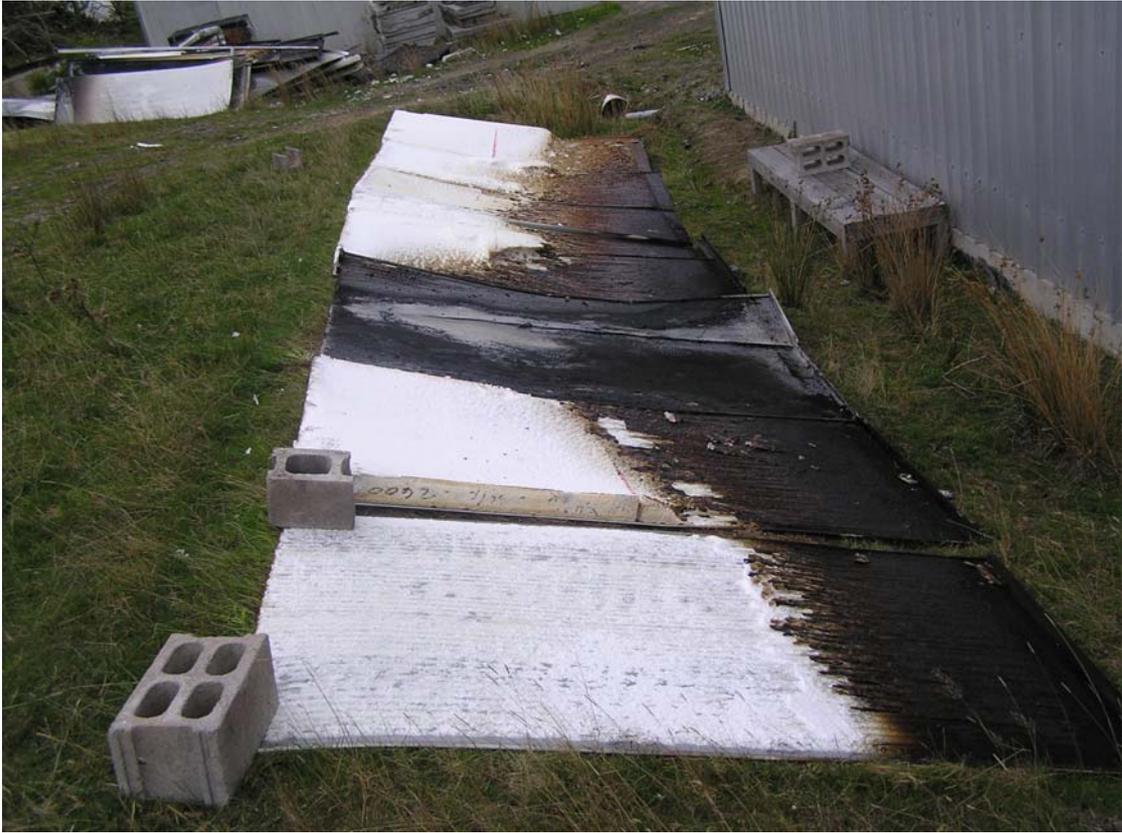
Figure 38: EPS core in walls remaining at the end of test PIP 4
