# STUDY REPORT

No. 164 (2007)

## Maximum Wall Bracing Rating that is Compatible with NZS 3604 Construction. Phase III: Testing of Room 2

SJ Thurston

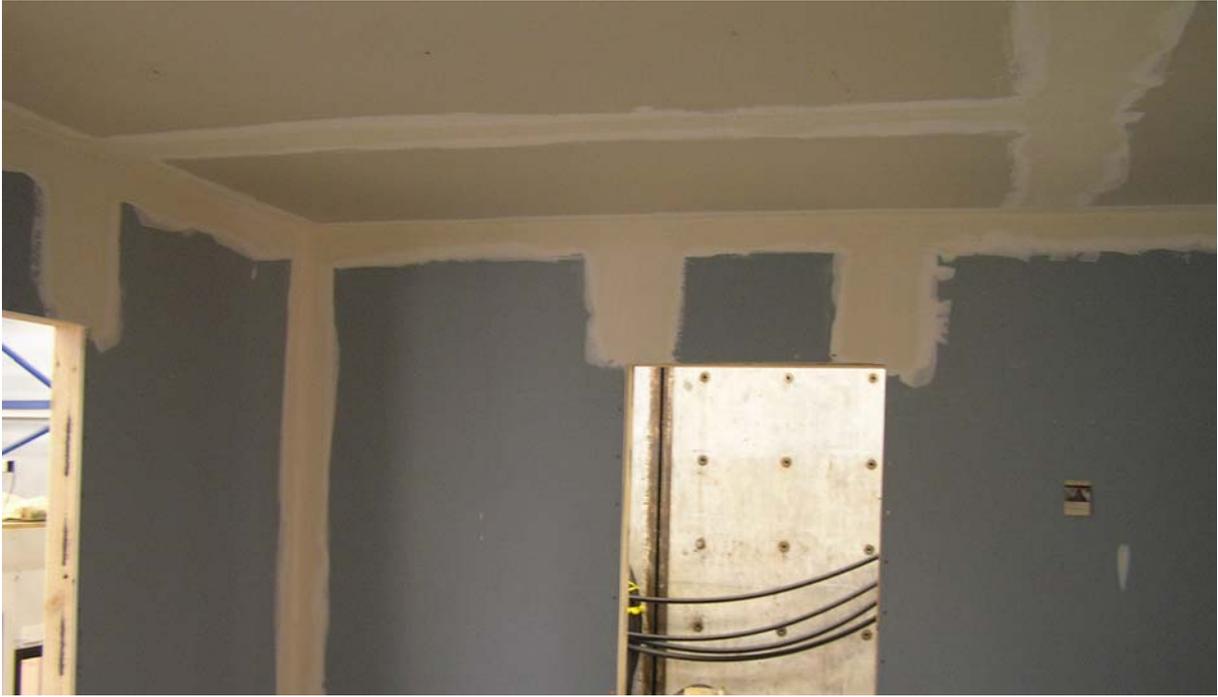
**Figure 11. Photograph of Room 2 interior plastered joints**

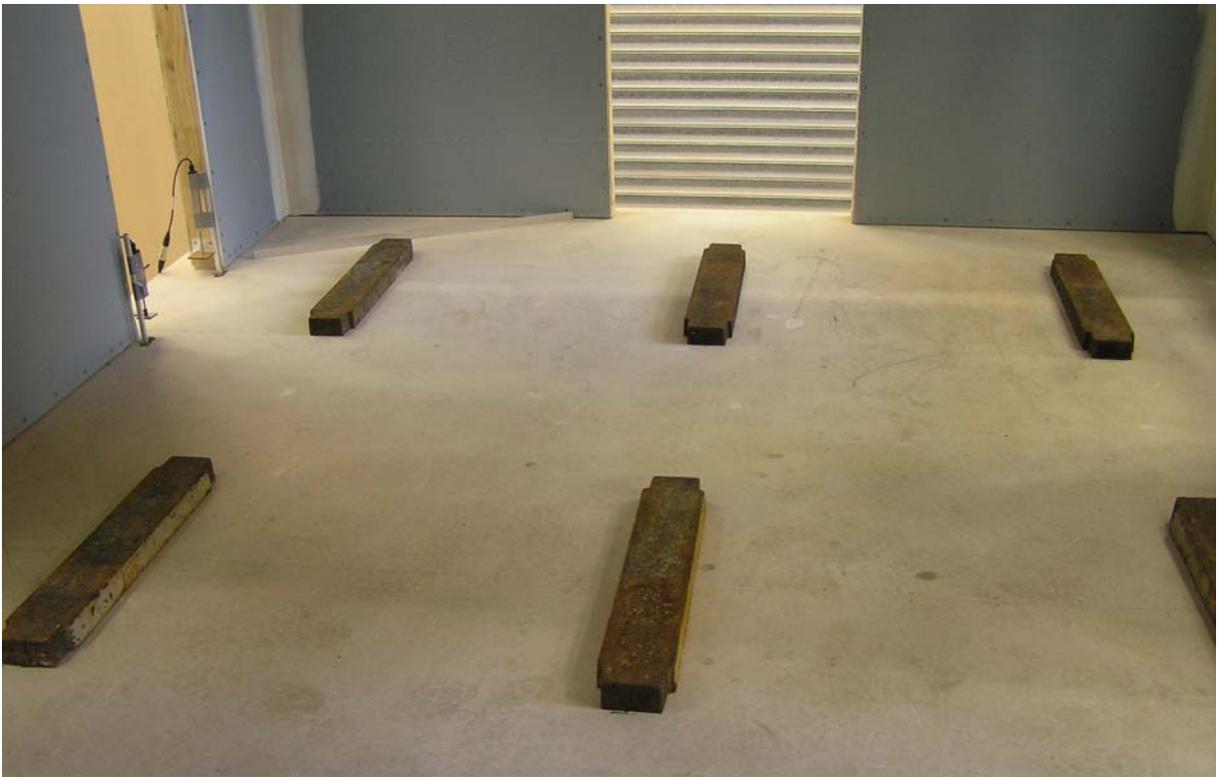
**Figure 12. Photograph of weights added to interior floor**

Roof dead load and a floor live load of 0.2 kPa were simulated by weights, as shown in Figure 10 and Figure 12.

Roof dead load and a floor live load of 0.2 kPa was simulated by weights, as shown in Figure 10 and Figure 12.

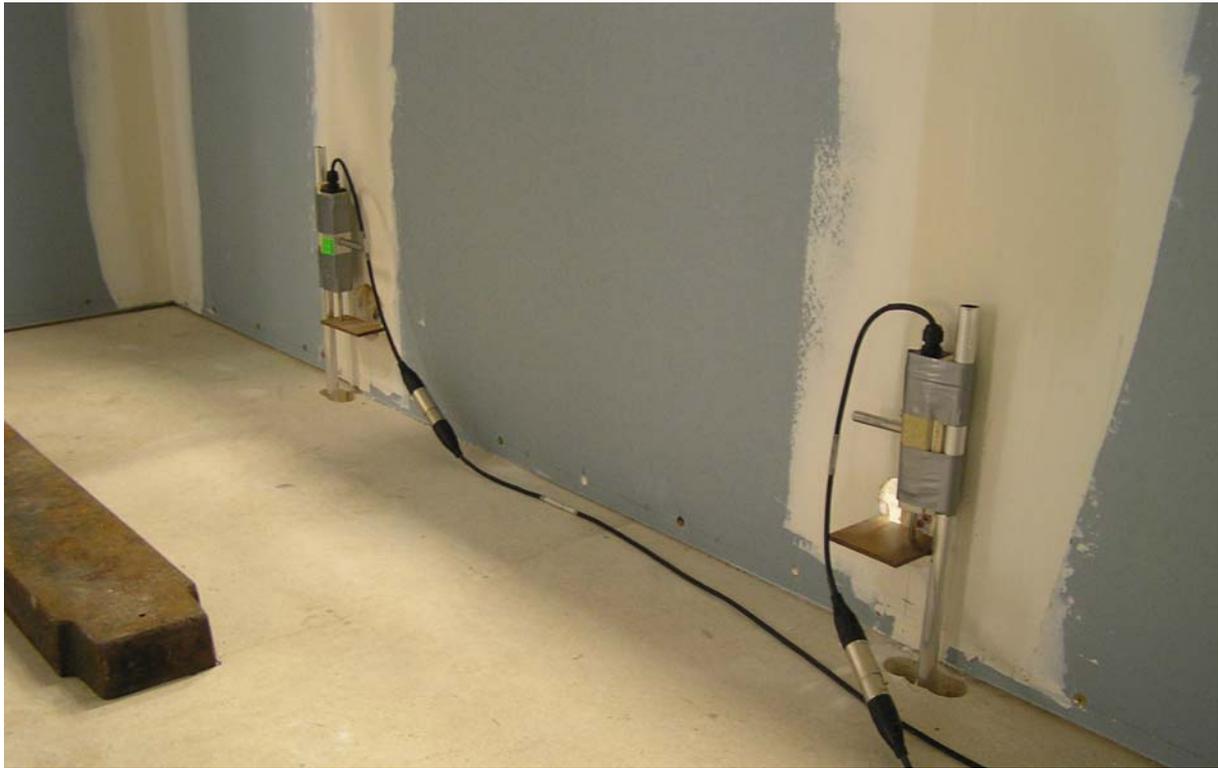
Figure 14. Measurement of inter-storey uplift

- (4) Vertical separation of the bottom of the stud in the top storey from the studs in the bottom storey at the boundaries of each wall opening. An example at door openings is shown in Figure 13. This was accomplished by fixing rods to the studs in the lower storey. The rods passed through slots in the flooring. A potentiometer was fixed to the top of the rods with the target attached to the upper studs. Slightly different arrangements were required at window openings (as shown in Figure 14) and wall corners (as shown in Figure 16).

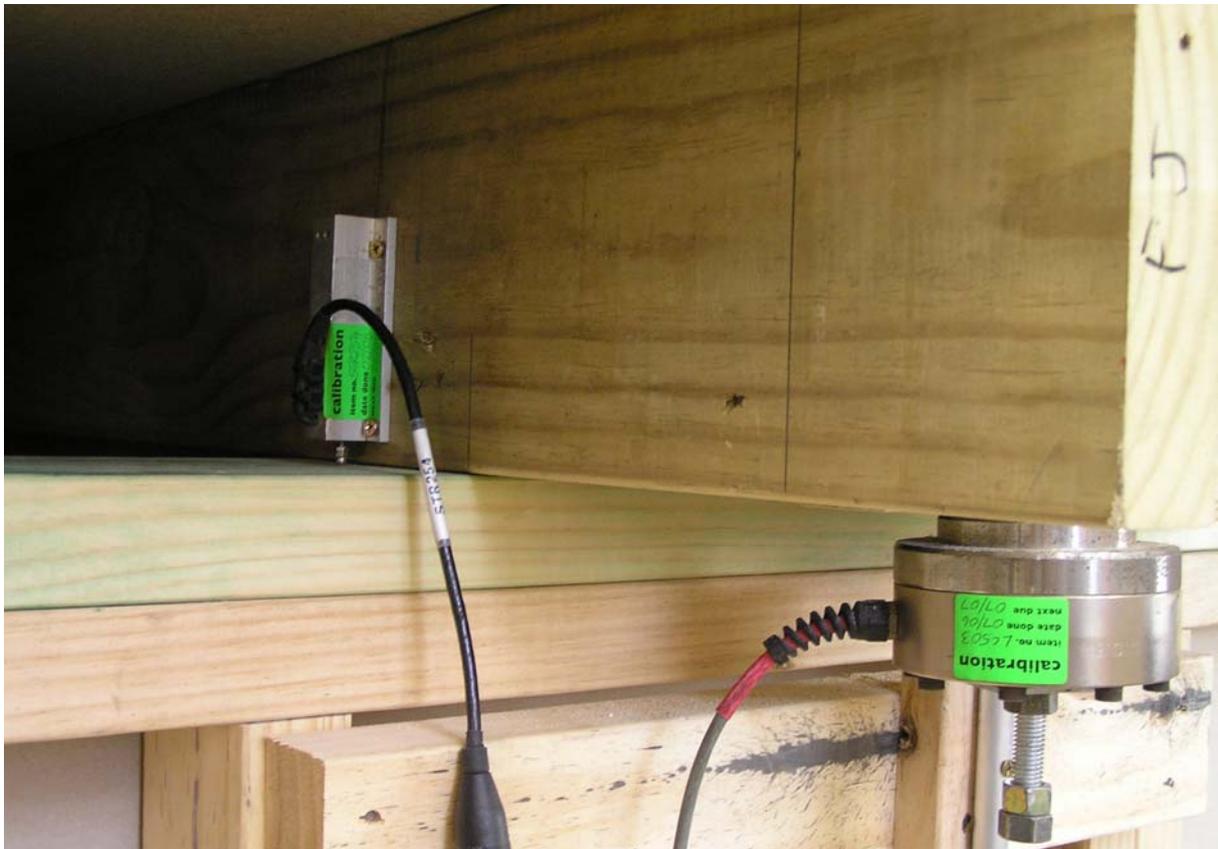
Figure 15. Measurement of floor joist uplift from the lower storey top plate

- (5) Vertical movement of joists from wall top plate below (Figure 15).
- (6) Vertical forces in bracing wall hold-down through-bolt anchors using load cells (see Figure 13 and Figure 15).

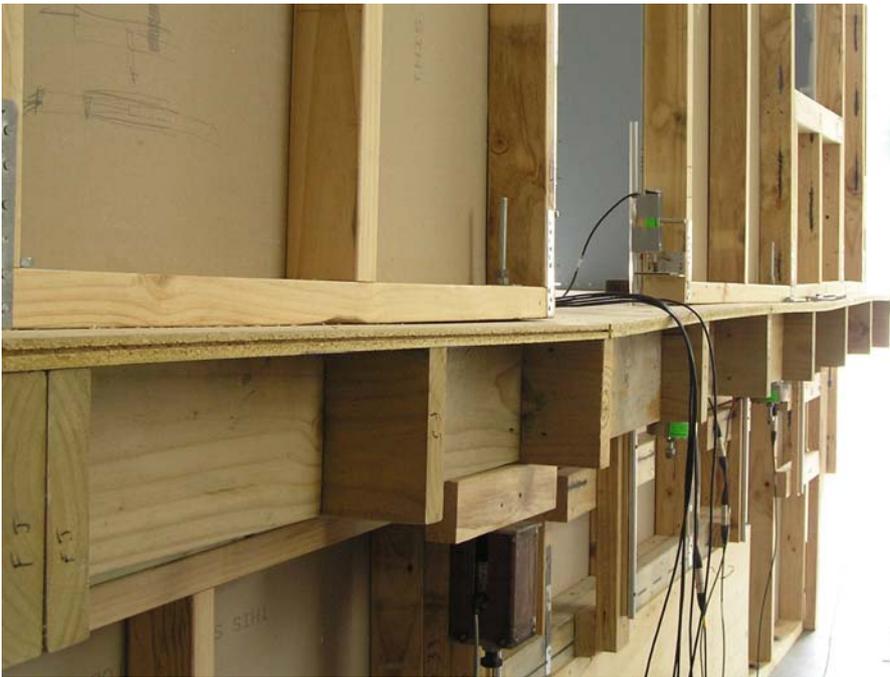
**Figure 19. Distortion of floor and blocking due to racking loads in Side 1 for Test 3 of Stage I at +25 mm deflection**

At 25 mm inter-storey movement, significant distortion still occurred at the blocking, as shown in Figure 19. Figure 20 and Figure 21 show this distortion at 40 mm imposed wall deflection. The floor joists lifted off their supports, as shown in Figure 22. Floor vertical movement is illustrated in Figure 20 and Figure 21. Floor joist and blocking uplift at the End 1 corner are shown in Figure 23.

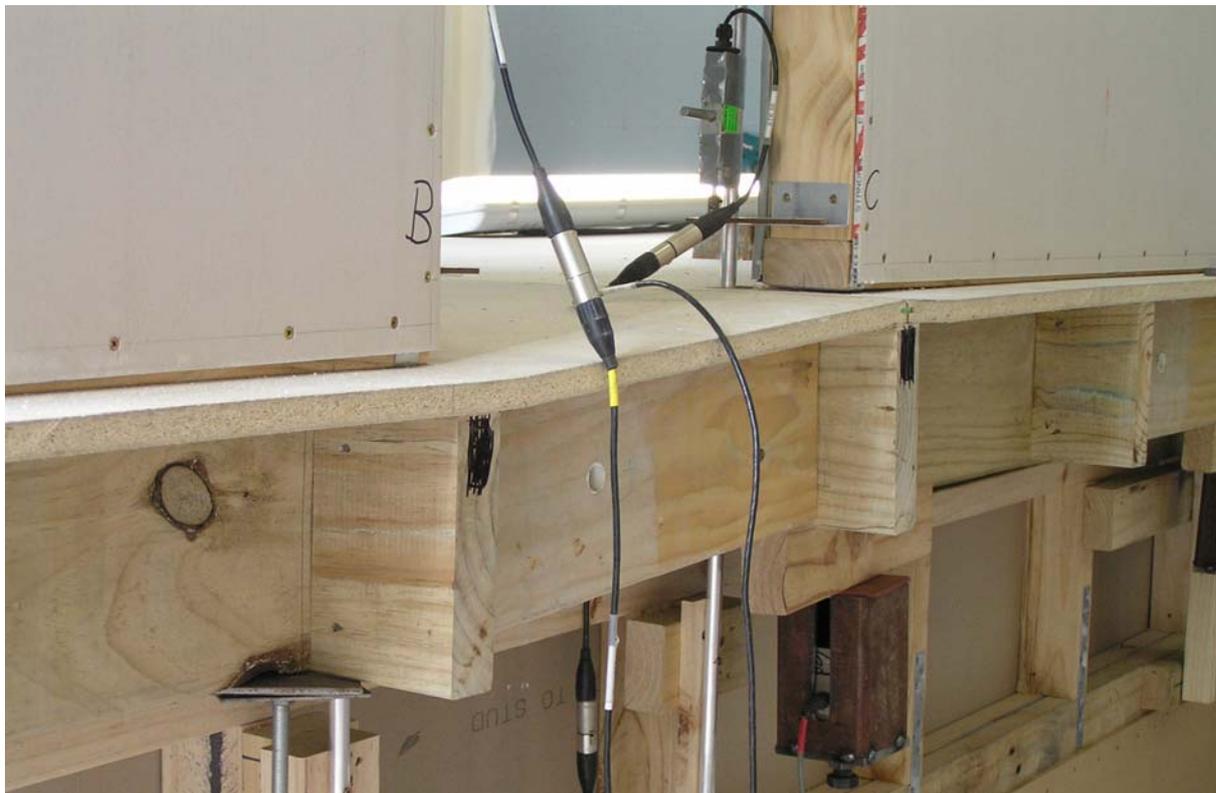
**Figure 21. Distortion from both upwards and downwards loads in Side 2 for Test 3 of Stage I at -40 mm deflection**

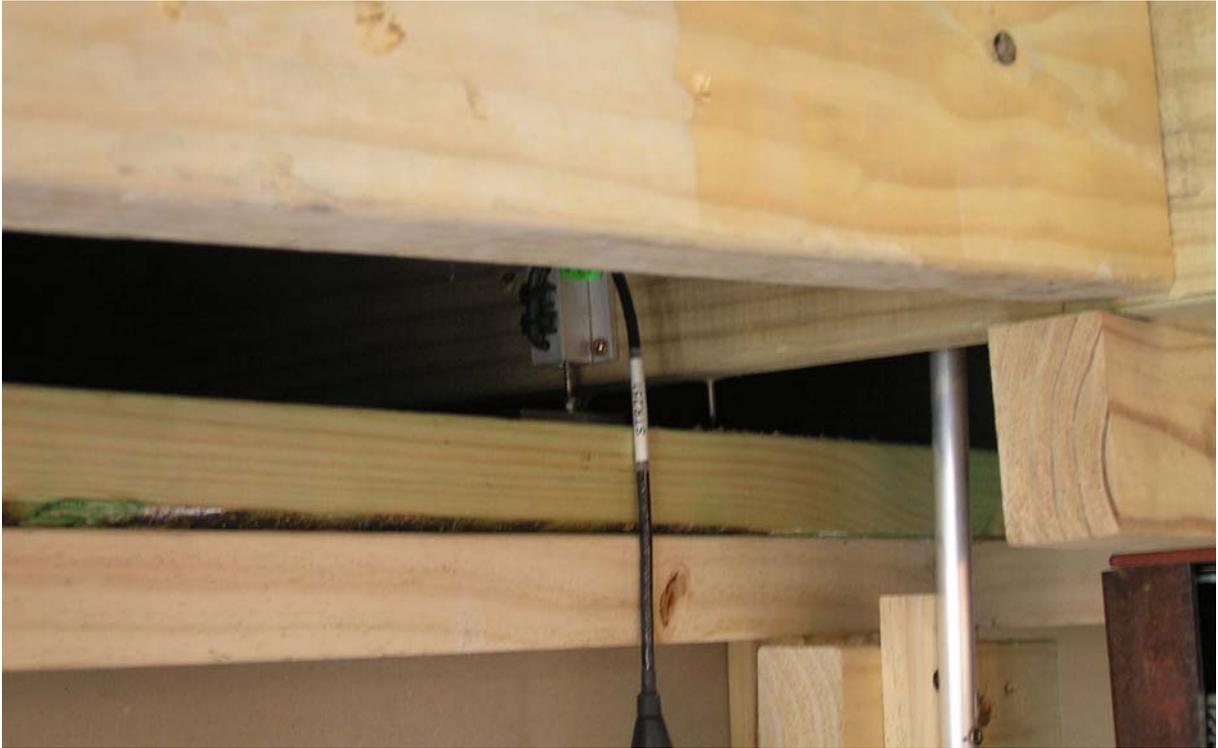
Figure 22. Joist uplift from wall below in Test 3 of Stage I at 40 mm deflection

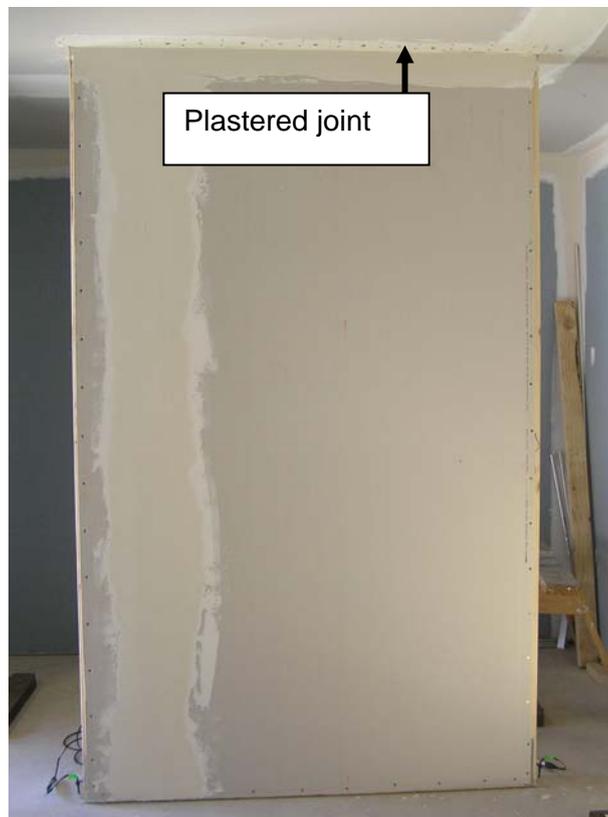
Figure 33. Internal wall used for Stage II testing

A general view of Stage II testing is shown in Figure 32. The same deflection regime was simultaneously imposed onto the top of both End 1 and the interior wall shown in Figure 33. A view under the floor is given in Figure 34 which shows the floor joists, blocking and instrumentation.

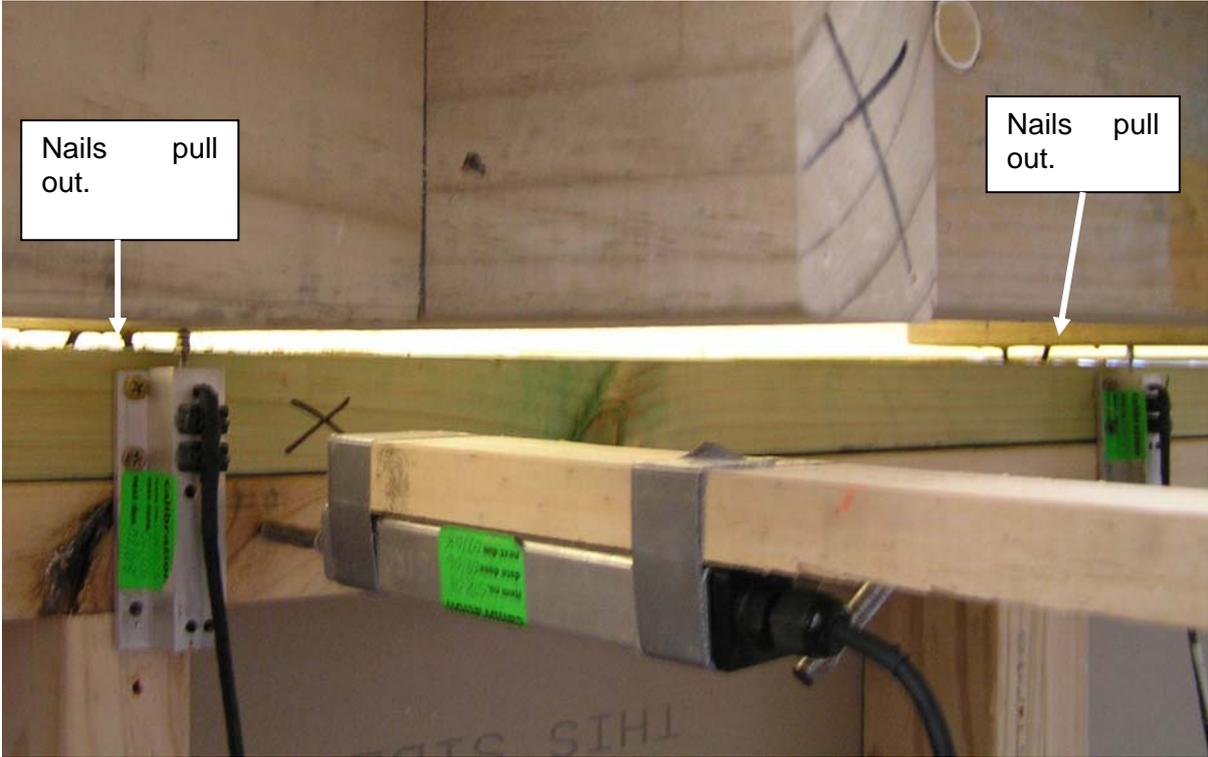
Figure 36. Joist uplift along Side 2 at joist ends for Stage II testing

- (b) Test 2 consisted of one cycle to  $\pm 14$  mm and one-and-a-half cycles to  $\pm 25$  mm inter-storey movement. The boundary joist along End 1 lifted 16 mm at one end and 21 mm at the other during these cycles (Figure 35). The internal floor joists were now lifting excessively from their supports as shown in Figure 36 (13 mm at W, 10 mm at Y and 6 mm at V and X). Refer to Figure 1 for nomenclature. The joist beneath the End 1 wall was also lifting excessively, as shown in Figure 37. The horizontal slip between the boundary joist along End 1 and the wall below reached 9 mm. The hysteresis loops of load versus deflection had flattened or were sloping downwards with increased deflection. It was decided that the joist connections had exceeded their maximum strength and the only purpose in continuing testing was to measure the strength of the upper storey walls. Hence, the connections between the joists and the wall below were strongly strapped together and the test continued to examine the maximum racking strength the walls themselves could achieve.

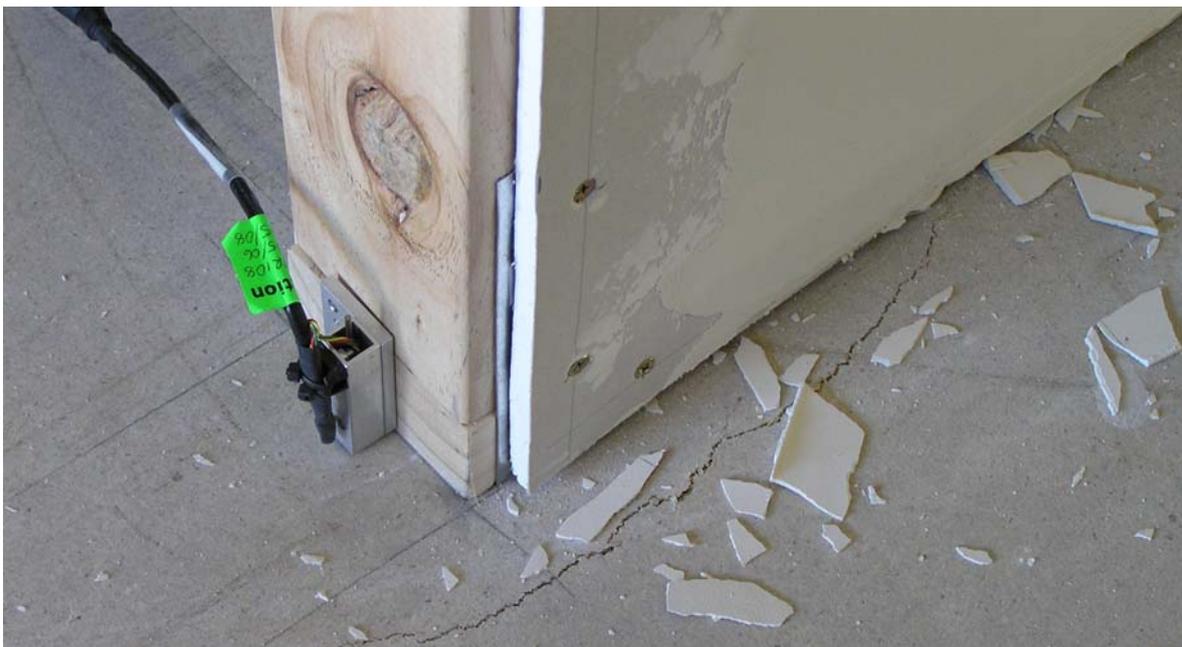
Figure 39. Flooring breakage due to blocking vertical movement at the internal wall for Stage II testing

- (c) Test 3 consisted of two cycles to  $\pm 27$  mm, one to  $\pm 40$  mm and two cycles to  $\pm 62$  mm inter-storey wall deflection. At this stage the hysteresis loops had flattened, as shown in Figure 41. The internal wall had 'rocked' considerably, sinking into the floor at one end (Figure 39) and lifting at the other, thereby creating a gap between the ceiling and wall top at the compression end (Figure 40) and tearing off the plastered joint at this location. However, there was no horizontal slip between the wall top and ceiling. The floor joist blocking was slipping vertically by approximately  $\pm 10$  mm relative to the floor joists at the ends of the internal wall. The adjacent flooring was lifting by a similar amount from the supporting joists – being forced upward by the lifting blocking. The upper wall lining-to-ceiling joint had torn along part of End 1. However, an examination of the condition of the lining at the internal fasteners showed that the wall shear strength had not been exceeded.

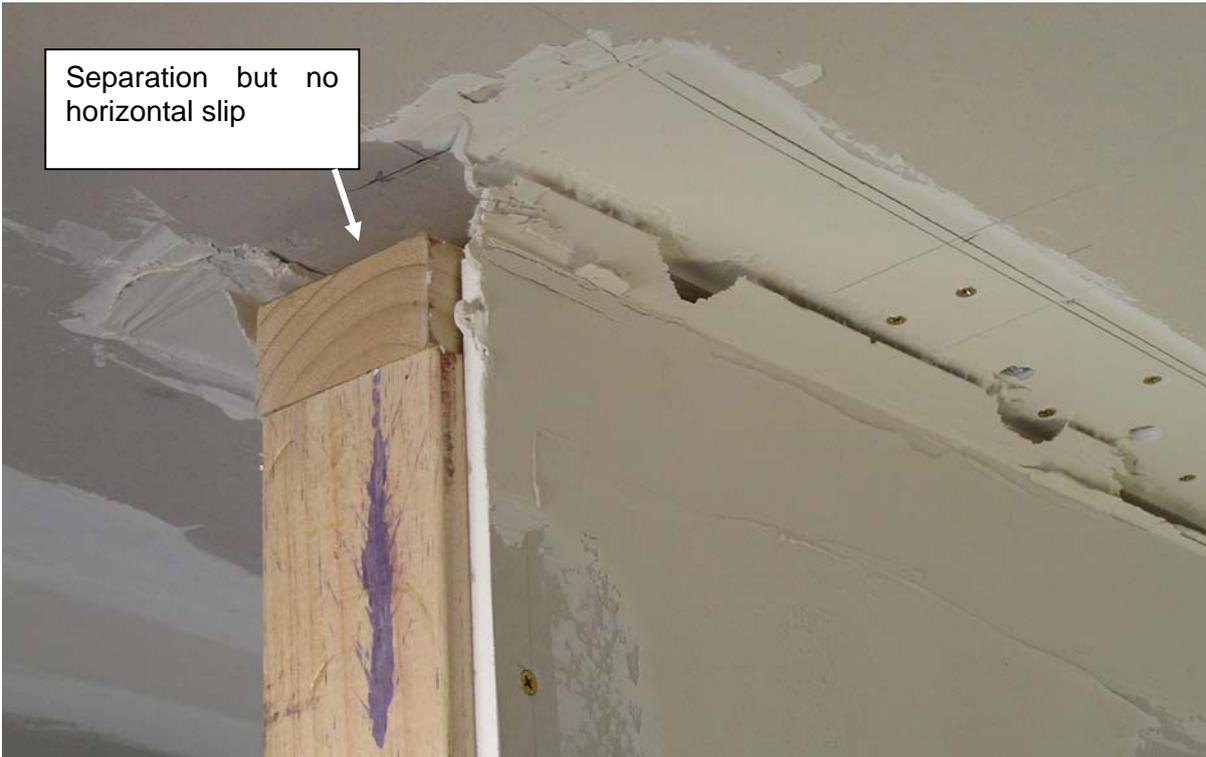
**Figure 40. Separation of internal wall top corner from ceiling in Stage II testing**

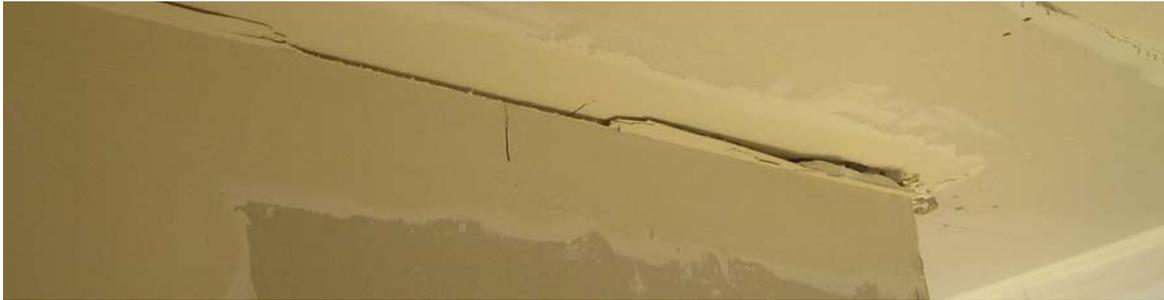
Figure 52. Ceiling-to-wall plasterboard joint cracks in Stage III

(a) Cracking from Test 1

(b) Cracking from Test 2

- (a) Test 1 consisted of three cycles to  $\pm 7$ ,  $\pm 14$ ,  $\pm 24$ ,  $\pm 33$  mm and one cycle to  $\pm 48$  mm inter-storey movement. Cracks had formed in the plaster joint above the internal wall, as shown in the top photograph of Figure 52. The hysteresis loops of load versus deflection had flattened or were sloping downwards with increased deflection. The floor joists had lifted excessively (as discussed later). Consequently, it was decided that the substructure below the first floor had exceeded their maximum strength and the only purpose in continuing testing was to measure the strength of the top storey walls. Hence, the connections between the joists and the wall below (including the boundary joists) were strongly strapped together and the test continued to examine the maximum racking strength that the walls themselves could achieve.
