STUDY REPORT

SR 208 (2013)

Optimised Wall-to-Floor Junctions in Multi-Storey, Multi-Residential Light Timber-Framed Buildings

T Walther and GJ Beattie

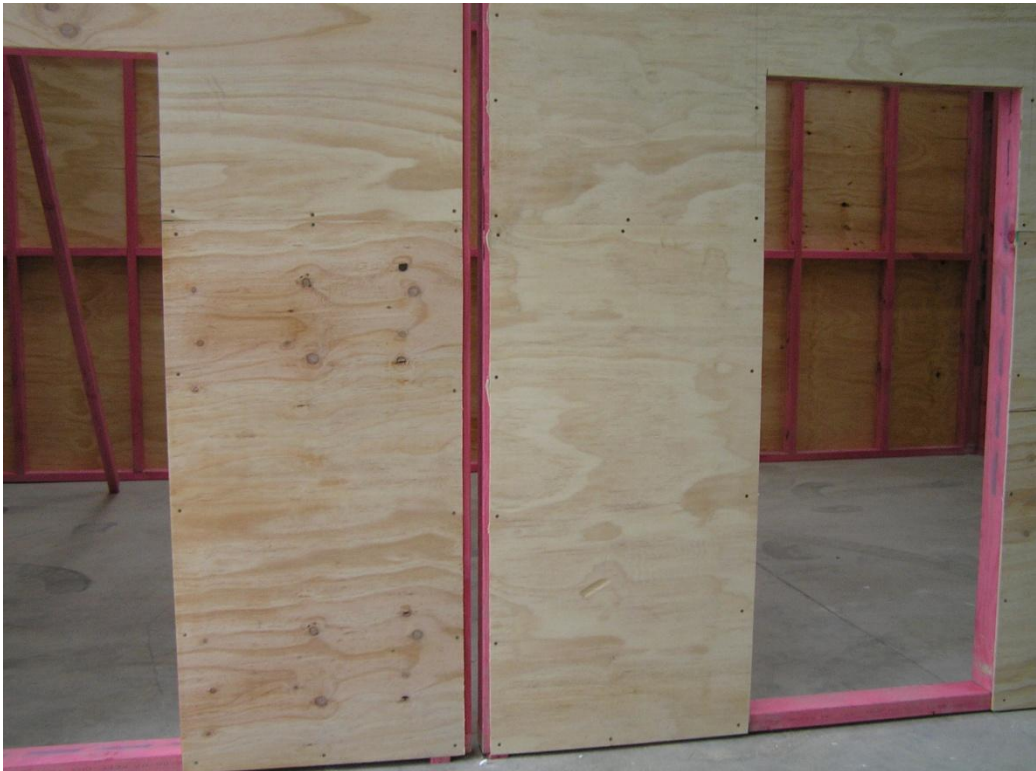
Figure 6. The 20 mm gap separating Chamber 1 from Chamber 2 and Chamber 3 from Chamber 4

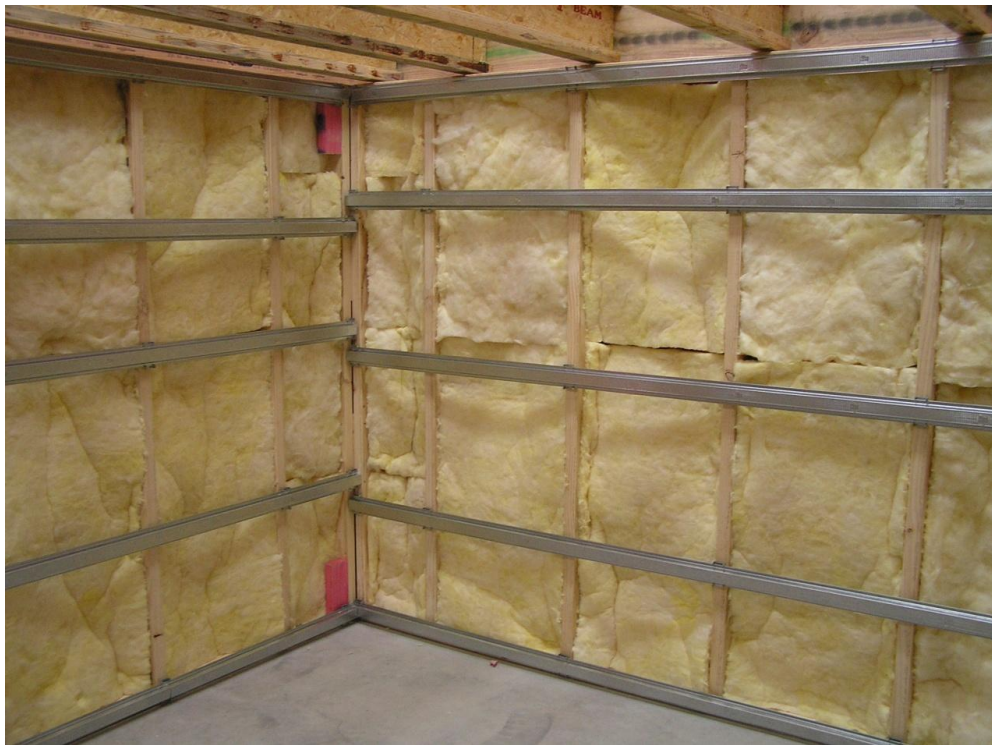
Figure 8. Photograph of exterior walls of the acoustic chamber taken during construction showing the acoustic absorption and furring channels connected to the frame with RSIC-1 clips.

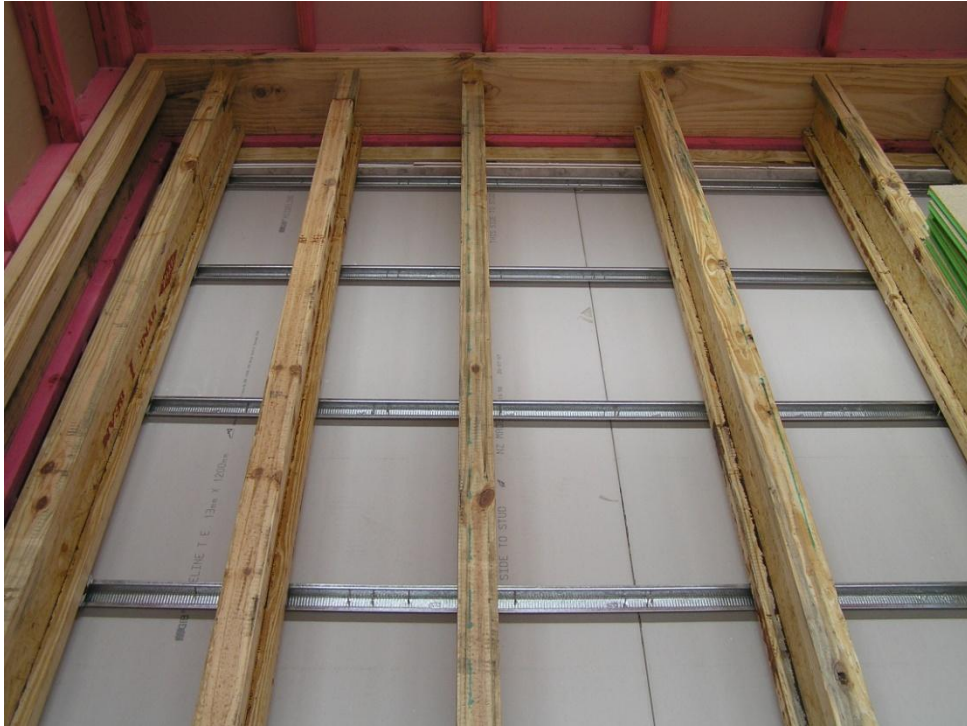
Figure 9. Photograph of the basic floor taken during construction

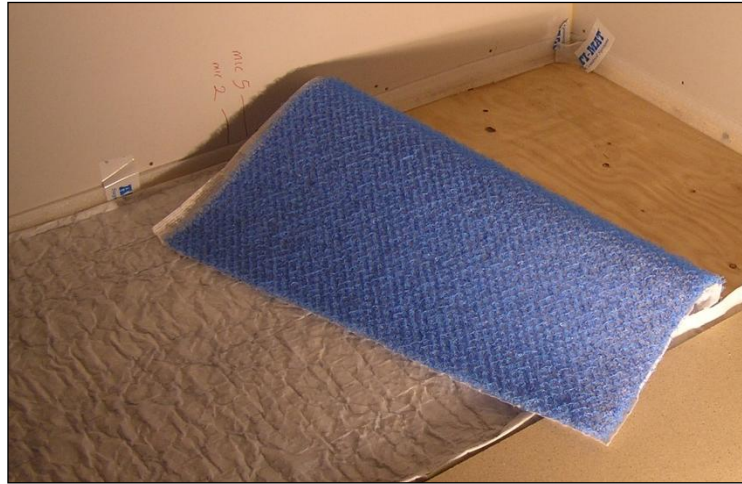
Figure 17. Maxxon Acousti-Mat 3

The floor was constructed using the basic floor plus a sound suppressing mat with two layers of 20 mm particleboard floating on top as shown in Figure 16. The two layers were screwed together. This is a conventional floating floor system using a proprietary product as the sound suppressing material (see Figure 17).

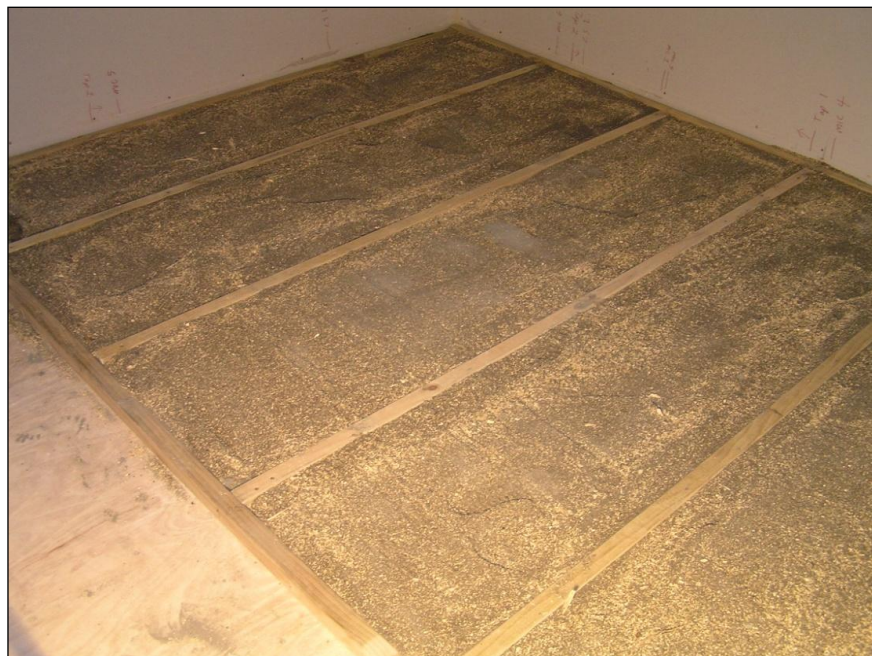
Figure 20. 45 x 45 mm thick batten frame with sand/sawdust mix infill

The floor consisted of the basic construction plus 45 x 45 mm battens at 450 mm centres fixed to the plywood top surface of the basic floor and running at right angles to the joists. The 40 mm thick paving sand/sawdust infill (shown in Figure 19 and Figure 20) was then placed in the cavities between the battens and the top layer of 20 mm particleboard was screwed to the battens.

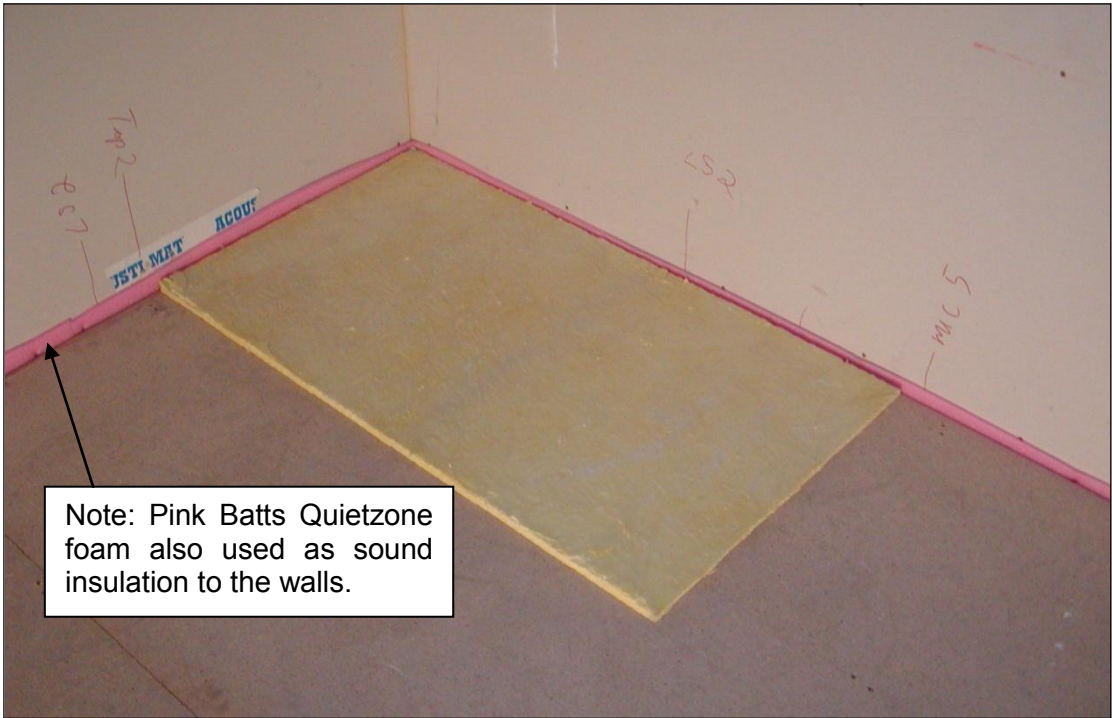
Figure 25. 13 mm fibreglass sound-suppressing layer

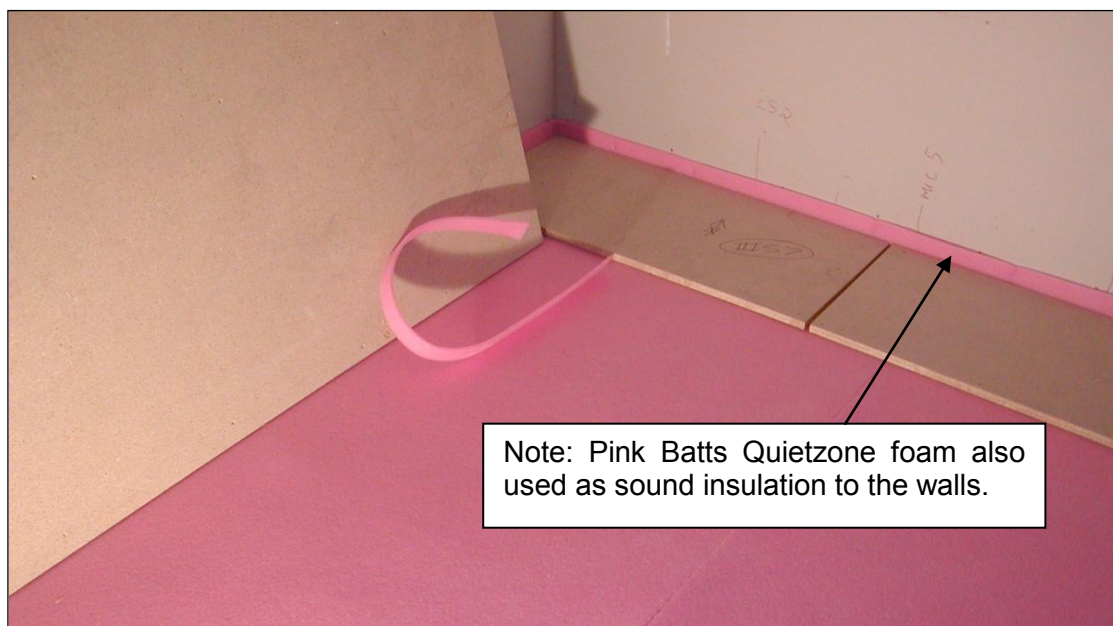
Figure 27. 10 mm Pink Batts Quietzone foam underlay

The floor was the basic construction plus a 10 mm Quietzone sound-suppressing mat with two layers of 20 mm particleboard screwed together and floating on top as shown in Figure 26. This is a conventional floating floor system using 10 mm foam underlay as sound suppressing material (see Figure 27).

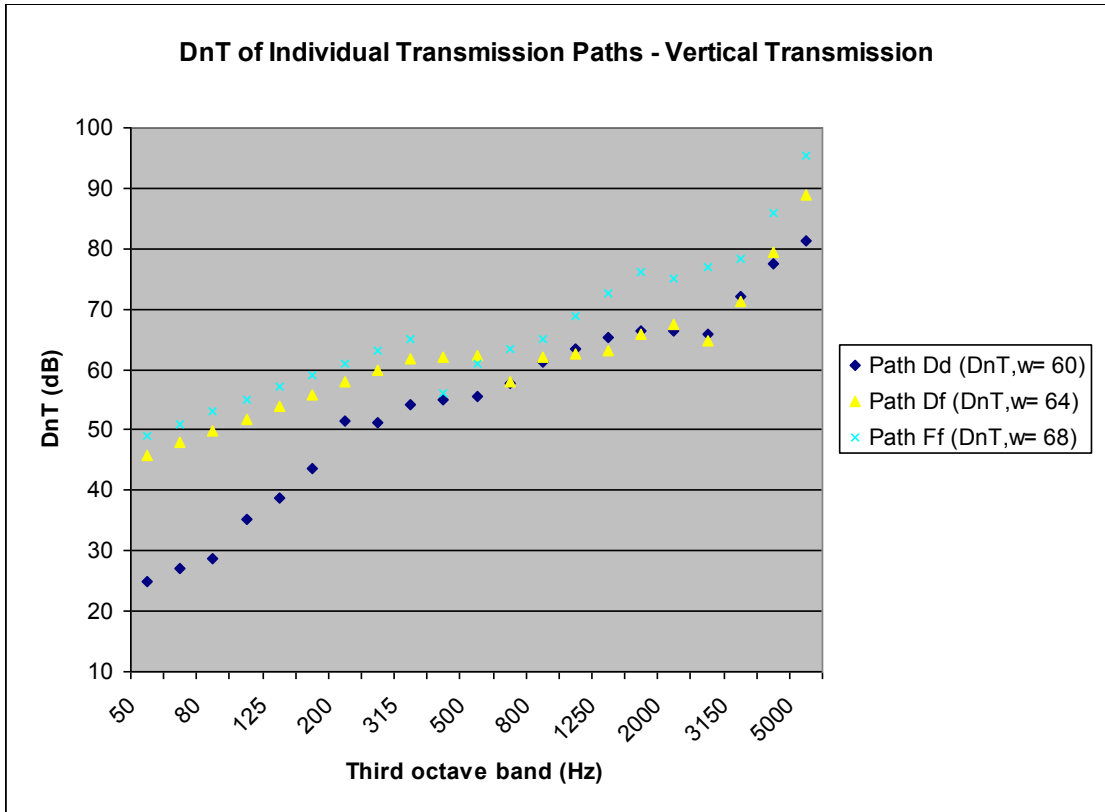
Figure 32(a). Individual airborne sound horizontal transmission for basic floor

Figure 32(b). Combined airborne sound horizontal transmission for basic floor

Figure 32(c). Individual airborne sound vertical transmission for basic floor

Figure 32(d). Combined airborne sound vertical transmission for basic floor

Figure 32. Basic floor with no floor covering – airborne sound transmission

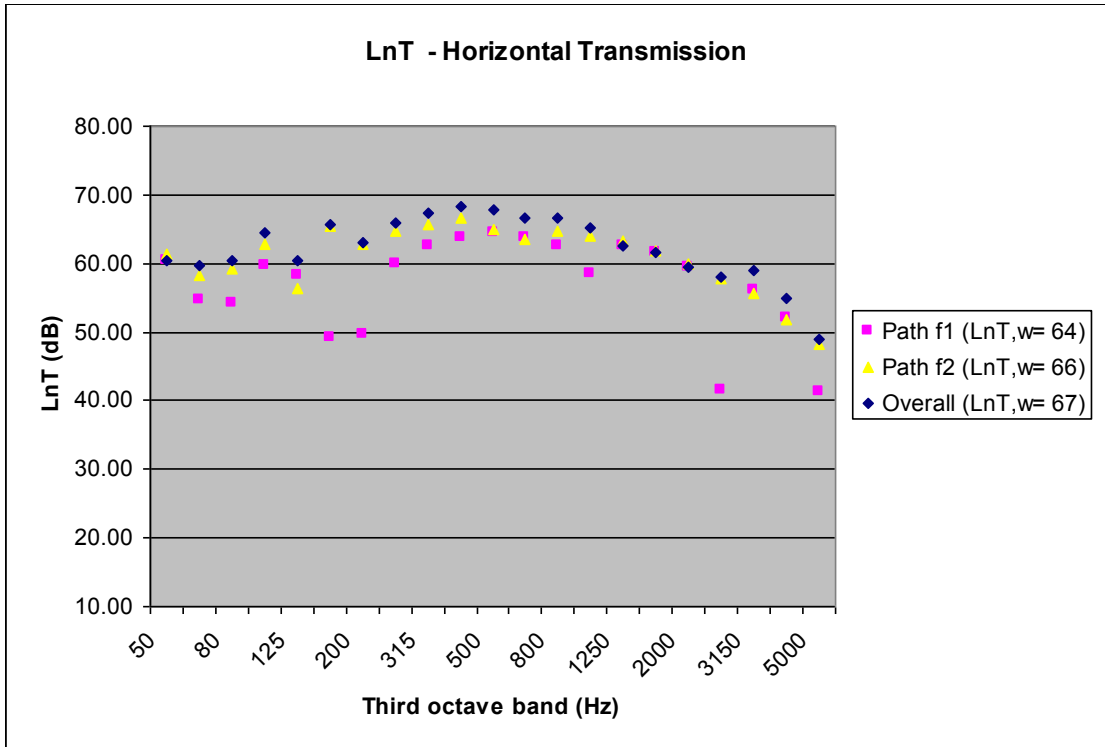
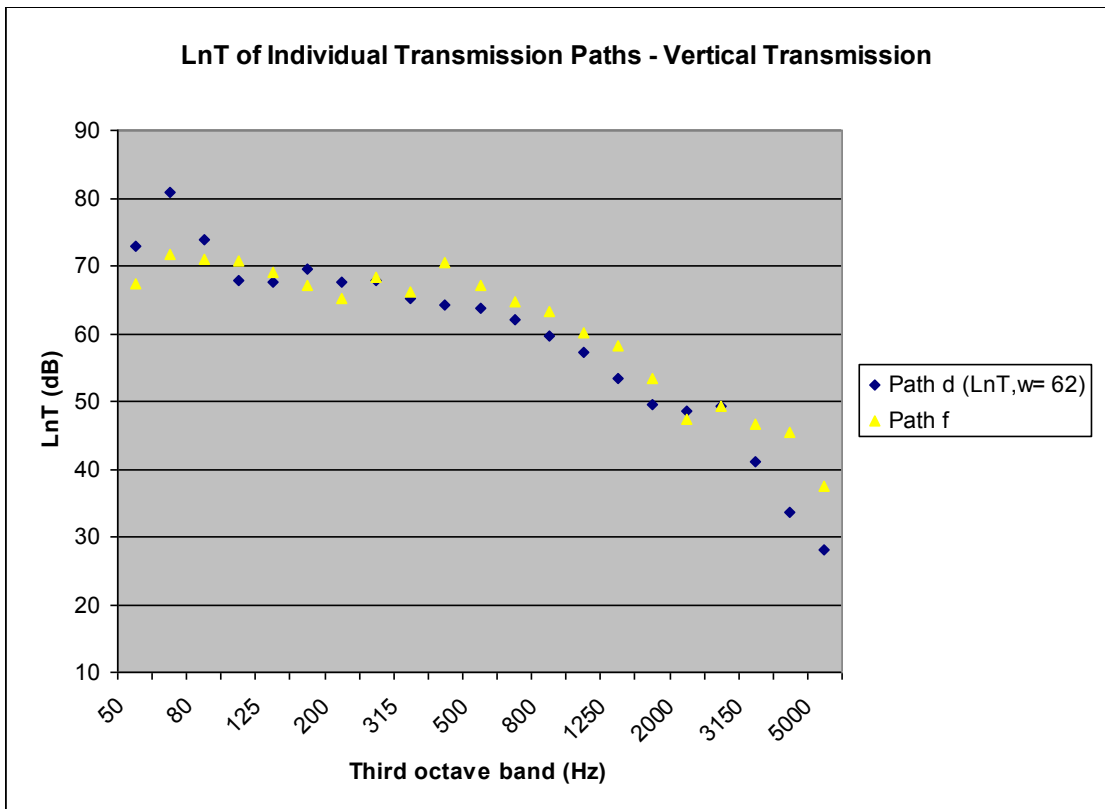
Figure 33(a). Impact sound horizontal transmission for basic bare floor

Figure 33(b). Individual impact sound vertical transmission for basic bare floor

Figure 33(c). Combined impact sound vertical transmission for basic bare floor

Figure 33(d). Impact sound vertical transmission for all coverings on basic floor

Figure 33(e). Combined impact sound diagonal transmission for basic bare floor

Figure 33. Basic floor – impact sound transmission with and without floor coverings

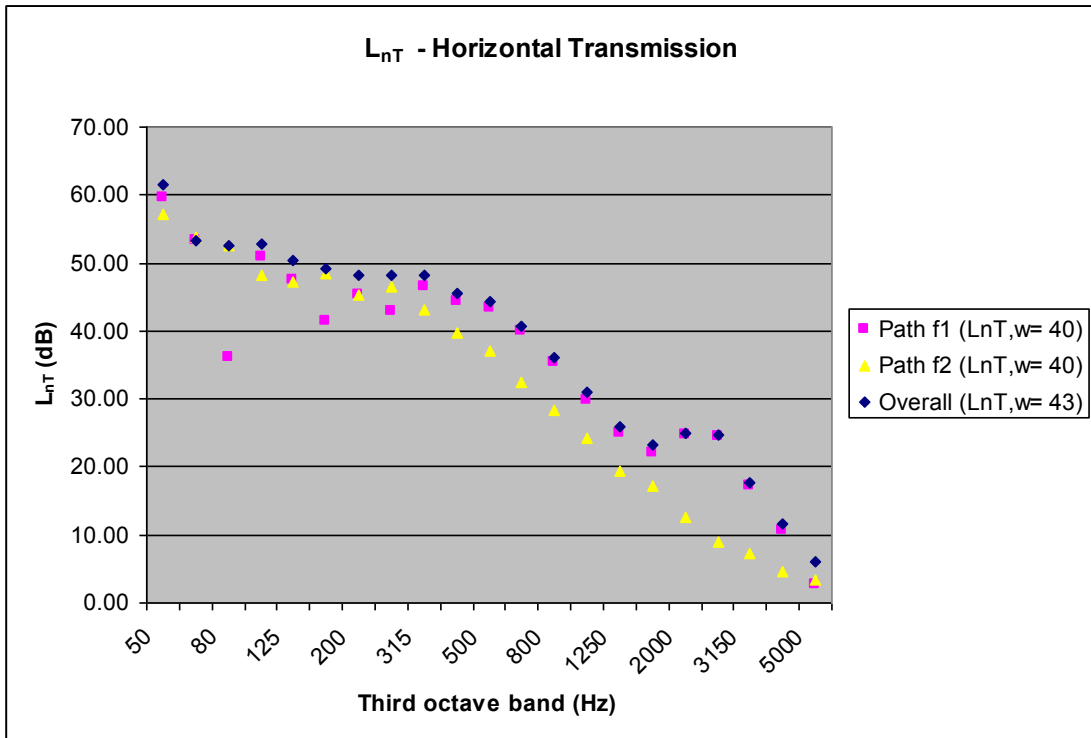
Figure 43(a). Impact horizontal transmission for 2 x 20 mm particleboard raft on 13 mm Bradford Quietel fibreglass board on basic floor with no floor coverings

Figure 43(b). Individual impact vertical transmission for 2 x 20 mm particleboard raft on 13 mm Bradford Quietel fibreglass board on basic floor with no floor coverings

Figure 43. 2 x 20 mm particleboard raft on 13 mm Bradford Quietel fibreglass board – impact sound transmission with and without floor coverings.

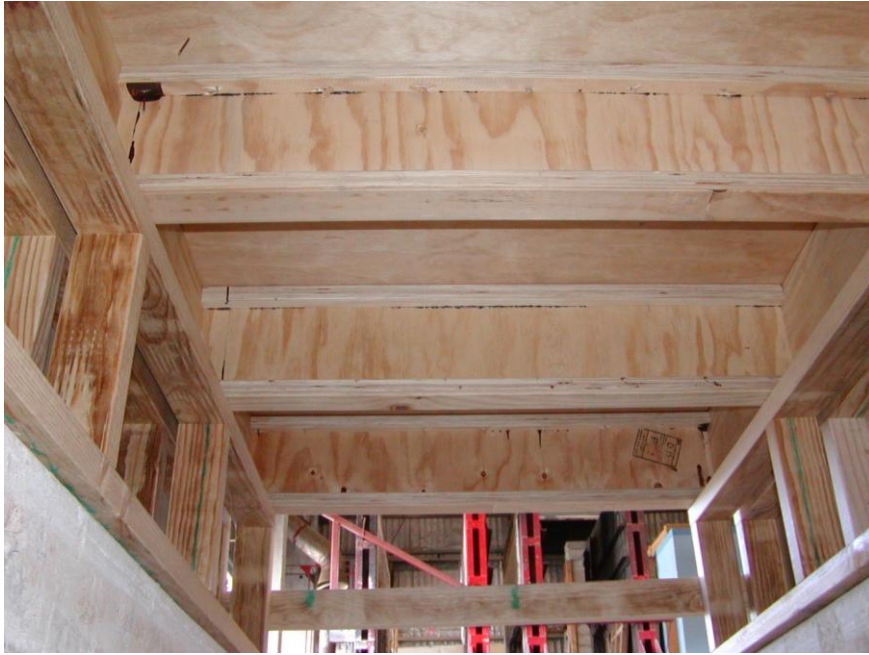
Figure 48. Photograph during construction of Pilot Fire Test Specimen 1

A photograph during construction is shown in Figure 48. The details of the construction are given in Figure 49 and Figure 50. The specimen consisted of a floor bounded below on two of its edges, with the 13 mm GIB Fyrelite[®] lined walls described as lining option (2) in Section 5.1. The other two edges were sealed off. The I-beams created a compartment below the floor which was exposed to the furnace temperatures.

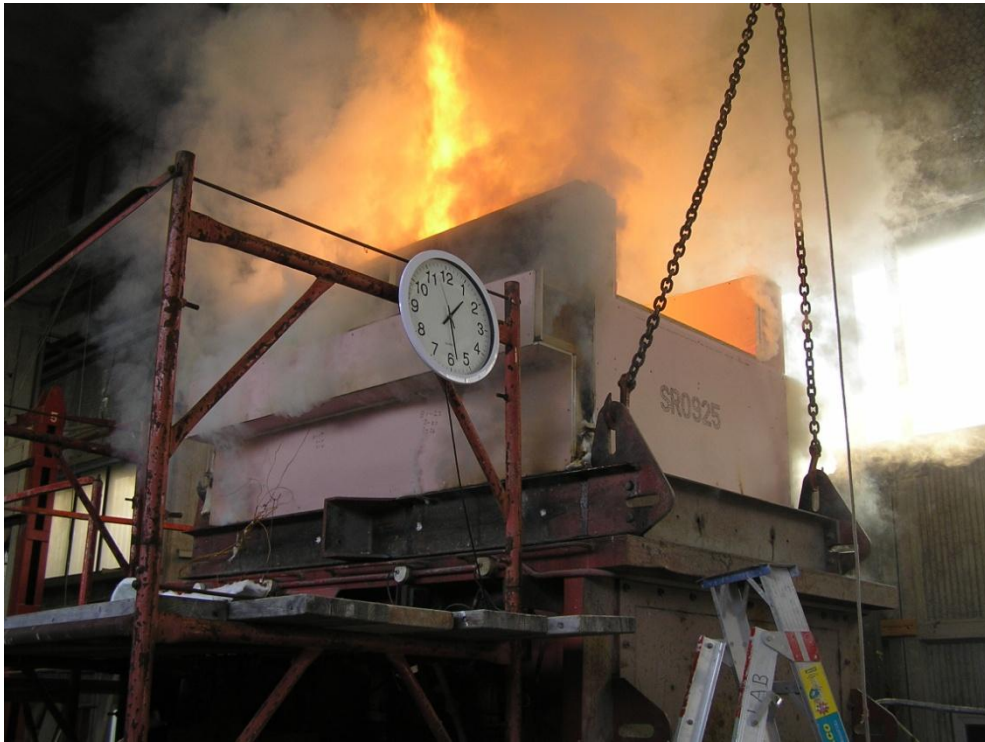
Figure 51. Pilot Fire Test Specimen 1 when fire broke through the floor

The test continued until just less than 90 minutes when fire broke through the 17 mm plywood of the basic floor (Figure 51). An analysis of test thermocouples indicated that the fire resistance of the Acoustic Floor 5 was better than the basic floor. Both indicated a fire resistance greater than 60 minutes.

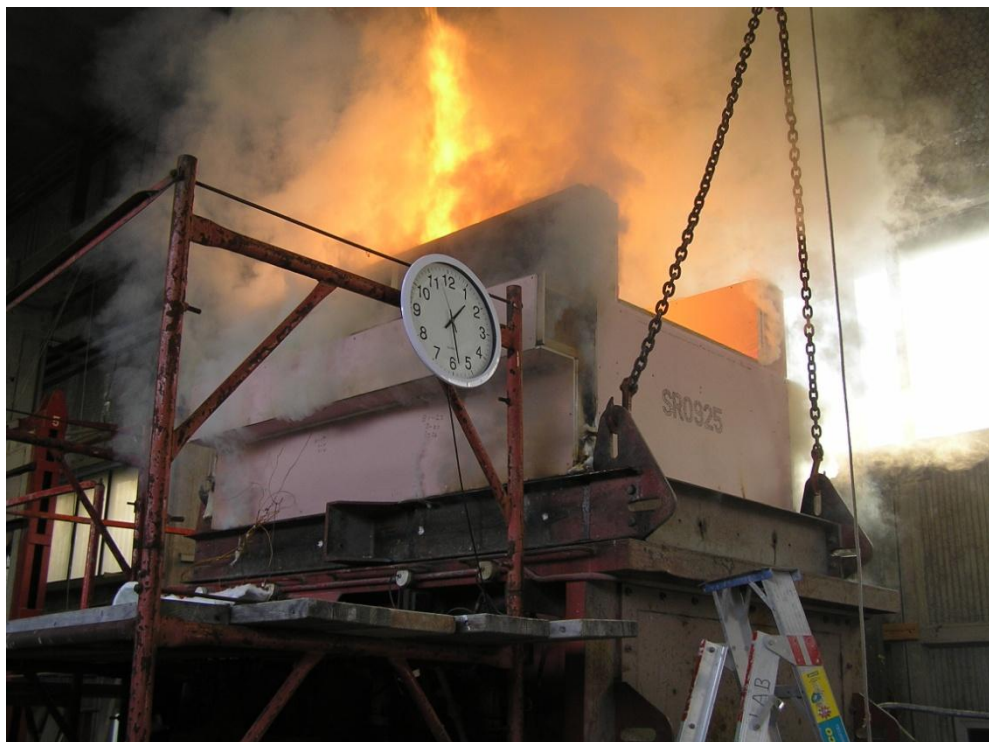
Figure 59. Pilot Fire Test 1 when fire broke through the floor at about 89 minutes

The test followed the time-temperature curve in Figure 54 and continued until just less than 90 minutes when fire broke through the plain 17 mm plywood floor as shown in Figure 59.

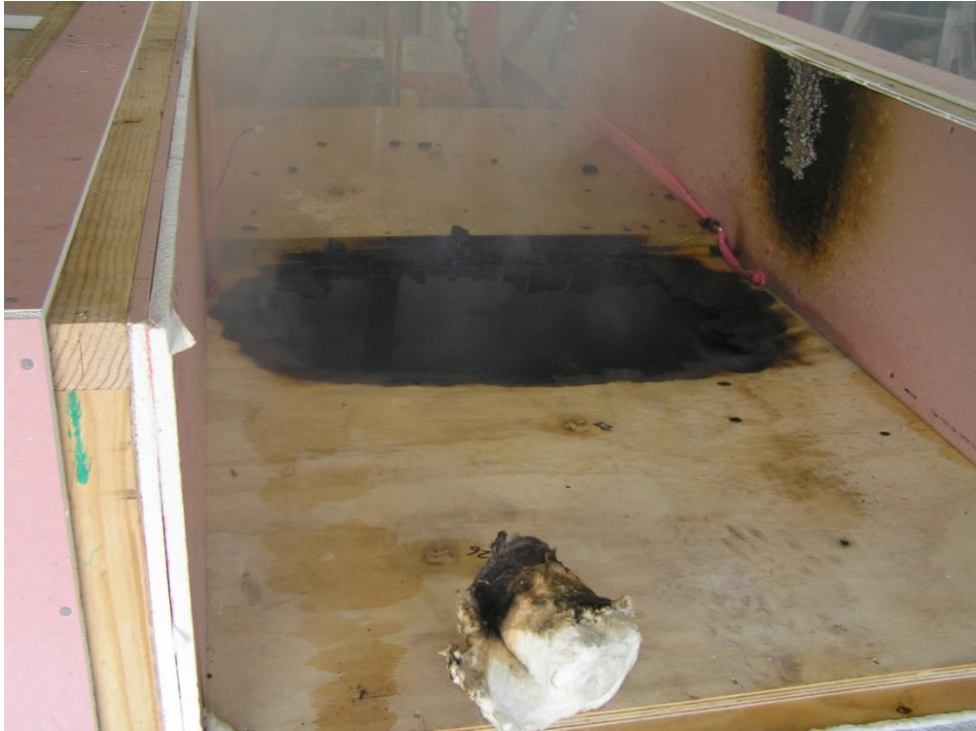
Figure 60. Area of Integrity failure on floor surface in Pilot Fire Test 1

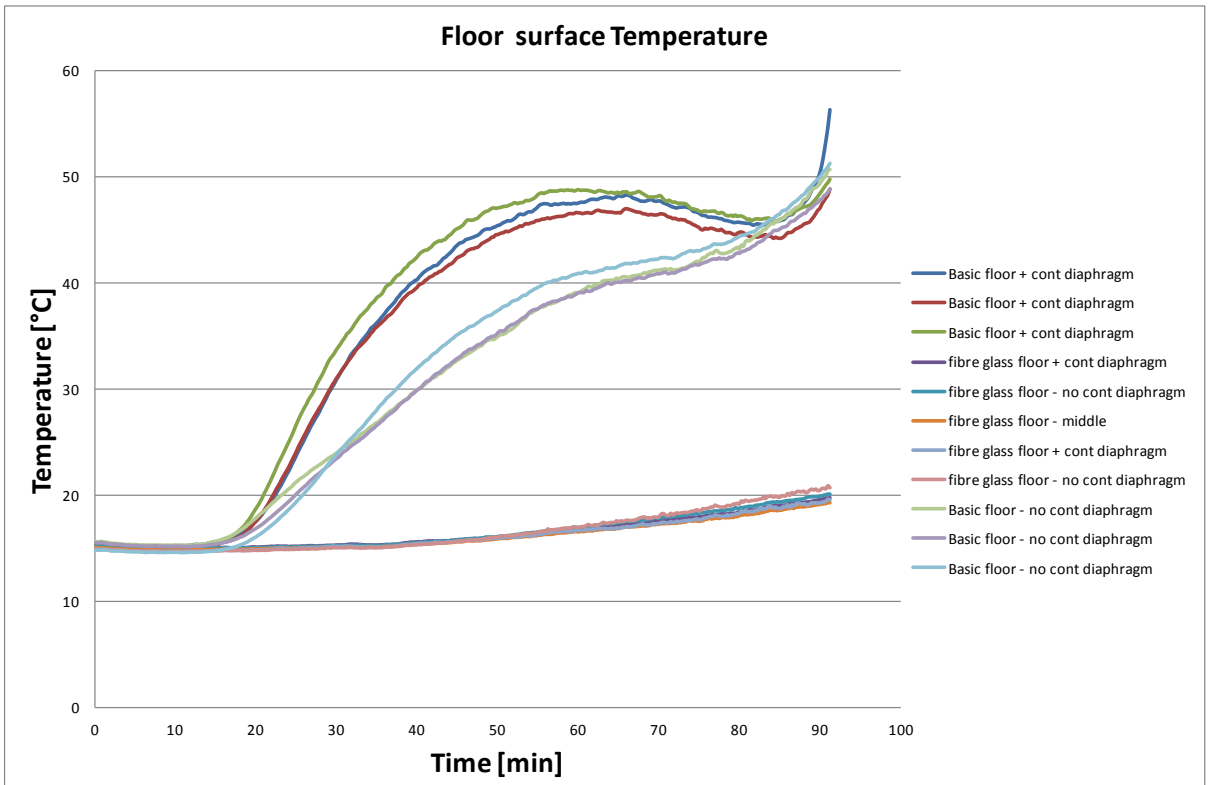
Figure 62. Floor surface temperature in Pilot Fire Test 2

The floor surface temperature in Figure 62 indicates a marginally more rapid rise on the basic floor compared with the fibreglass form. This is because the additional insulating effect of the fibreglass and particleboard delays the temperature rise on the upper surface. A parallel effect is that more heat is trapped within the system resulting in higher temperatures on the 17 mm plywood such that it chars more rapidly under the insulating fibreglass and eventually the region of Integrity failure is at the junction of the basic and fibreglass floor. The post-test photograph in Figure 66 shows the area under the fibreglass wool and 20 mm particleboard. In this test the plywood had not burnt through and there was no Integrity failure at the junction of the two floor surfaces as there was in Pilot Fire Test 1.

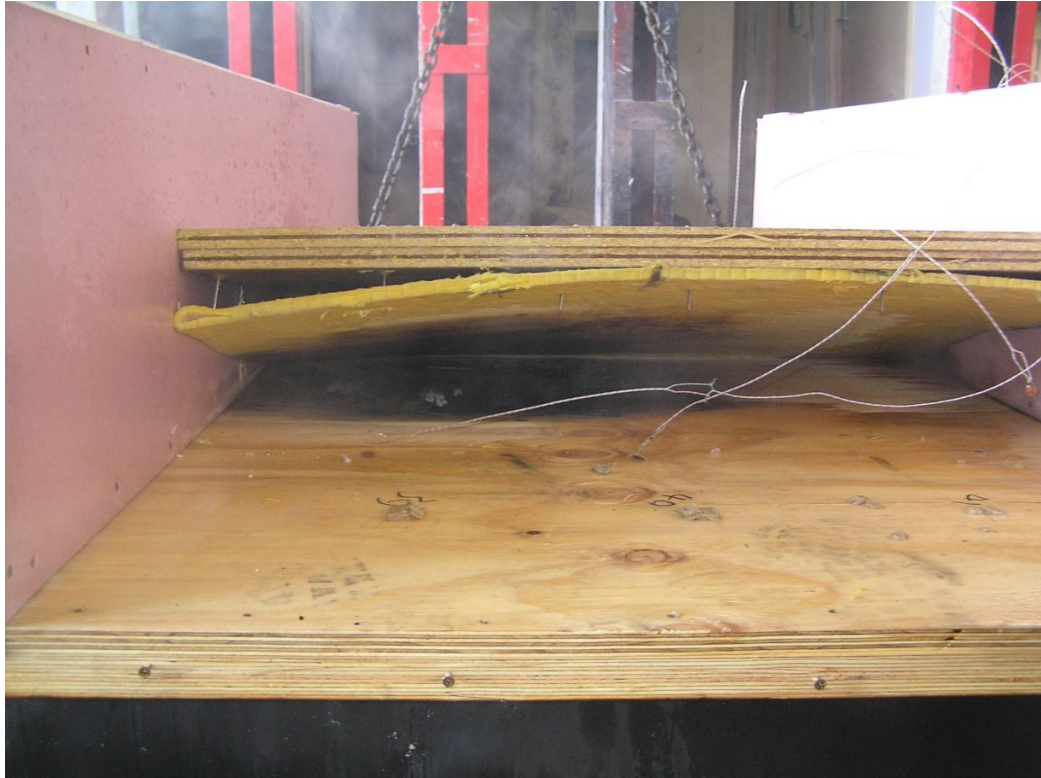
Figure 66. Area of Integrity failure on floor surface in Pilot Fire Test 2
