# STUDY REPORT

NO. 34 (1991)  
FIRE RESISTANCE OF NEW ZEALAND  
CONCRETES - PART 1

A. Woodside  
J.J. de Ruiter  
C.A. Wade

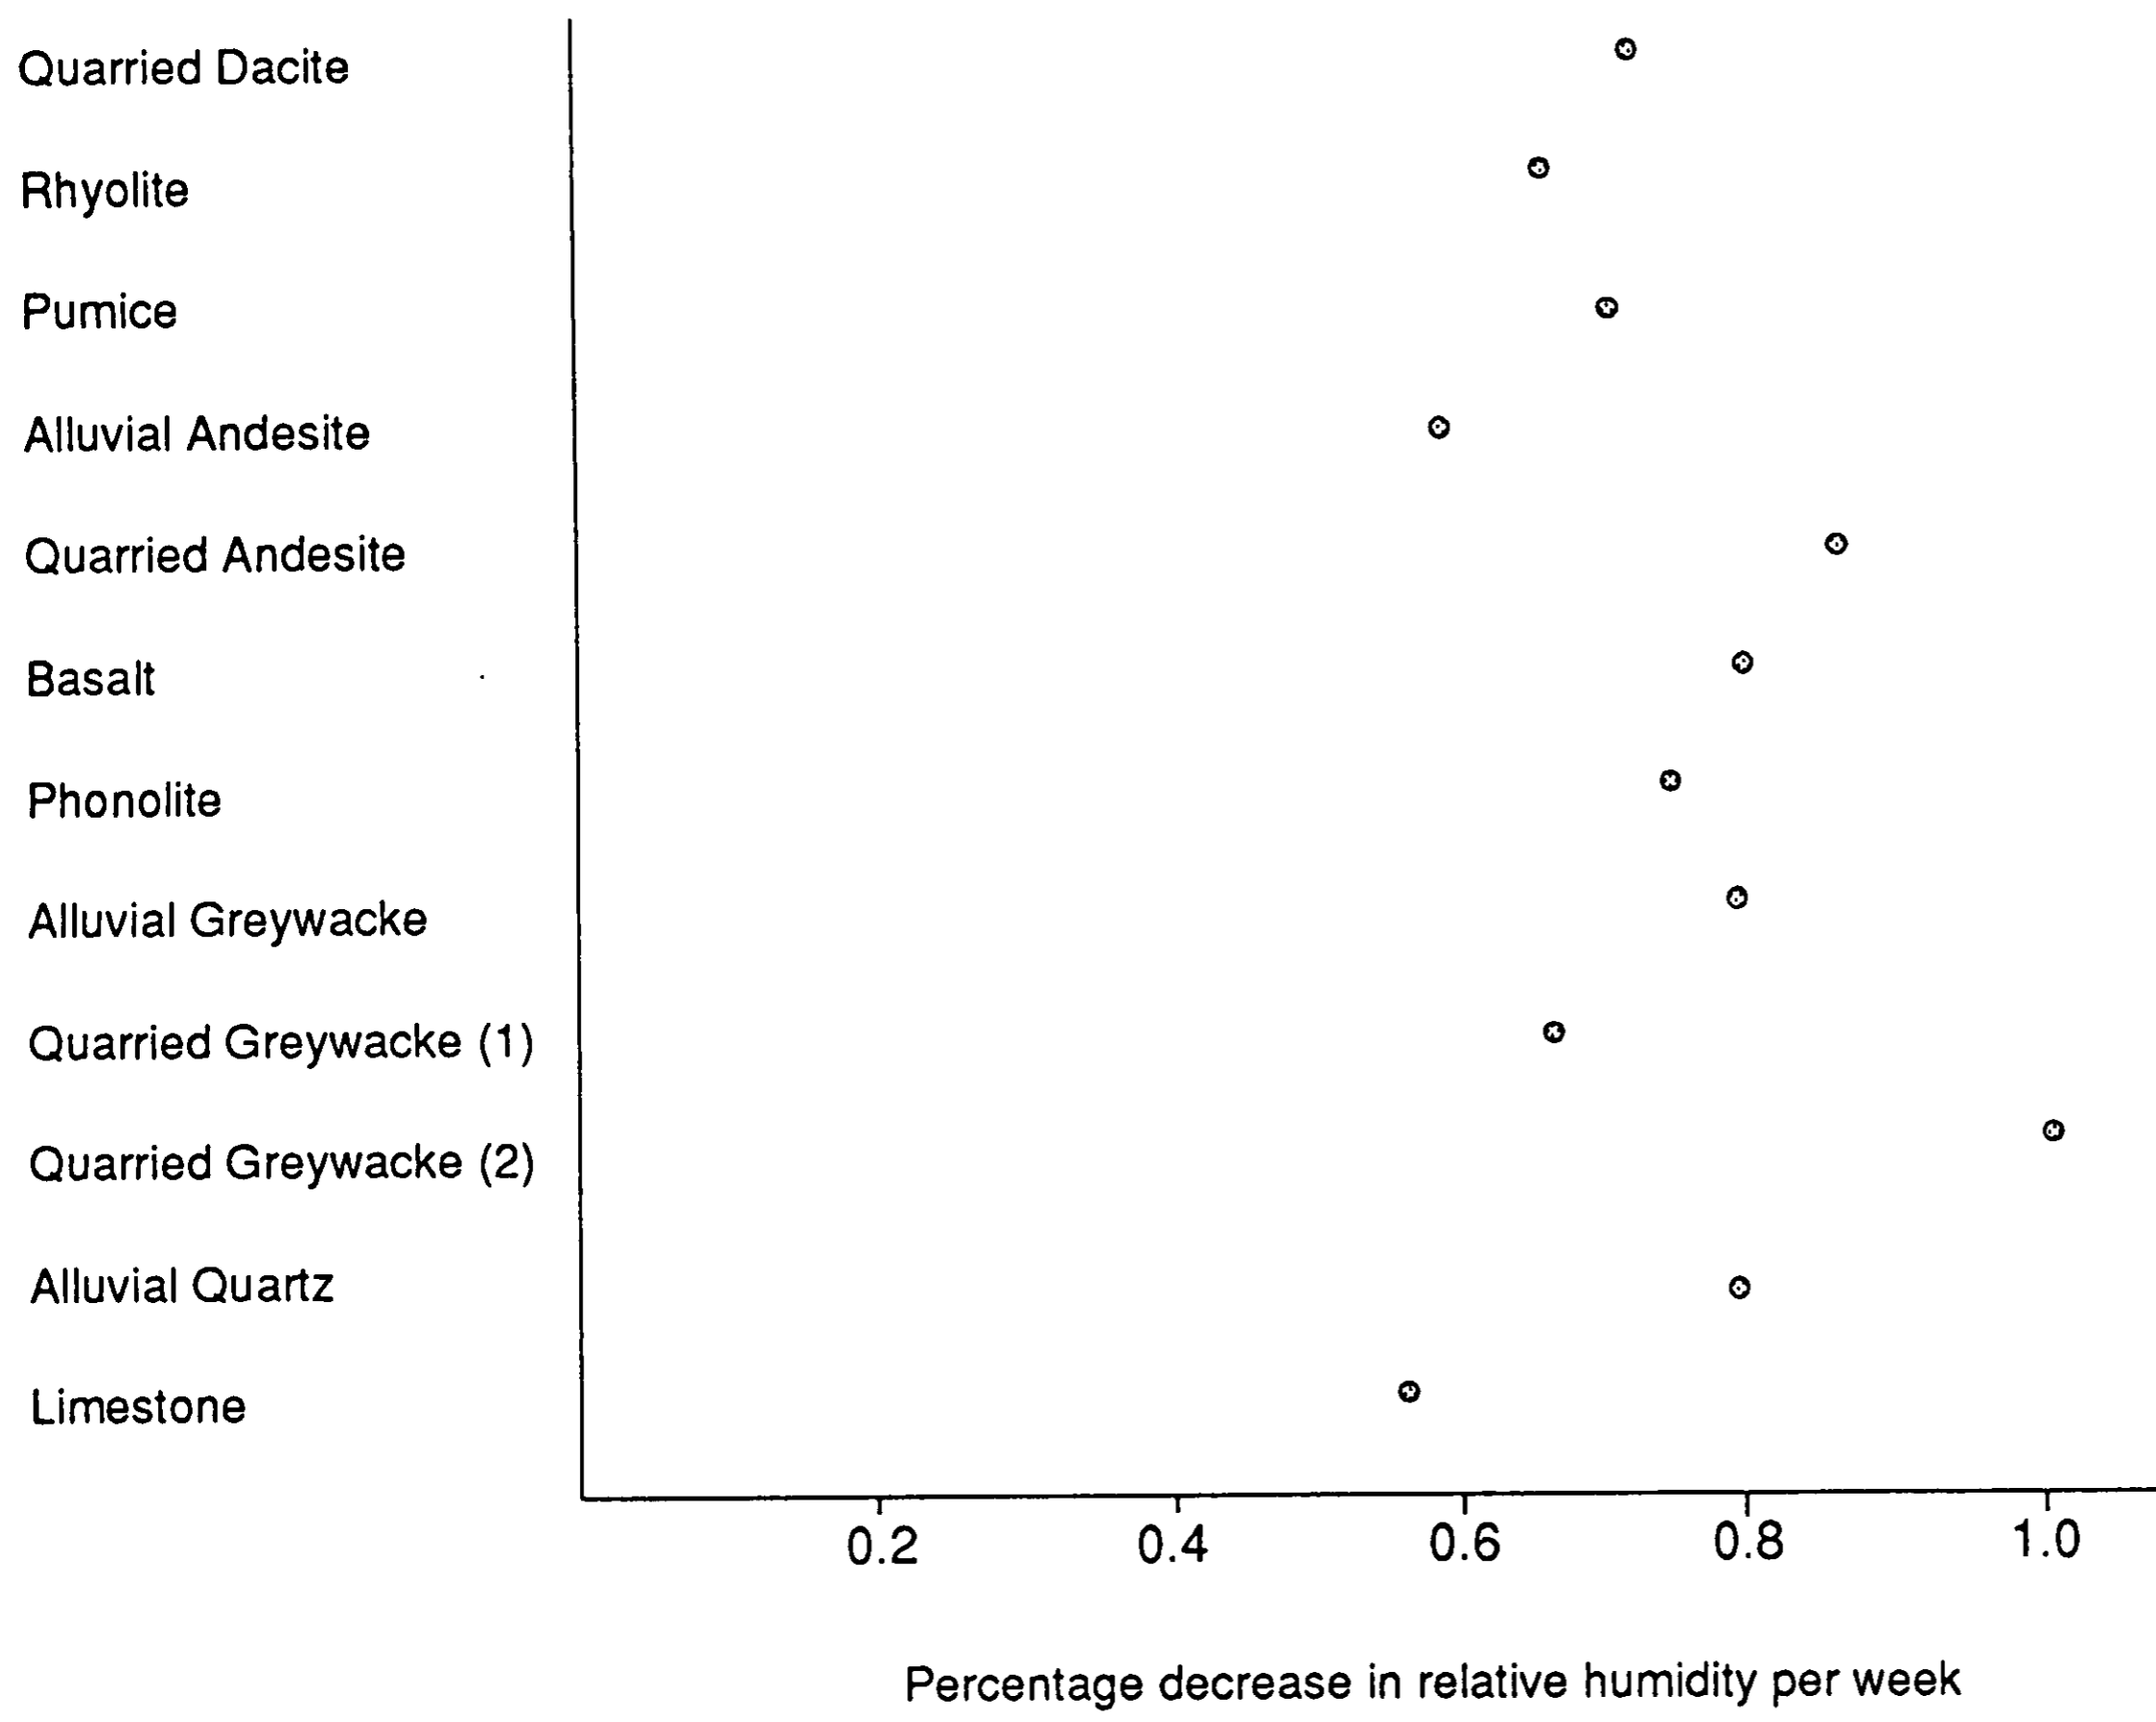
Figure 9 : Average concrete drying rates from casting to testing

Figure 9 shows the average drying rate of each concrete slab as measured prior to fire testing, expressed as the percentage decrease in mid-depth relative humidity per week.

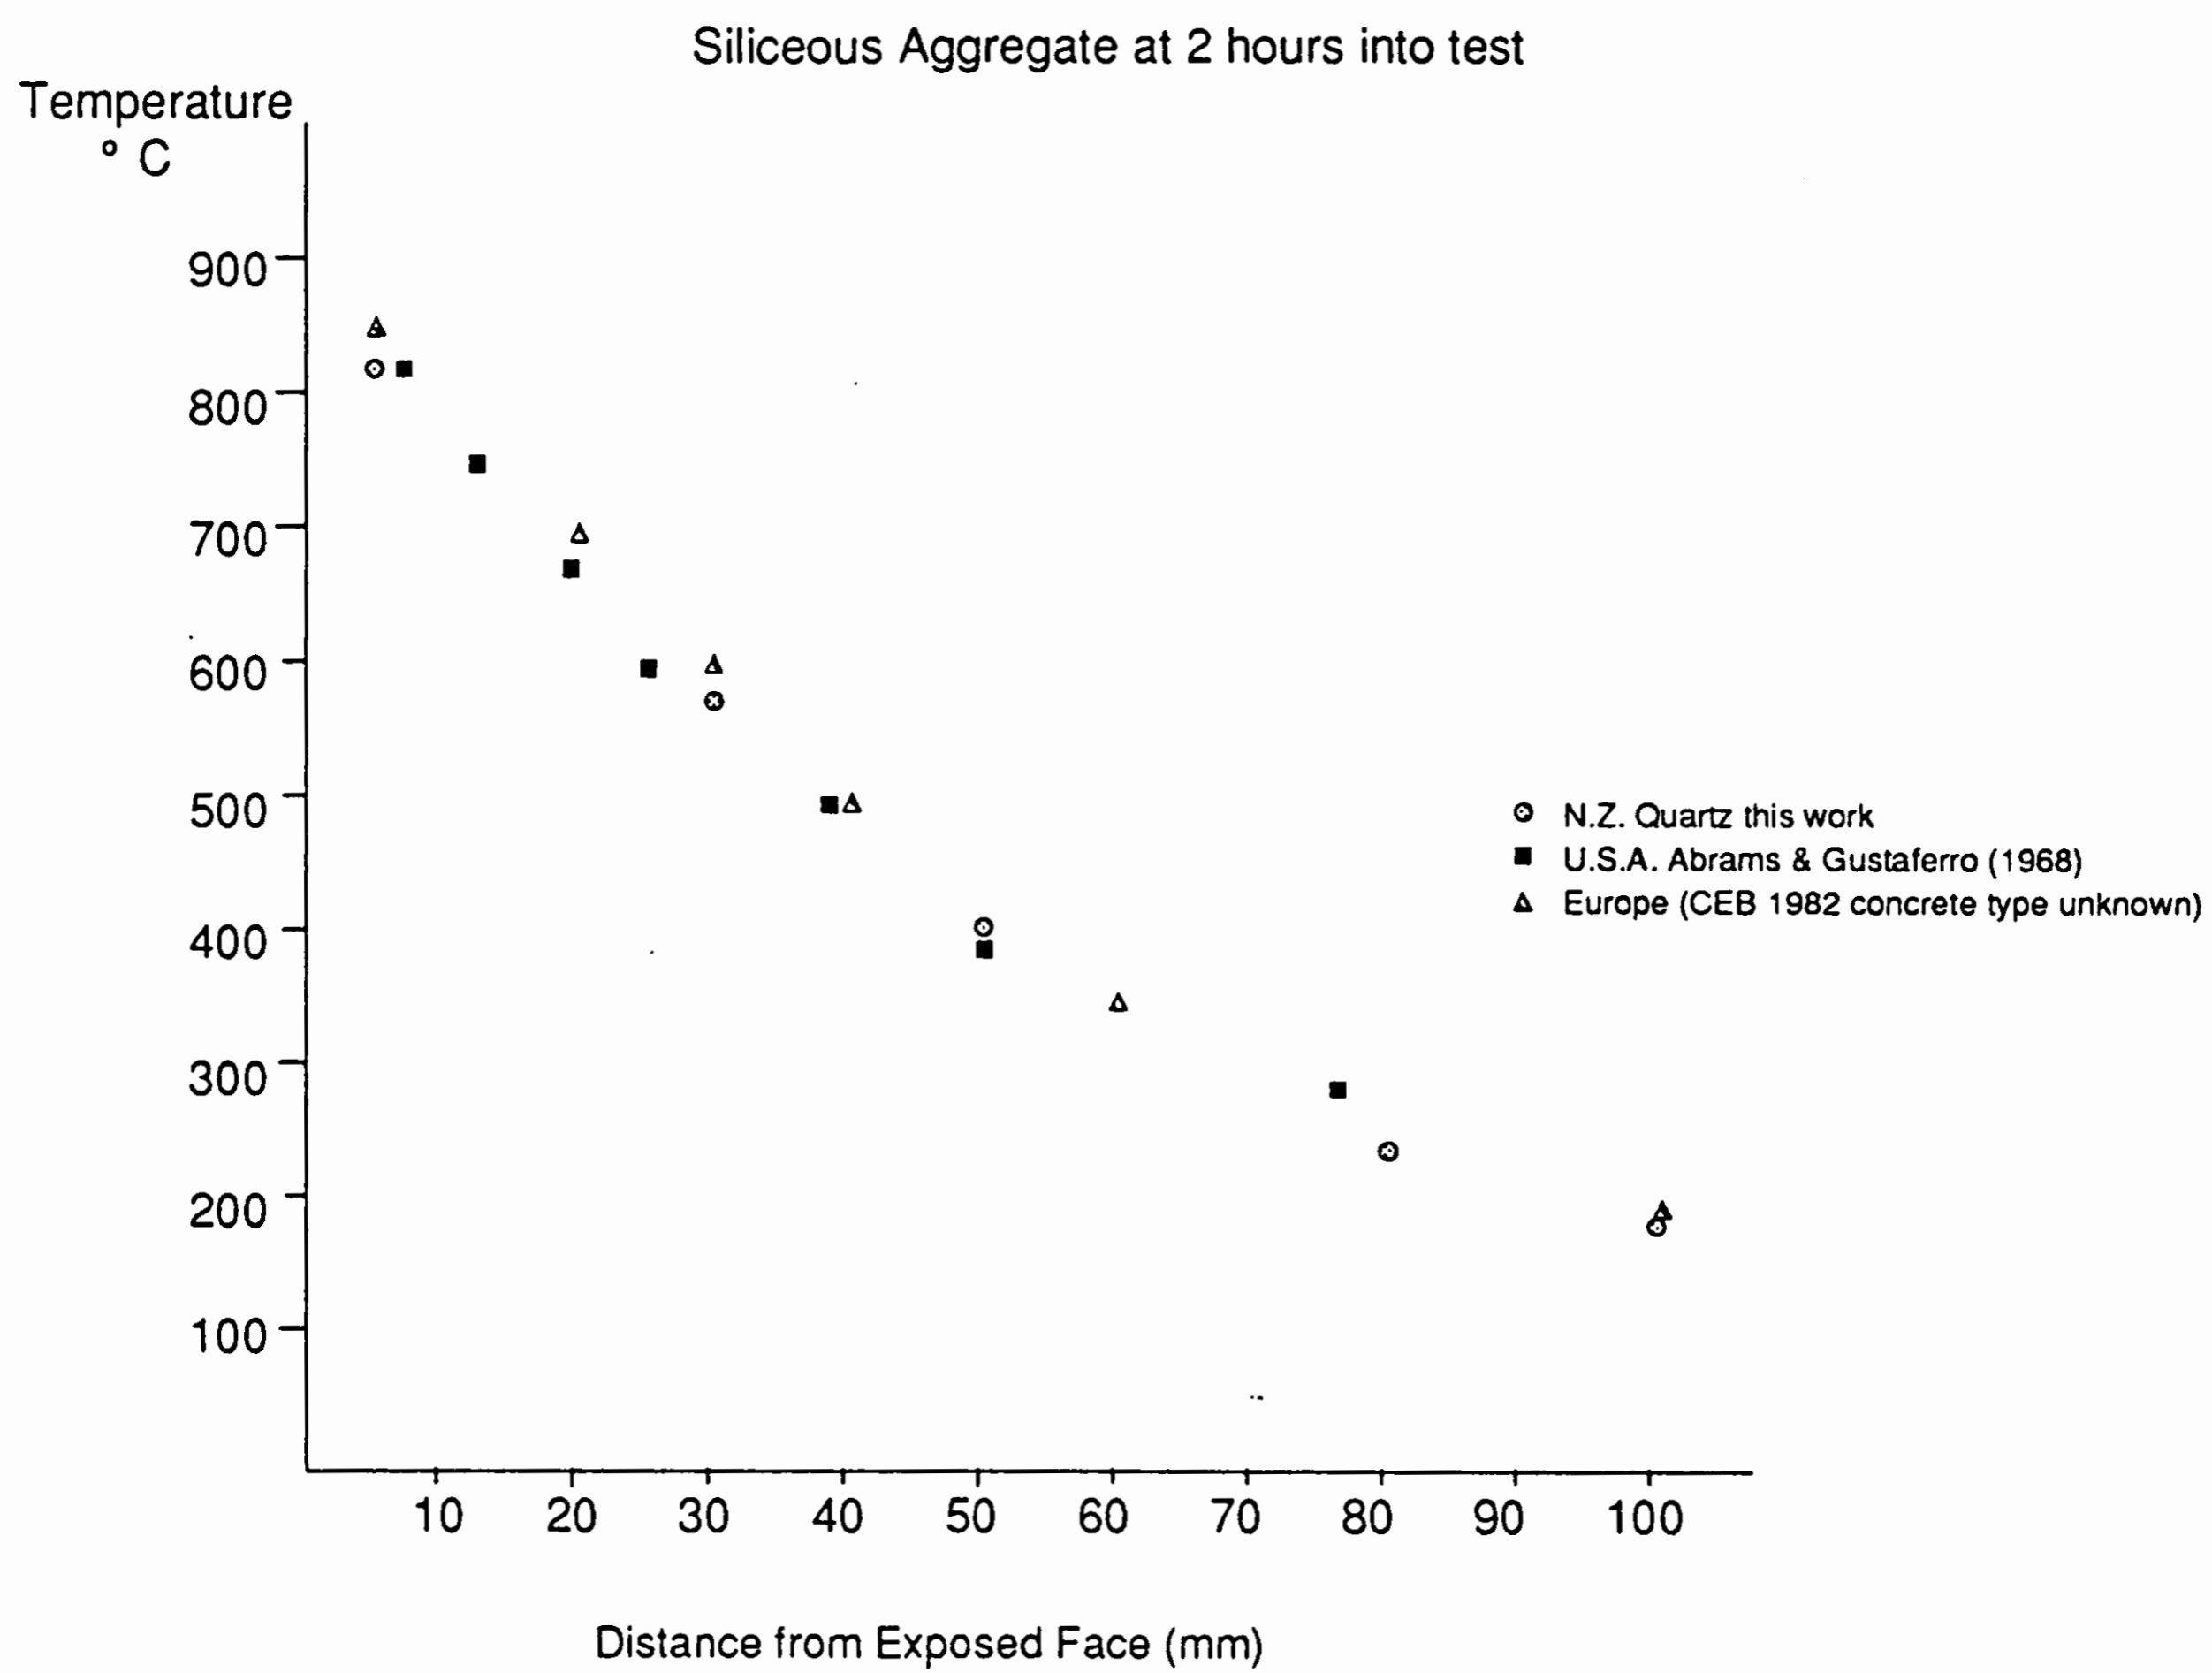
Figure 56: Temperatures Within Concrete During Fire Tests

Figure 56 also plots data from the CEB (1982) work on the fire performance of European concretes. Although nothing is known about testing conditions or concrete type, the correlation of these results with data from both the USA (Abrams and Gustaferrero, 1968) and this work is very close.
