Investigative pull-out testing of anchors near corners of concrete house foundations formed with masonry header blocks

BRANZ Study Report SR357

Abstract

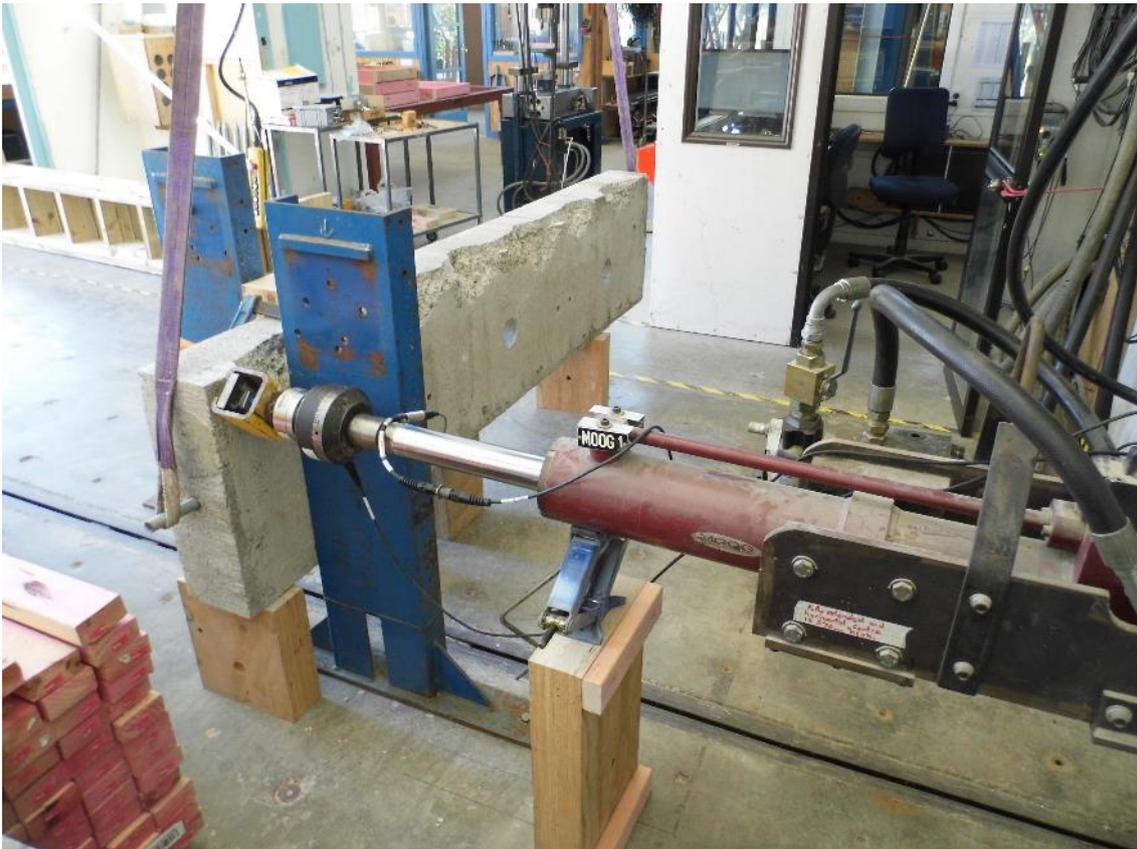
Details of the tension test set-up are presented in Figure 6, and a view of the set-up is shown in Figure 7.

Figure 7. View of the test set-up for the anchor testing.
