# Airtightness of selected apartments in New Zealand

Greg Overton and Stephen McNeil

## BRANZ Study Report SR455

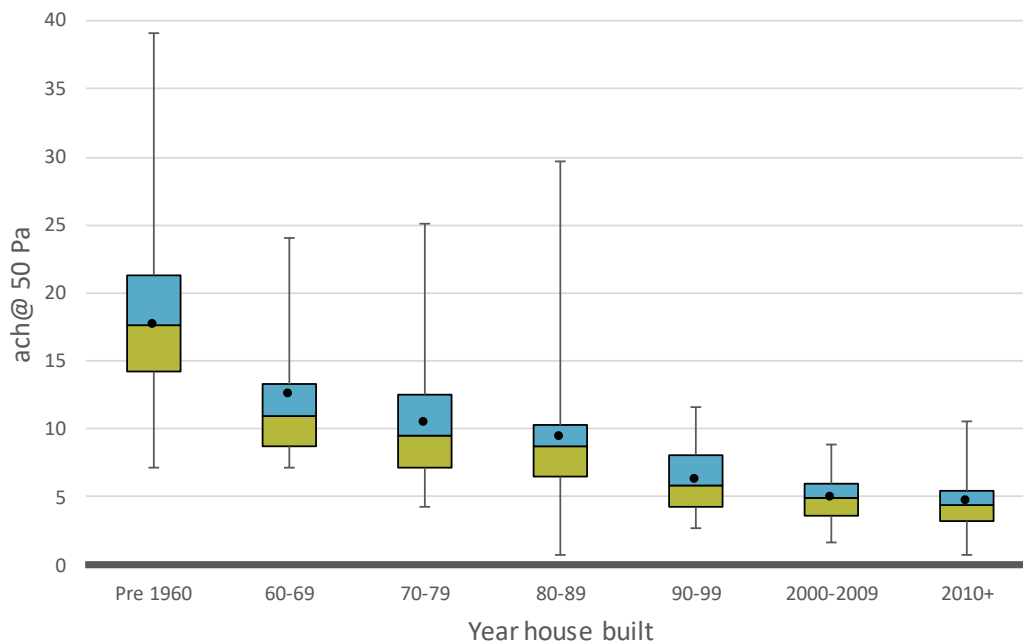
**Figure 1. Airtightness of New Zealand houses by date of construction.**

For houses built since 2000, the mean airtightness level was just below 5 ach @ 50 Pa. Incidentally, the floor area of the newer houses was also larger than in the previous surveys, increasing from 115 m<sup>2</sup> to 155 m<sup>2</sup>. The recent airtightness results also generally fell in a tighter range, suggesting more consistency in construction, but there are evidently new homes where the airtightness exceeds 10 ach @ 50 Pa. Cases where this occurred tended to deviate from simple construction and contained a wider variety of interior finishes other than the paper-faced gypsum board typically used (Overton, Bassett & McNeil, 2013; McNeil, 2018).

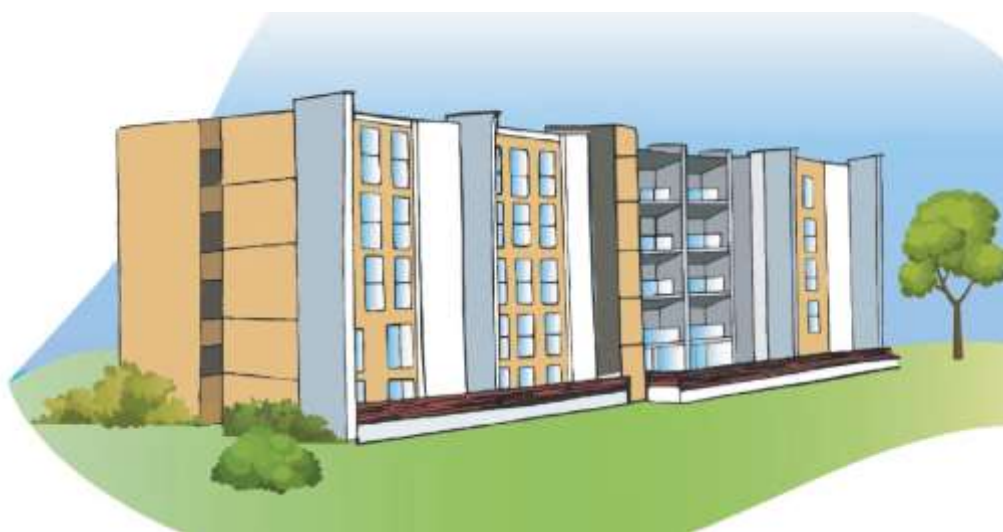
Apartments #1 was in the Stonefields development in Auckland (Figure 2). This 5-storey building was constructed in 2017 and tested in October 2017 prior to occupancy over 3 days. The units are mechanically ventilated, although the ventilation system wasn't operational at the time of testing. Additional rangehood exhausts were also present. Each unit was separated from its neighbours by a concrete fire separation wall, and guarded testing showed no significant flow occurred between units. BRANZ tested units across the lower three floors at the western end of the building. Floor areas for these units ranged from 60 m<sup>2</sup> to 105 m<sup>2</sup>.

**Figure 2. Apartments #1, Auckland.**

- Building status: Complete but unoccupied.
- Average airtightness for apartments = 2.7 ach @ 50 Pa.

The average result for Apartments #1 of 2.7 ach @ 50 Pa is more airtight than the average modern stand-alone house from the earlier BRANZ data. The results between apartments are fairly consistent, but one apartment appeared slightly leakier at 5.0 ach @ 50 Pa. There was no time to investigate this further whilst on site.

The apartments were well compartmentalised with no significant flow observed between them. The apartments have whole-house mechanical ventilation, so overall, the airtightness is well matched to the ventilation strategy.

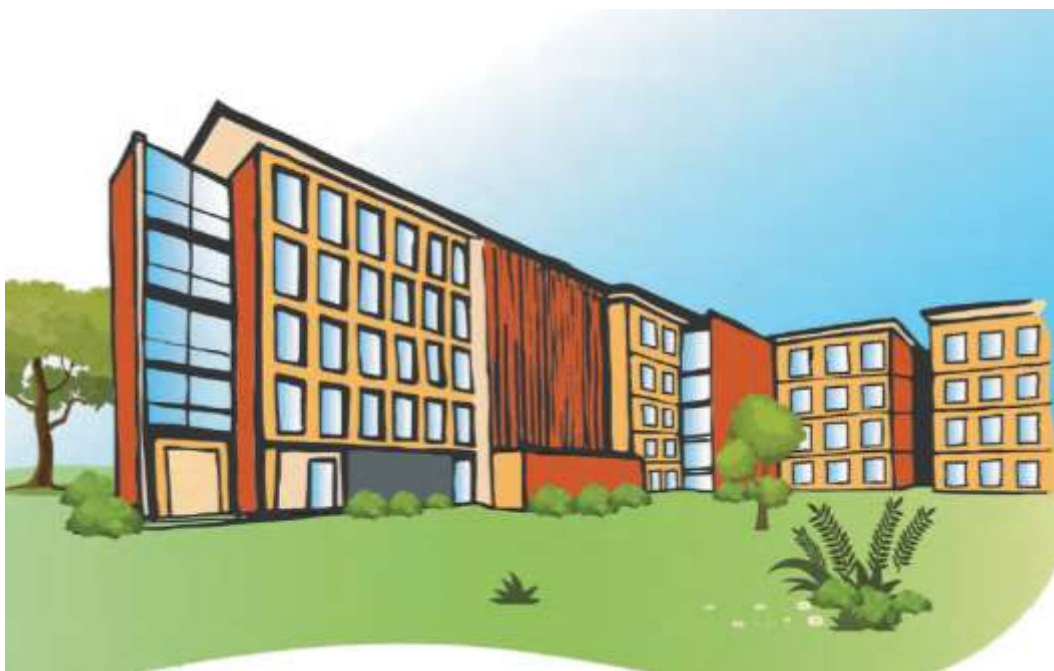
**Figure 3. Apartments #2, Dunedin.**

- Building status: Incomplete – airtightness could have improved post testing.
- Average airtightness for apartments = 5.1 ach @ 50 Pa.
- Average airtightness for studios = 6.9 ach @ 50 Pa.

The average result for Apartments #2 was somewhat higher (worse) than expected. Although there was no airtightness target for the project, the construction reportedly had air barriers on both the interior and exterior of the framing and so it was assumed that the units themselves would be relatively airtight, especially given their reasonably simple form. The fact that no guarded testing could be performed means it is not known if the leakage was mainly to outside or to neighbouring apartments.

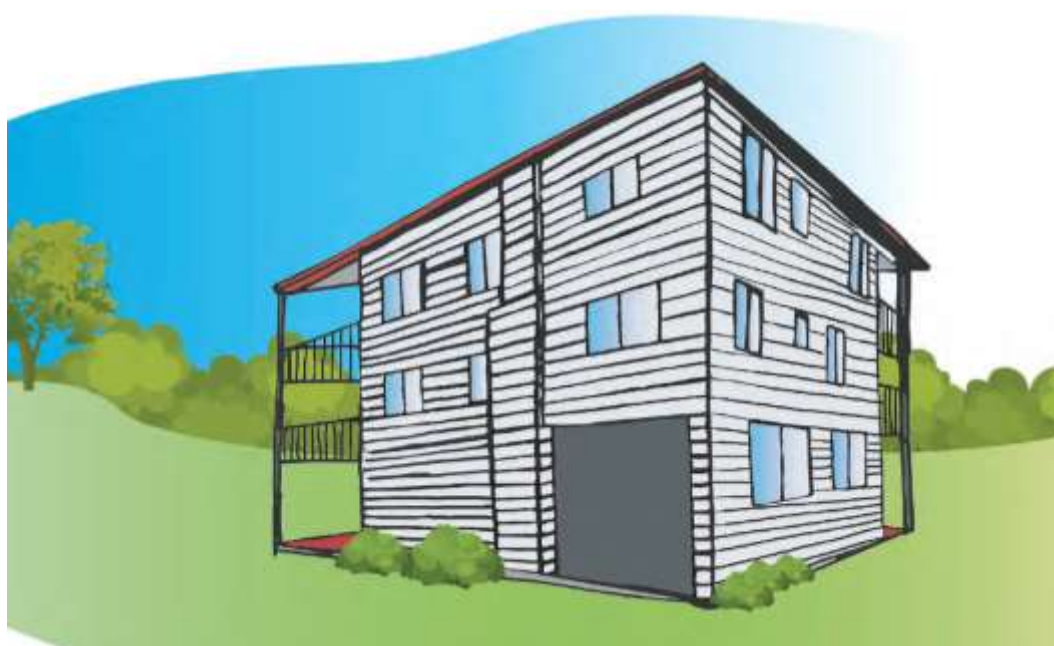
Apartments #3 were located in Miramar, Wellington, and were tested in December 2018 (Figure 4). Because of the small number of units, it was possible to get the consent of the tenants and coordinate the testing around their activities. The apartments were naturally ventilated with spot exhaust ventilation for bathrooms, rangehoods and tumble dryers.

**Figure 4. Apartments #3, Wellington.**

The average result for Apartments #3 was similar to the airtightness of a typical new-build house. The upper units (3 and 4) had higher ceilings than the ones below but similar results in terms of air changes per hour. It was not possible to determine whether the higher flows for units 3 and 4 were simply due to the increased wall area or whether the leakage was into the roof space. The apartments are naturally ventilated so the airtightness level is broadly in line with this strategy.

Guarded testing was performed between units 1 and 3 and between units 2 and 4. In both cases, leakage through the floor/ceiling was being eliminated, but the testing showed no significant difference in the airtightness result, suggesting there was insignificant flow between the units.

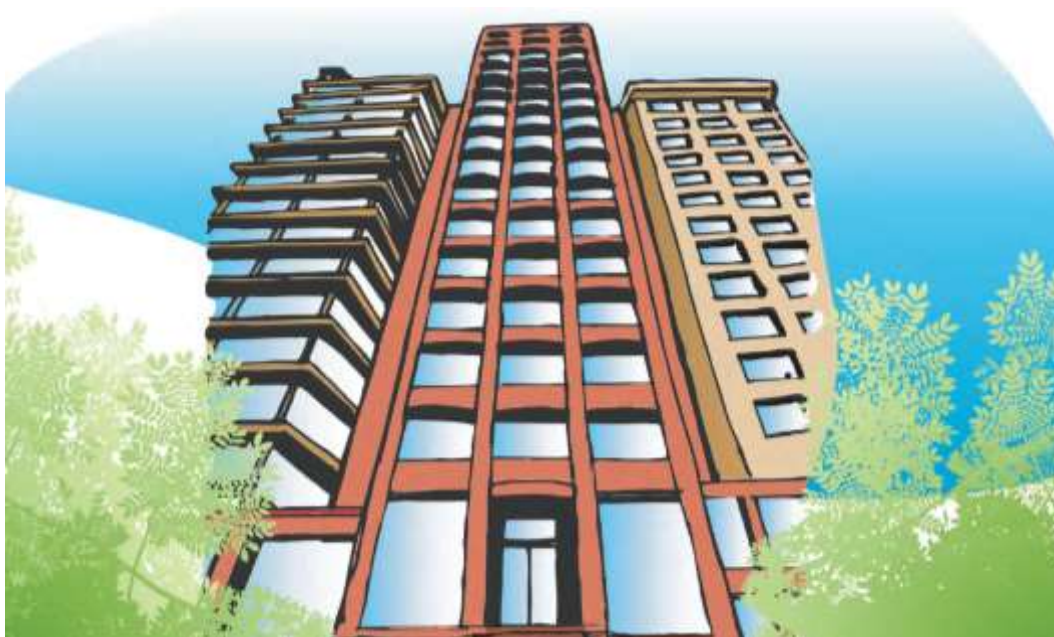
Apartments #4 were 2-storey penthouse apartments in central Wellington and were tested in January 2019 whilst being renovated (Figure 5). Because construction work was ongoing, only three of the five units could be tested. The apartments were naturally ventilated with spot exhaust ventilation for bathrooms, rangehoods and tumble dryers.

**Figure 5. Apartments #4, Wellington.**

- Building status at time of testing: Construction active – airtightness unlikely to be affected by the remaining work.
- Average airtightness for apartments = 7.1 ach @ 50 Pa.

The average result for Apartments #4 was higher than a typical new-build house. Guarded testing showed there were some airflow paths connecting the units. The shared party wall area was approximately 45 m<sup>2</sup> between unit D and E and about 20 m<sup>2</sup> between unit D and C. The increase in airtightness of unit D does not exactly follow the ratio of the shared wall areas, but it does suggest a reasonably uniform leakage associated with the party walls.

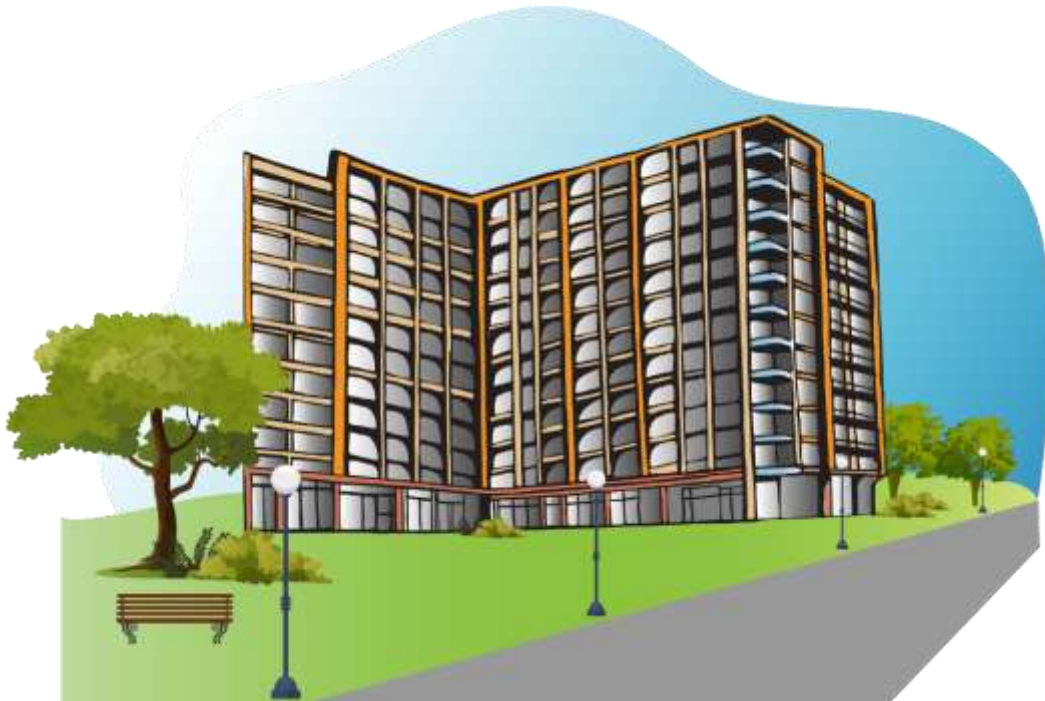
Apartments #5 were located in Auckland CBD (Figure 6). A total of 23 units were tested in February 2019. Whilst the overall building was nearing completion, all the units tested were in a finished state, so the airtightness was unlikely to change post testing. The units were generally separated from each other by concrete fire separation walls and so there was no significant leakage between these units. However, some of the units were dual-key apartments divided using a timber-framed partition wall, and

**Figure 6. Apartments #5, Auckland.**

- Building status at time of testing: Construction active – airtightness unlikely to be affected by the remaining work.
- Average airtightness for non-dual-key apartments including 'home' configuration = 3.8 ach @ 50 Pa.
- Average airtightness for dual-key apartments = 6.0 ach @ 50 Pa.

The average result of 3.8 ach @ 50 Pa for the stand-alone apartments represents reasonably airtight construction. The airtightness was reasonably consistent across the similar units, which could be expected given the common features between them. There was no significant leakage across the concrete walls and floors. The only air leakage in the single units was through the front and back faces. Fog testing was performed with one unit depressurised, and leakage was through the ranch slider at both the sliding door and the internal corner (Figure 7).

The dual key apartments had an average result of 6.0 ach @ 50 Pa from unguarded testing. The higher leakage arose from airflow paths between units. This leakage was primarily due to the IT cupboards (fog tested again) on the interior dividing wall and was roughly equivalent to a 60 mm diameter hole in the wall.

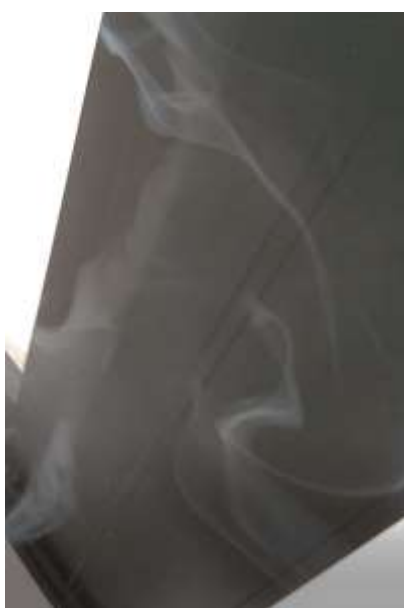
**Figure 7. Air leakage paths through ranch slider joinery shown by passage of smoke.**

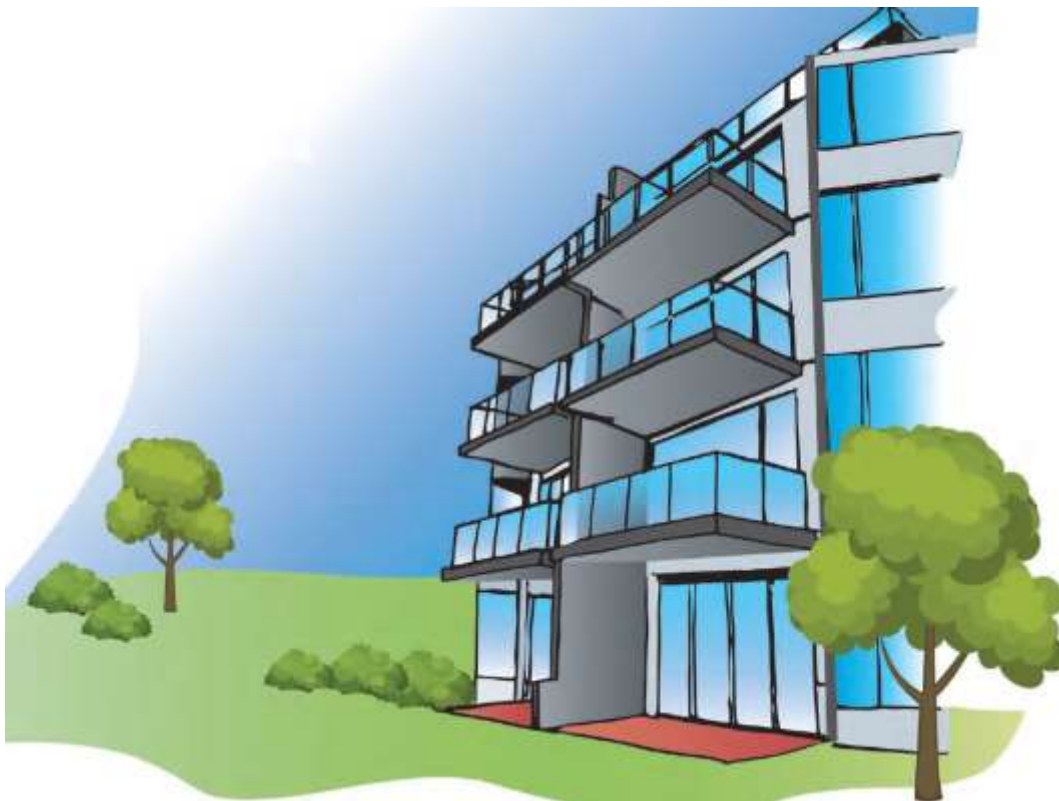
Apartments #6 were a hotel in Queenstown and were tested in May 2019 prior to being renovated (Figure 8). Some areas of the walls and ceilings had been opened up for inspection. These areas were taped as much as possible. Some of the hotel rooms were essentially bedsits. In these cases, the adjoining door to the larger neighbouring units was opened so that the combined space was more like a real apartment.

**Figure 8. Apartments #6, Queenstown.**

- Building status at time of testing: Some defects due to inspection openings but considered unlikely to have a large effect on the measurements.
- Average airtightness for apartments = 8.98 ach @ 50 Pa.

There was no significant leakage to the neighbouring units on the same floor. In terms of leakage to the units above and below, in a spot check at 50 Pa, about 10% of the airflow went through each of the ceiling and floor, so the majority of the leakage appeared to be to the outside through joinery and the non-concrete external walls.

Overall, Apartments #6 represents a building with a high amount of uncontrolled air leakage to outside. It would be interesting to see how the remediation affects this. If higher levels of airtightness are desired, the key areas to look at would be the joinery and the perimeter of the wall (bottom plates), which smoke testing showed to be significant airflow paths.

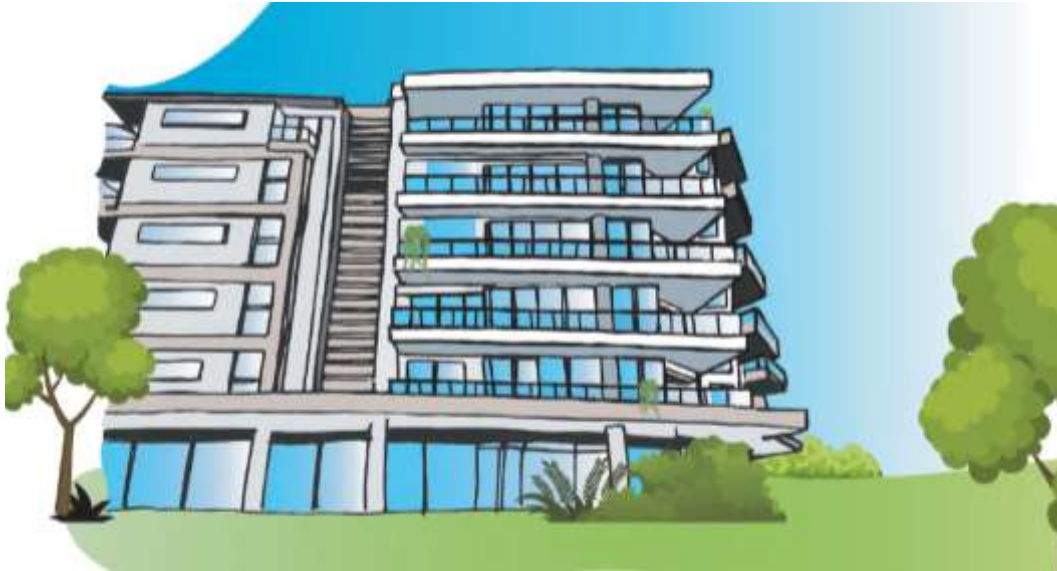
Apartments #7 were in Te Atatū, Auckland, and were tested in June 2019 prior to being renovated (Figure 9). The apartments were naturally ventilated with spot exhaust ventilation for bathrooms, rangehoods and tumble dryers.

**Figure 9. Apartments #7, Auckland.**

- Building status at time of testing: Apartments complete and unoccupied.
- Average airtightness for all apartments = 4.33 ach @ 50 Pa.
- Average airtightness for top-floor apartments = 7.66 ach @ 50 Pa.
- Average airtightness excluding top-floor apartments = 3.68 ach @ 50 Pa.

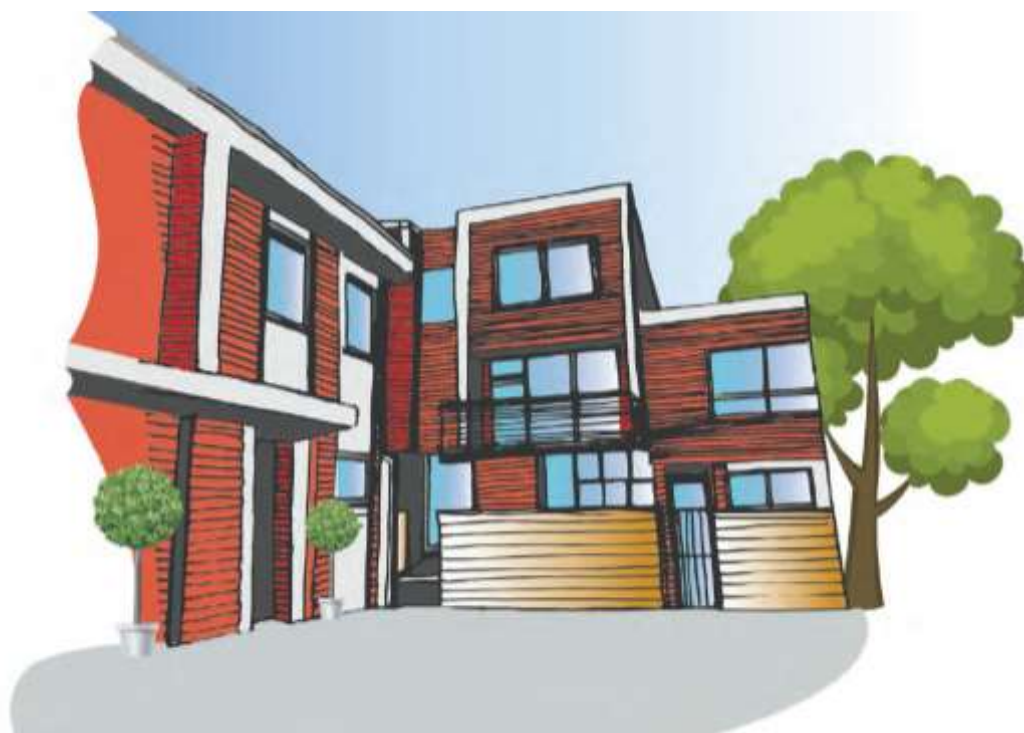
Apartments #8 were a newly built social housing development in Wellington (Figure 10). They were tested in their completed state in July 2019. The units are a mixture of single-storey units and 2-storey units and are naturally ventilated with spot exhaust ventilation for bathrooms and rangehoods.

**Figure 10 Apartments #8, Wellington**

The average test result was 4.7 ach @ 50 Pa. This is in line with what would be expected for a new-build house. In terms of a ventilation strategy, Apartments #8 had local extract ventilation at the rangehood and in the bathrooms but otherwise was naturally ventilated.

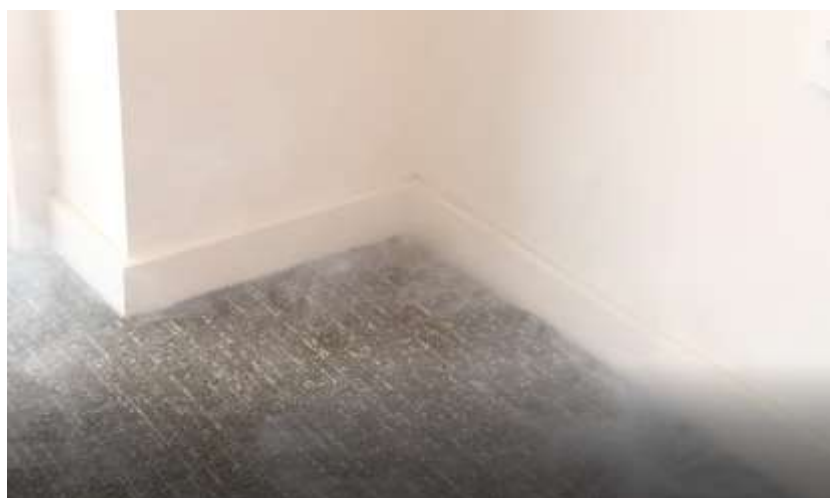
A limited amount of smoke-testing was performed to identify areas of air leakage. Figure 11 shows leakage at the bottom plate of an external wall.

**Figure 11. Smoke coming through the bottom plate of an external wall under depressurisation of the apartment.**

The leakage shown in Figure 11 is commonly seen and is not being flagged as a defect with the apartments. If there was a desire to increase the airtightness of the structure, the bottom plate detail is an area that should be targeted. Note that this wall was specified as having a fire resistance rating of 60/60/60. The fire resistance rating does not correspond to smoke control requirements, and there is no evidence to suggest the smoke leakage observed under depressurisation corresponds to a reduction in the fire resistance level.

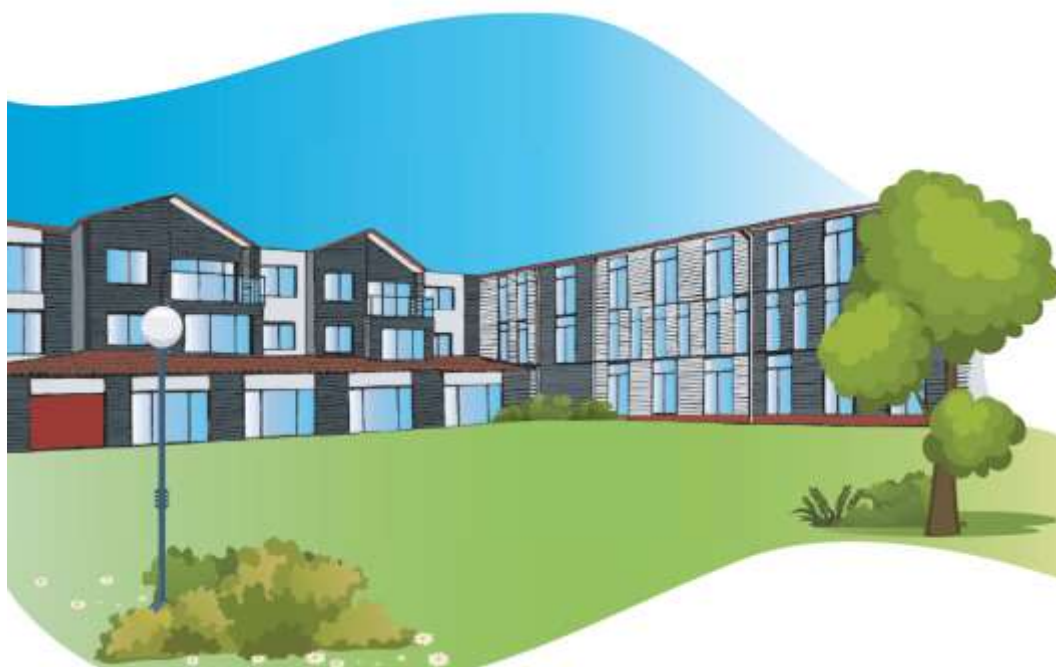
Apartments #9 was a retirement village in Upper Hutt and was tested in December 2019, just as construction was finishing (Figure 12). Some units required a few areas to be taped up prior to fixtures being installed. The apartments were mechanically ventilated using a centralised system with spot exhaust for rangehood and dryers. Testing was performed on the western wing across all three floors.

**Figure 12. Apartments #9, Upper Hutt.**

- Building status at time of testing: Construction ongoing but tested units were in a near-complete state.
- Average airtightness for all apartments = 4.2 ach @ 50 Pa.
- Average airtightness for top-floor apartments (excluding 304) = 6.3 ach @ 50 Pa.
- Average airtightness excluding top-floor apartments = 3.4 ach @ 50 Pa.

Overall, the data in Table 10 shows reasonably consistent airtightness across units. The apartments on the first two levels had an average airtightness of 3.4 ach @ 50 Pa. The top-floor apartments were less airtight with an average of 6.3 ach @ 50 Pa if we exclude unit 304. The explanation for the higher air leakage on the top floor is because the roof space is above it, which in turn is open to the outside. The lower apartments are separated by concrete floors, which are more airtight than the roof space.

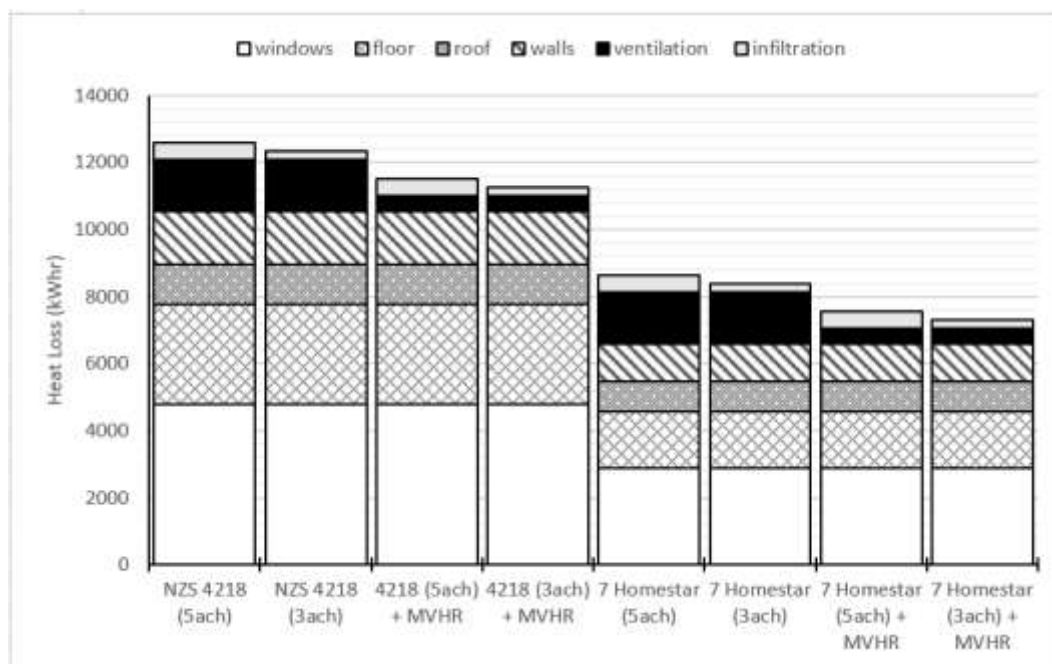
In terms of the heat losses associated with ventilation and infiltration, Figure 15 shows the approximate heat losses for our hypothetical Christchurch case using ALF at two airtightness levels: 3 ach @ 50 Pa and 5 ach @ 50 Pa. Mechanical ventilation at 0.4 ach is shown, both with and without heat recovery (70% overall efficiency). Two levels of insulation have also been used: the schedule method of NZS 4218:2009 *Thermal insulation – Housing and small buildings* and the Homestar V4 schedule method (NZGBC, 2017) for 7 Homestar, which was chosen arbitrarily as something higher than the minimum Code requirements.

Several things can be inferred from Figure 15. The first is that, given the airtightness typically associated with new houses built today, the energy argument for introducing airtightness targets (in isolation) is not that strong. The infiltration heat loss is of course reduced, but this is small compared to the rest of the heat losses. Ventilation still has to be provided, and there is a heat loss cost associated with this. The ventilation heat loss can be reduced using a heat recovery system, but again the value of that should be compared with where other savings can be made. Note also that our 70% overall system efficiency is considered to be representative of a case where the ducting is within the thermal envelope. This would drop considerably if this were not the case. For the 7 Homestar case, the ventilation heat losses are a bigger proportion of the total heat loss, and heat recovery therefore has a proportionately bigger effect.

**Figure 15. Heat loss components for an illustrative case in Christchurch with mechanical ventilation.**
