Study Report

SR456 [2020]

Assessing the condition of New Zealand housing: Survey methods and findings

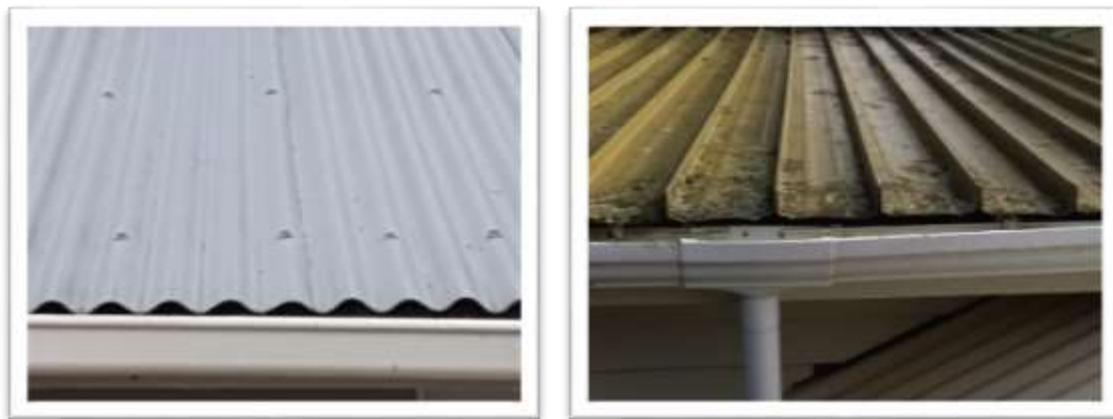
Overall, in nearly half (47%) of dwellings surveyed, the roof was considered in excellent or good condition, while in 11%, it was serious or poor (Figure 12). The roof was more likely to be in better condition for owner-occupied dwellings compared to non-owner-occupied houses (Figure 13), a finding consistent with the previous HCS (White, Jones, Cowan & Chun, 2017).

Figure 12. Almost half of roofs were in excellent or good condition, and one in 10 roofs were considered to be in poor or serious condition.

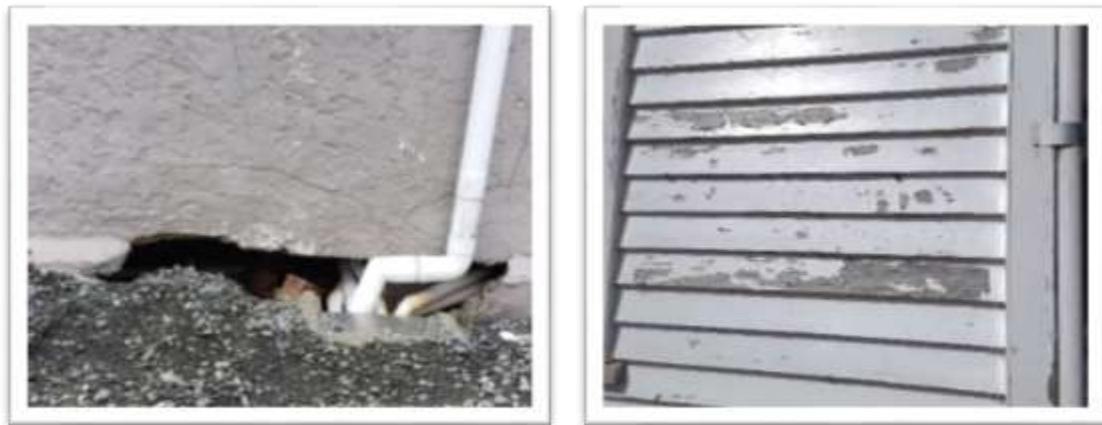
For nearly half (47%, ±2 pp) of surveyed dwellings, the wall cladding was considered in excellent or good condition, while nearly one in five houses had cladding in poor or serious condition (Figure 14). Owner-occupied dwellings were again more likely to have cladding in better condition (excellent or good) compared to non-owner-occupied houses (Figure 15). This trend is again consistent with the latest (2015/16) HCS (White, Jones, Cowan & Chun, 2017).

Figure 14. Wall cladding was in poor or serious condition for one in five dwellings.

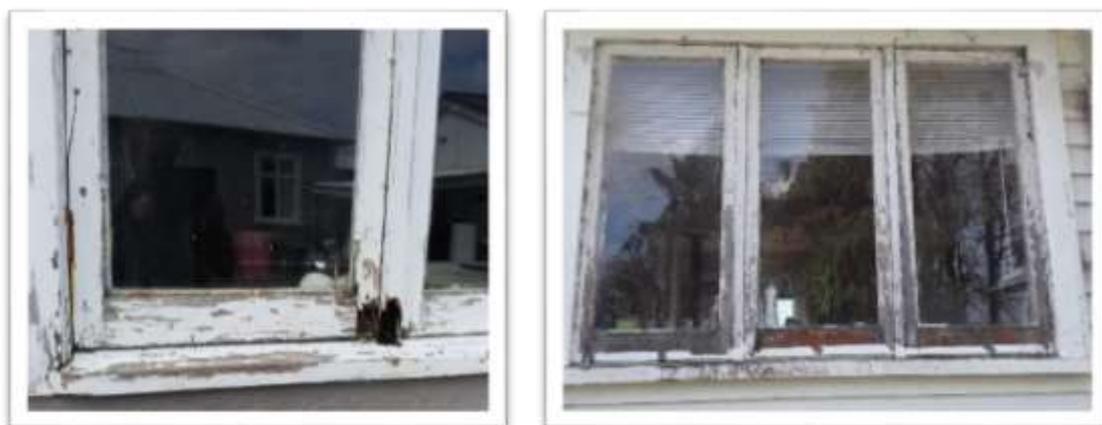
The higher prevalence of defects in rentals aligns with the lower overall condition rating of windows/doors (Figure 18). While 58% (± 5.1 pp) of owner-occupied dwellings had windows and exterior doors in excellent or good condition, this applied to less than two-fifths (38%, ± 7.8 pp) of non-owner-occupied dwellings (Figure 19).

Figure 18. One in five rental dwellings had windows in poor or serious condition.

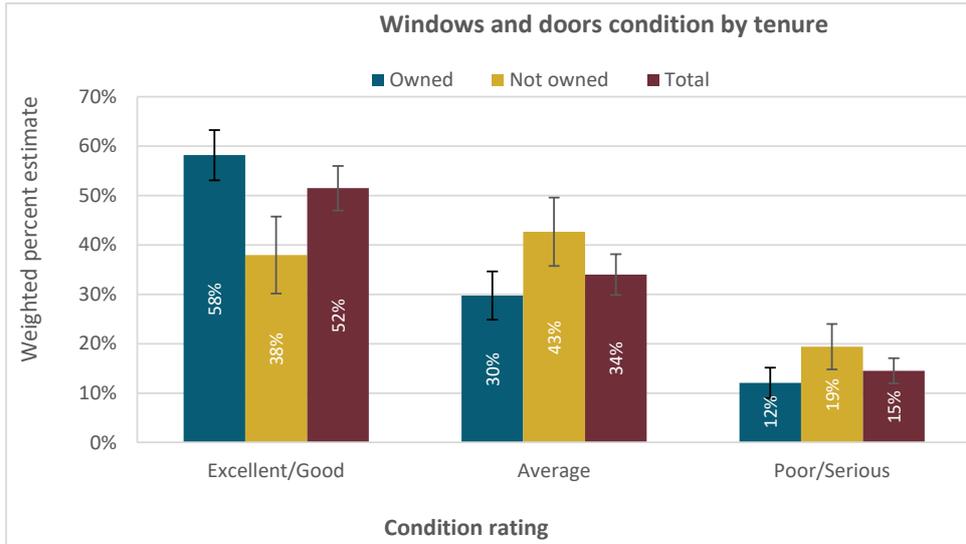
Figure 19. Condition of windows and exterior doors by tenure and overall.

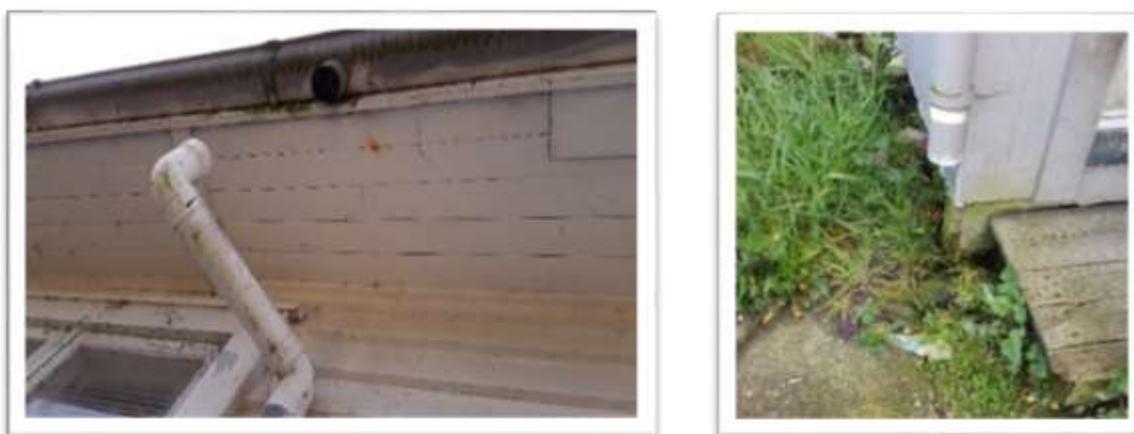
The results from the PHS assessment of guttering and downpipes show two-thirds of houses surveyed (67%) had no visible defects with the guttering or downpipes, while one-fifth (21%) had signs of holes, broken or missing parts (Figure 21). Blocked guttering was more commonly observed in rented dwellings (17%) compared to owner-occupied dwellings (9%).

Figure 21. One-third of dwellings required some maintenance or repair to guttering or downpipes.

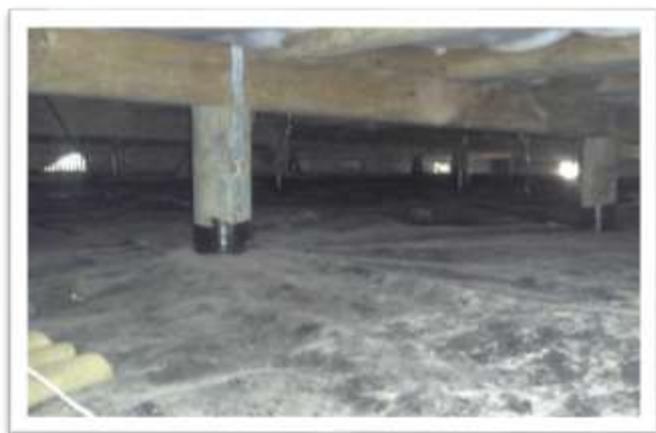
Figure 22. A ground cover is important for preventing ground-sourced moisture entering the home.

The healthy homes standards specify that rented dwellings with suspended floors must have a ground moisture barrier where the subfloor space is enclosed unless it is not reasonably practicable to install one (MBIE, 2019c).

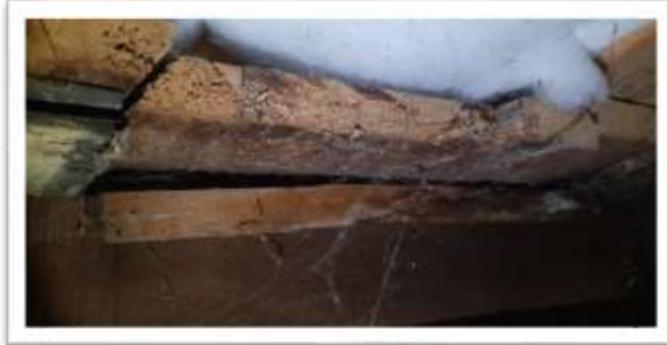
Poor fixing was the most common defect, identified in 16% of those with a subfloor cavity, followed by rot/borer (6%) (Figure 23). In 16% of houses, the assessor was unable to accurately assess the condition of the foundations due to poor visibility from the access hatch.

Figure 23. Signs of borer in subfloor timber.

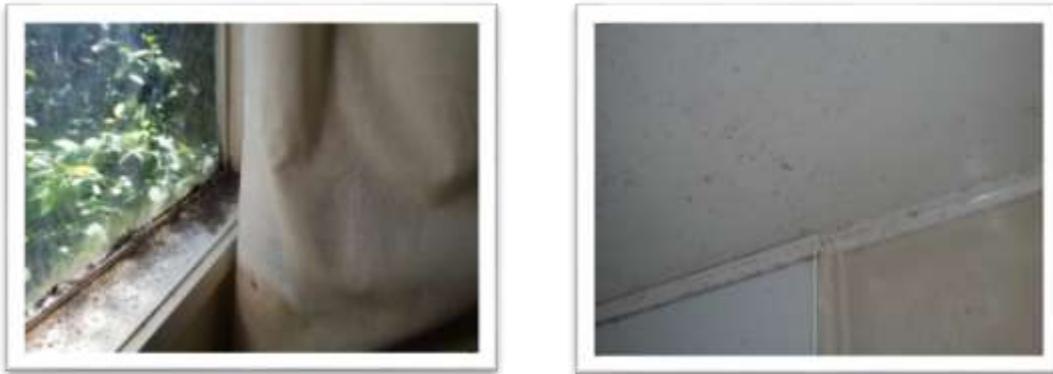
All surfaces were considered in the assessment, including windows and curtains (Figure 25). This is an important change to note from previous HCSs. It will likely result in a higher rate of observed mould. In addition, to align with new questions on mould in the 2018 Census and GSS, moderate was described as roughly equivalent to the size of an A4 piece of paper (which is the indicator used in the Census and GSS).

Figure 25. An assessment of visible mould was applied to all surfaces, including wall, floor and ceiling linings, windows and curtains.

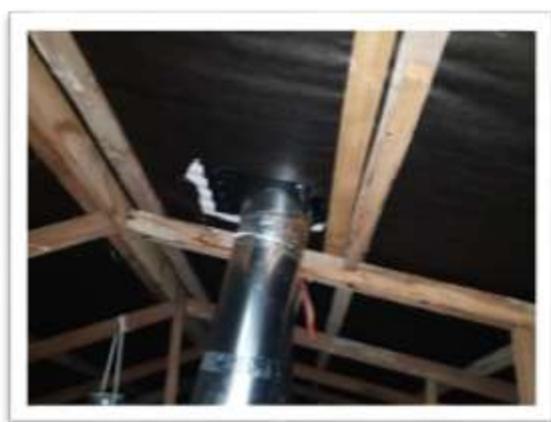
Of those with a roof cavity, in half of houses (50%, ± 4.3 pp), at least one defect from the survey was identified. The most common issues related to underlay (missing or damaged, 10% – Figure 28) and signs of gaps, holes or leaks (11%). Exposed roofing was more commonly observed in non-owner-occupied dwellings (27% compared to 15% of owner-occupied houses). However, this may relate, in part, to roof material types and buildings practices – for example, concrete tile roofs were not always typically installed with underlay, and this roofing was more common on the rental stock surveyed. Furthermore, whilst the survey gives an indication of the prevalence of different issues affecting the roof cavity, the severity and full extent of implications are not clear (issues could be minor or could be severe and present weathertightness or structural risks).

Figure 28. Damaged roof underlay.

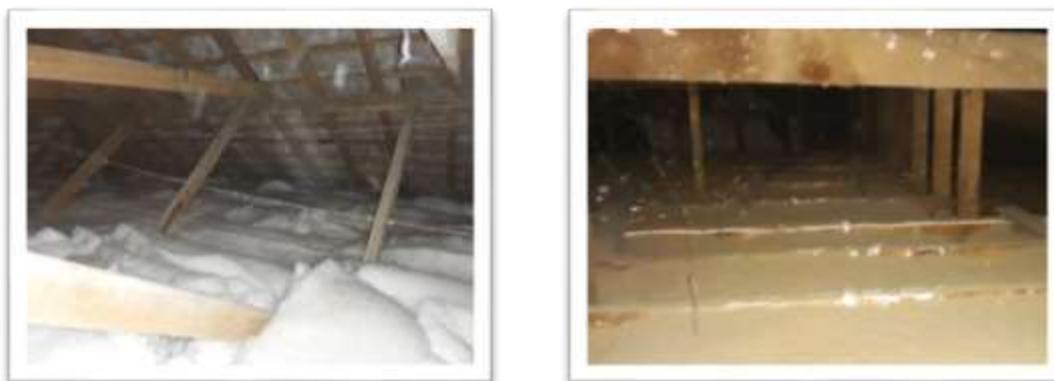
Figure 30. Roof spaces should be insulated to help prevent heat loss from the home. Around half of houses surveyed lacked adequate insulation in the roof.

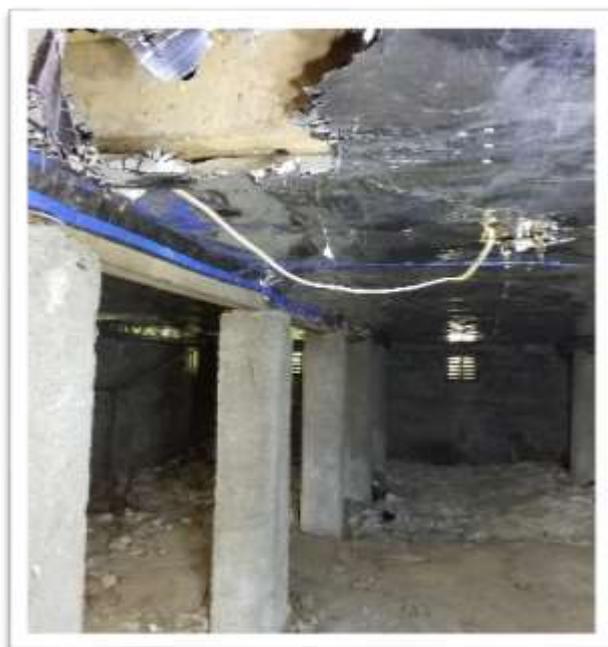
An uninsulated subfloor can be another major source of heat loss from a home. The HHS require rental homes to have subfloor insulation consistent with the 2008 Building Code (at least R1.3 or around 60 mm thick, depending on the material) (MBIE, 2019b). Foil may be acceptable under the HHS, depending on when it was installed and its state of repair. However, BRANZ research has shown foil insulation is far less effective and subject to wind damage (Figure 32) and therefore not recommended (McNeil et al., 2016).

Figure 32. Subfloor foil insulation is prone to damage

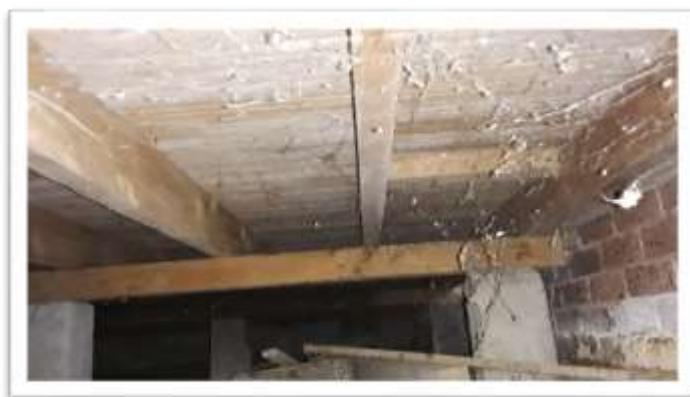
- in 16% (± 4.9 pp) of houses, the extent of insulation could not be determined, hence these are classed as 'unable to tell'
- 61% (± 4.8 pp) had at least 80% coverage of insulation in the subfloor – most of these had bulk insulation (80%), while 16% had foil insulation
- 23% (4.2 pp) had less than 80% coverage – most of these had no insulation at all, while a small proportion had some but less than 80% coverage (Figure 34).

Figure 34. Almost one-quarter of houses with a subfloor cavity lacked adequate insulation. This applied to owned and rented dwellings.

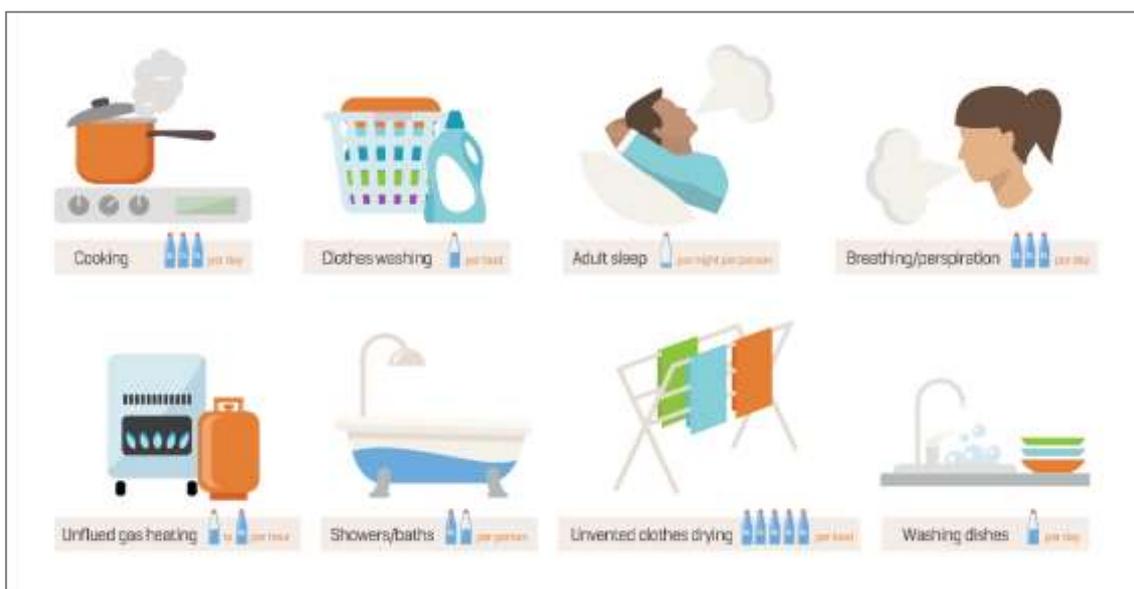
While installing a ground moisture barrier and ensuring effective drainage can help prevent moisture entering the home from outside, daily activities within the home also generate moisture. Occupant behaviour is therefore key to effectively managing moisture – for example, not drying clothes indoors, keeping lids on pots when cooking and limiting shower time can help reduce the amount of moisture released into the indoor environment (Figure 37). It is also important to ventilate, to effectively move moisture to outside, reducing the risk of damp and mould and helping maintain a healthy, comfortable indoor environment. This is particularly important in high moisture areas of the home, such as the kitchen and bathrooms.

Figure 37. Sources of moisture in the home.

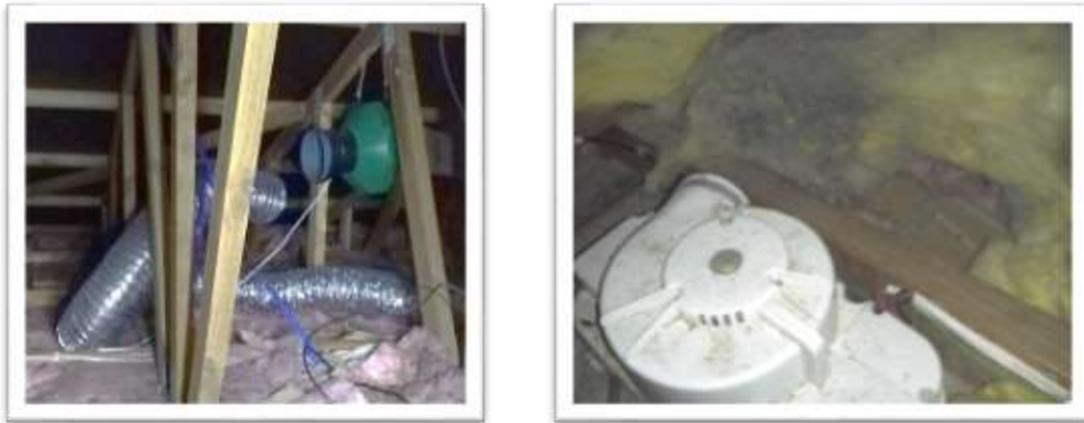
Mechanical extract ventilation is important for removing moisture generated in the home, particularly in areas such as bathrooms and kitchens where everyday activities can produce a lot of moisture (Figure 37). The HHS require kitchens and bathrooms in rental dwellings to have mechanical extract ventilation (rangehood or extractor fans) and specify that living, dining, kitchen and bedrooms must have openable windows or external doors (HUD, 2020). The PHS recorded the presence of mechanical extract ventilation in kitchens and bathrooms and openable windows in all rooms. When considering extract ventilation, the survey only counted appliances that were venting to the outside (Figure 38) and working at the time of the survey.

Figure 38. Mechanical extract ventilation must extract outside not to the roof space.

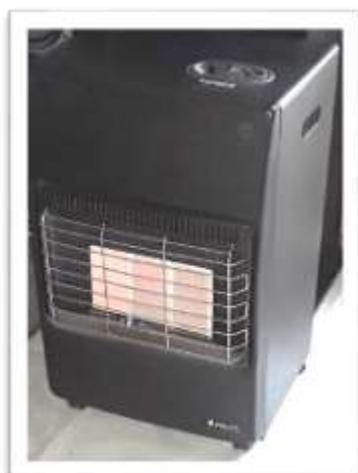
Figure 45. Portable LPG heaters are unhealthy, dangerous and expensive to run.

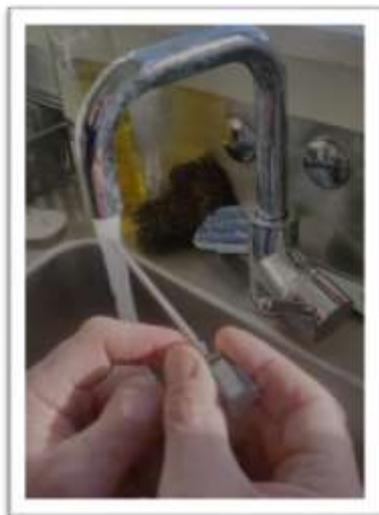
The PHS recorded the temperature at the hot water tap in all bathrooms (Figure 48). The results suggest around one-third of houses (33%, ± 4.1 pp) had hot water exceeding 55°C in a bathroom (Figure 49). Hot water tap temperatures exceeding this threshold were more commonly observed in non-owner-occupied dwellings. These results are consistent with previous measurements in HCSs when sample error is taken into account (BRANZ, 2018).

Figure 49. Around one-third of dwellings had hot water exceeding the recommended temperature at the tap.
