Study Report

SR484 [2023]

# Assessing retrofitted external wall insulation techniques

## BRANZ Study Report SR484

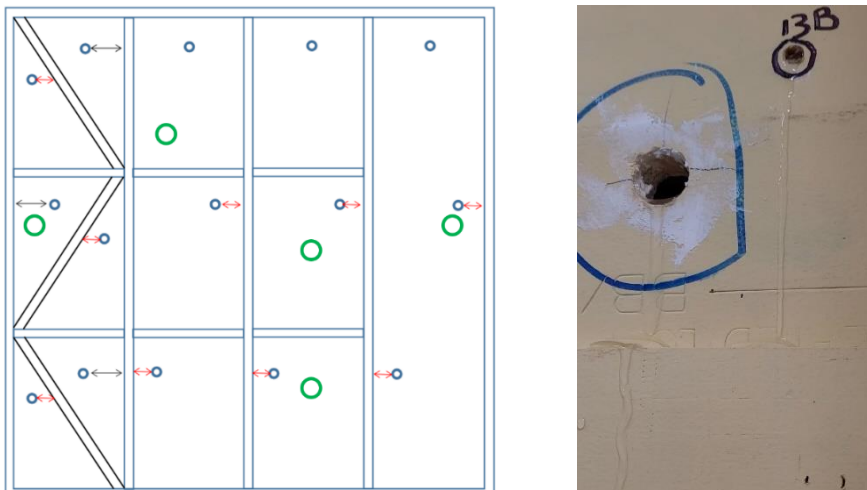
**Figure 4. Left: Wall framing layout for test specimen (not to scale); Right: Water flow from leak points within the cladding (back of cladding shown).**

Wall specimens (approximately 2.4 x 2.4 m) were constructed using timber framing and direct-fixed bevel-back pre-primed weatherboard cladding by tradespeople following standard trade practices in New Zealand. The framing timber used was 100 mm (90 + 10 mm) dressed framing or 100 mm rough-sawn framing. Figure 4 shows the layout of the test specimen and water flow from leak points within the cladding.

Three diagonal bracing timbers were included within the wall specimen and the wall was divided into 12 small cavities and one tall cavity. There were 15 small leak points (6 mm diameter holes) and five large leak points (18 mm diameter holes) on the weatherboard cladding. The leak points were made on the cladding to simulate what

might happen if there were face leaks through the cladding. The series of five 18 mm leak points were not included in the test method developed for the blown-in insulation tests. They were introduced for this present study to create a significantly higher water load through the cladding. This higher water load was used for testing the retrofitted insulation with cavity via drainage plane mesh and underlay (Figure 2c and Figure 3). In this study, except where indicated, the water load was created by the 15 small leak points (6 mm diameter holes).

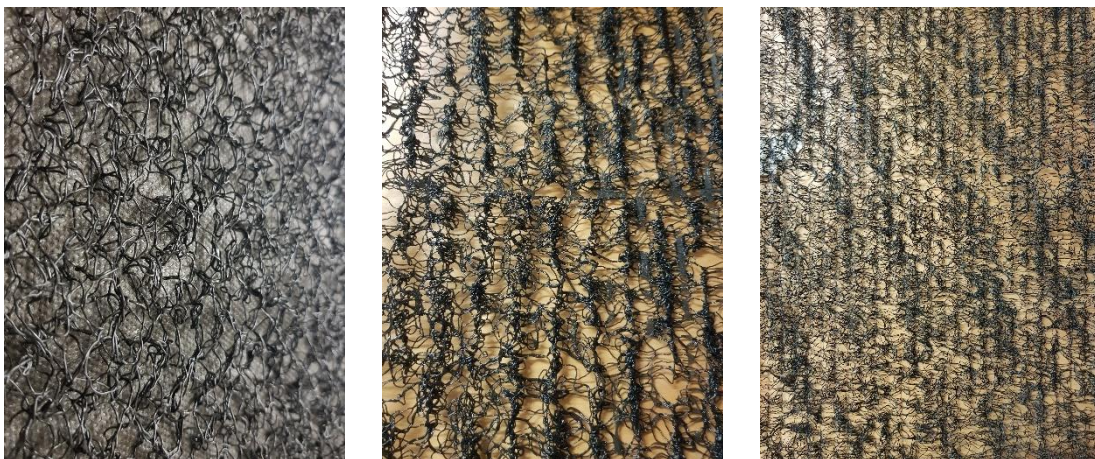
**Figure 5. Drainage plane mesh used in this study.**

Three drainage plane meshes from different sources were used in the tests (Figure 5). All were made from polypropylene plastic.

(a) 8 mm, integrated underlay (b) 7 mm, separate underlay (c) 7 mm, separate underlay

One of the drainage plane mesh products was supplied with an underlay already attached (Figure 5a) so there was no opportunity to add folds to the edge of the underlay (pan method). For the other two drainage plane meshes, there were no underlay attached (Figures 5b and 5c) so it would have been possible to use an oversize underlay and fold the edges.

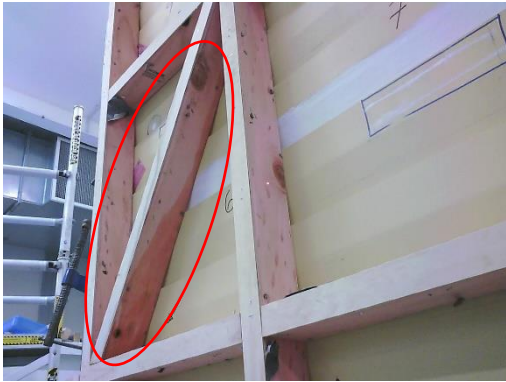
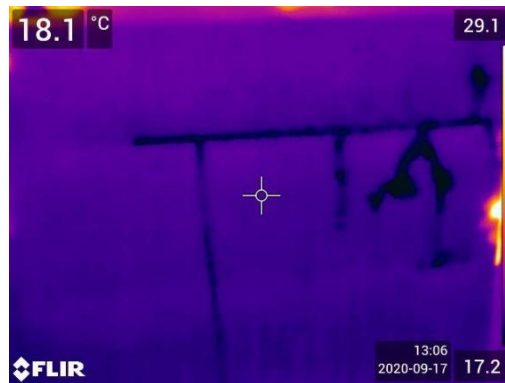
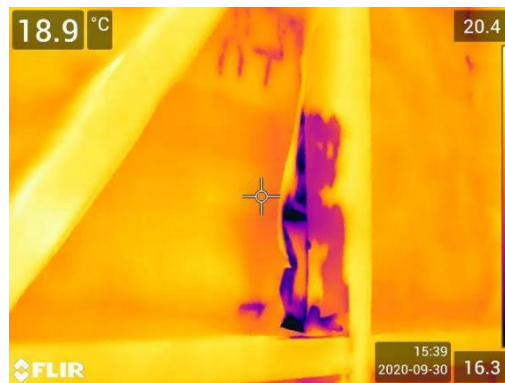
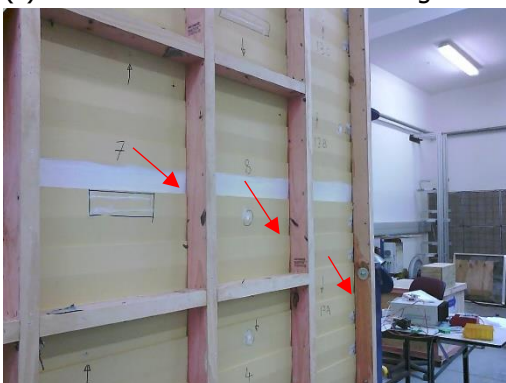
**Figure 6. Walls insulated with underlay and without cavity where water transfer occurred.**

With the diagonal bracing, the water was able to run down the underlay to the bottom corner and onto the framing (Figure 6a). With the rectangular cavities, the underlay appeared to block the water from running down the back of the cladding and instead the water was trapped along the top edge of the weatherboards. Water was then transported along the top edge to the fold in the retrofitted underlay against the side of studs. From there, the water ran down the vertical edge of the stud (the edge nearest to the cladding) and eventually onto the bottom plate in the corner against the stud or sometimes onto the dwangs (Figures 6b–6d).

(a) Water was transferred to diagonal bracing

(b) Water was transferred to back of underlay

(c) Water was directed onto framing behind folded underlay edges

(d) Water was transferred onto framing and back of cladding

There were some differences in the way the water drained between the back of cladding and the various retrofitted underlays when there was no cavity (Table 1, walls D–G). However, the outcome was always the same with some of the water being transferred onto the studs, dwangs, bottom plate or diagonal bracing. Figure 6 shows some of the test photos. One possibility is that water was trapped between the retrofitted underlay and studs/dwangs, potentially reducing the ability of the latter to dry. Therefore, while insulation might have been unaffected, the outcome is still undesirable.

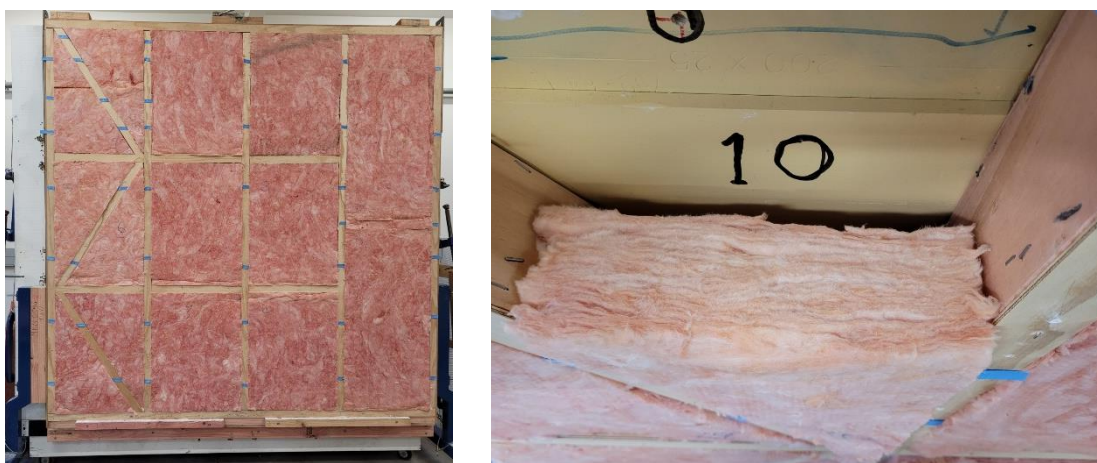
**Figure 7. Walls insulated with 20 mm separation via strapping holding the insulation and without underlay.**

The purpose of the tests was to evaluate the water management of retrofitted wall insulation with a 20 mm separation and without an underlay (Table 1, wall H). Initial tests were conducted following the NZS 4246:2016 guidance where the semi-rigid insulation (glass wool) was held in place with horizontally installed strapping. The strap was installed horizontally at intervals no greater than 300 mm centres by stapling into the wall studs (Figure 7). The strapping chosen was a stiff woven type rather than the more flexible type. As a result, it was difficult to staple with a 90-degree corner and precise positioning. This difficulty in fixing resulted in a less even separation than shown in NZS 4246:2016.

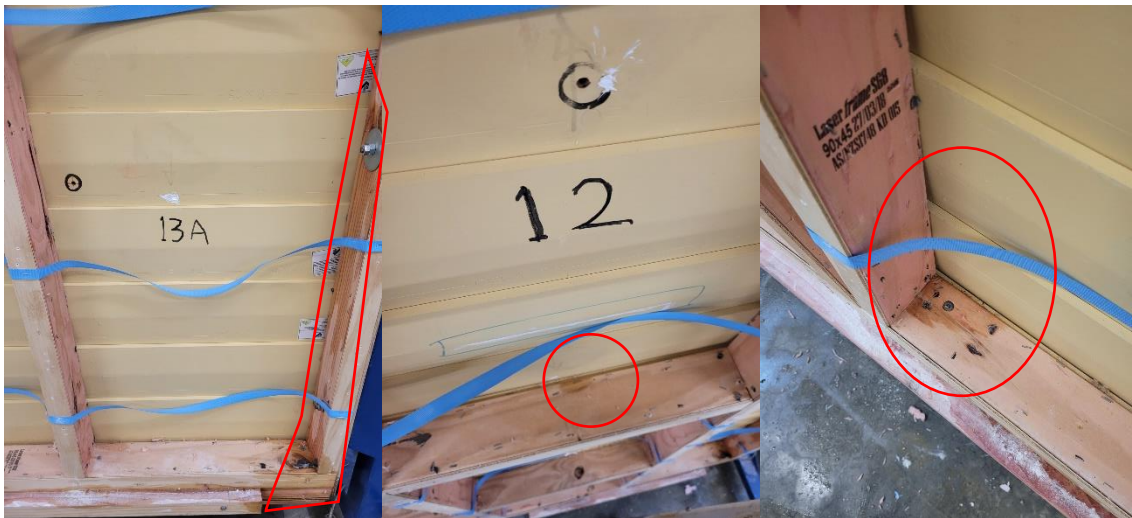
**Figure 9. Close-up view – walls insulated with 20 mm separation via strapping holding the insulation and without underlay where water transfer occurred (circled).**

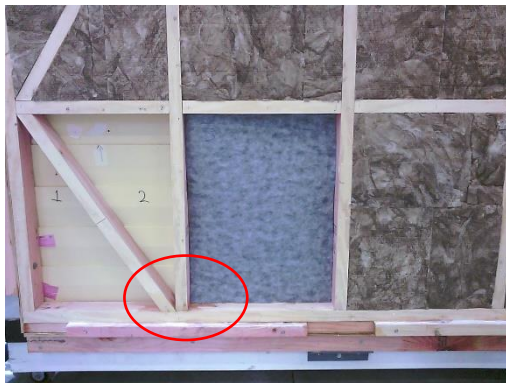
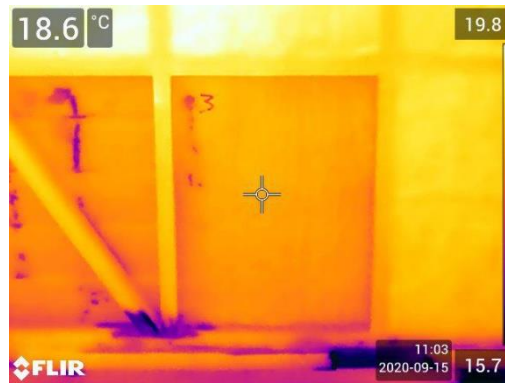
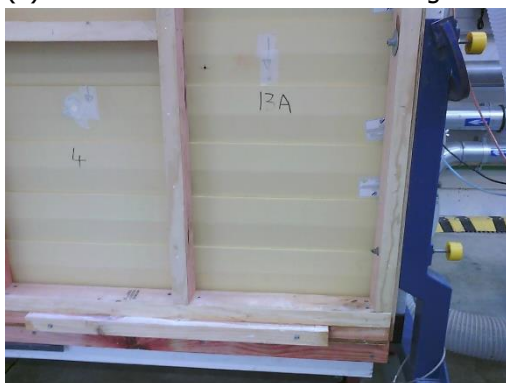
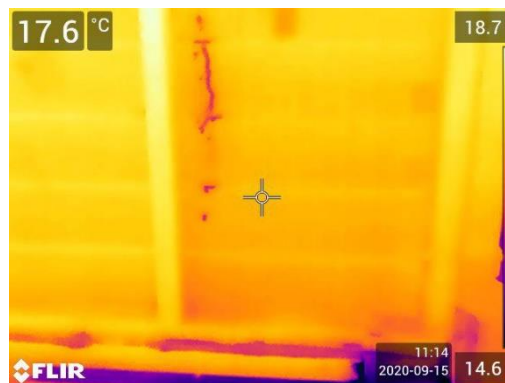
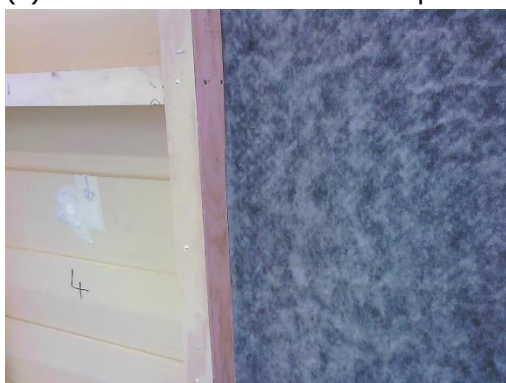
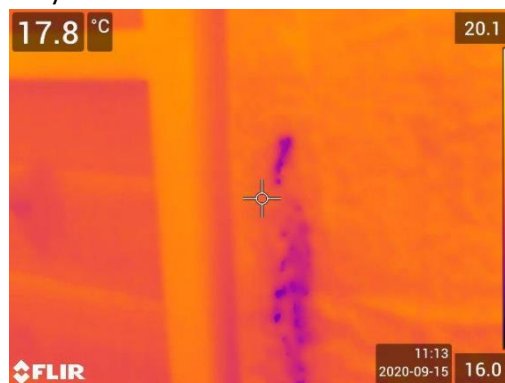
**Figure 10. Walls insulated with drainage plane mesh and underlay.**

The testing started with the drainage plane mesh supplied with the attached underlay (Table 1, walls I–K). This product performed satisfactorily. Water was only transferred to the bottom corner of the diagonal bracing, stud and bottom plate (Figure 10a). Compared with the previous walls, no water was found at the bottom plate of the tall cavity (Figure 10b). Although there were no folded edges down the side of the underlay, water was not transferred onto the sides of the studs (Figure 10c).

(a) Water was transferred to framing

(b) No water was found at bottom plate of tall cavity

(c) No water was found at sides of stud

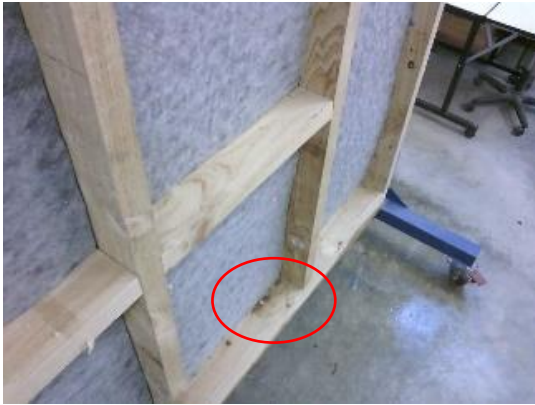
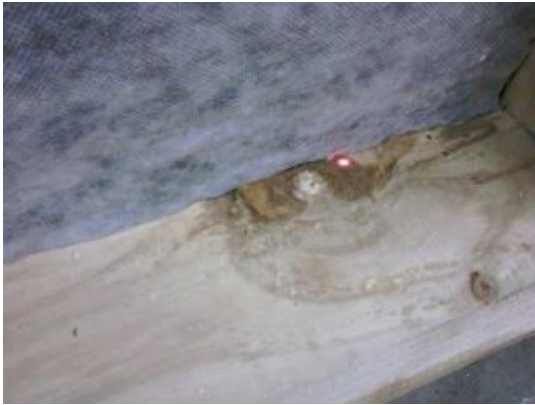
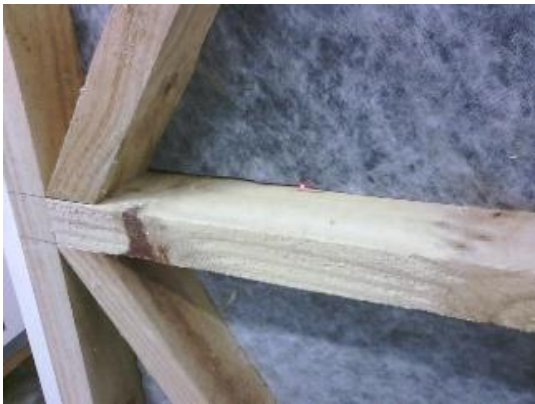
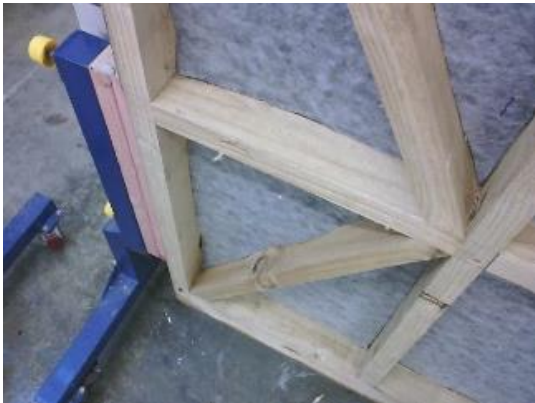
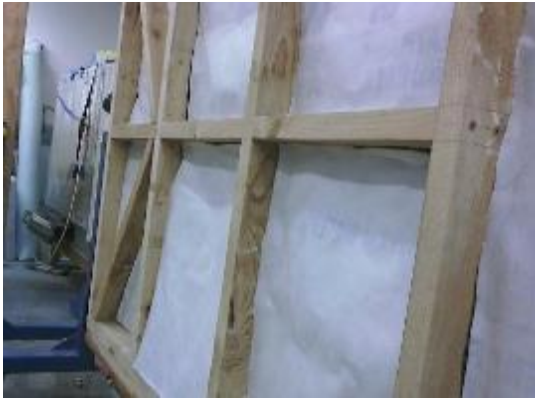
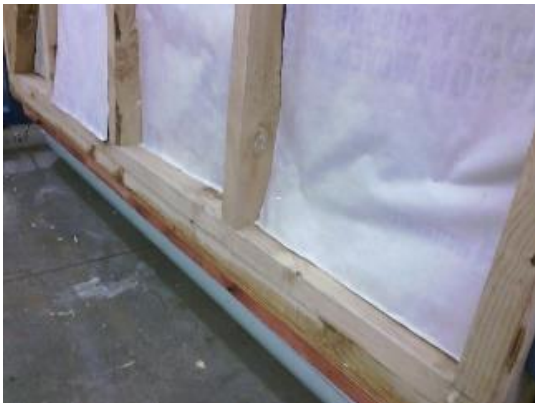
**Figure 11. Walls with cavity via drainage plane mesh and synthetic underlay or kraft paper without folded tape around edges.**

Since the first mesh tested performed reasonably well despite it not having the folded edges, folded edges were also not used for the underlays used with the other two mesh materials. Repeated testing using this drainage plane mesh (Figures 11a–11d) and the other two drainage plane meshes in conjunction with synthetic underlay (Figures 11e and 11f) and kraft paper (Figures 11g and 11h) resulted in similar observations. These indicated that only small amounts of water were transferred onto the framing at the point where the back of the weatherboard abutted the diagonal bracing or at the points around the knot in the bottom plate or dwang. This indicates that pre-existing framing defects may have an impact on water transfer.

(a) Small amount of water was transferred to bottom plate with knot in it

(b) Close-up view – water was transferred to bottom plate with knot in it

(c) Water was transferred to corner of diagonal bracing

(d) Water was transferred to bottom corner of diagonal bracing and bottom plate

(e) Water was transferred to dwang

(f) Water was transferred to bottom plate

(g) Water was transferred to dwang

(h) Water was transferred to diagonal bracing

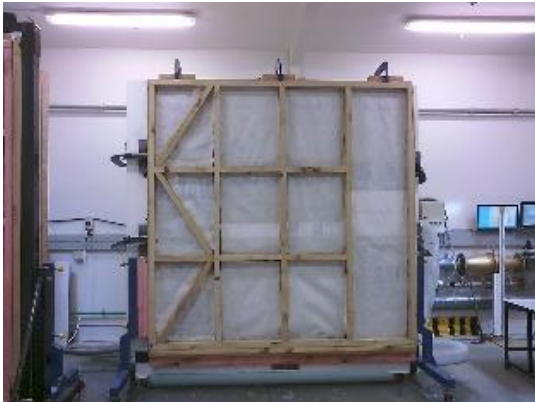
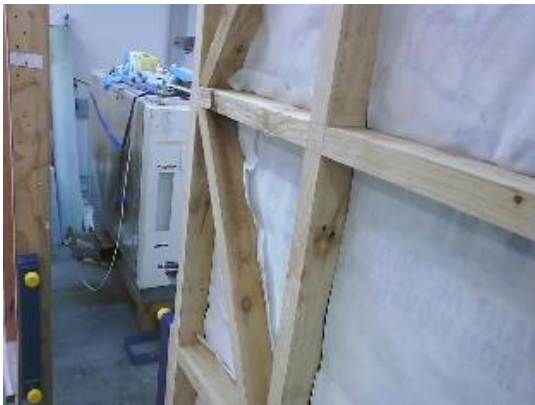
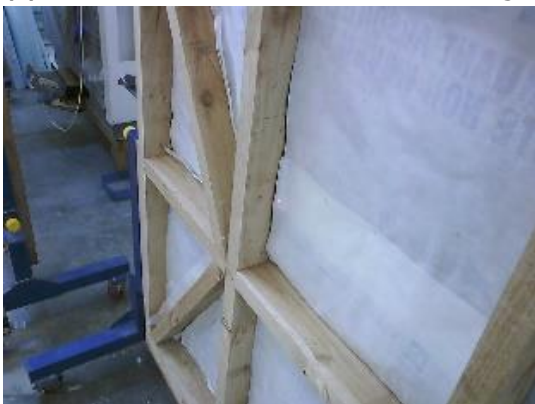
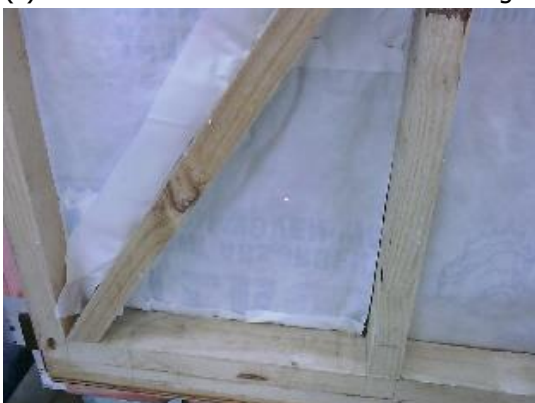
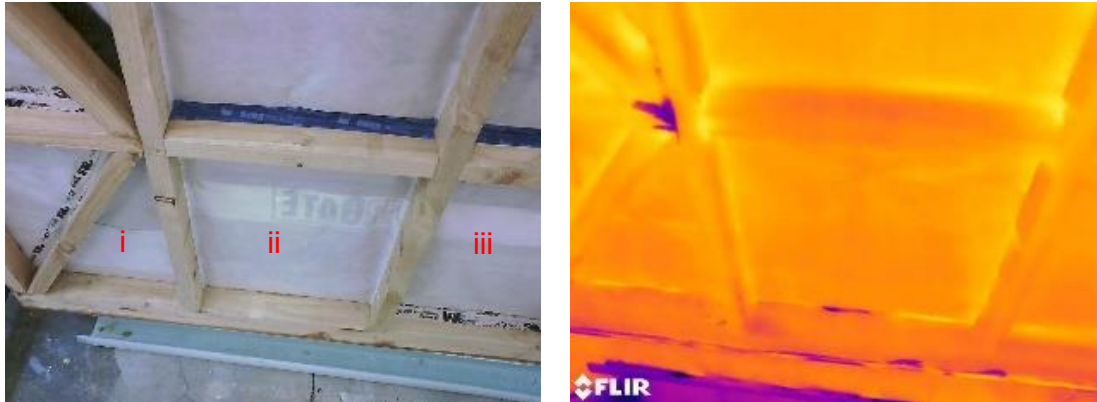
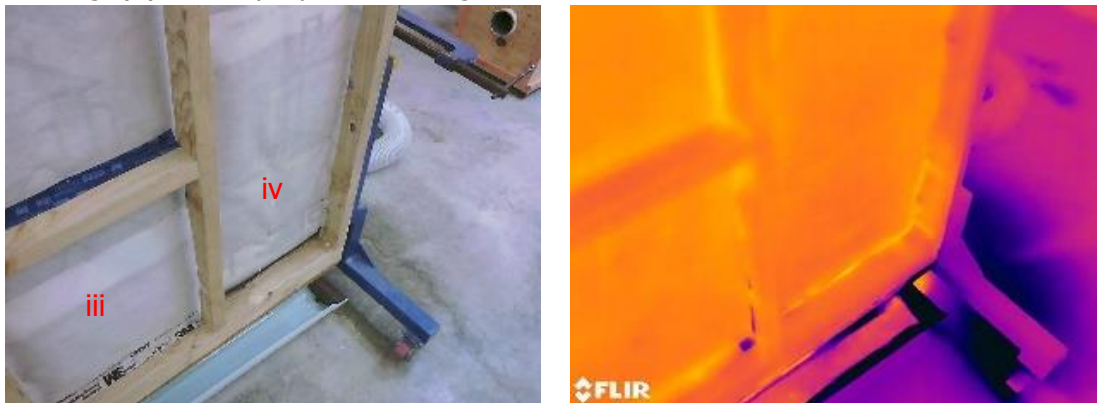
**Figure 12. Walls with cavity via drainage plane mesh and synthetic underlay or kraft paper with strip of underlay tucked behind framing or taped to framing.**

Results showed that tucking the edge of underlay into the bottom plate caused very small amounts of capillary water transfer back onto the bottom plate. The alternative method of strips of kraft paper tucked into the bottom plate was successful at preventing water being transferred onto the bottom plate and was easy to install (Figures 12m and 12n and the appendix).

(a) Strip of synthetic underlay tucked between framing and back of cladding

(b) Water was not transferred onto framing

(c) Water was not transferred onto framing

(d) Small amount of water was transferred onto corner of diagonal bracing and bottom plate

(e) Strip of kraft paper tucked between framing and back of cladding

(m) (i) Underlay cut to fit the cavity, (ii) underlay tucked between bottom plate and back of cladding, (iii) underlay taped to framing

(n) (iii) Underlay taped to framing, (iv) strip of kraft paper tucked between framing and underlay

- i) Underlay was cut to fit the cavity.
- ii) Underlay was cut approximately 5 mm longer and tucked between the framing and the back of the cladding.
- iii) Underlay was taped to framing.
- iv) A strip of kraft paper was tucked between the framing and underlay.

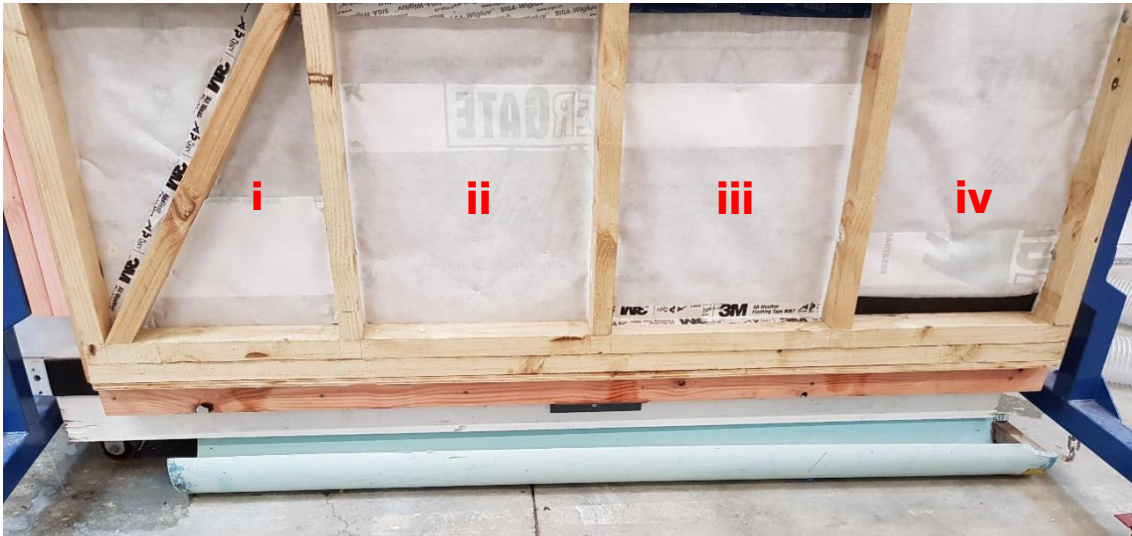
**Figure A1. Four types of configurations were tested: i) the underlay was cut to fit the cavity; ii) the underlay was cut approximately 5 mm longer and tucked between the framing and the back of the cladding; iii) the underlay was taped to the framing; iv) strip of kraft paper was tucked between the framing and underlay. This image was taken before the test.**

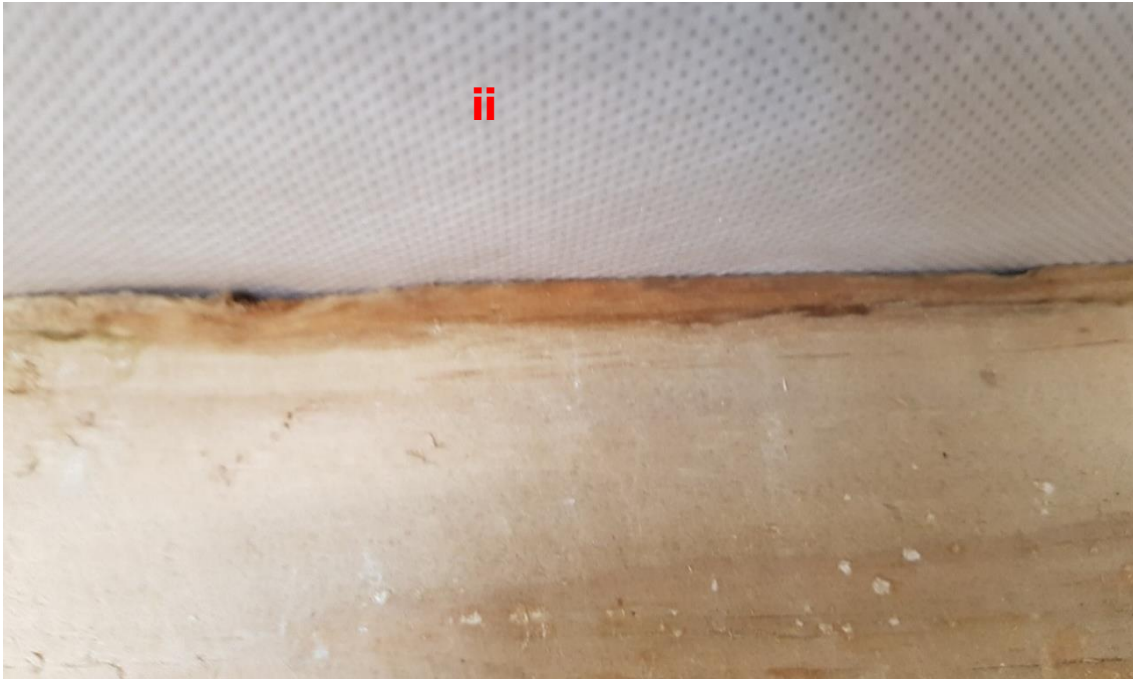
**Figure A3. Close-up view of (ii) the underlay cut approximately 5 mm longer and tucked between the framing and the back of the cladding. This image was taken after the test.**

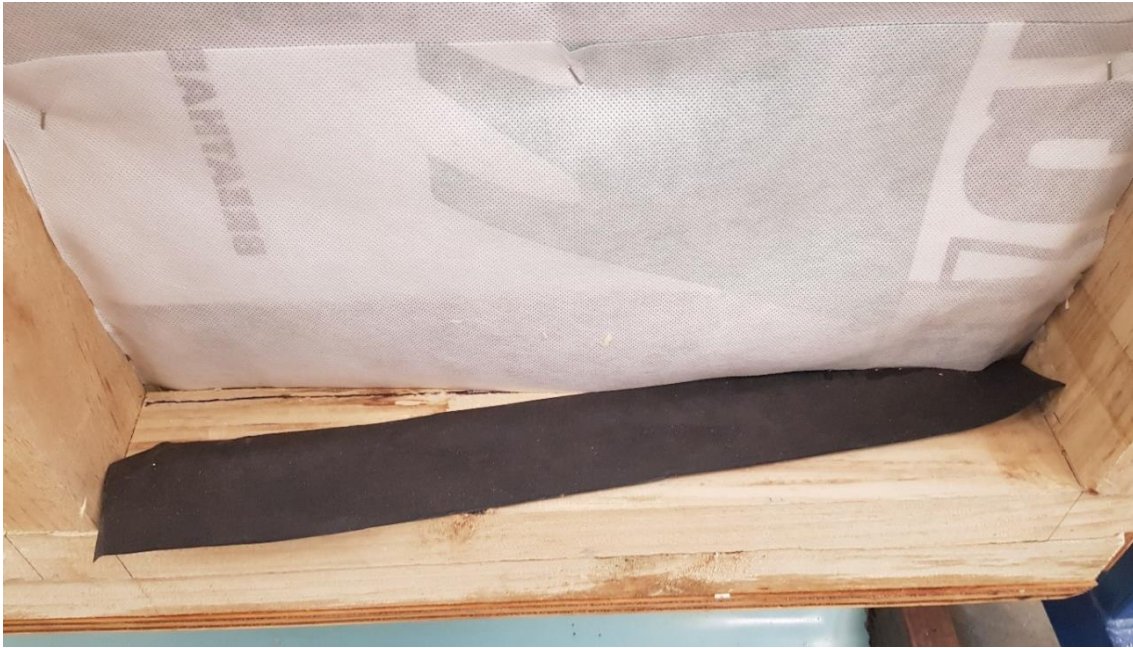
**Figure A5. Close-up view of the pulled-out strip of kraft paper tucked between the framing and the underlay. This image was taken after the test.**
