STUDY REPORT

No. 100 (2001)

Repair and Reinstatement of Earthquake Damaged Houses – Derivation of Repair Techniques

G. J. Beattie

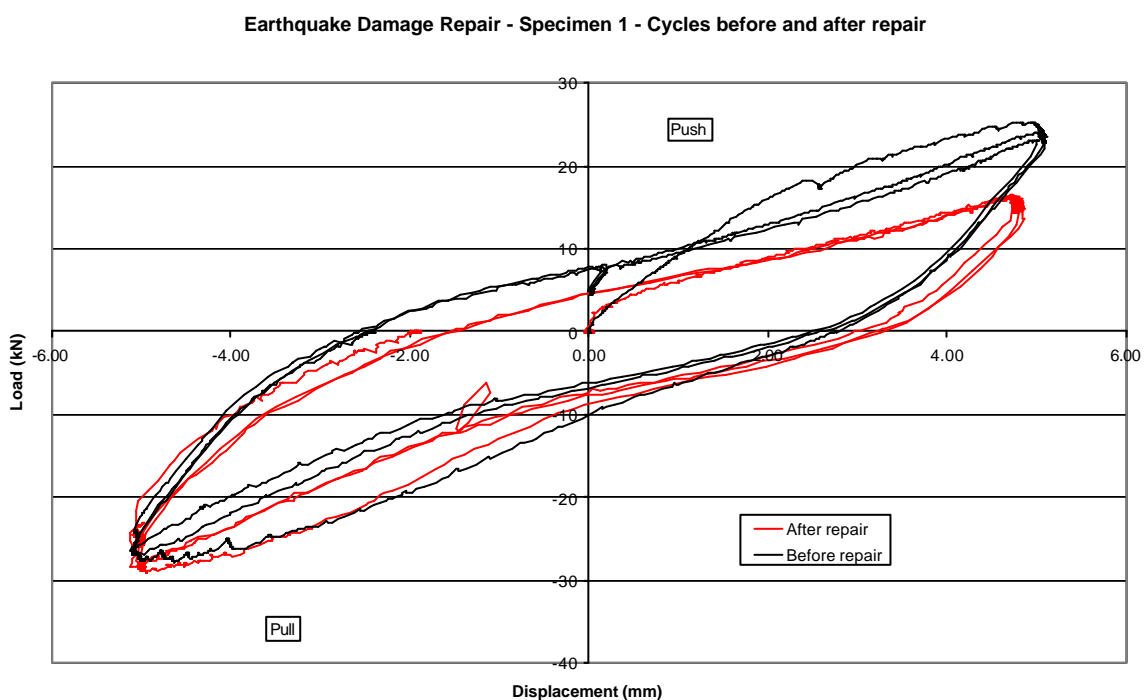
Figure 6: Comparison of performance before and after the first repair work

A small crack had formed up to about 1 mm wide on the fibre cement sheet joints, extending from the bottom corners of the windows to the bottom plate. These cracks were filled with joint filler 1. Overcoating with a new textured coating would have been necessary to hide the repair to the satisfaction of a building owner.

The specimen was then re-cycled to ± 5 mm and the strength and stiffness compared. A plot of the before and after repair cycles is presented in Figure 6. The repaired strength in one direction matched the initial strength but only reached about 65% of the initial strength in the other. There was no clear reason for this asymmetric behaviour.

Cracks had appeared in the painted plasterboard joints below the window corners during these cycles. The repair method selected was based on what was done at Edgcombe after the 1989 earthquake. This procedure involved V-ing out the joint. In doing this the tape was cut and the paper edges of the sheets were also cut. The joint was filled with normal first coat stopping compound. The compound shrank on drying and did not bond well to the sides of the V. There was no apparent damage where the wallpaper was present. If there were cracks in the plasterboard joints, these were hidden behind the wallpaper.

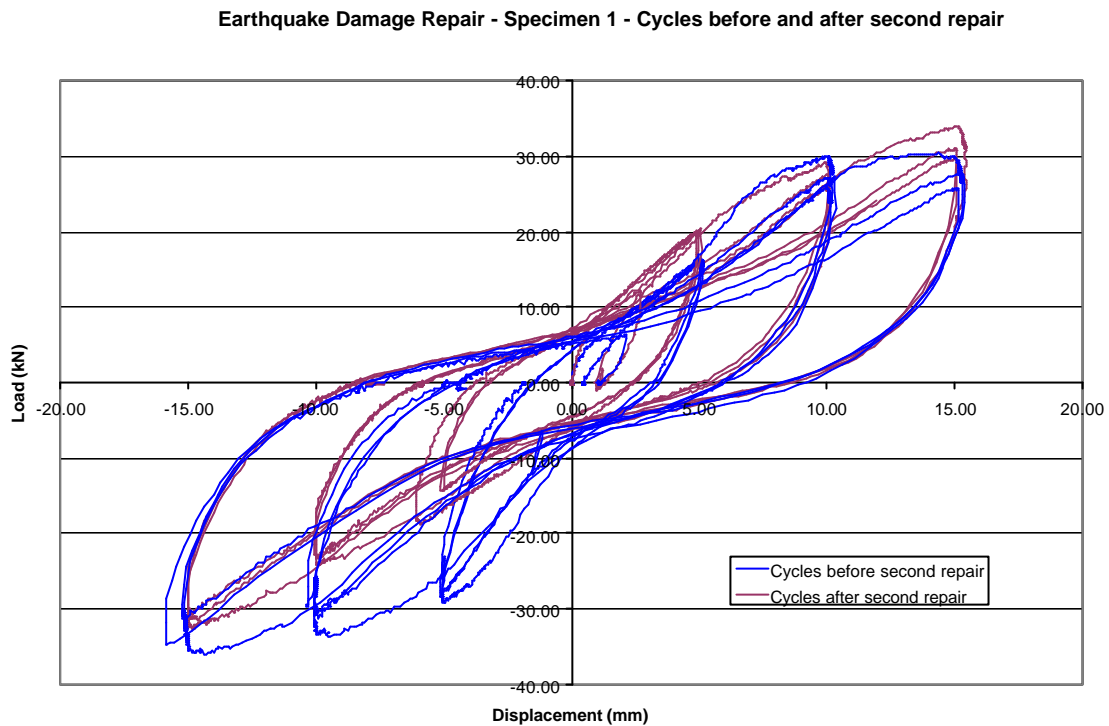
Figure 10: Comparison of the load deflection behaviour before and after the second repair

In one direction the after-repair plots closely matched the before-repair plots but in the other direction there was a significant mismatch until the 15 mm displacement. The reason for the asymmetry is uncertain but because the load levels were almost recovered and well above the design load the wall was still effective as a bracing element.

The left side joint was ground back to original sheet face and the joint V-ed out. The repair involved the application of a water-based primer and then filling with joint filler 3 (Figure 8).

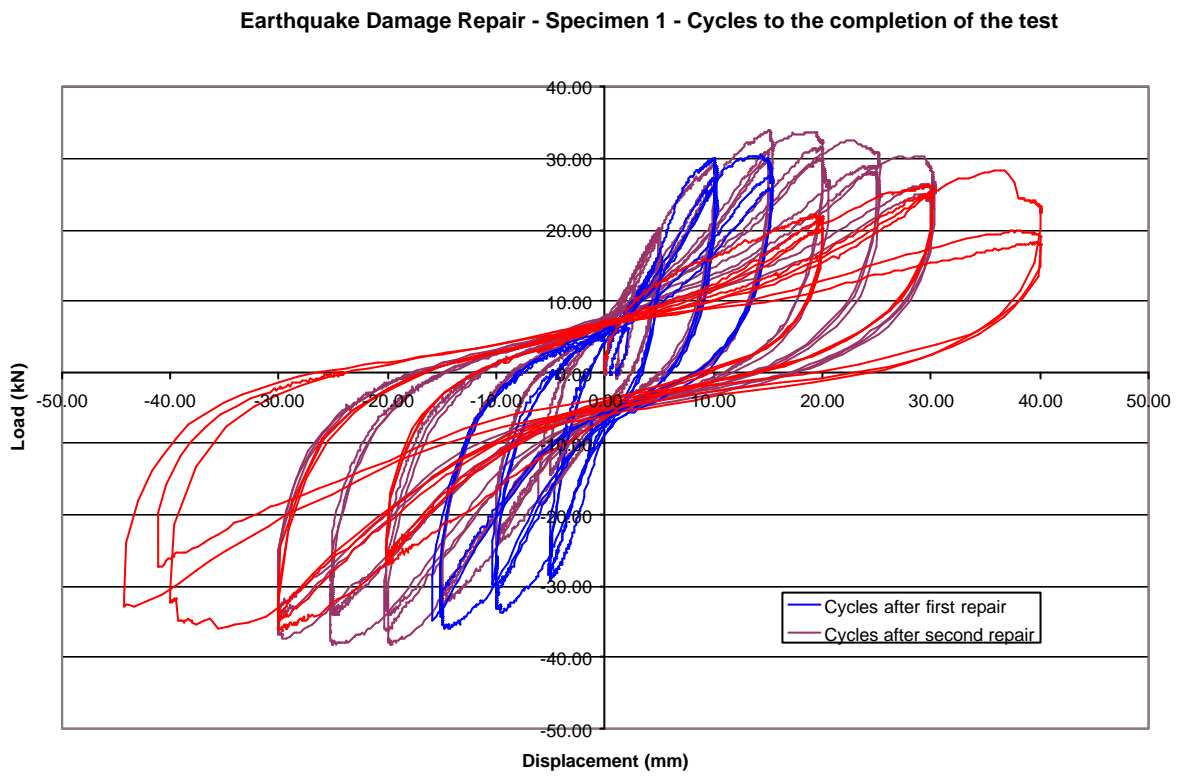
Figure 11: Load displacement history

The specimen was then cycled to displacements in excess of ± 15 mm. During these cycles the gypsum plasterboard joints began to open again, as they had done before the repair was undertaken. The connection to the bottom plate was lost as the nails pulled completely through the bottom edge of the sheet.

At the completion of the cycles to ± 30 mm and ± 40 mm the individual fibre cement sheets were still in good condition but the nailing along the bottom plate was in a bad condition. The nail heads had pulled through the sheet and it was hanging proud of the bottom plate.

The sheets could be re-nailed to the bottom plate but with a textured coating in place it may be difficult to find the original nail positions for re-nailing, unless they can be felt from underneath. A plot of the load-displacement cycles up to ± 40 mm is presented in Figure 11.

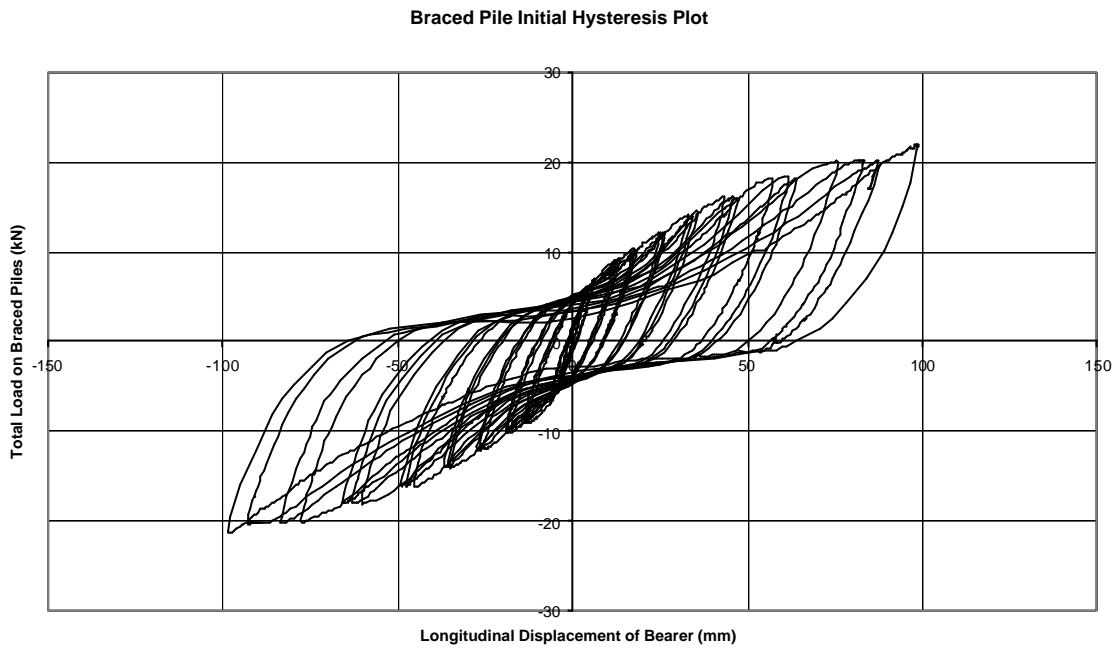
Figure 13: Longitudinal displacement of bearer against load

As cycling progressed, it was difficult to tell what damage was occurring in the joints between the piles and the braces because there was nothing visible happening, except that tell-tale lines on the members at the joints indicated clear movement between them.

A major difficulty for an inspector after an earthquake will be that he/she will not have tell-tale lines to refer to, to judge how much movement has occurred. Also, because the damage is hidden, it won't be possible to determine the extent of it without removing a brace and checking the state of the bolt and the timber around it.

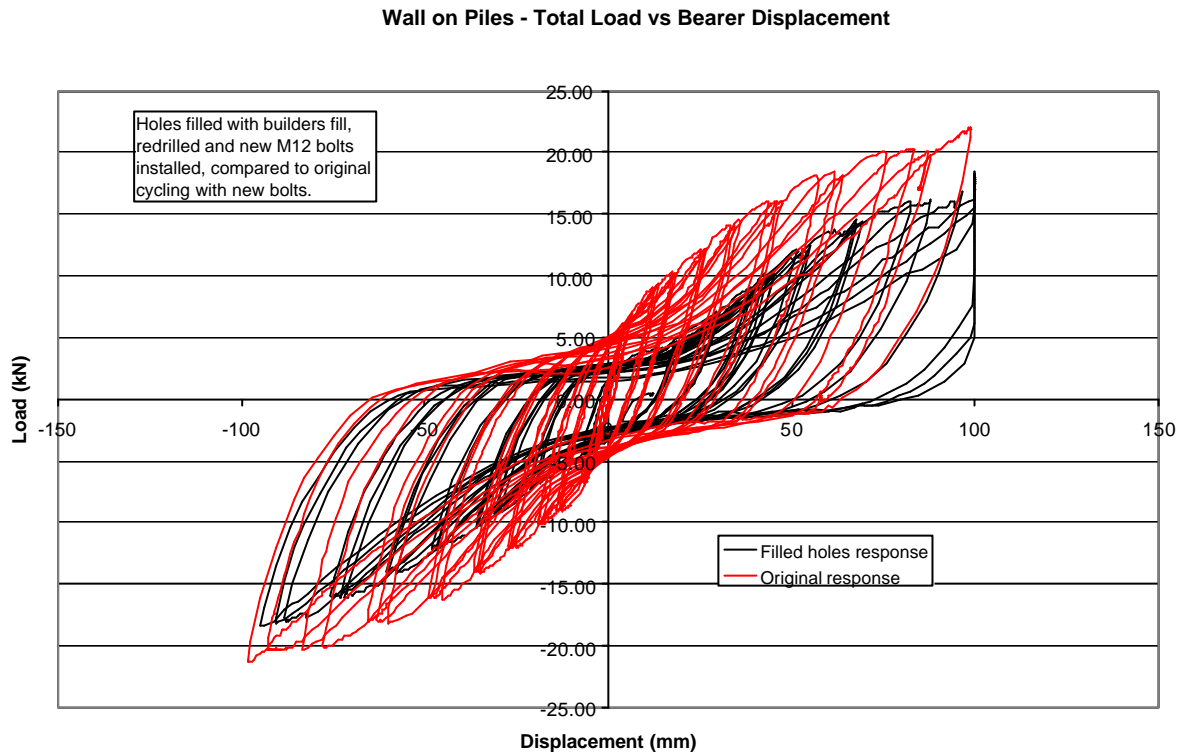
Figure 15: Comparison of performance before and after holes repaired with builders' fill

When the specimen was cycled after the repair the service stiffness was of the order of 50-60% of the stiffness in the initial cycling (Figure 15). As the displacement increased, the difference between the two plots remained relatively constant so that at 100 mm displacement the difference was about 10-15%.

The bracing rating in NZS 3604 for a single braced pile is 120 bracing units which translates to 6 kN. Therefore, the design load for the specimen is 18 kN. To achieve this load with a system that had never been subjected to earthquake loading before, the displacement of the bearer was between 60 and 70 mm. After the repair, the system displaced to 100 mm in one direction and further in the other before the design load could be achieved (note that the right side plot in Figure 15 does not extend beyond 100 mm because the deflection gauge had reached the end of its stroke).

Two repair procedures were attempted for the damaged bolted joints. The first of these involved filling the holes with builders' fill, available off the shelf at most hardware stores and redrilling them once the fill had hardened. The bolts were also replaced with new straight bolts. The second involved removal of the bolts and enlarging the holes for M16 bolts.

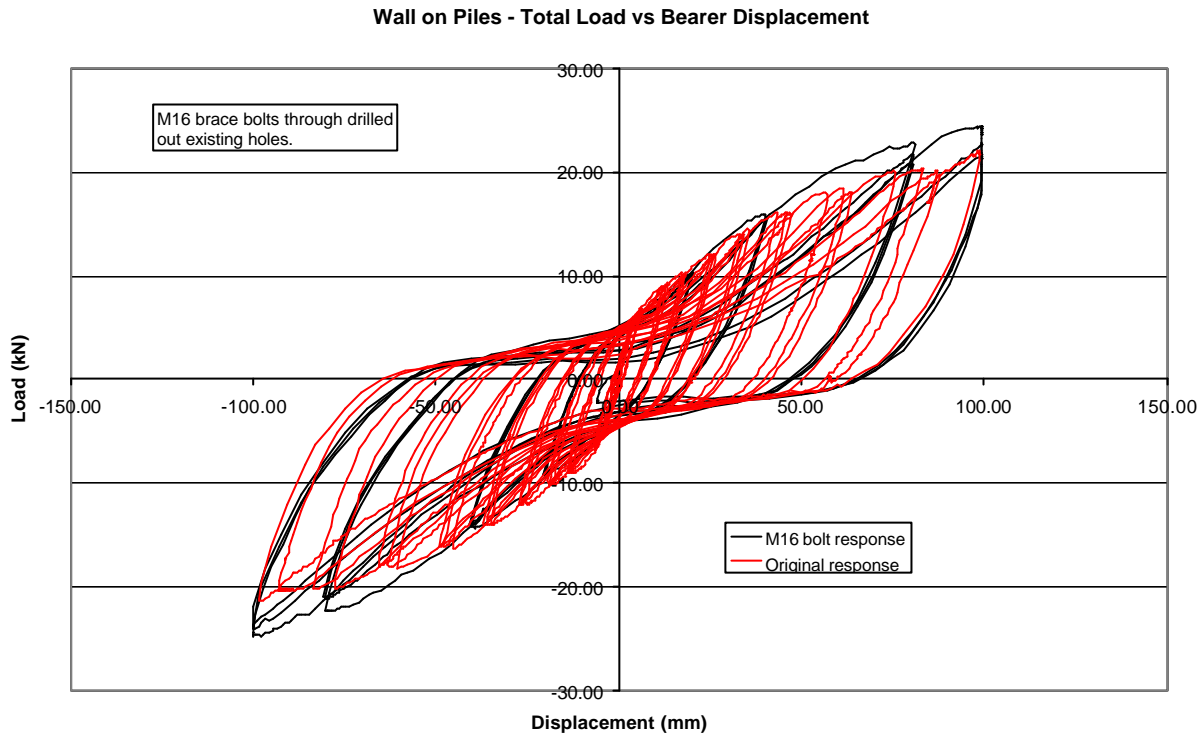
Figure 16: Comparison of performance before and after holes drilled out and m16 bolts installed

The initial stiffness of the repaired specimen was not quite as good as that of the virgin specimen but was likely to be sufficient to provide resistance to movements under service loads after an earthquake. As cycling continued, the strength gain was faster than in the original specimen (Figure 16). Once the displacements had reached approximately 40 mm the strength of the repaired structure was greater than the original and this continued up to displacements of ± 100 mm, when the testing was terminated.

For this alternative, the braces were removed from the piles and turned over so that the hole adjacent to the pile was not damaged. The holes were then drilled out to accept the M16 bolts and these were installed complete with flat square washers beneath the bolt heads and nuts.

With braced piles, it appears that it will probably be necessary to remove at least one brace after a severe earthquake to check for internal damage. A decision can be made at that point about whether it will be sufficient to retighten the existing bolts (thus mobilising greater friction between the two timber surfaces and stiffening the joint) or whether the holes should be drilled out and M16 bolts installed.

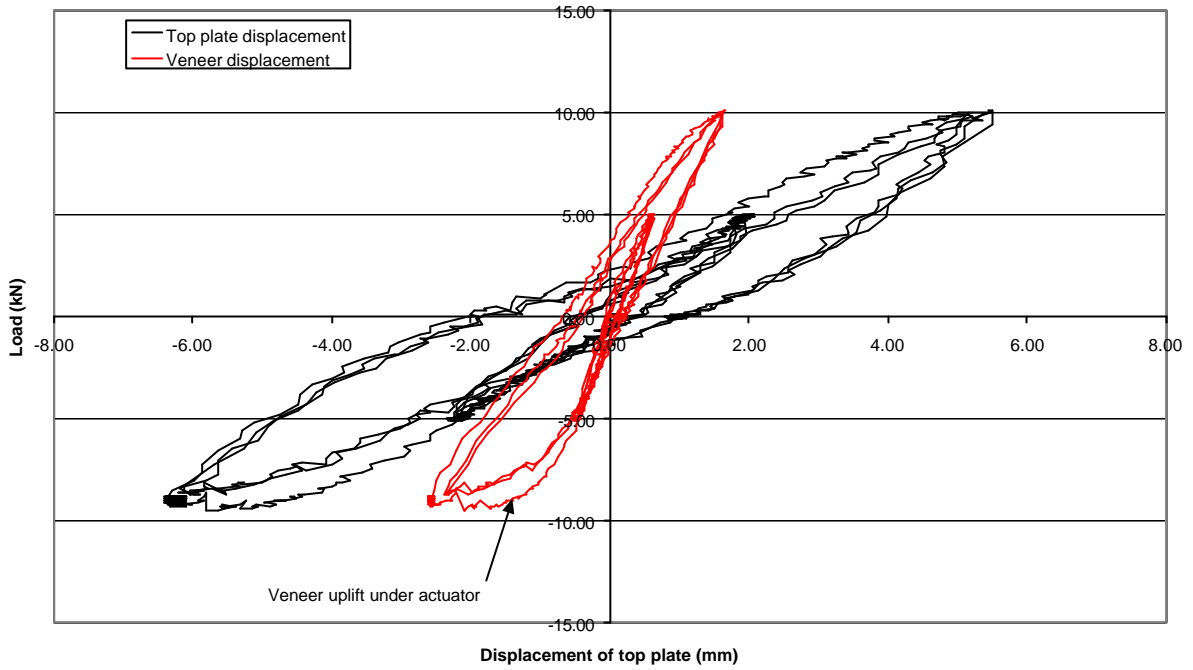
Figure 21: Comparison of top plate displacement and veneer displacement against load – cycles to 10 kN.

The second set of cycles repeated the 5 kN cycles from the initial series and then went on to cycles targeting 10 kN. When approximately 9 kN was reached, the end of the veneer under the actuator began to lift from the slab during the push cycles. For this direction, a target displacement of 6 mm was set so that 3 complete cycles could be achieved to 10 kN in the pull direction. Once again, there was differential movement between the veneer and the framing, in the order of 4 mm at the peak load (Figure 21).

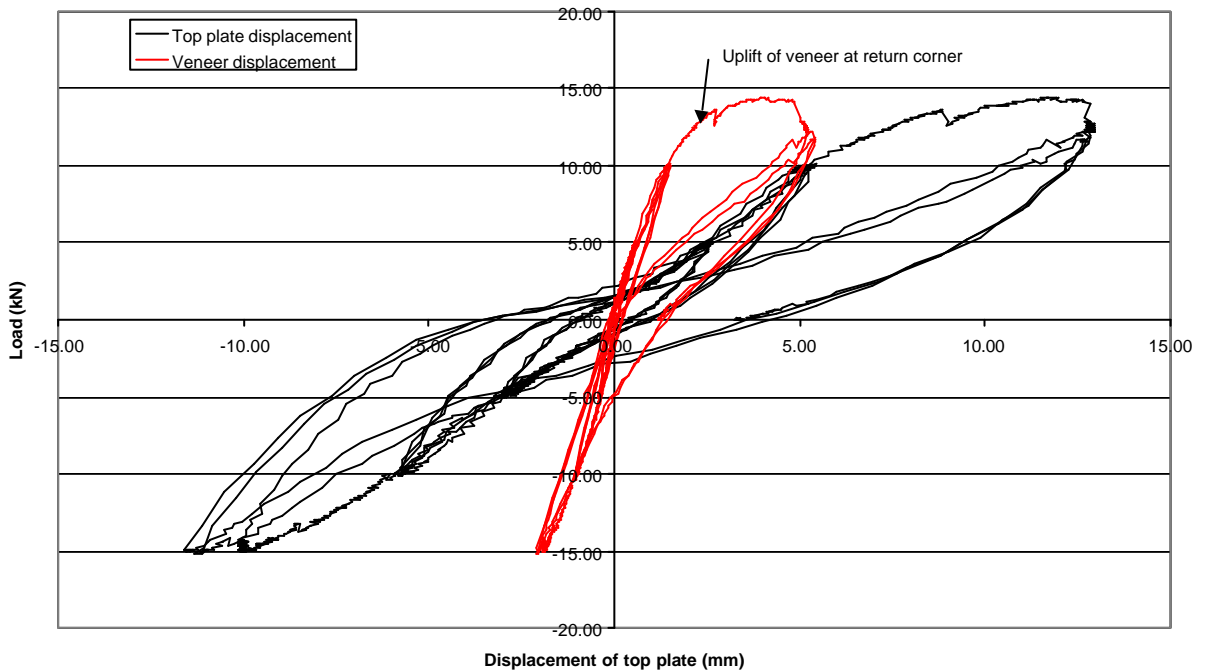
Figure 22: Comparison of top plate displacement and veneer displacement against load – cycles to 15 kN.

A vertical restraint was installed over the end of the veneer beneath the actuator and the third set of cycles was commenced. A target load of 10 kN was achieved in both directions and an attempt was made to continue on with cycles to 15 kN. In the pull direction, at a load of about 14 kN, the remote end of the long veneer and the attached return veneer began to lift off the foundation slab. Testing continued to achieve three complete cycles but the displacement in the pull half cycles was limited to approximately 13 mm (Figure 22).

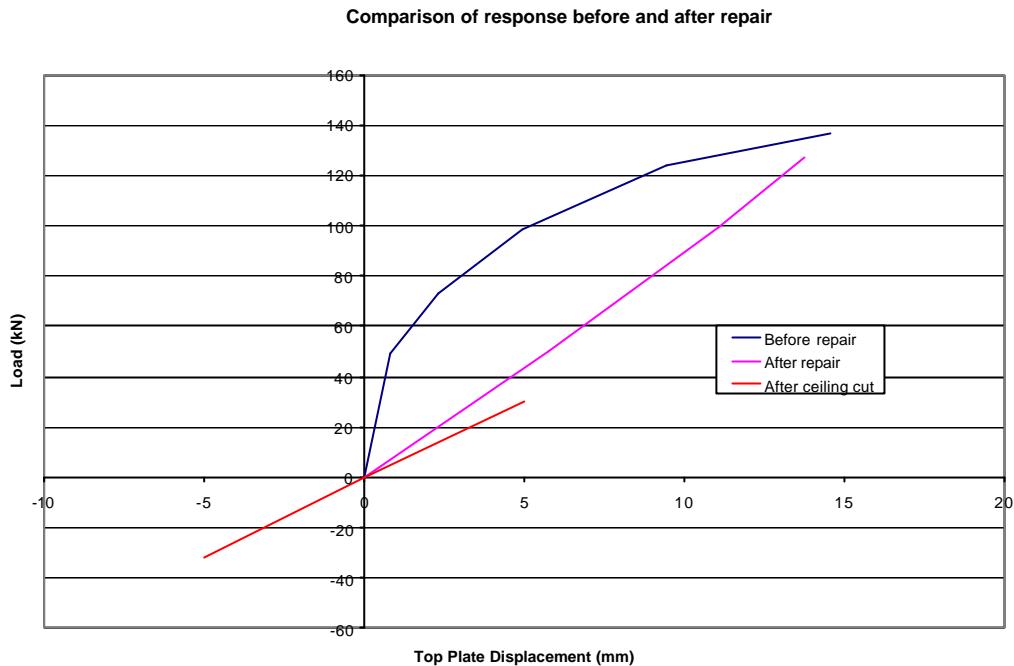
Figure 34: Comparison of the wall strength and stiffness before and after the re-nailing and re-stopping and after ceiling diaphragm interrupted

After carrying out the repairs the wall was again racked to increasing load levels to compare the strength and stiffness with the previous series. A plot showing a comparison of the backbone curve of the load-displacement hysteresis loops is presented in Figure 34. The top plate failed in tension during the last cycle at about mid length of the section of wall between the hallway and the third bedroom.

This section of wall was cycled to compare the strength and stiffness of the wall element with its strength and stiffness before the ceiling was cut. Top plate displacement was set as the controlling parameter for these cycles. Three cycles to ± 5 mm were completed before the top plate failed again, this time in compression at a knot. The backbone curve covering these cycles is also plotted in Figure 34. As expected, the strength was less because of the discontinuity introduced in the ceiling and because then only one wall element was resisting the load.

At no time during the testing did the joints between lining sheets in the region of the diagonal brace open or shear, despite there being no tape in place. The reason for this was that the wall element containing the brace behaved as a rigid element, rotating and lifting the bottom plate as load was applied. There was therefore insignificant stress on the joints between the sheets.

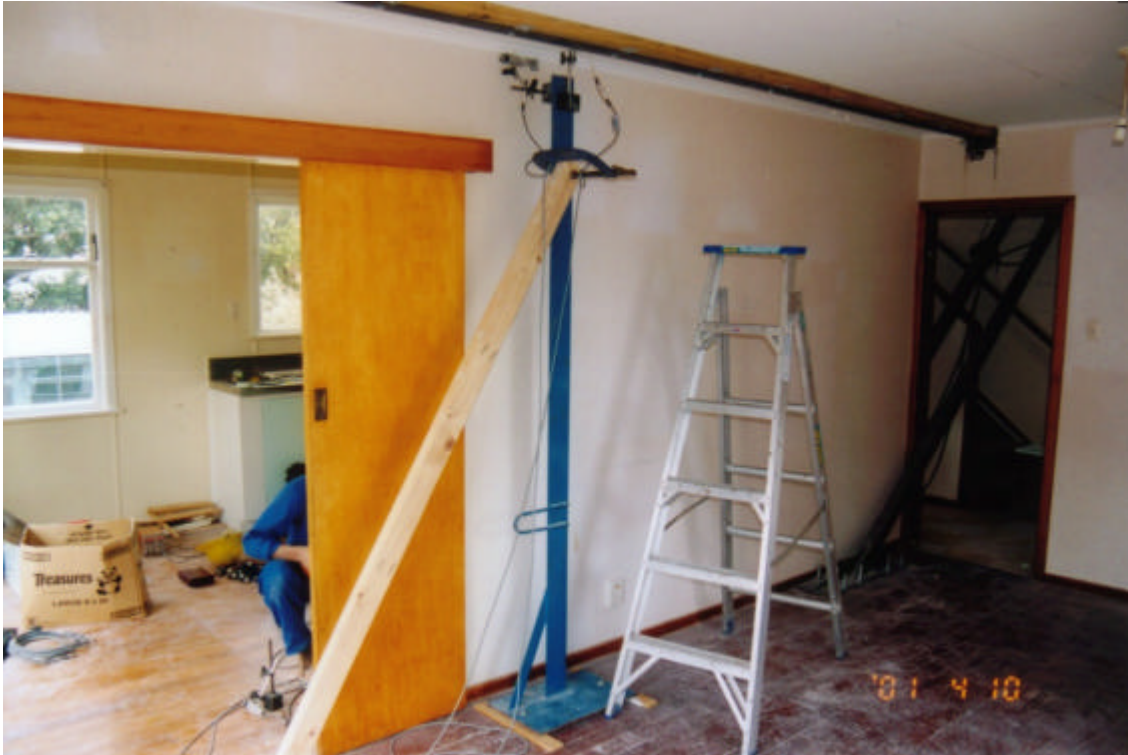
Figure 35: General view of the test wall between the lounge and the kitchen (note that the load application is through the doorway at the right end of the photograph)

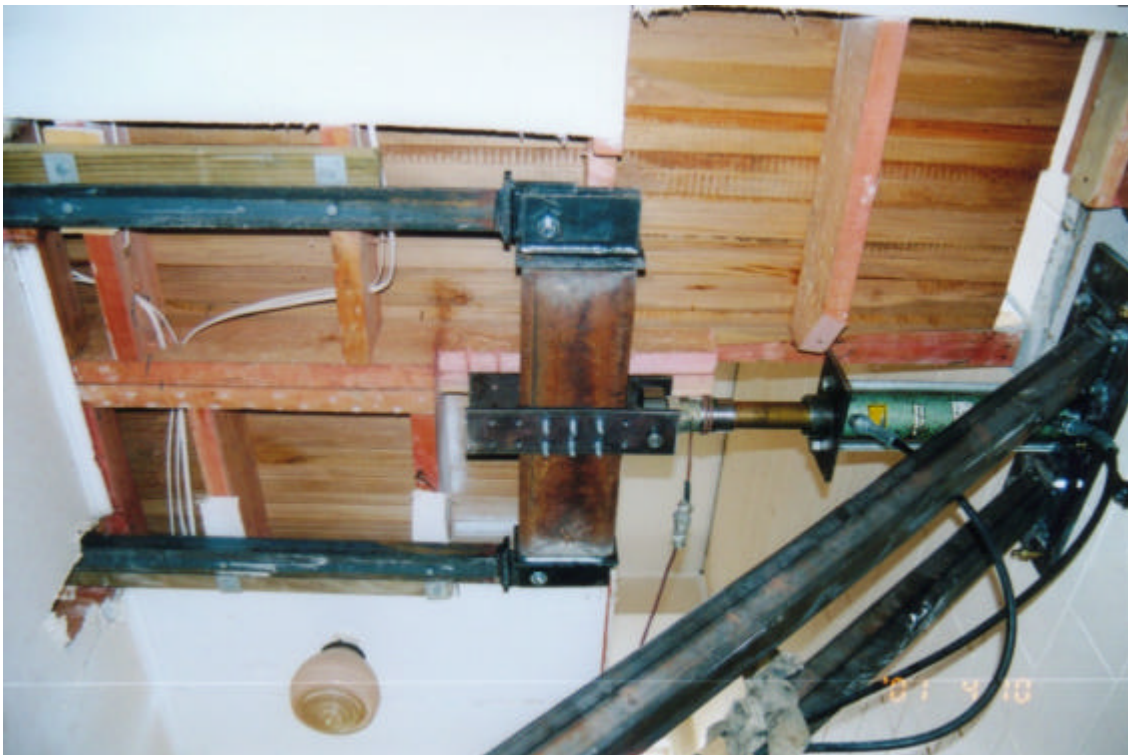
Figure 36: Details of the load application rig (load was applied via the spreader beam in the centre of the photograph to the two beams fixed to the underside of the joists)

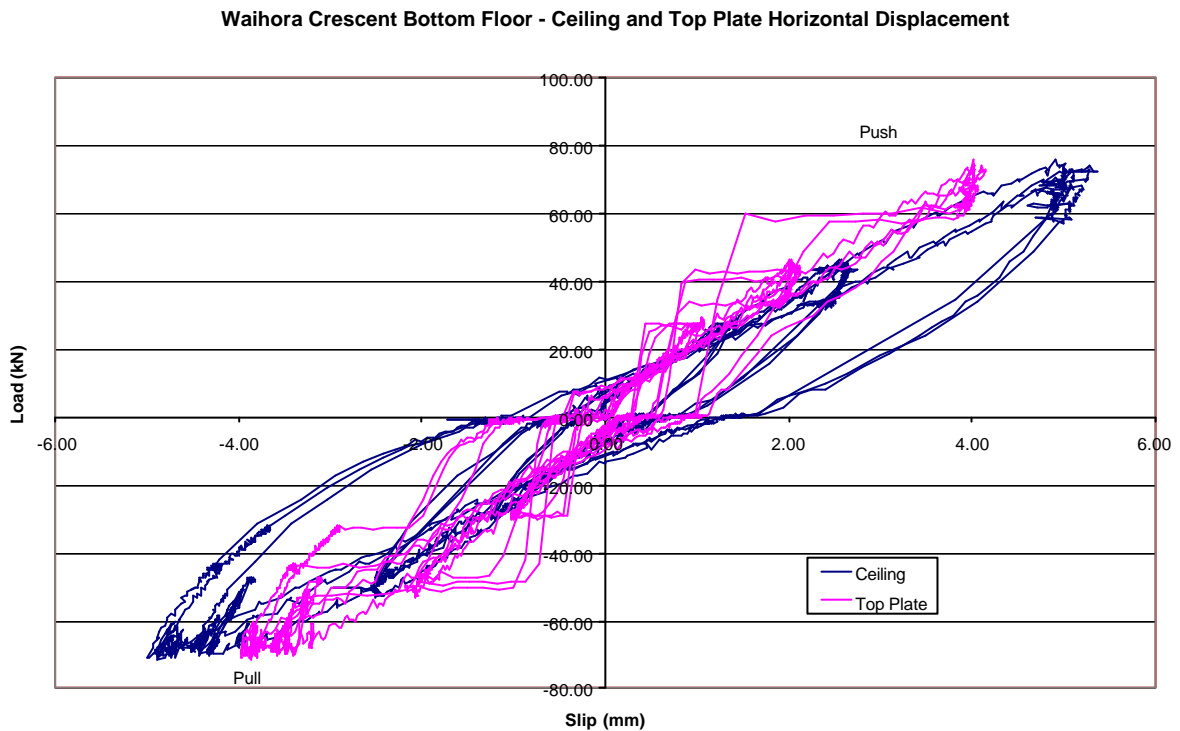
The initial set of cycles was made to ± 1 mm, ± 2 mm and ± 4 mm of the top plate (3 cycles to each displacement level). Plots of the load-displacement hysteresis loops are provided in Figure 37. It can be seen from the plot that the displacement of the ceiling was about 25% more than that of the top plate. This was caused mainly by weak axis bending of the top plate but partially by slippage at the joint between the wall and the ceiling. The loads achieved were very high, reaching 72 kN at 4 mm of top plate displacement.

Figure 37: Load-displacement cycles up to ± 4 mm of the top plate

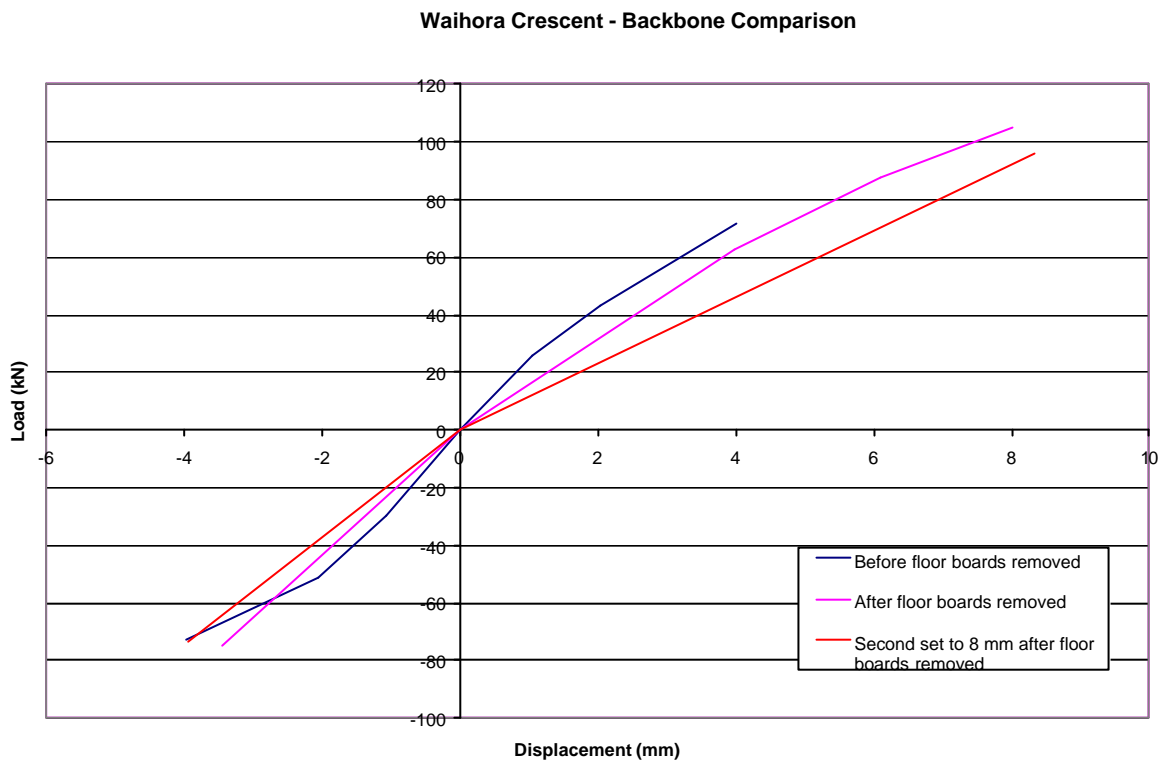
It was decided to lift a series of four adjacent floor boards in the upper storey at the previously made saw cuts in an effort to reduce the diaphragm action that appeared to be occurring in the floor. Loading cycles were repeated to 4 mm for comparison with the previous set and then continued on to 6 mm and 8 mm. Backbone curves for the first cycle peak loads have been plotted in Figure 39. It can be seen from the curves that there was some small drop off in stiffness after the floor boards were removed. At the peak loads of these cycles there was no perceptible movement across the openings that had been created by removing the floor boards, nor was there any obvious slippage between the boards that remained. Uplifts of up to 0.5 mm occurred at the two ends of the test wall.

Figure 39: Comparison of the backbone curves of first cycle peak loads before and after the floor boards were removed

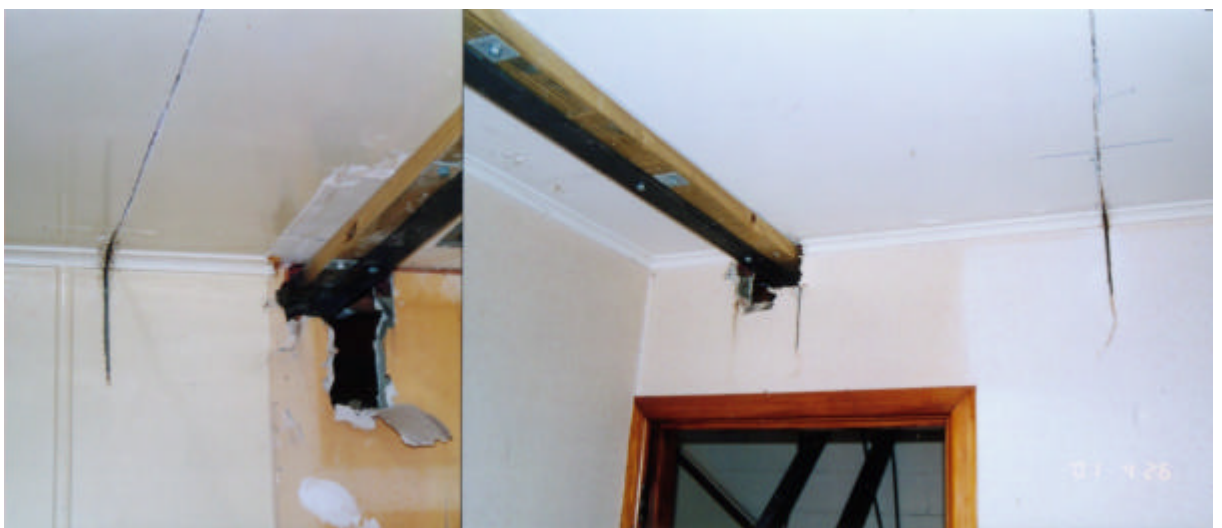
The top plates of the transverse wall adjacent to the slots cut in the ceiling lining were then cut through so that there was no continuity for force transfer along the transverse wall (Figure 41). The wall was then cycled to 8 mm, then 12 mm before all the linings were removed from the wall between the hall and the laundry to prevent any load-resisting contribution from it.

Figure 41: Photographs of the kitchen (left side) and the lounge (right side) showing the cut through the top plate

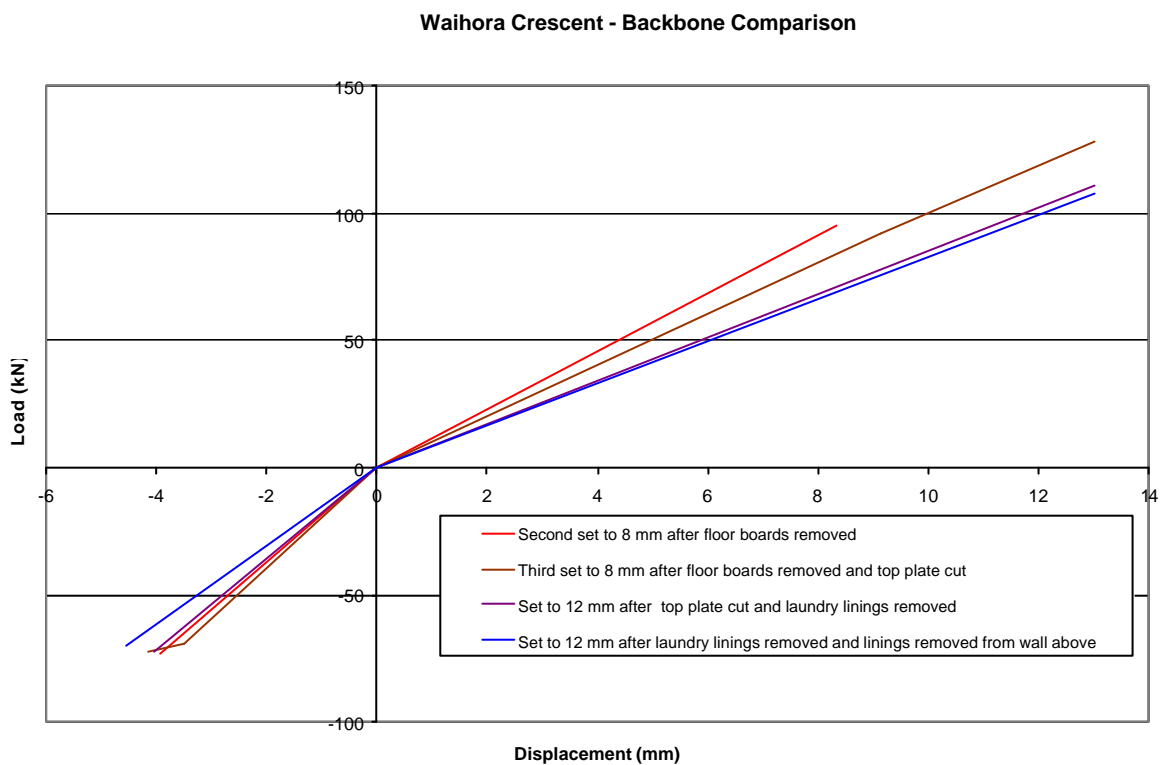
The linings were then removed from the upper storey test wall and the tongue and groove flooring was separated from the concrete block masonry wall over the full width of the house rather than the width to the removed floor boards. Plots of the backbone curves for the first cycle peak loads are presented in Figure 42. It can be seen from the plot that the removal of the laundry wall linings had a significant effect on the load resistance but the wall above was offering little resistance.

Figure 42: Comparison of backbone curves as potential load transferring elements successively removed

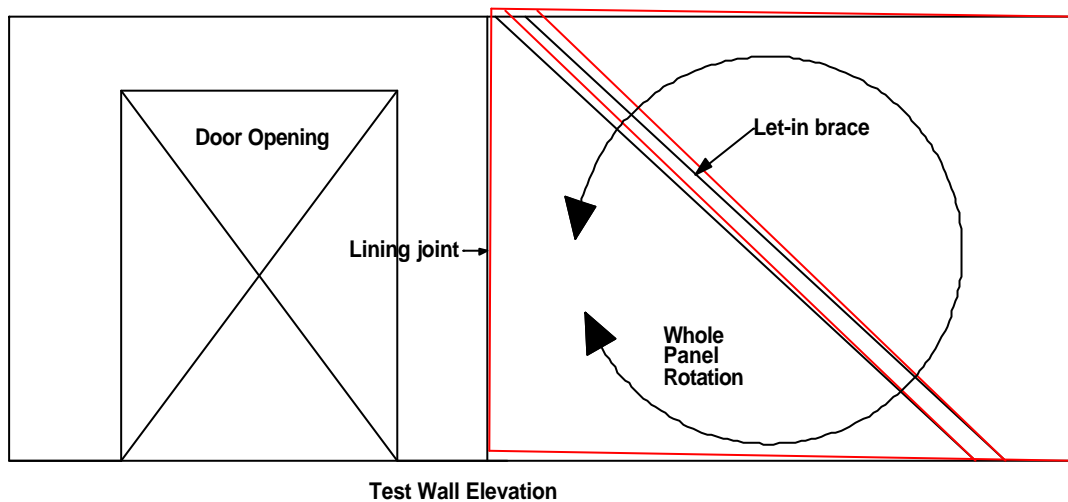
During these cycles the hallway end of the test wall was uplifting to greater than 20 mm (deflection gauge ran out of travel), but at the sliding door the uplift was still only 1.5 mm. Bottom plate slip peaked at 3.2 mm in one direction and 1 mm in the other. Inspection of the lining on the lounge side of the wall clearly showed that there was shear slippage occurring on the vertical joint between lining sheets just to the hallway side of the sliding door (Figure 43). All the movement at this joint accounted for the lack of uplift at the sliding door. Other vertical joints along the wall were not showing any signs of differential movement. The reason for this behaviour was that a let-in 150 mm by 25 mm diagonal brace on the kitchen side of the wall was maintaining that part of the wall in a rectangular shape and it was rotating under the applied loads (Figure 44).

Figure 44: Diagrammatic representation of wall panel rotation during the test

Sheet damage was limited to around the perimeter of the individual sheets and could be repaired by removal of the skirting boards and scotias and re-nailing and re-stopping. Replacement of the sheets would not be necessary.

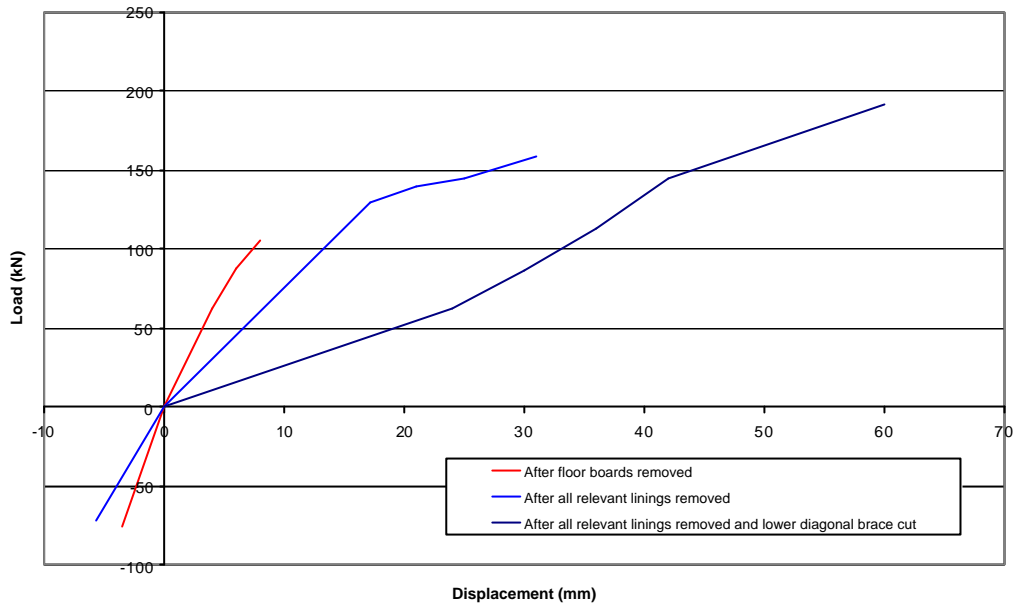
Finally, the diagonal brace in the test wall was cut between each stud crossing so that it would no longer be able to function as a brace and the wall was loaded once again until 60 mm top plate displacement was reached. A comparison of the backbone curves before and after the brace was cut is shown in Figure 45. There was a clear reduction in stiffness up to 40 mm but the load continued to climb until the test was terminated. The maximum uplift reached at the hallway end of the test wall was 24 mm. The bottom plate slip remained at about 3 mm in one direction and 1 mm in the other.

With there being essentially no bracing resistance left in the test wall but with the applied load as high as it was, it is very likely that the tongue and groove floor was transferring the force to the external walls of the house. There were no obvious signs of any distortion of the exterior walls.

Figure 45: Comparison of the backbone curves before and after the diagonal brace was cut in the test wall
