# STUDY REPORT

No. SR 114 (2002)

## Survey of Nail Plate Corrosion In the Roof Space of Houses Near the Coast

L. R. Jordan

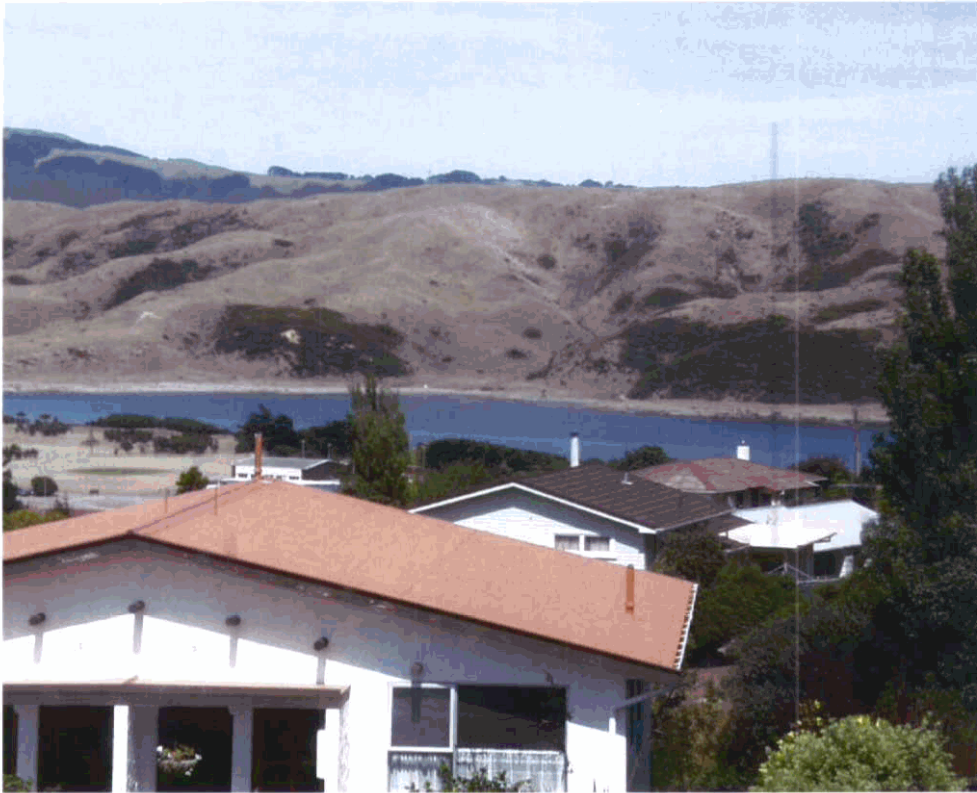
**Figure 1: House 001 Outlook from house.**

This house at Camborne, Wellington, was 28 years old and is approximately 500 metres from the coast (west coast). The coast near the house is predominantly sandy and the swell is from nil to approximately 1 metre. The house is sheltered from the predominant on shore wind from the westerly direction by a hill. The outlook from the house, (Figure 1), is in a west direction. Overall this house could be considered to be an extreme case of a house in a Zone 1 corrosion zone or ISO Category 3.

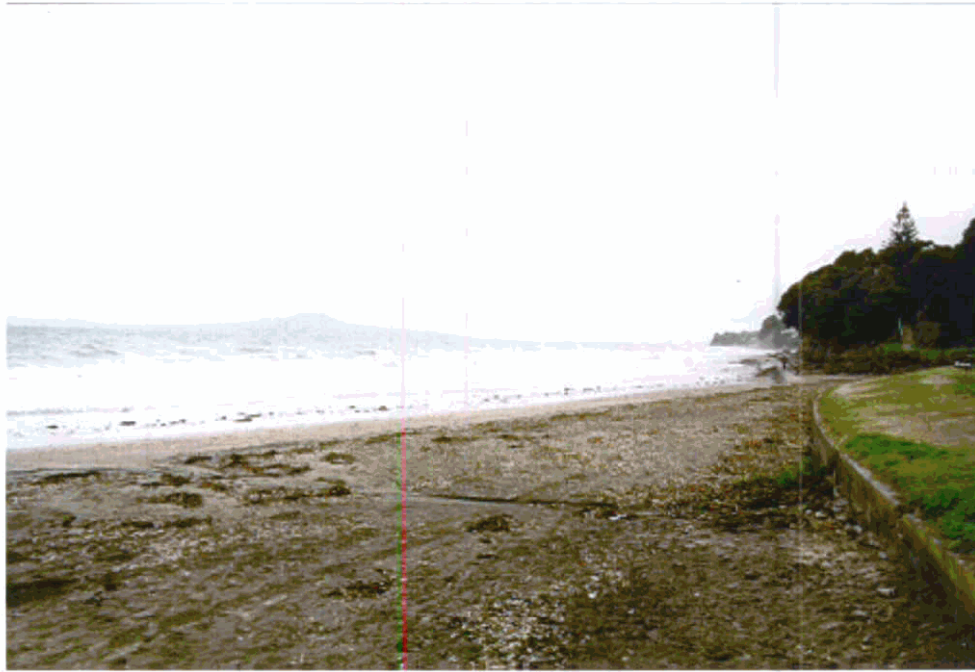
**Figure 5: House 002 Coastline near house.**

This house at Murrays Bay on Auckland's North Shore was approximately 24 years old and approximately 200 metres from Murrays Bay beach. The coast near the house as shown in Figure 5 is predominantly sandy and the swell is from nil to approximately 1 metre. The house is very exposed to the NE wind. This house is in the sea spray zone or ISO Category 3. The coast near the house is not a rough breaking surf beach with a prevailing on shore wind, subsequently the house is not in the most severe corrosion conditions found in New Zealand.

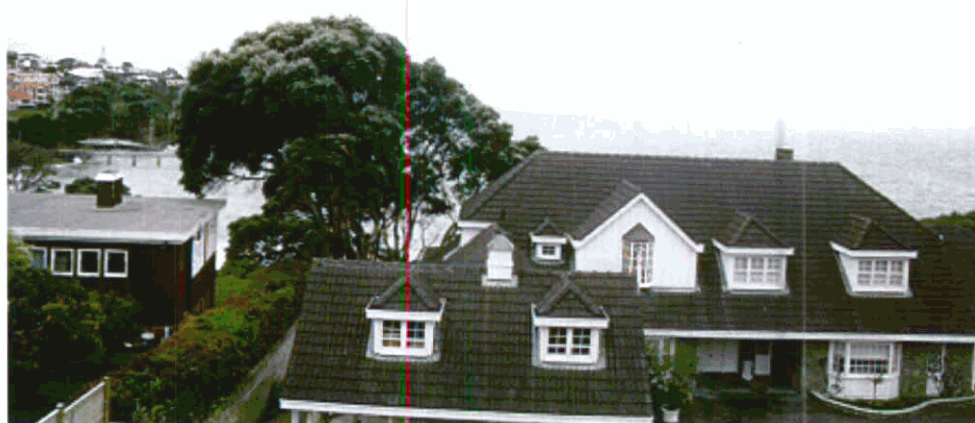
**Figure 8: House 003 Outlook from house.**

This house in Murrays Bay is approximately 25-30 years old and is in a similar location to House 002 but is closer to the coast at a distance of approximately 100 metres. The outlook from the house is shown in Figure 8.

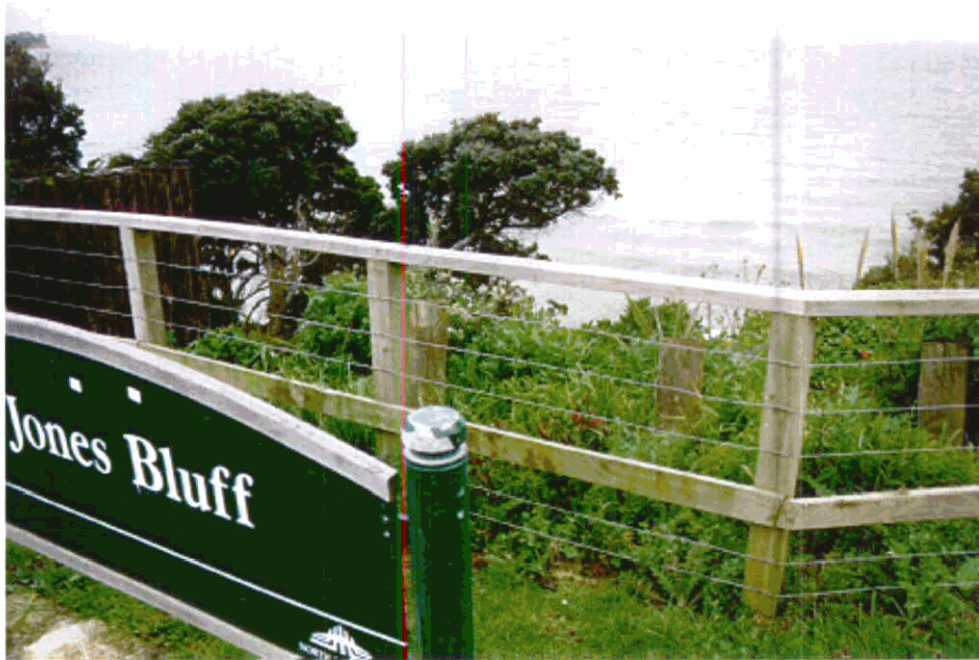
**Figure 10: House 004 Coast near house.**

This house in Browns Bay is approximately 30-35 years old and is in a similar location to House 002 and 003. It is approximately 150 metres from the top of a steep cliff as shown in Figure 10.

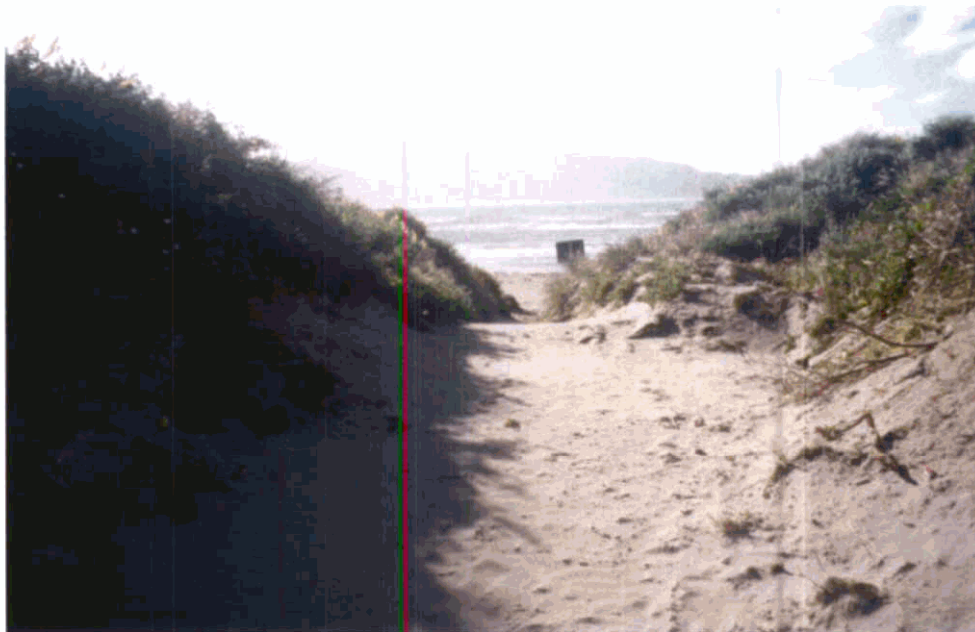
Figure 14: House 005 Coast near house.

This house in Paraparaumu, Wellington, was approximately 10 years old and about 50 metres from Paraparaumu beach. The coast in front of the house is shown in Figure 14. The coast nearest the house is predominantly sandy and the swell is from nil to approximately 1 metre. The predominant wind from the westerly direction is on shore and the house is very exposed. This house is in the sea spray corrosion zone or ISO Category 4.

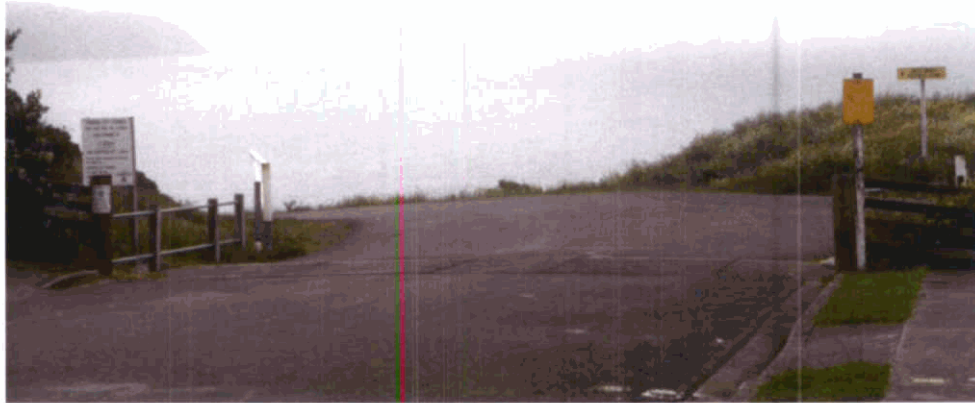
Figure 17: House 006 Outlook from house.

This house in Titahi Bay, Wellington, was 18 years old and is at the top of a cliff and approximately 300 metres from the coast. The outlook from the house is shown in Figure 17. The coast nearest the house is predominantly rocky and the swell is from nil to approximately 1 metre. The predominant wind from the westerly direction is on shore and the house is very exposed. This house is in the sea spray corrosion zone or ISO Category 3.
