STUDY REPORT

No. 147 (2005)

Post-earthquake Performance of Passive Fire Protection Systems

P.C.R. Collier

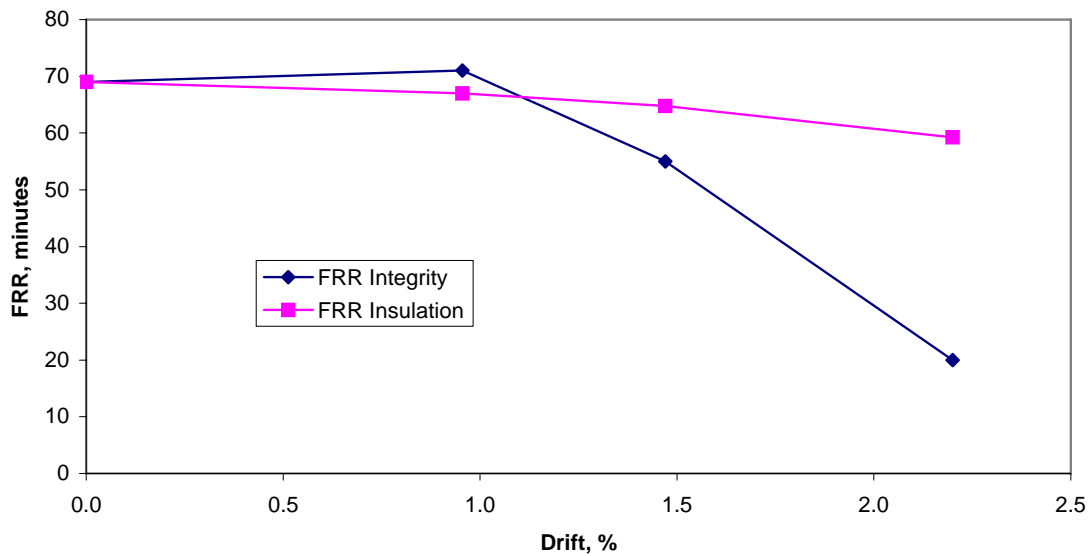
Figure 20: Effect of drift ratio on fire resistance for timber-framed walls with lining confined on all lining edges

In Figure 20 the wall that was racked to a maximum drift of 2.25% (mean of each direction) was left in a partially deflected state of 45 mm drift (1.5%) to the left when viewed from the non-exposed side. This remaining drift was to simulate the effect of the building not necessarily returning to the pre-earthquake position, which is a likely outcome. The first Integrity failure occurred on the left hand top corner at 20 minutes; this was in a location where a lining to stud gap that opened up near the end of the racking travel had not closed as completely as it otherwise would have had the wall been restored to 0% drift. Conversely on the right hand side the gap had closed up tightly for the fire test and an Integrity failure did not occur till 44 minutes.

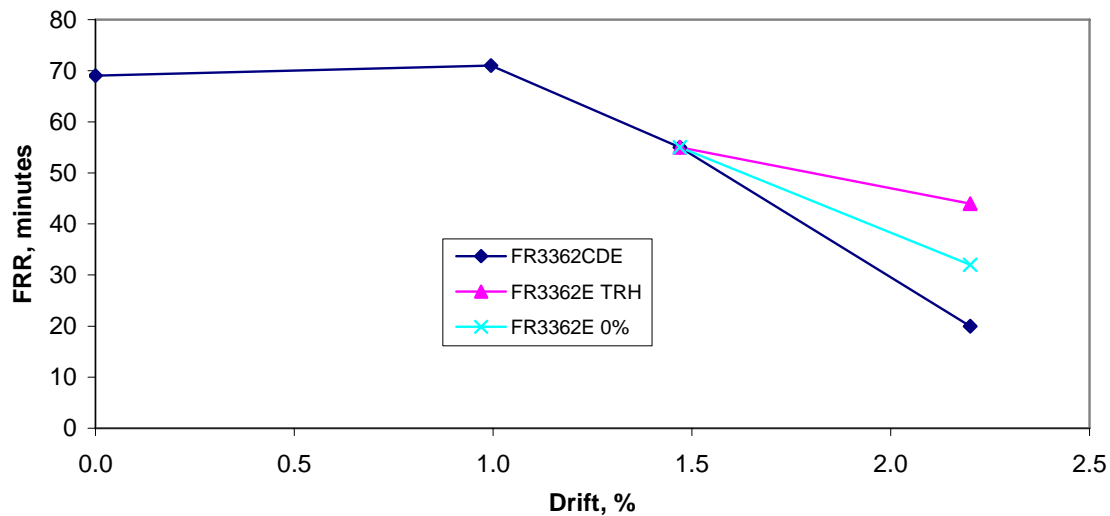
Figure 21: Supposed effect of remaining deflection on Integrity fire resistance

In comparing the two Integrity failure times of 20 and 44 minutes at the two top corners (and taking an average of 32 minutes and plotting the three points on an updated version of Figure 20 as Figure 21), then the apparent discontinuity of the trend downwards is partially smoothed out. It could be surmised that that may have been the value achieved for an Integrity failure had the wall been restored to 0% drift. So if a wall remains in a distorted (drifted) state the Integrity fire resistance appears to be adversely affected if there is a larger gap remaining in a particular location than what would have been at 0% drift. The Insulation fire resistance was not affected to the same extent.

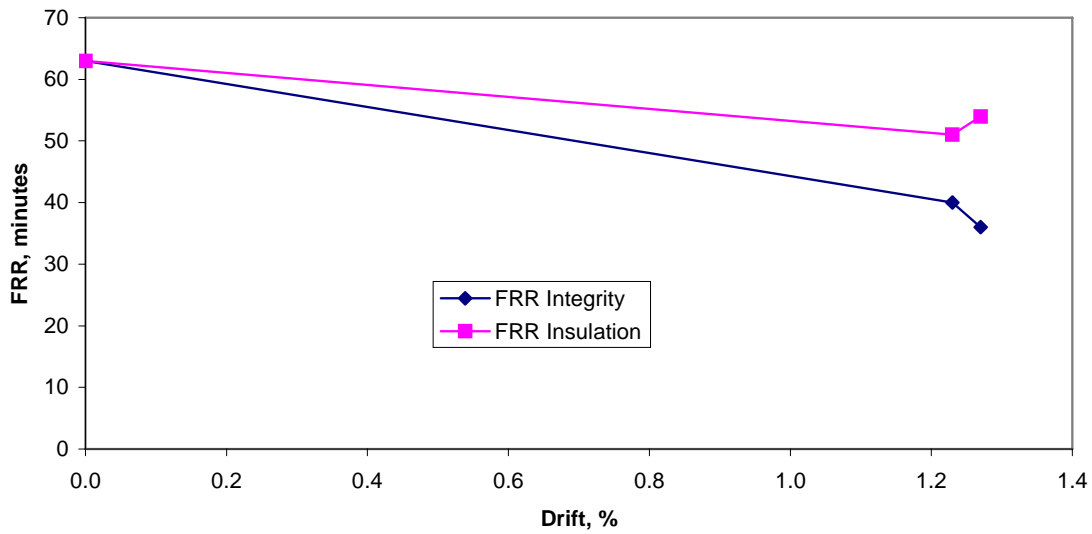
Figure 22: Effect of drift ratio on fire resistance for steel-framed walls with lining unconfined on the lining edges and not fixed to top or bottom channel

Two tests were performed on steel-framed walls and one of them included a timber door and frame fire-rated for 60 minutes. The failure times for the two walls were 40 minutes for the wall without a door and 36 minutes for the wall with a door. Each failure was an Integrity failure at either the top right hand or top left hand corner respectively. The presence of a door did not seem to make a significant difference to the fire resistance of the steel wall, the 4 minute reduction equating to 10%. The Insulation failure time increased from 51 to 54 minutes with the addition of the door to the steel wall a 5.9% increase. No Insulation failure of the door leaf occurred. The Integrity and Insulation fire resistance versus drift ratio for the two steel walls are graphed in Figure 22.

The door frame assembly failed Integrity due to flaming at the top of the door leaf at 51 minutes, but this was after the Integrity failure of the wall at 36 minutes. It is possible that the earthquake racking was responsible for some reduction in the fire resistance. But measurements taken before the fire test of the clearances around the perimeter of the leaf, particularly at the top, did not indicate any opening of gaps that would be expected to cause a problem with flaming along the top edge. Considering also the presence of intumescent strips on the door frame that are intended to expand on heat and close any gaps no explanation for what is a 60 minute fire-rated door failing at 51 minutes is apparent – this is a reduction of 15%.

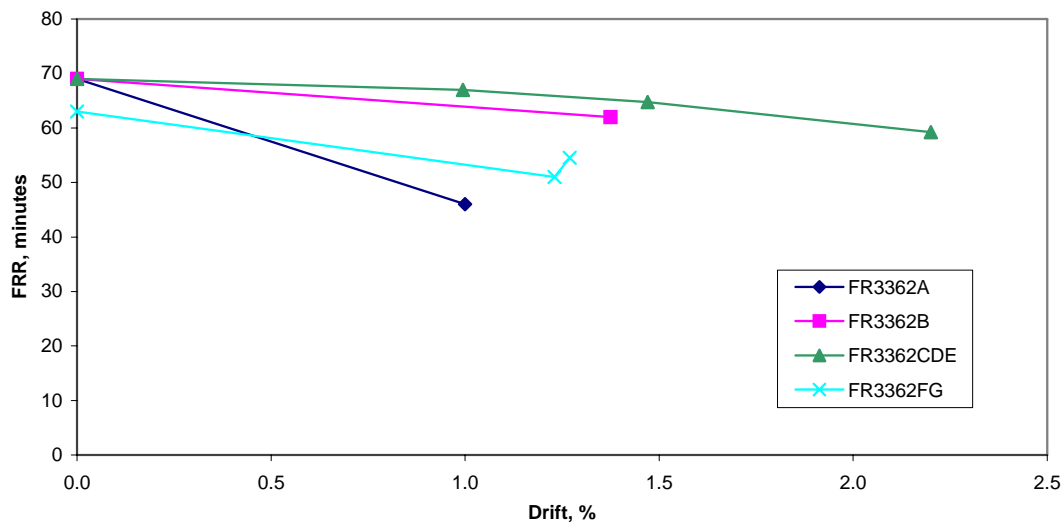
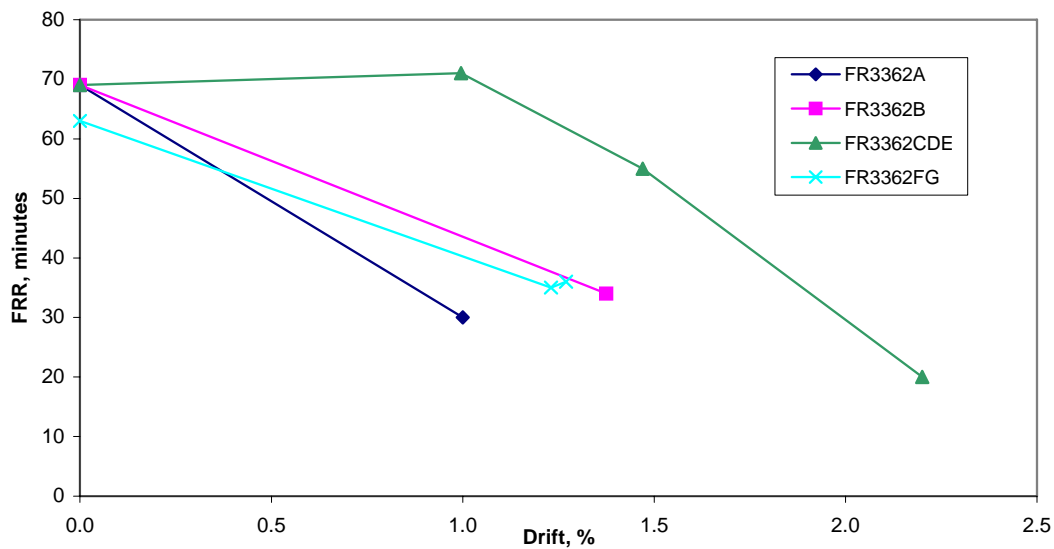
Figure 23 and Figure 24 compare the Insulation and Integrity failures respectively. The detrimental effect of earthquake racking is more marked on the Integrity than the Insulation. Considering the tests with the confined edges (FR3362C, D and E) there appears to be a threshold beyond 1% drift that the lining is essentially broken, potentially resulting in a marked reduction in the Integrity fire resistance. This is consistent with the drop off in the racking force required at greater displacements (shown in some of the racking graphs).

The Insulation criterion does not appear to be affected to the same extent.

Comparing the relative downward slope of fire resistance for the steel-framed tests FR3362F and FR3362G in Figure 23 and Figure 24 with the timber specimens, the loss of fire resistance is not significantly different for timber or steel-framed walls. The presence of the door did not seem to significantly affect the fire performance of the wall; while the door leaf itself is very rigid the gap between the leaf and the frame introduces flexibility to the system as a whole such that the racking damage was about the same. It is also significant that in general throughout all tests conducted the damage to the lining was greater around the perimeter due to the greater relative movement between the lining and the frame. Therefore a door frame in the middle region of a wall is unlikely to be subjected to the same level of movement. This is a likely explanation for the absence of damage to the door and frame and the similarity in performance of the wall/door test to the previous combinations.

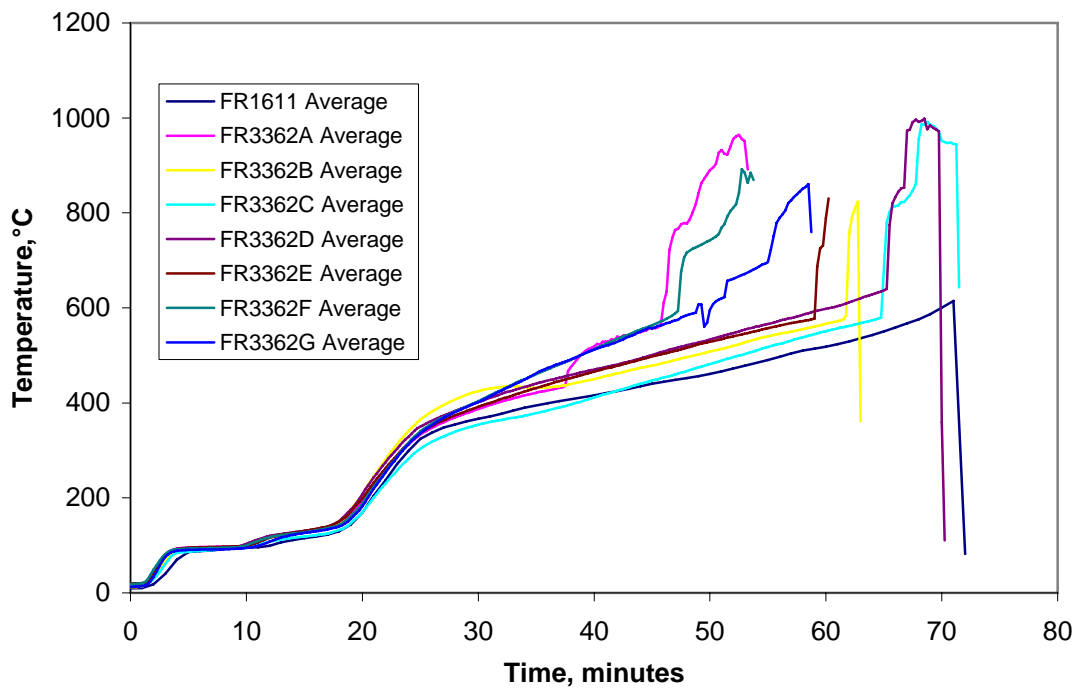
Figure 25: Temperature of exposed linings on cavity side

The temperature of the exposed lining measured on the cavity side is graphed in Figure 25. These temperatures are usually recorded to give an indication when the studs in a timber-framed wall begin to char and that is taken as when the temperature exceeds 300°C on the stud. For the 13 mm thick fire-rated lining used in all seven tests conducted there did not appear to be any detrimental effect at the 300°C milestone, which occurred around 23 minutes. However beyond that time there is some divergence of varying degrees indicating a degraded performance perhaps attributable to the racking damage. The most significant indicator is when the temperature spikes up several hundred °C (00's °C) coinciding with the loss of the lining by falling off in parts or over the majority of the wall surface. It is feasible to expect that such loss of the lining was in part caused by the racking damage and since all racked tests lost some exposed lining before the baseline test, which hadn't lost any at 69 minutes, this hypothesis is supported.

However in all tests the loss of some exposed lining followed the initial Integrity failure rather than preceded it, so it can be dismissed as a direct cause of the failure but it is influenced by the racking as indicated in Table 11.

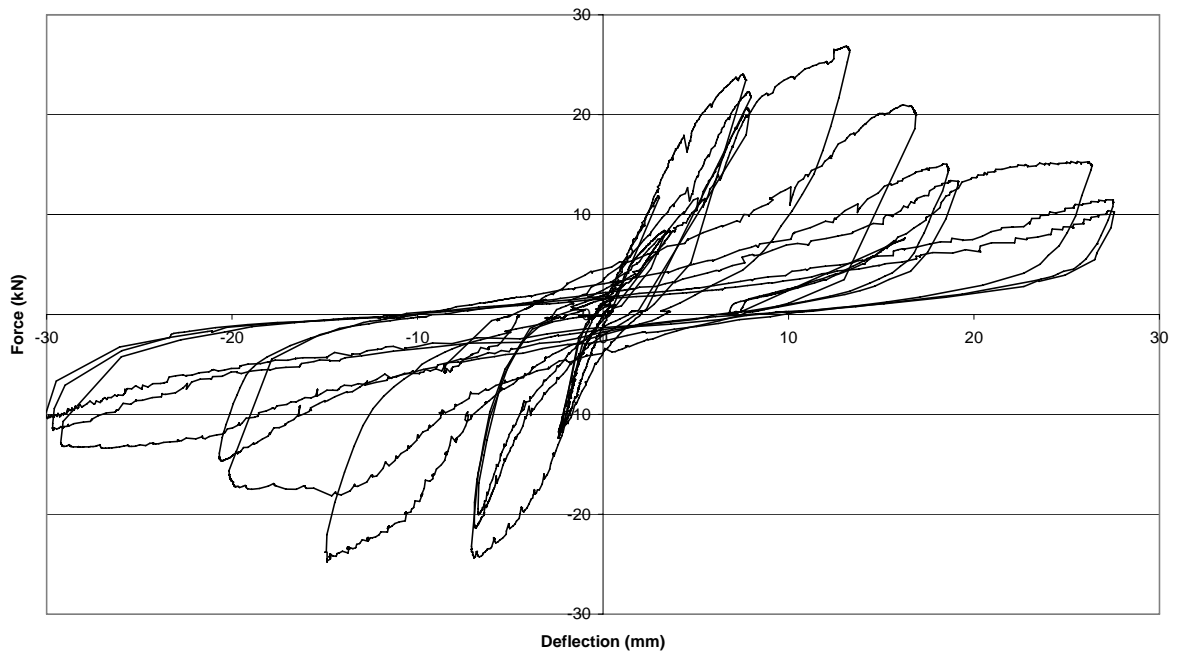
Figure 27: Racking of wall FR3362A

The hysteresis loop for wall FR3362A is shown in Figure 27. The energy expended in racking the wall was 2.1 kJ and is a measure of the resistance of the wall on the basis of the cumulative force x distance summed over the entire racking procedure.

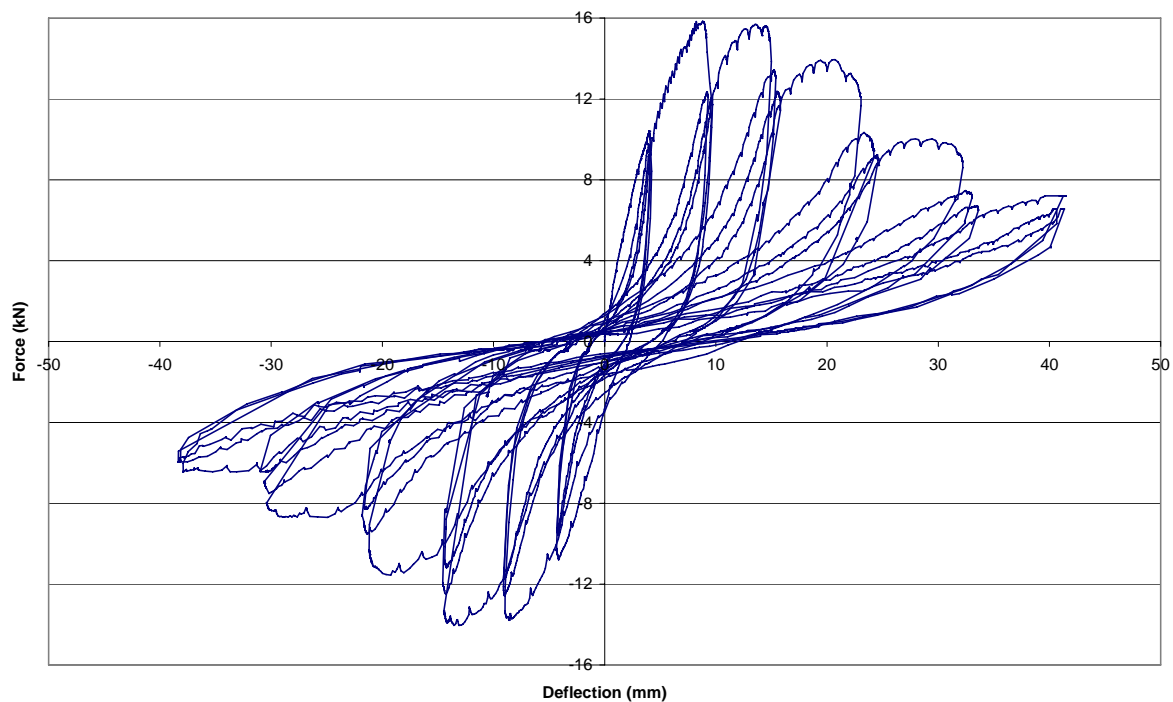
Figure 29: Racking of wall FR3362B

Figure 29 shows a graph of the hysteresis loop, a notable difference to test 1 FR3362A as graphed in Figure 27 is the reduced force required initially before the force reduces for greater drifts as the lining fixing is progressively damaged. This is a function of the degree of restraint around the perimeter where the 10 mm gap allows easier movement of the lining as only the nails are there to resist it.

The energy in racking to 1.5% was also 2.1 kJ (the same as in FR3362A) as a measure of the resistance, even though the % drift was greater, it would appear that once a certain level of damage had been sustained the resistance to racking reduces. Also whether the major failure is at the top or bottom is somewhat dependent on the overall restraint of the lining in each region and which nails tear the lining first.

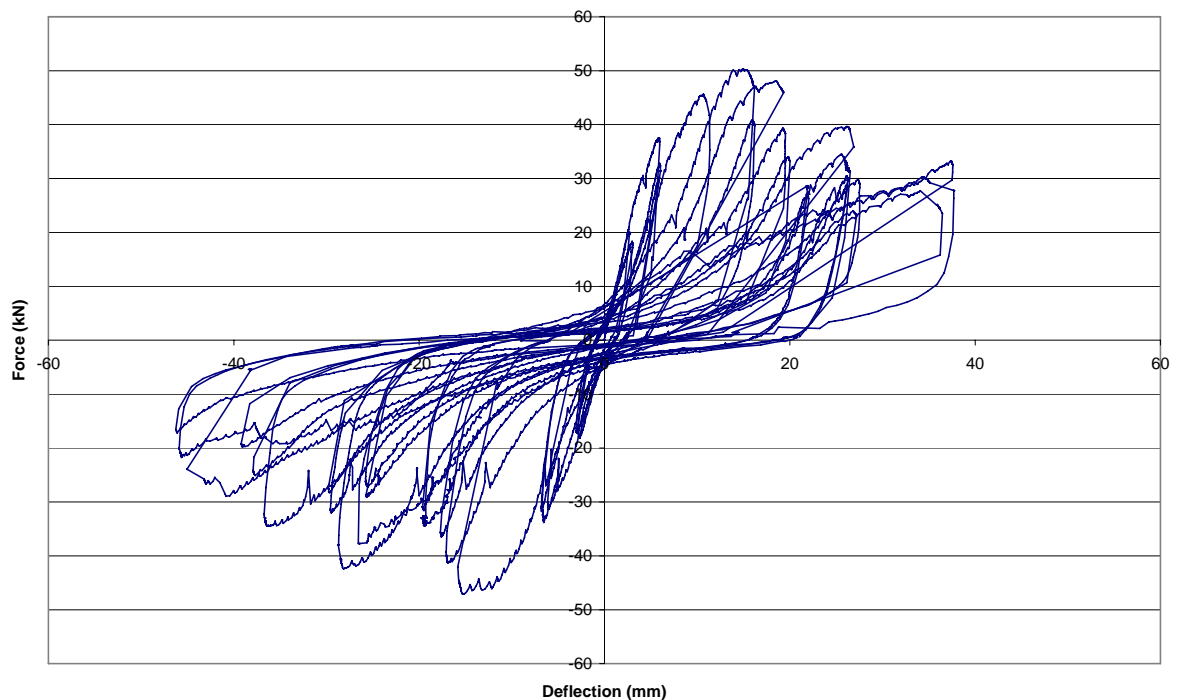
Figure 34: Racking of wall FR3362D

The racking resistance increased accordingly (to ~50kN max for nominally 1.5% drift) and (missing word?) with the stiffer side studs the deflection at the top plate was significantly reduced. But at the bottom the side studs bent and fractured at the corners where there was a weakness because the additional side stud was cut short 25 mm. This resulted in significant popping and tearing at the wall to wall junctions and distortion/bending of the skirting board that eventually became detached from the bottom plate, but not before the nails had torn 50 mm long gouges in the plasterboard.

The racking force vs deflection is shown in Figure 34 and the energy expended in racking increased to 10.3 kJ.

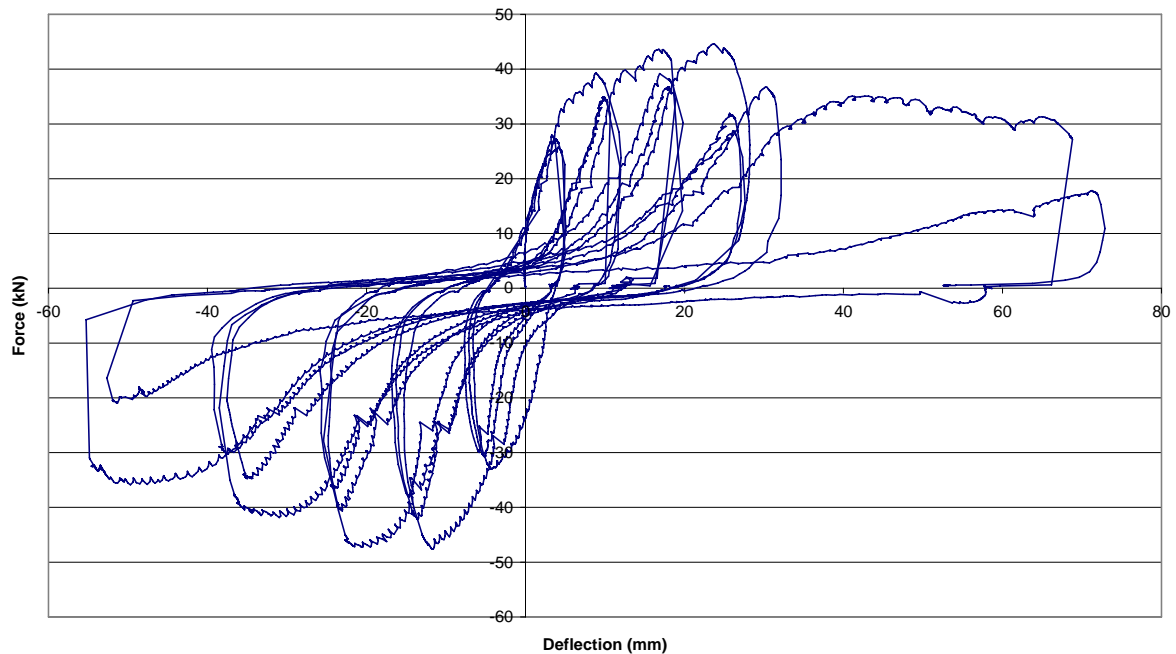
Figure 37: Racking of wall FR3362E

The additional stiffness in the side studs by the two 90 x 45's with the 90 mm dimension in the plane of the wall contributed to greater deflection and damage on the top plate, particularly at each end of travel where it had bowed upwards (15-20 mm) over a length of 300 to 400 mm. This was in spite of the load skates at each end of the top plate to prevent uplift.

The adjusted racking plot is shown in Figure 37. Some adjustments were required for some practical difficulties in conducting the racking. On balance it was determined that the objective of 2.5% drift was achieved. The energy required was 12.9 kJ.
