STUDY REPORT

SR 233 (2010)

Investigation into the Performance of Urea Formaldehyde Foam Insulation

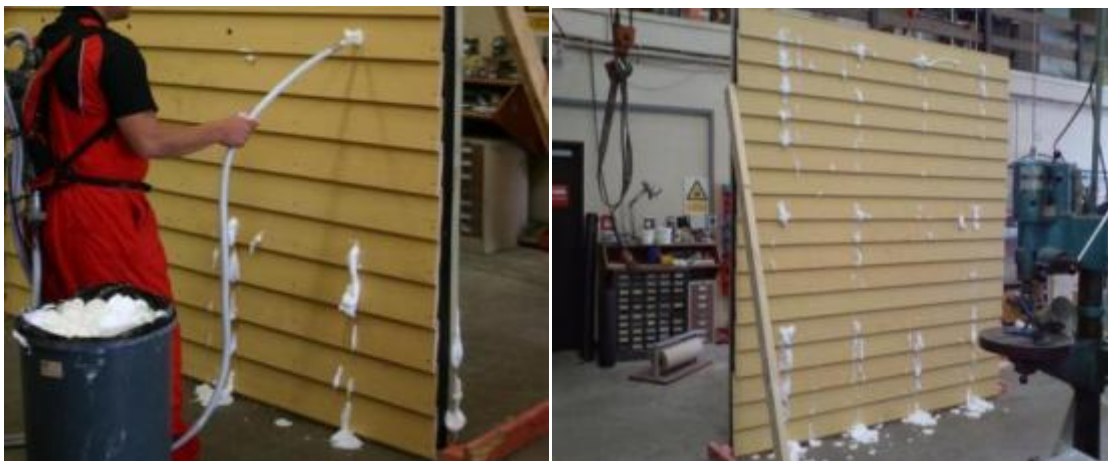
Figure 13a & b: Installation of Airfoam in large scale test wall (D4861) at BRANZ

It should be noted that during the Airfoam installation at BRANZ, thermal imaging was used to evaluate the installation process. In some cases the installation of the foam was found to be unsatisfactory. For optimum results the thermal imaging analysis should be carried out post installation of the Airfoam and not during the installation process.

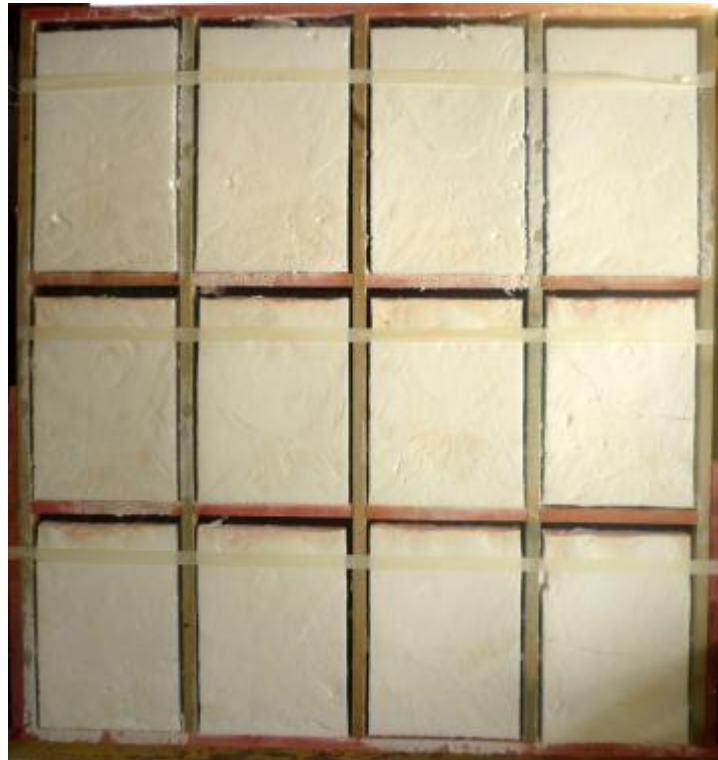
Figure 14: Test wall (D4861) after Airfoam installation and plasterboard removed

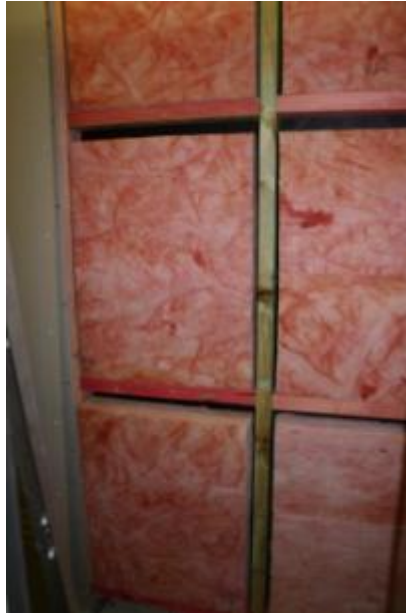
As a demonstration of the effects that shrinkage gaps can have on the thermal performance, a further 2.4 m by 2.6 m panel was constructed (designated wall D4862) and tested that was identical to the first except an R 2.8 glasswool insulation product was used instead of Airfoam. In the first of two tests (D4862a) with the panel the insulation was well fitted without gaps, whereas for the second test (D4862b) gaps representing 6% of the insulation width were deliberately created at the sides (3% either side) and top (6%) of each frame cavity. However unlike the Airfoam panel, which was expected to have shrinkage gaps between the face of the insulation and the inside face of the cladding and lining, gaps were only created around the edges of the glasswool and not against the faces (shown in Figure 17 to Figure 21).

Figure 21: R 2.8 glasswool insulation fitted with 3% gaps at side and 6% gap at the top of each frame cavity (D4862b)

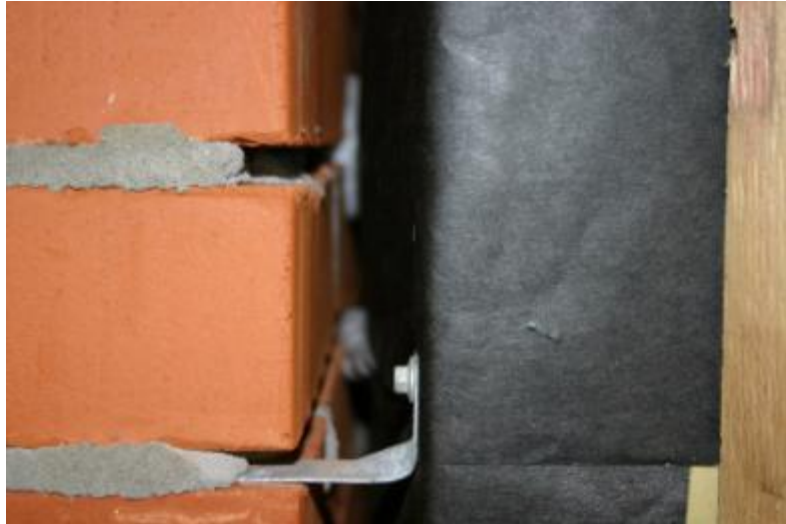
Figure 22: Cavity of Brick Veneer Wall (D4863a)

After the thermal testing, the plasterboard lining was removed from the UFFI-insulated brick veneer wall (D4863a). The UFFI insulation was observed to have shrunk approximately 6% (Figure 23). It should also be noted that within one panel the UFFI insulation was incomplete, resulting in a larger void. One further observation was that the installation of the UFFI caused bulging of the kraft paper and in some areas was in contact with the brick veneer.

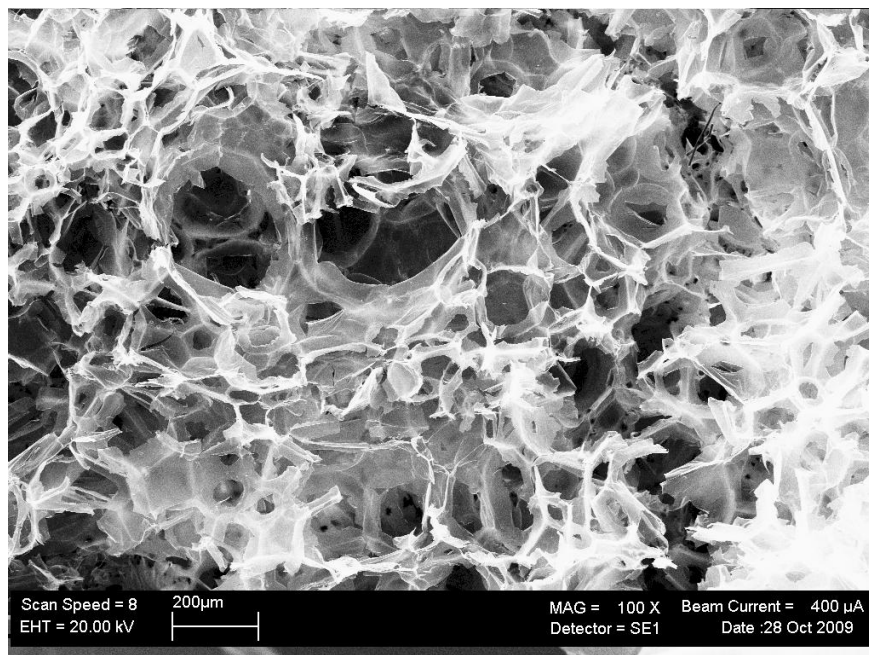
The results indicate that there is potential for further shrinkage of installed and dry UF foam material if subjected to thermal / humidity cycling and that this potential additional shrinkage will vary in the different directions within the wall. Since the results indicate further shrinkage is possible, additional work was completed on Airfoam-prepared samples, as described in Section 5.2.7. Scanning electron microscope (SEM) images of the cell structure of the foam pre- and post aging are shown in Figure 25 and Figure 26

Figure 25: SEM of Airfoam sample removed from House W3

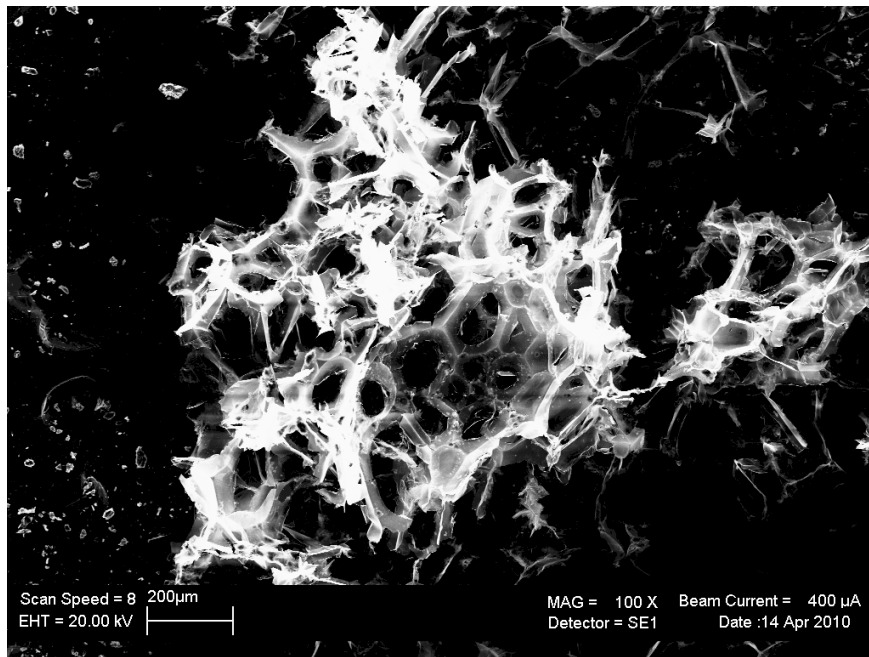
The results confirm that there is potential for further shrinkage of installed and dry UF foam material if subjected to elevated temperatures / humidity during service. The AS4073-1993 Table 1 'Properties of Set Foam' requires a maximum shrinkage of 4% at elevated temperature and humidity. The results for the Airfoam-prepared samples (Table 10) indicate that the product does not satisfy these requirements. Samples were examined using scanning electron microscopy (SEM) to inspect the cell structure of the foam. The results further supported earlier work by CSIRO,¹¹ which demonstrated that the UF foams collapse under high humidity conditions and potentially emit formaldehyde as the foam structure breaks down. Images of a control sample and a sample aged following the procedures of AS 4073-1993 Appendix H are shown in Figure 28 and Figure 29.

Figure 28: SEM of Airfoam sample C1A

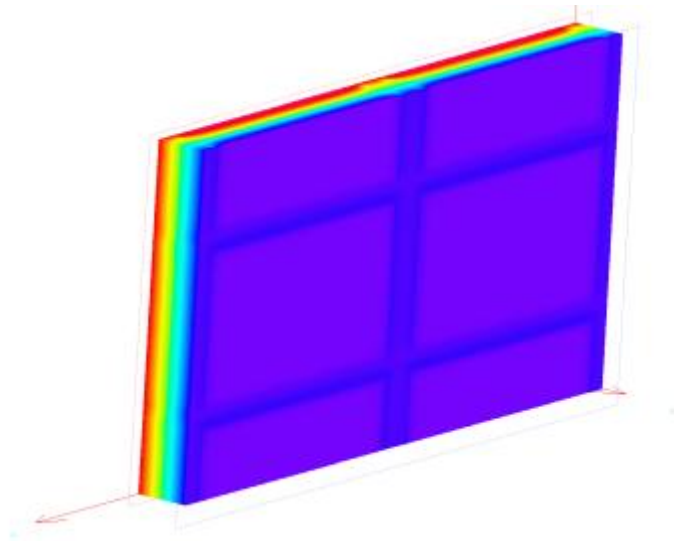
Figure 31: Example image from 3D model (colour indicates temperature)

The best fit with the measured result for the Airfoam panel is with the model for 6% shrinkage. 6% shrinkage is what has been observed with the test sample created for the heat flow meter measurements. The model for the R 2.8 m²K/W glasswool insulation with 6% gaps is a perfect fit with the results measured for the test panel with 6% gaps. Likewise the model result for the glasswool with no gaps is almost identical to the measured result.

There is good correlation between measurement and models indicating that where there are gaps due to shrinkage of Airfoam insulation the system thermal performance can be predicted and explained by the missing insulation associated with those shrinkage gaps.
