STUDY REPORT

SR234 (2010)

Investigation into the Performance of Brick Veneer Walls Installed with Urea Formaldehyde Foam Insulation – A Case Study

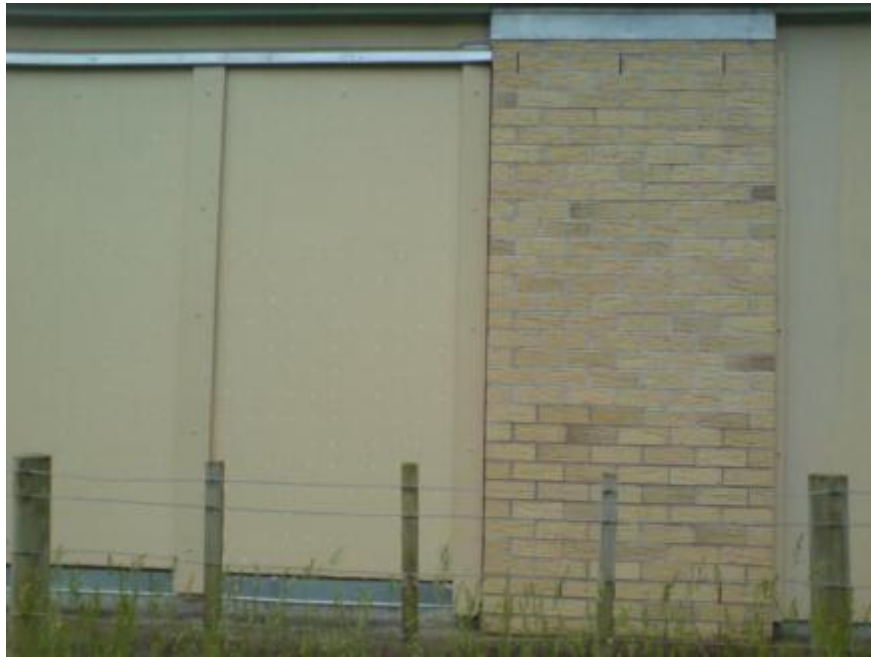
Figure 5: Brick veneer cladding on BRANZ test building

Two brick veneer walls were installed on both the north and south elevations of the weathertightness test building at BRANZ in 2003-2004 and used for moisture studies within various research programmes. The walls are fully instrumented and actively logged for temperature, humidity and timber moisture content. From December 2009 the two brick veneer walls have been used to investigate the effects of introducing UFF insulation into the stud cavities and the effect on timber moisture content levels within

the wall. The brick veneer test walls in the weathertightness test building at BRANZ were also installed with Airfoam during an initial visit in December 2009.

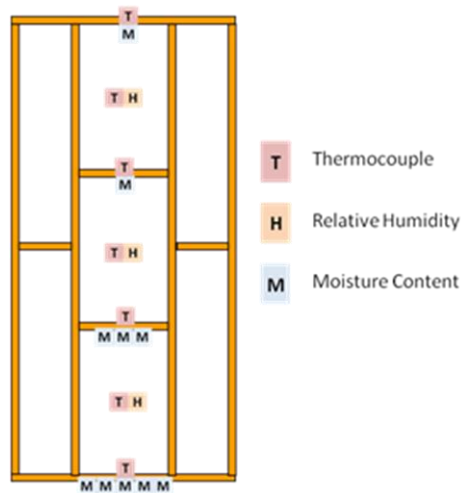
Figure 7: Framing and instrumentation layout for test building sample

The framing and instrumentation layout is shown in Figure 7. For the purposes of the current study the moisture content pins were all moved to the middle of their respective framing member, as shown in Figure 7. This was done in an attempt to look at the moisture distribution across the frame from the internal lining to the building wrap. The exposed ends of the moisture pins were coated with an adhesive in an attempt to

eliminate shorting of the pins through the wet foam. The humidity sensors were located in the stud space and were protected from liquid water by placing masking tape over the ends of their sheathing.
