# **STUDY REPORT**

**SR 241 (2011)**

## **Corrosion of Fasteners in Treated Timber**

**Z.W. Li, N.J. Marston and M.S. Jones**

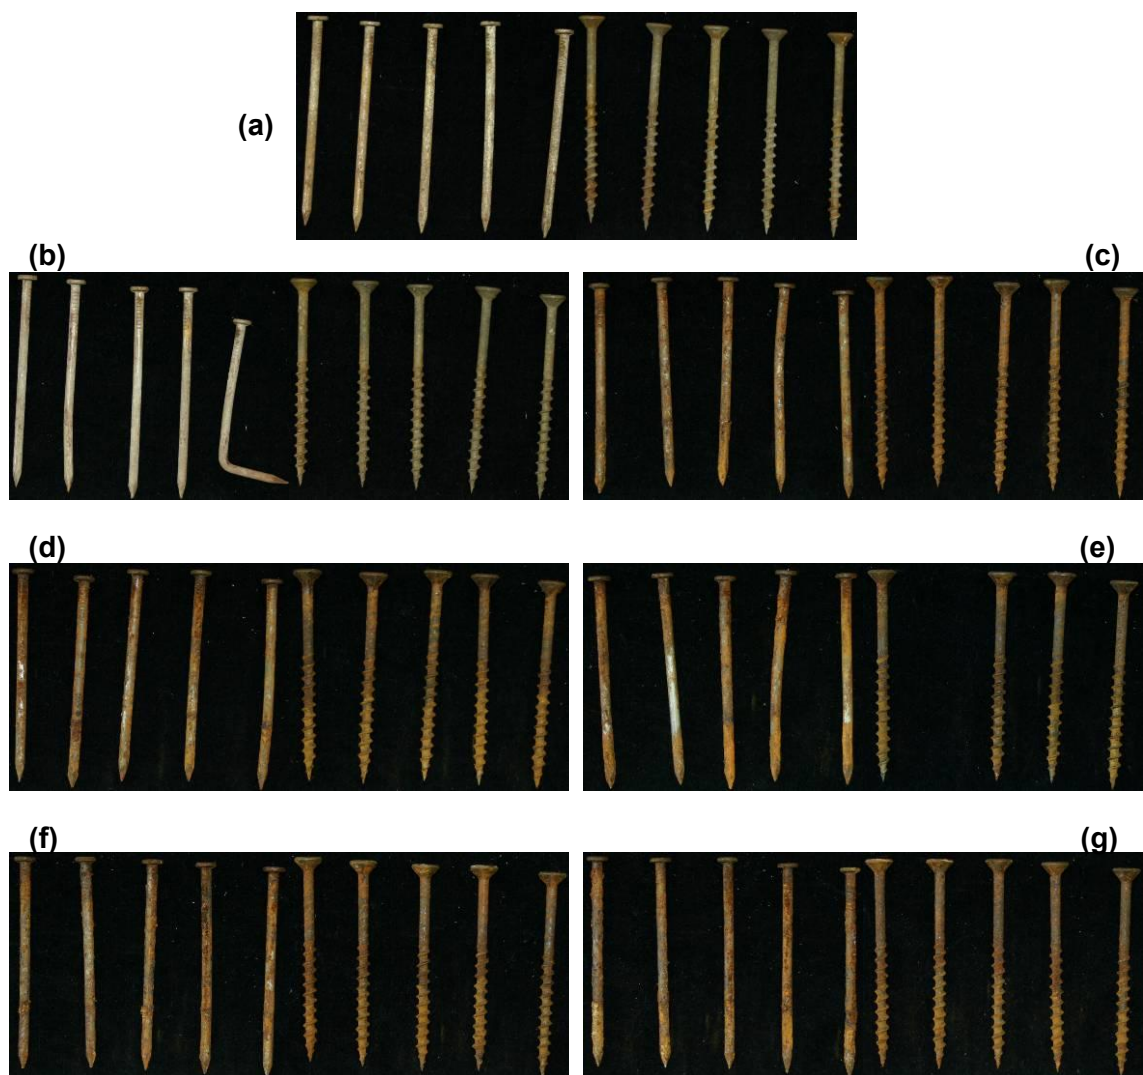
In general, mild steel nails and screws suffered relatively uniform corrosive attack. However, nails and screws embedded into untreated and CCA treated timbers were much better preserved than those in ACQ and CuAz treated timbers. Even in H3 CuAz and ACQ treated timbers, heavy iron-rich red rust had formed and covered the whole surface areas of the fasteners (Figure 5).

**Figure 5:** Surface morphology (before cleaning) of mild steel fasteners embedded into timbers exposed at Judgeford site for one year – (a) untreated, (b) H3 CCA, (c) H4 CCA, (d) H3 CuAz, (e) H4 CuAz, (f) H3 ACQ and (g) H4 ACQ

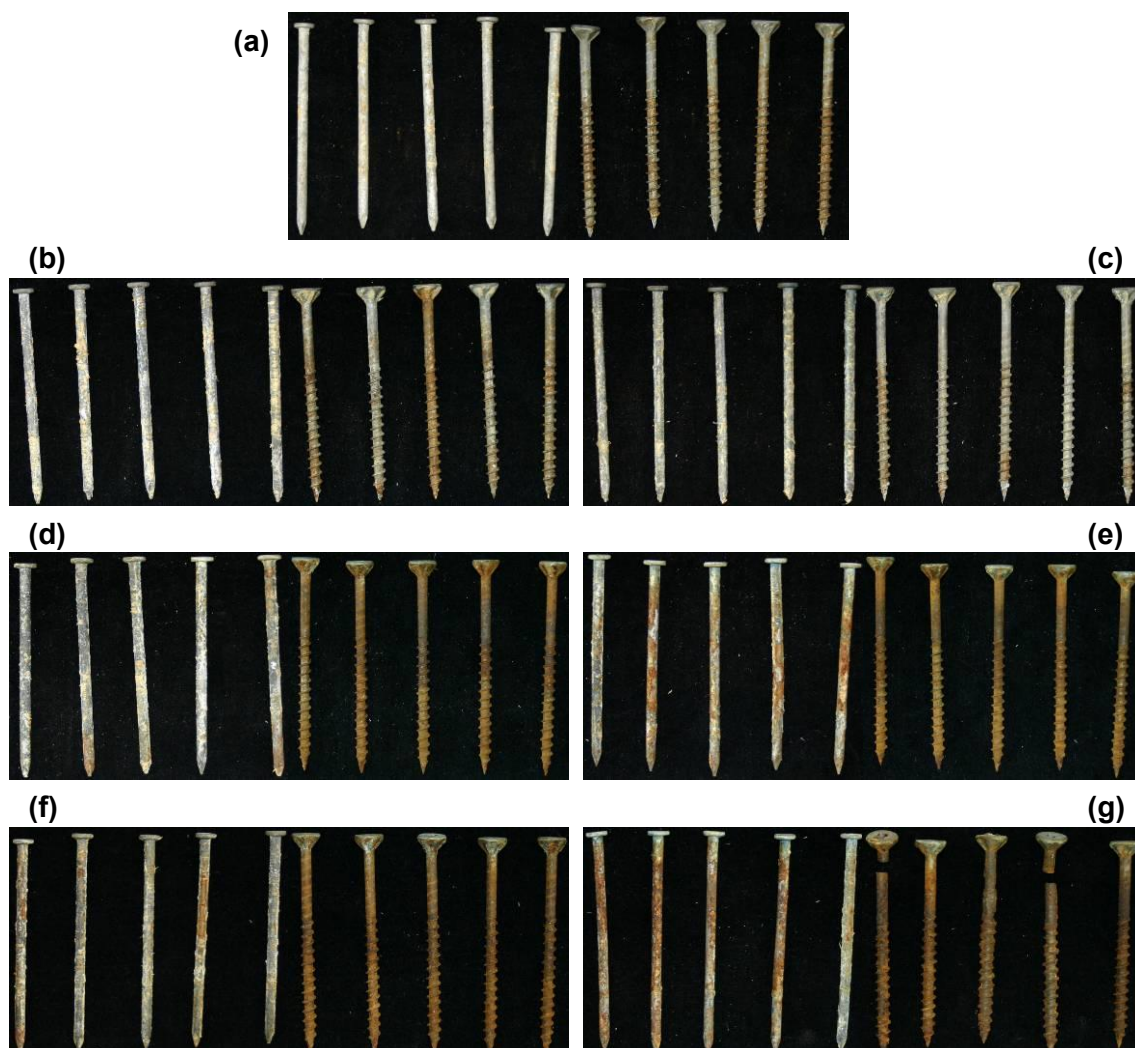
Hot dip galvanised nails demonstrated a better performance than mild steel nails in all timbers (Figure 6). The zinc coating on the head of these nails was still in relatively good condition and no obvious corrosion failure was observed. Instead, corrosion was mainly localised on their shaft and tip areas. This location-related performance difference has probably resulted from the aggressivity difference between the atmosphere and the micro-environment inside the timber, and also from the nail driving-in process. The quantity of corrosion products formed was strongly related to the timber treatment, both with respect to preservative type and Hazard Class.

Corrosion was more extensively developed for nails embedded in the CuAz and ACQ treated timbers, particularly at the H4 treatment level. In these cases, iron-rich red rust could cover most of the shaft area. In comparison, nails in CCA timber were much better preserved.

**Figure 6:** Surface morphology (before cleaning) of zinc-coated fasteners embedded into timbers exposed at Judgeford site for one year – (a) untreated, (b) H3 CCA, (c) H4 CCA, (d) H3 CuAz, (e) H4 CuAz, (f) H3 ACQ and (g) H4 ACQ

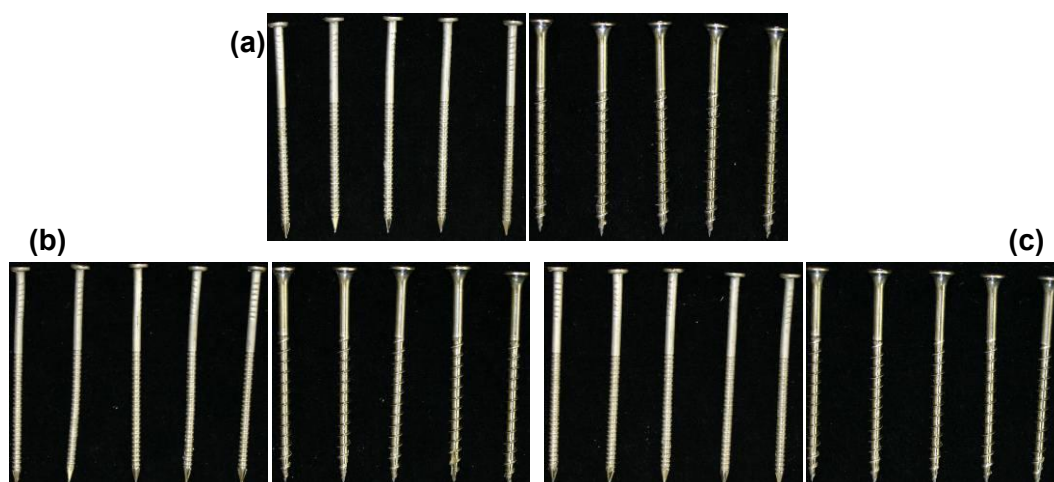
**Figure 7:** Surface morphology (before cleaning) of stainless steel fasteners embedded into timbers exposed at Judgeford site for one year – (a) H4 CCA, (b) H4 CuAz and (c) H4 ACQ

Stainless steel fasteners performed very well in all combinations of preservative type and hazard class. No obvious signs of corrosion were observed on their body sections (Figure 6). Occasionally very limited iron-rich rust (shown as small spots) was observed on the heads. This is likely to be the result of partial damage to the passive film and/or iron contamination from the hammer when the fastener was driven into the timber.

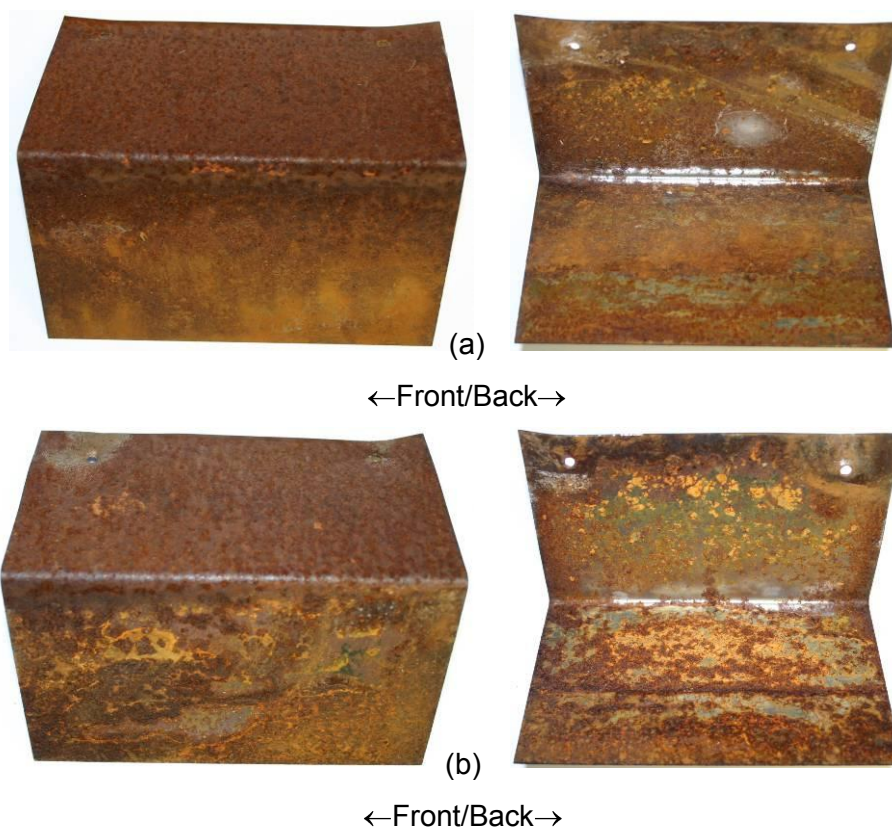
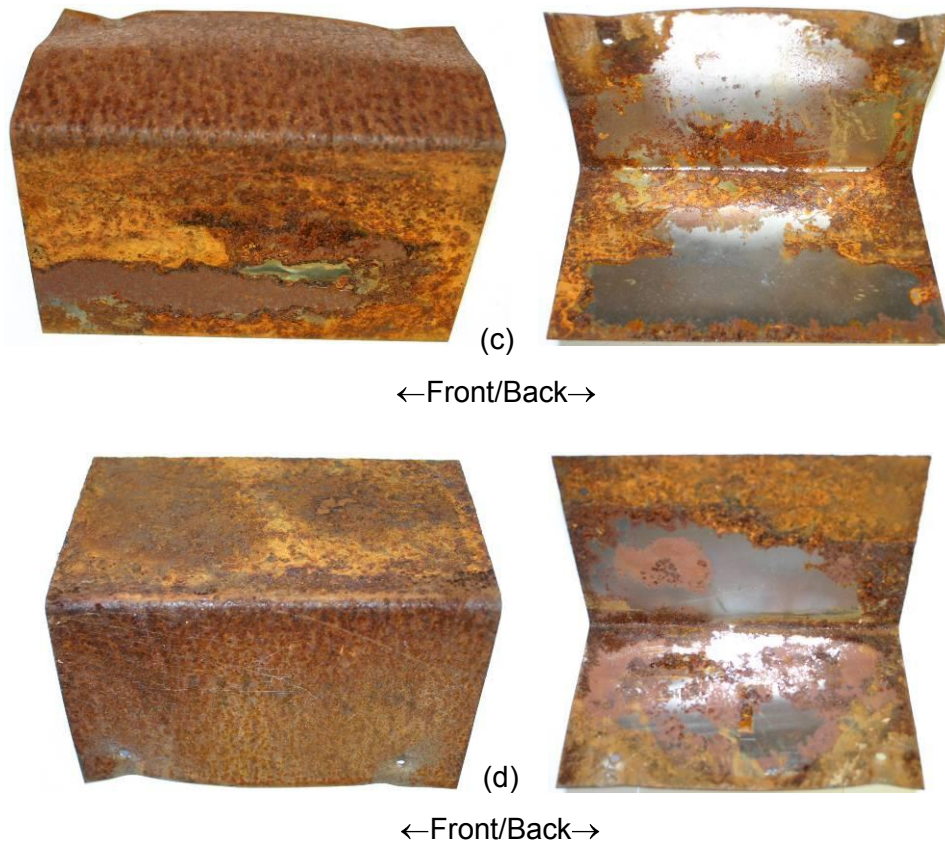
The mild steel flashings attached to all combinations of timber preservative and hazard class suffered from relatively uniform corrosion attack on the surfaces directly exposed to the atmosphere. Corrosion on the surfaces in direct contact with the timber was generally observed to be less uniform and was not obviously correlated with preservative or hazard class. Areas that appeared to have been in closest contact with the timber generally showed the most severe corrosion. This spatial dependency indicated that both the timber preservative composition and the environment in the crevice formed between the timber and the steel contributed to the material degradation through chemical and/or electrochemical processes.

After removal of the corrosion products, unevenly distributed regions characterised by large numbers of small and shallow pits could be observed on the surfaces contacting the timber. The non-uniform distribution of these regions probably reflects variations in contact between the steel and timber in the test structures. The corrosion morphologies of the flashings attached to timbers treated with different preservatives to different hazard levels did not show any significant differences (Figure 8).

**Figure 8:** Surface morphology of mild steel flashing attached to timber exposed at Judgeford site for one year – (a) untreated, (b) H3 CCA, (c) H4 CuAz and (d) H4 ACQ

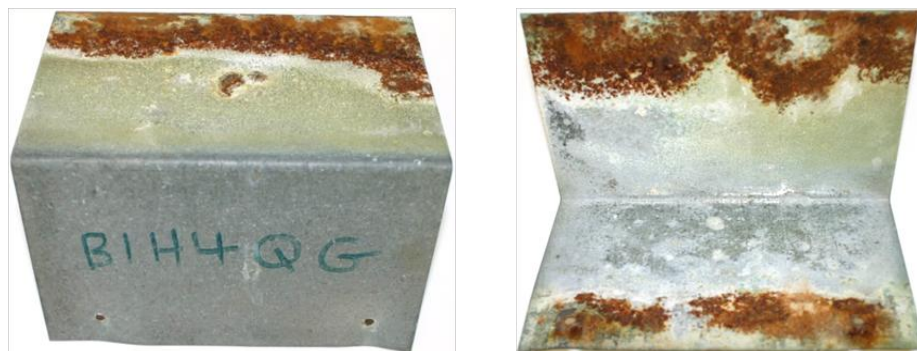
It was quite evident that the hot dip galvanised steel flashings attached to the ACQ or CuAz treated timbers suffered serious attack during atmospheric exposure. Heavy zinc-rich white corrosion products could be seen on the surfaces in contact with the timber. Even more striking was that a significant portion of the surface area that was directly contacting the timber was covered with iron-rich red rust. This implies that the galvanised zinc coating on these areas had been completely consumed by corrosion within one year and then the steel substrate was exposed to corrosive environment.

**Figure 9:** Surface morphology of hot dip galvanised steel flashing attached to timber exposed at Judgeford site for one year – the timber was treated with H4 ACQ

It was also evident from Figures 9 and 10 that an increase in the preservative level from H3.2 to H4 significantly accelerated the corrosion process, suggesting some underlying causation related to the retained copper concentration within the timber.

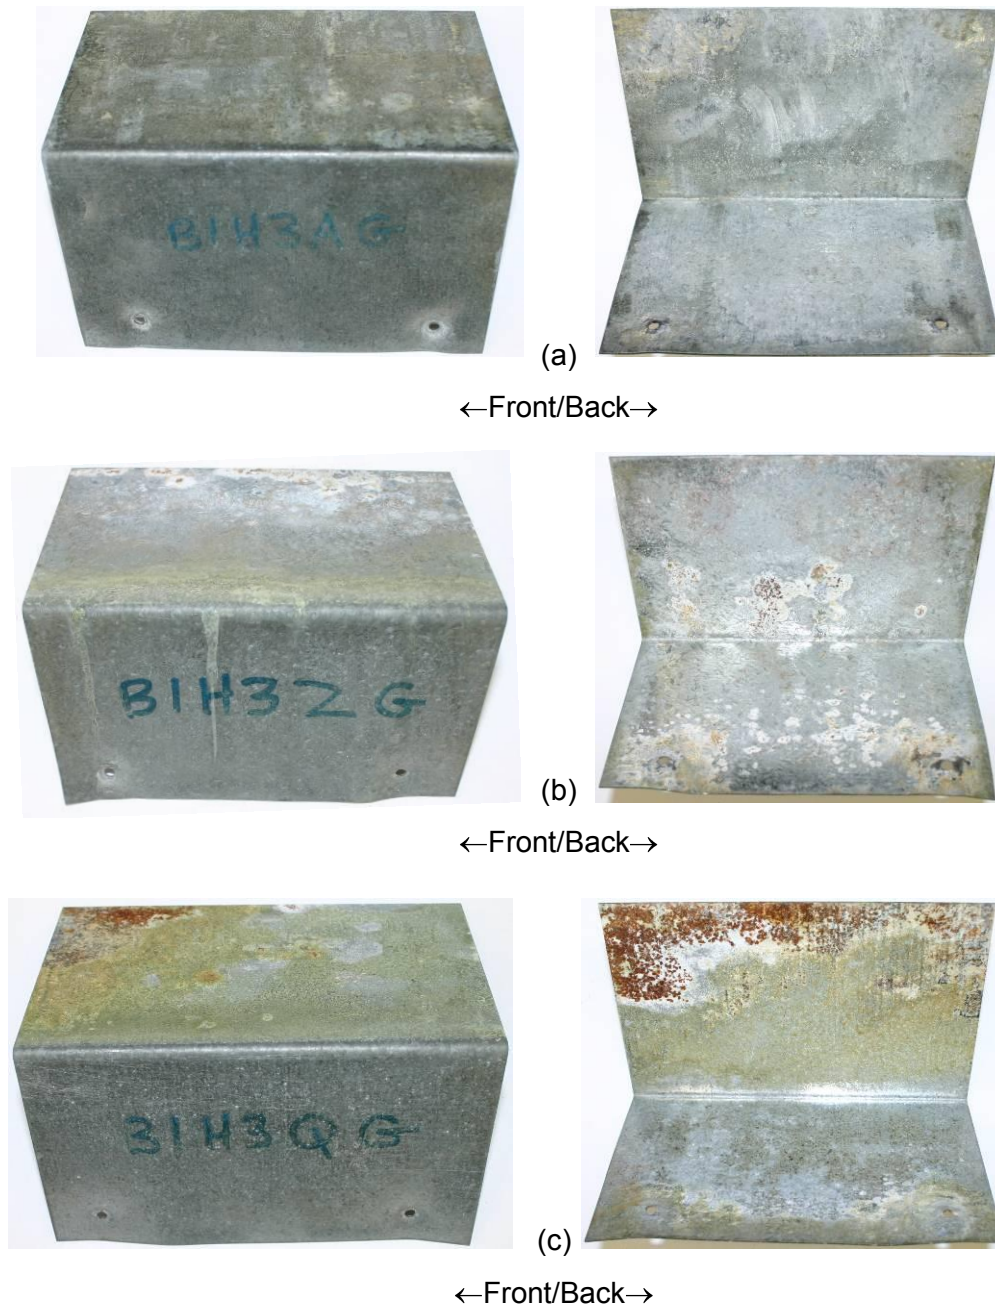
Consumption of the zinc coating on the galvanised flashings had occurred to a much greater extent with ACQ and CuAz than with CCA in the equivalent hazard class. The galvanised flashings attached to CCA treated timbers developed extensive white zinc-rich corrosion products, particularly on surfaces in direct contact, and incidences of red rusting were comparatively rare.

**Figure 10:** Surface morphology of hot dip galvanised steel flashing attached to timber exposed at Judgeford site for one year – (a) H3 CCA, (b) H3 CuAz and (c) H3 ACQ

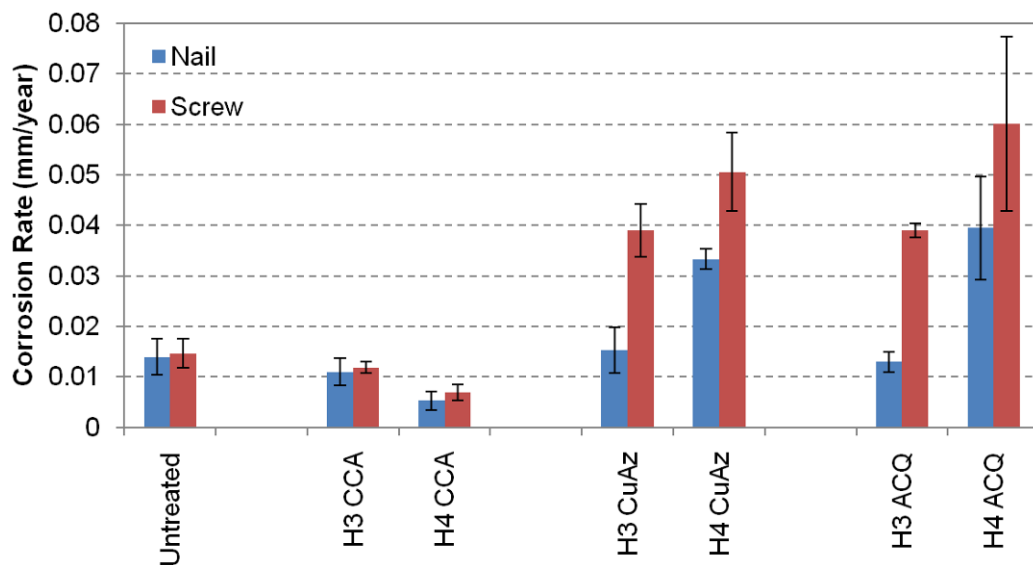
In general, fasteners exhibited a relatively low corrosion rate when embedded into CCA treated timbers, and this is consistent with the surface morphological observations. It is also interesting to note that the mass losses of the fasteners embedded in CCA (H3.2 and H4) treated timbers do not differ greatly from those of the fasteners embedded in untreated timbers. CuAz and ACQ treatments promoted markedly increased corrosion rates. For example, the mild steel nails had a corrosion rate of  $6.63 \times 10^{-2}$  mm/year in H4 ACQ treated timber, while equivalent corrosion rates in H4 CCA and untreated timbers were  $1.87 \times 10^{-2}$  mm/year and  $2.66 \times 10^{-2}$  mm/year, respectively. In addition, an increase of the copper content in the preservation chemicals appeared to increase the aggressivity of the treated timber towards metal. This measurement result also agrees with the morphological characterisation where heavier corrosion products (zinc-rich and/or iron-rich rusts) covered larger surface areas.

**Figure 13:** Corrosion rates of mild steel fasteners embedded into timbers exposed at Judgeford site for one year

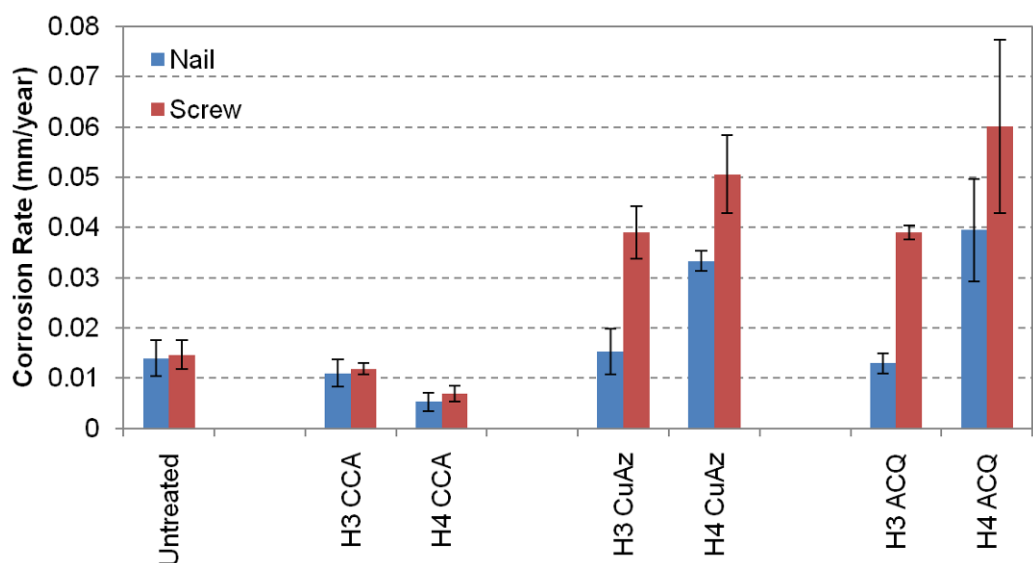
**Figure 14:** Corrosion rates of zinc-coated fasteners embedded into timbers exposed at Judgeford site for one year

Zinc coatings provided enhanced protection to the steel substrates, reflected in lower mass losses, particularly with hot dip galvanised nails. However as observed from the morphological observations, the coating in the thread area of screws was prone to damage during the driving-in process. Thus, a mechanically applied zinc coating cannot always be anticipated to provide long-term protection from corrosion.

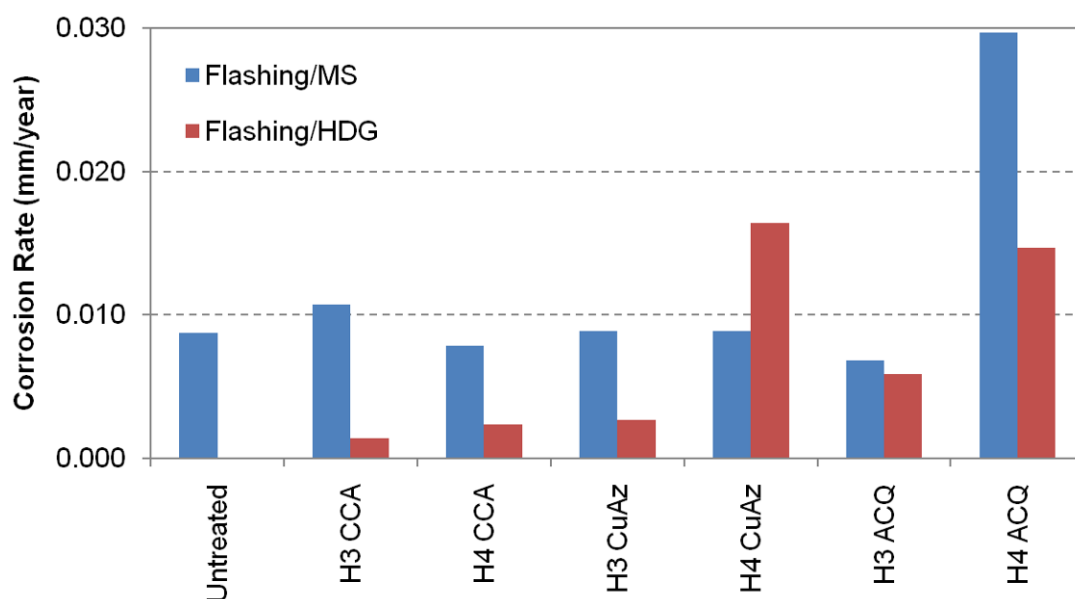
The corrosion rates of the mild steel flashings in contact with different timbers were generally very similar (Figure 15). The only exception was that the flashing attached to the H4 ACQ treated timber showed a much higher mass loss,  $2.97 \times 10^{-2}$  mm/year, which is three to four times higher than the others.

**Figure 15:** Corrosion rate of flashings in contact with timbers exposed at Judgeford site for one year. Note that corrosion rate of galvanised steel flashing in untreated timber is omitted and results are from single specimens so an estimate of uncertainty is impossible (MS: Mild Steel; HDG: Hot Dip Galvanising)

In the case of the hot dip galvanised steel flashings, it is readily apparent that contact with timbers treated with ACQ or CuAz resulted in a higher corrosion rate than contact with CCA or untreated timbers. Furthermore, an increase of the hazard class from H3.2 to H4 also increased the corrosion rate. This result is consistent with the morphological observations.

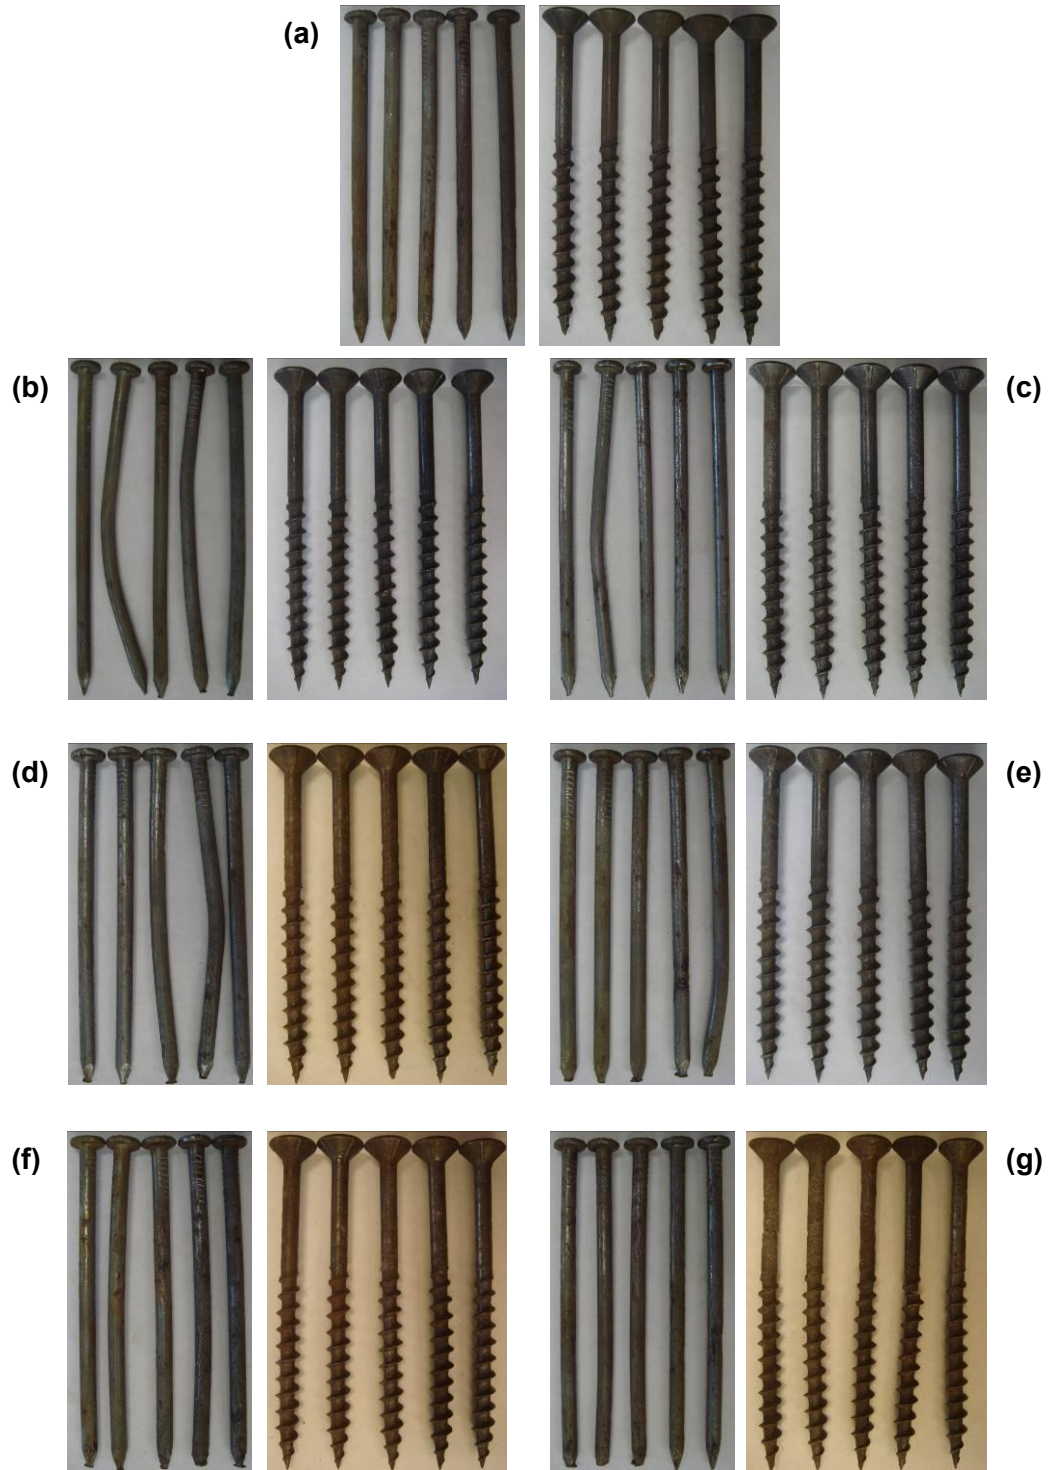
Again, visual inspections showed that mild steel nails suffered uniform corrosive attack in all timbers. This was indicated by the formation of iron-rich red rust on their surfaces. On some nails inserted into CuAz or ACQ treated timbers, consumption of metal was quite serious, leading to observable thickness reduction in some areas of the shaft. On mild steel screws, serious corrosion was mainly found in the thread area. It was frequently observed that small parts of the spiral burr were lost. On their shank areas, attack was mainly observed as high-density small pits (Figure 16).

**Figure 16:** Surface morphology (after cleaning) of mild steel fasteners retrieved from timbers exposed at Judgeford site for two years (these fasteners were inserted into the timber blocks fixed at the lower (side) part of the gate structure and their longitudinal orientation was parallel to the ground) – (a) untreated, (b) H3 CCA, (c) H4 CCA, (d) H3 CuAz, (e) H4 CuAz, (f) H3 ACQ and (g) H4 ACQ

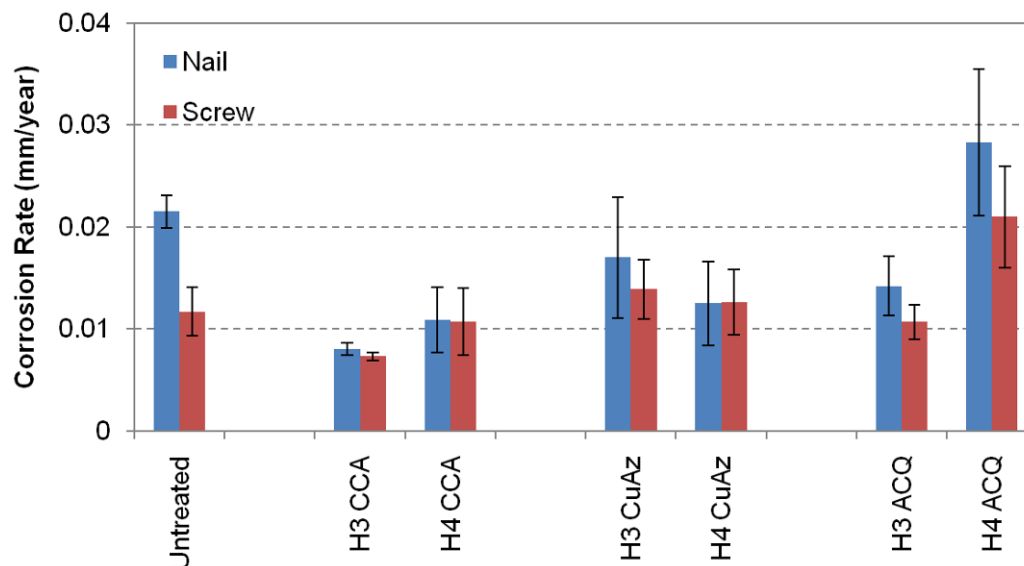
Measurements showed that the corrosion rates of the mild steel nails and screws inserted into the untreated timbers were higher than those of the nails and screws inserted into H3 and H4 CCA treated timbers. H4 ACQ treated timbers were the most corrosive. Metal corrosion in H3 ACQ, H3 CuAz and H4 CuAz treated timbers was not significantly accelerated in comparison with that in H3 and H4 CCA treated timbers under identical testing conditions (Figure 19). This observation is somewhat different from the results obtained after one year of exposure.

**Figure 19:** Corrosion rates of mild steel fasteners embedded into timbers exposed at Judgeford site for two years (these fasteners were inserted into the timber blocks fixed at the lower (side) part of the gate structure and their longitudinal orientation was parallel to the ground)

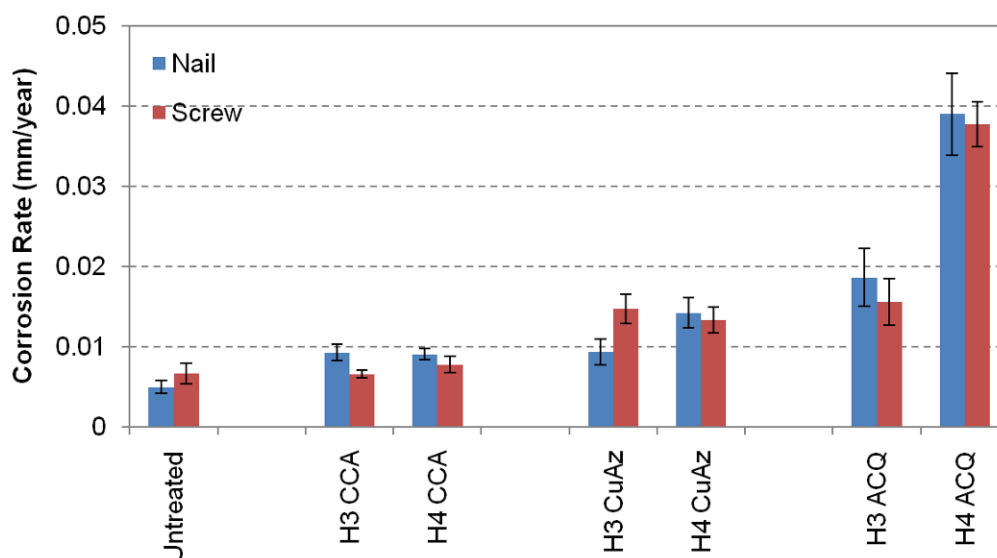
Zinc-coated fasteners in CuAz and ACQ treated timbers were losing their coatings at a higher rate than those in untreated and CCA treated timbers and this trend was particularly obvious for screws. Again, H4 ACQ treated timbers exhibited the highest aggressivity towards metallic fasteners. The mass loss rate of metal in this timber could be two to four times higher than that of metal in CCA and CuAz treated timbers (Figure 20).

**Figure 20:** Corrosion rates of zinc-coated fasteners embedded into timbers exposed at Judgeford site for two years (these fasteners were inserted into the timber blocks fixed at the lower (side) part of the gate structure and their longitudinal orientation was parallel to the ground)

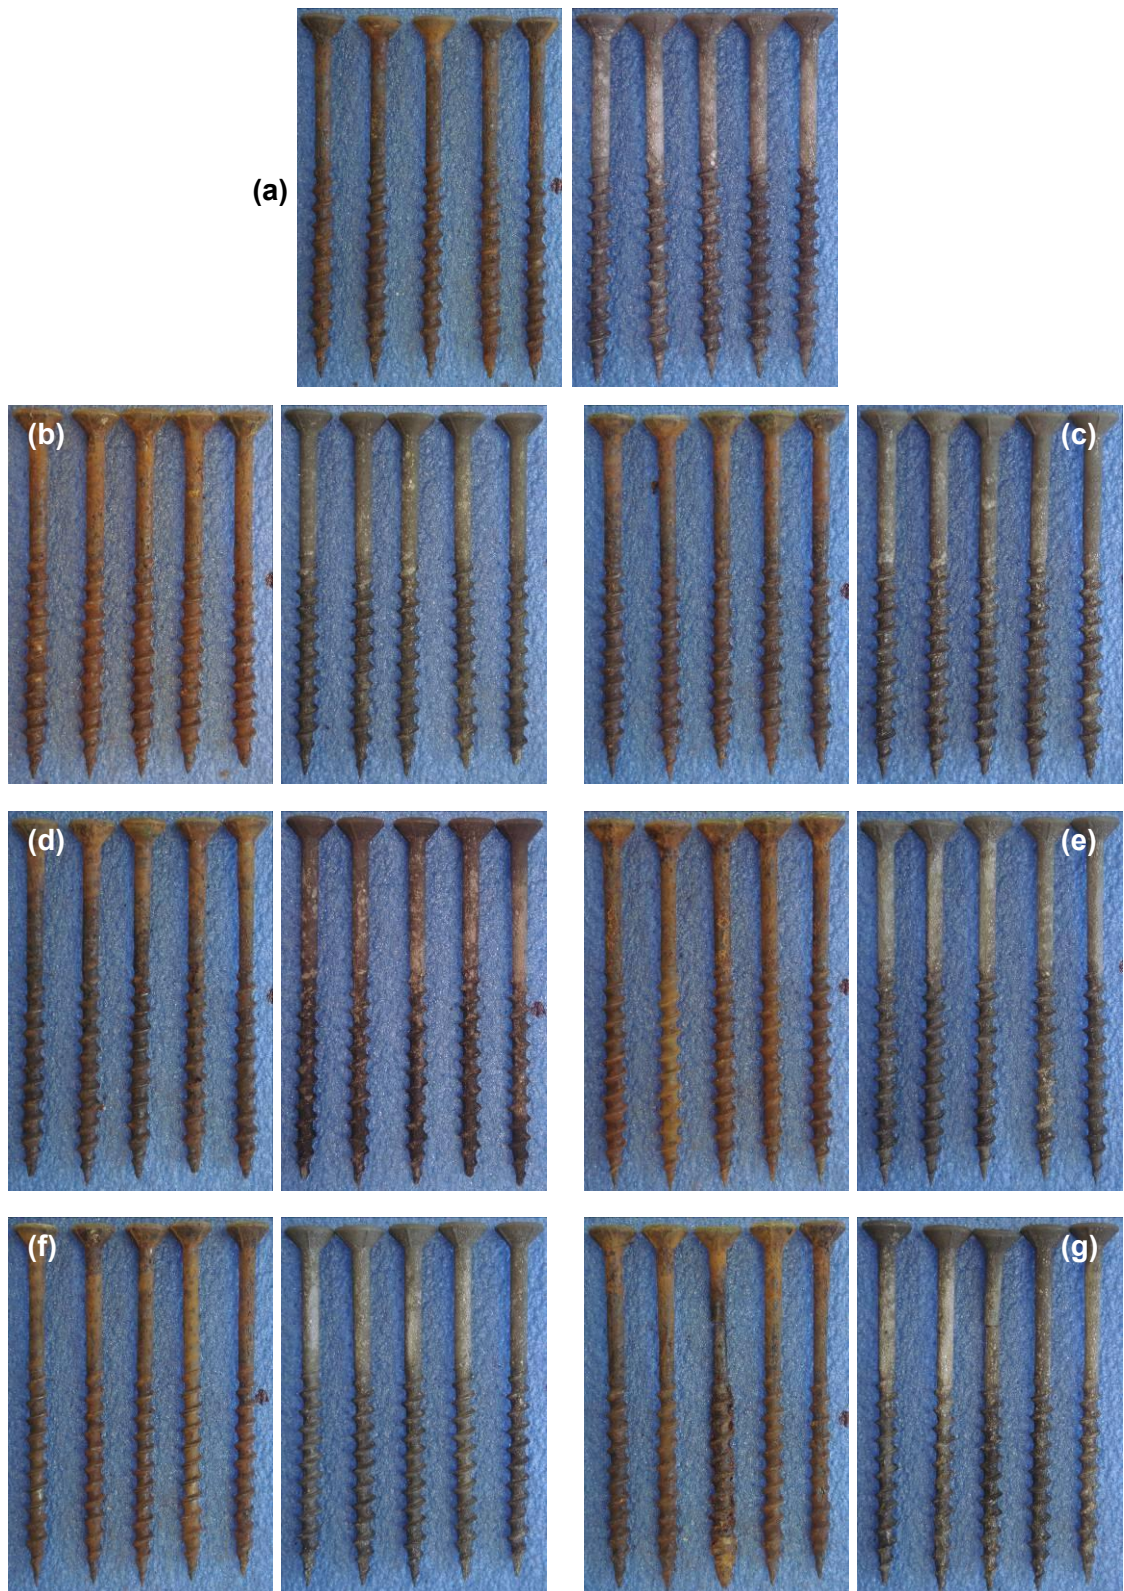
**Figure 22:** Surface morphology of mild steel screws retrieved from the top part of the timber gate structure exposed at Judgeford site for three years – (a) untreated, (b) H3 CCA, (c) H4 CCA, (d) H3 CuAz, (e) H4 CuAz, (f) H3 ACQ and (g) H4 ACQ

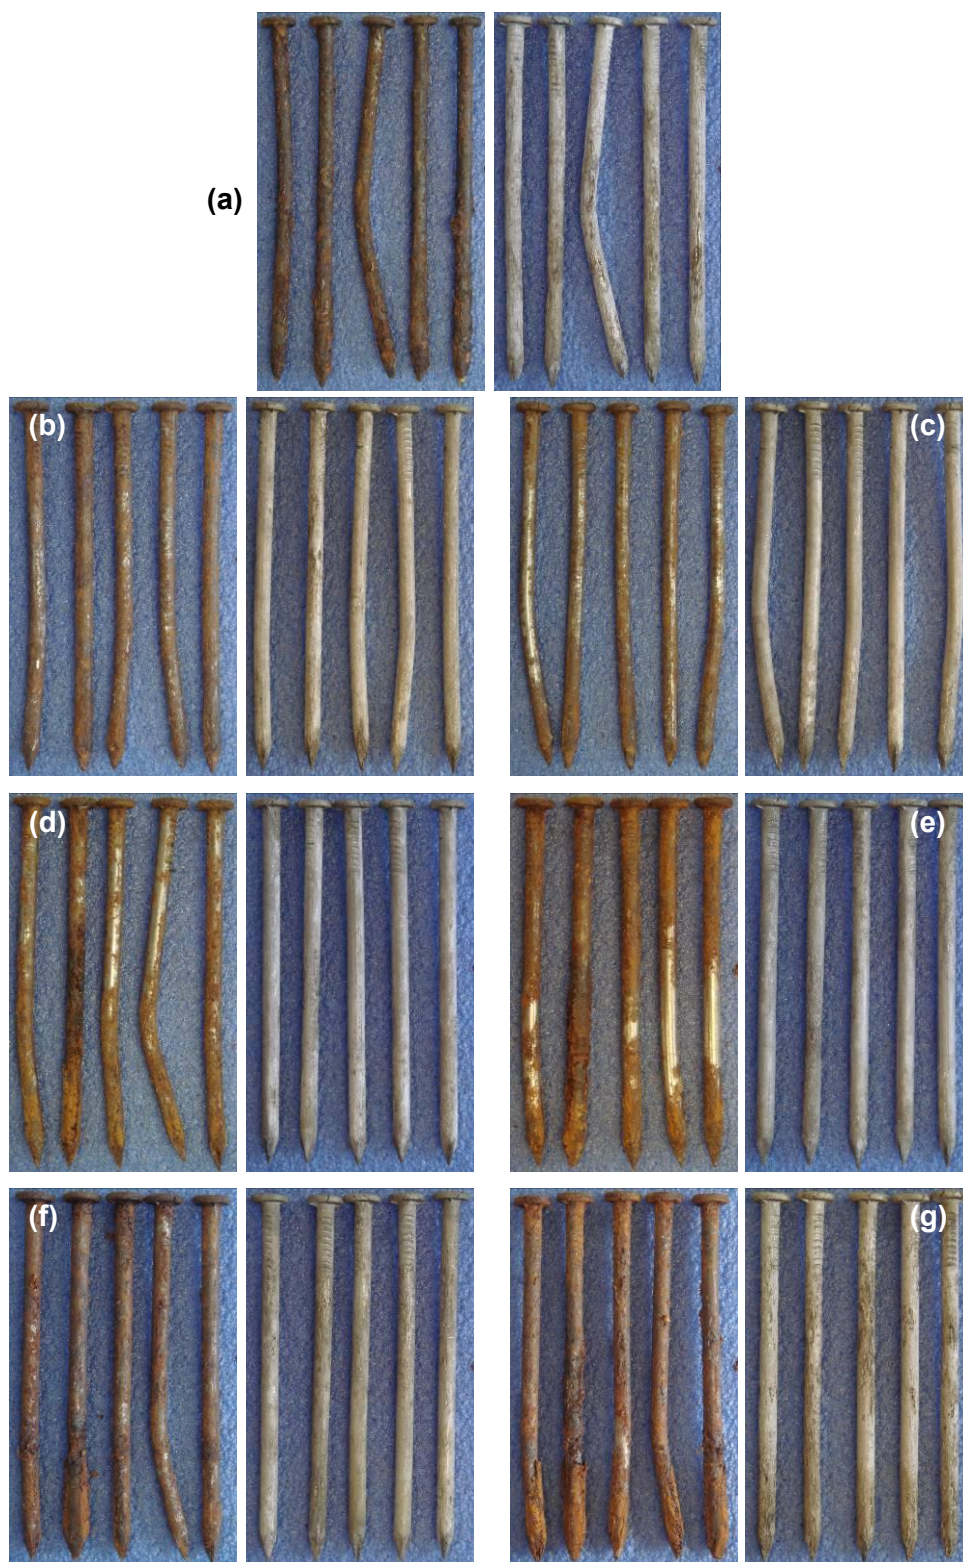
Comparatively, mild steel nails and screws retrieved from the side (bottom part) of the gate structures were in slightly better condition (Figures 23 and 24). On some nails, shiny areas could still be observed on their shafts. The iron-rich rust scale was also thinner. However, observations indicated that untreated timbers attacked mild steel nails and screws more quickly than other timbers, particularly those treated with CCA and CuAz, although ACQ treated timbers still appeared to be the most corrosive.

**Figure 23:** Surface morphology of mild steel nails retrieved from the lower (side) part of the timber gate structure exposed at Judgeford site for three years – (a) untreated, (b) H3 CCA, (c) H4 CCA, (d) H3 CuAz, (e) H4 CuAz, (f) H3 ACQ and (g) H4 ACQ

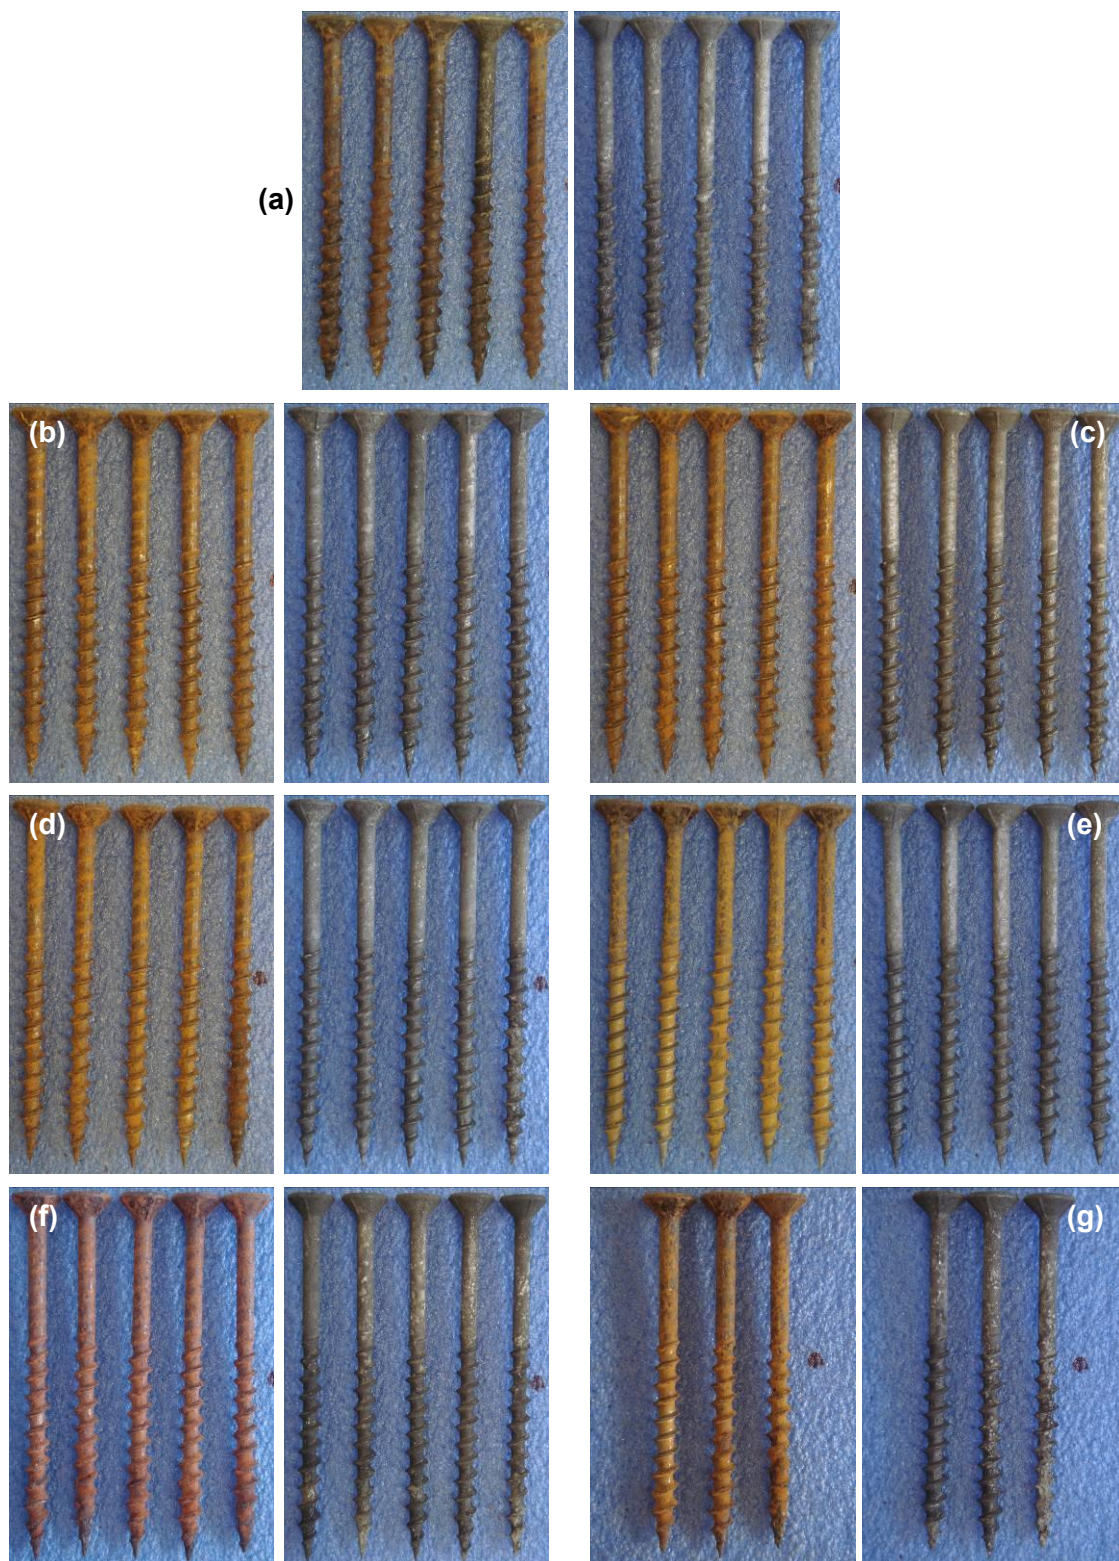
**Figure 24:** Surface morphology of mild steel screws retrieved from the lower (side) part of the timber structure exposed at Judgeford site for three years – (a) untreated, (b) H3 CCA, (c) H4 CCA, (d) H3 CuAz, (e) H4 CuAz, (f) H3 ACQ and (g) H4 ACQ

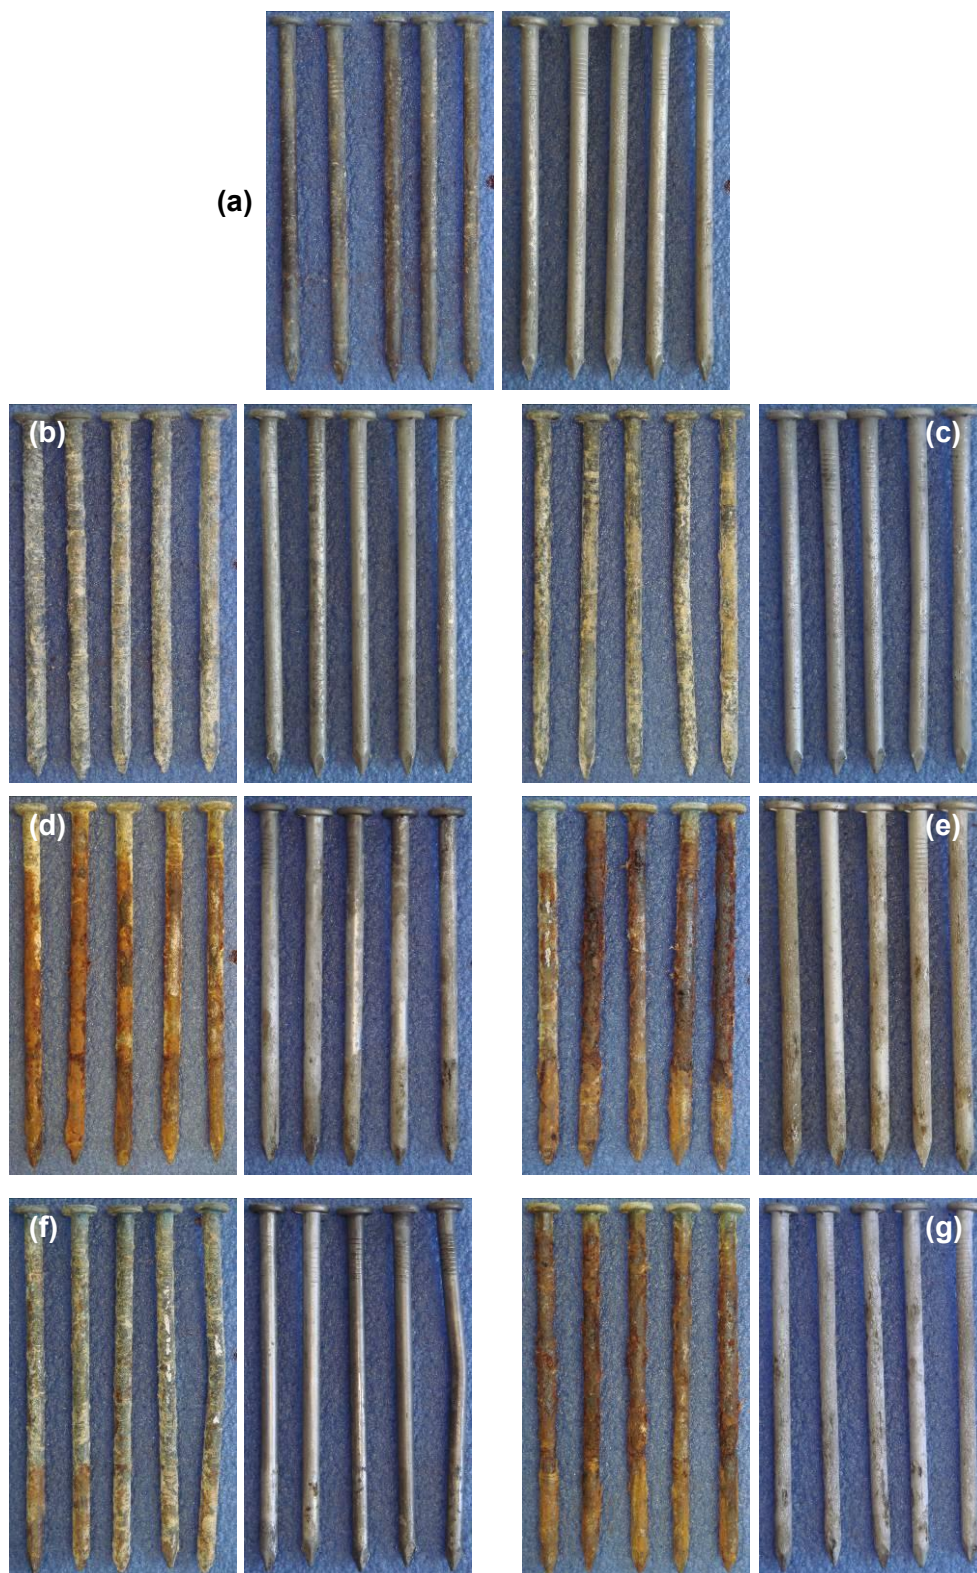
Although darkening (due to oxidation of the zinc) of the hot dip galvanised coating was quite obvious, signs of red rust were very limited on the hot dip galvanised nails inserted into untreated, H3 and H4 CCA treated timbers that were fixed at the top part of the gate structure. When the corrosion products were completely removed, it could be seen that most of the steel substrate was still covered and protected by the zinc coating (although it is believed that the original zinc coating had been thinned due to corrosion). However, white zinc-rich rust and red iron-rich rust were very obvious on the body section of the nails retrieved from both H3 and H4 CuAz and H4 ACQ treated timbers. After cleaning, uniform corrosion together with the formation of pits (i.e. highly localised corrosive attack) of various sizes could be found on the shafts (Figure 25).

**Figure 25:** Surface morphology of hot dip galvanised nails retrieved from the top part of the timber gate structure exposed at Judgeford site for three years – (a) untreated, (b) H3 CCA, (c) H4 CCA, (d) H3 CuAz, (e) H4 CuAz, (f) H3 ACQ and (g) H4 ACQ

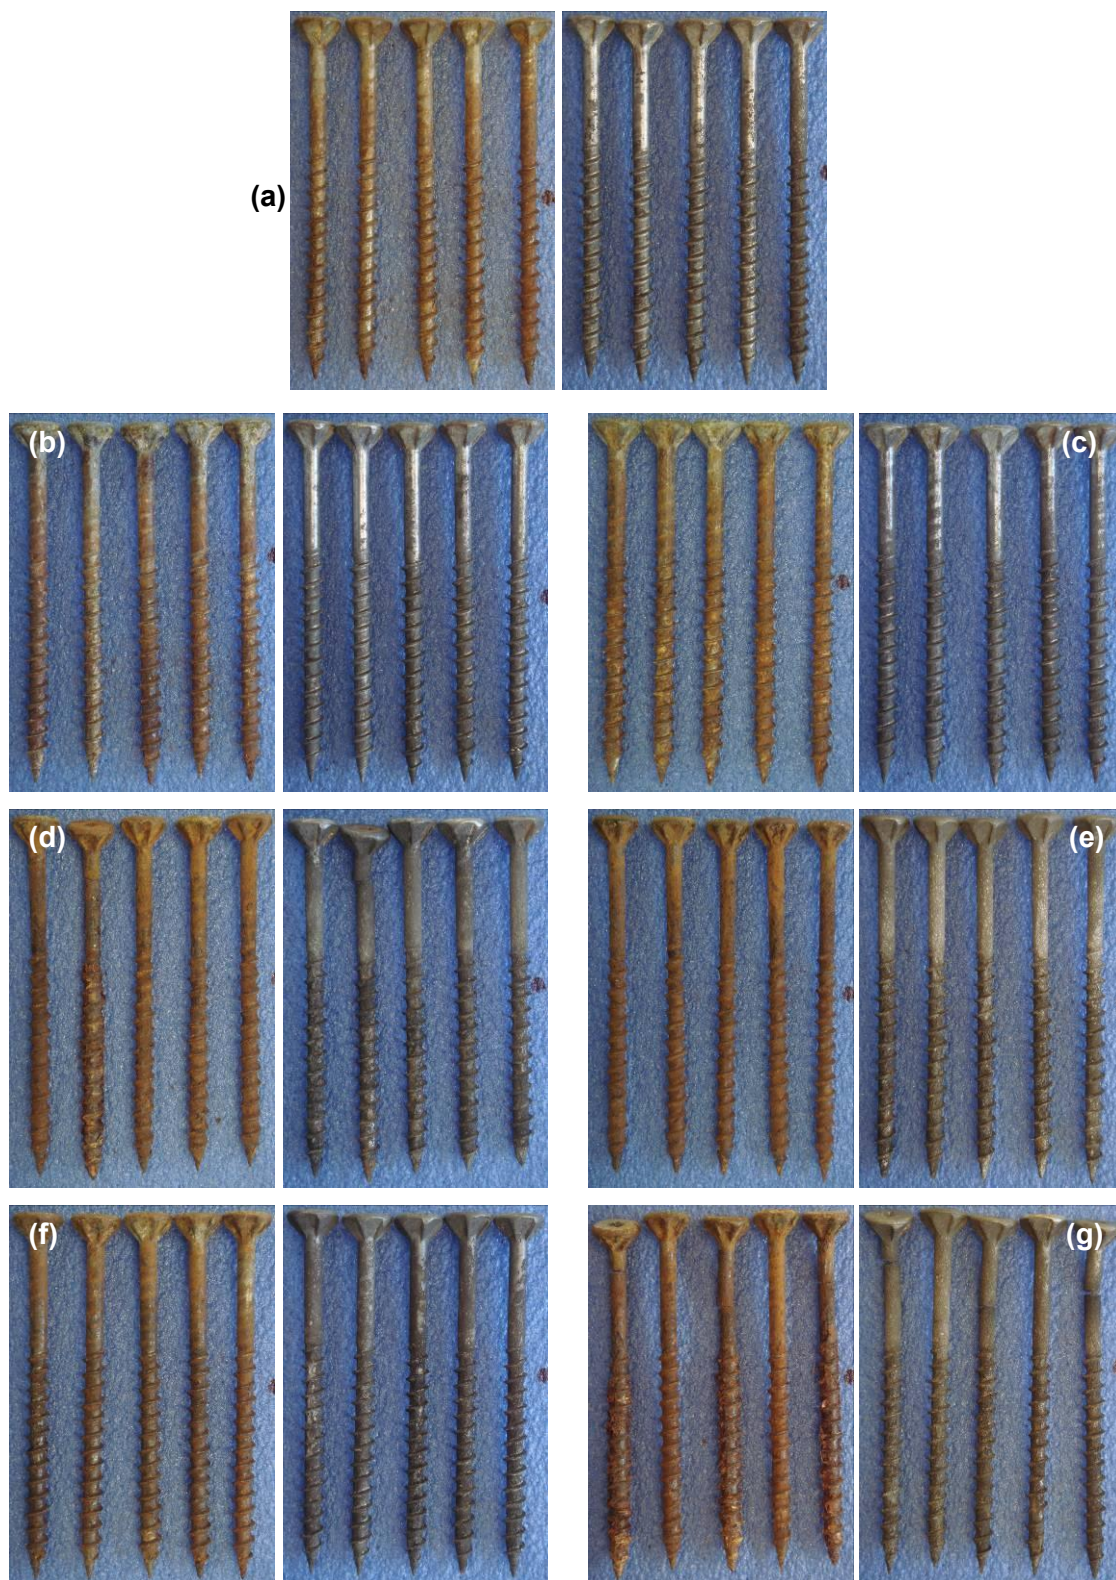
**Figure 26:** Surface morphology of mechanically-plated screws retrieved from the top part of the timber gate structure exposed at Judgeford site for three years – (a) untreated, (b) H3 CCA, (c) H4 CCA, (d) H3 CuAz, (e) H4 CuAz, (f) H3 ACQ and (g) H4 ACQ

The mechanically zinc-plated screws performed badly. After three years of exposure at the Judgeford site, all zinc-coated screws inserted into the top part of the gate structure showed serious formation of iron-rich rust on almost all their surfaces. Closer observation of the corrosion products remaining on the spiral section also revealed that extensive interactions were taking place between the rust and the surrounding timber structure. The presence of heavy corrosion products in the spiral sections also made retrieval of screws from the timbers, particularly ACQ treated timbers, very difficult. Consequently, some screws were broken (see Figure 26).

After cleaning, the corrosion-induced metal loss from the spiral sections of the screws inserted into CuAz and ACQ treated timbers was marked. The smooth section immediately below the head also suffered from relatively uniform attack, leading to an observable thickness reduction. These screws certainly could not perform their fastening functions properly and safely over any longer exposure.

By contrast, zinc coatings on the head top surfaces of these screws were better preserved. About 19 of 35 screws showed very limited signs of rust development on their heads and occasionally on the body section immediately below the head.
