# **STUDY REPORT**

**SR 241 (2011)**

## **Corrosion of Fasteners in Treated Timber**

**Z.W. Li, N.J. Marston and M.S. Jones**

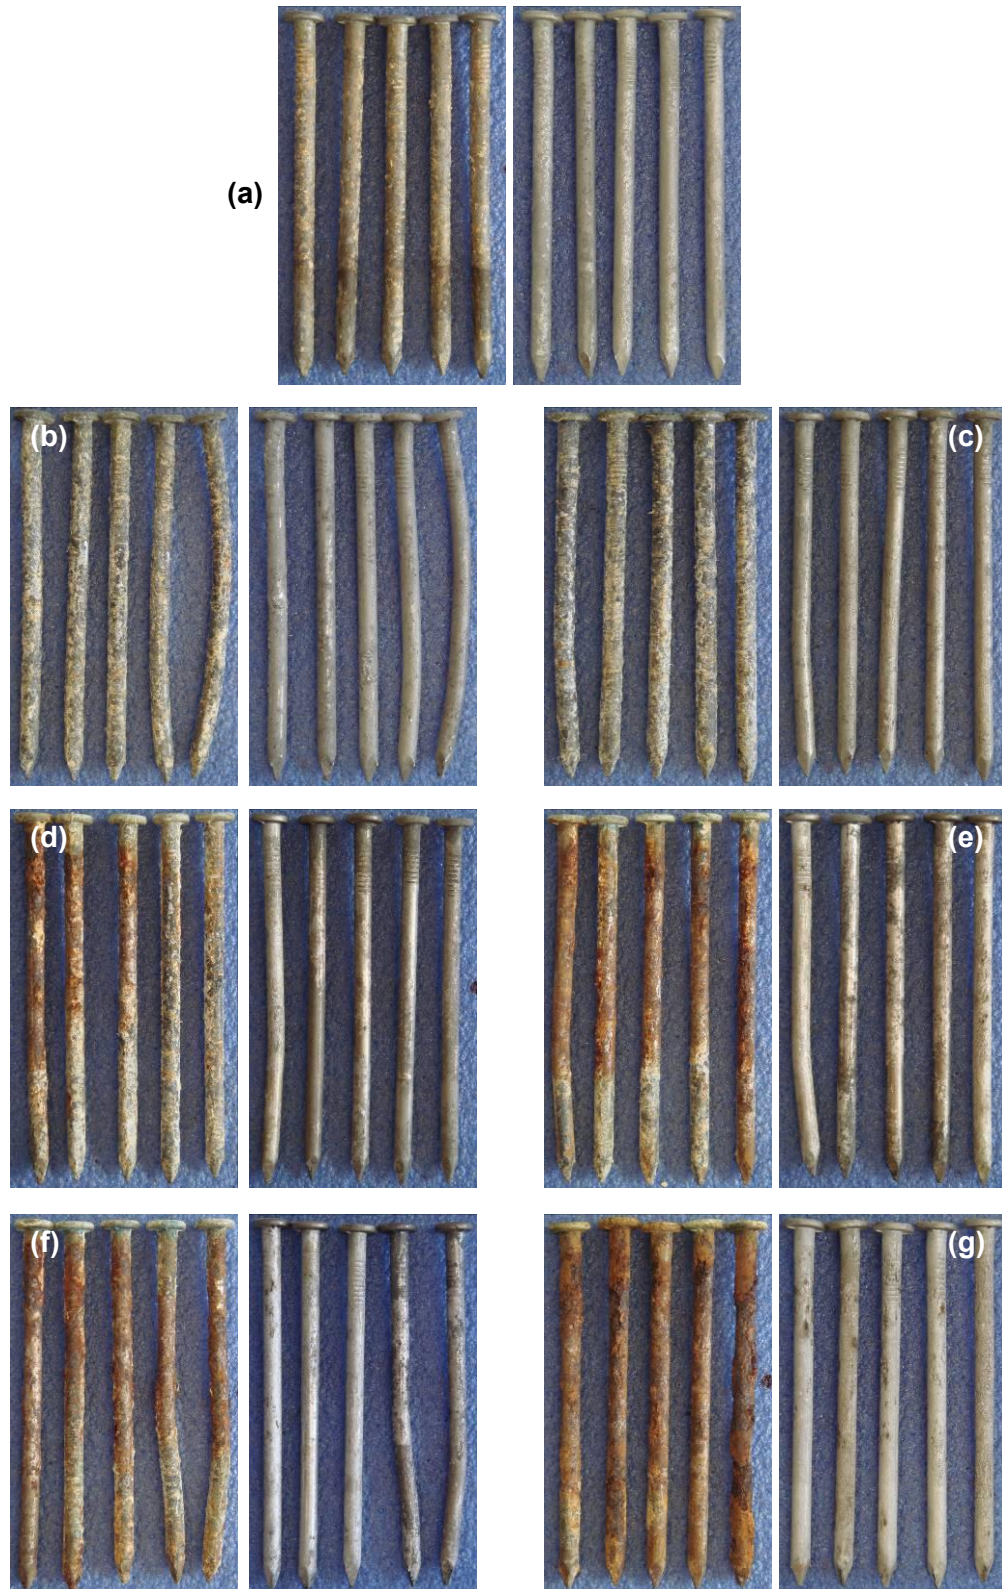
Limited iron-rich rust was occasionally found on the nails inserted into untreated, H3 and H4 CCA treated timbers (Figure 27), indicating that the zinc coating was still functioning. This was confirmed by morphological observations of the samples after chemical cleaning. Zinc coatings could still be found on most part of the surface (although it is believed that their thickness had been reduced due to oxidation). Although rust was quite evident on the nails inserted into CuAz and ACQ treated timbers, it was not as heavy as that on those embedded into the top part of the gate structure. Most of them (30 of 35) still had a better preserved head without any red iron-rich rust present.

**Figure 27:** Surface morphology of hot dip galvanised nails retrieved from the lower (side) part of the timber gate structure exposed at Judgeford site for three years – (a) untreated, (b) H3 CCA, (c) H4 CCA, (d) H3 CuAz, (e) H4 CuAz, (f) H3 ACQ and (g) H4 ACQ

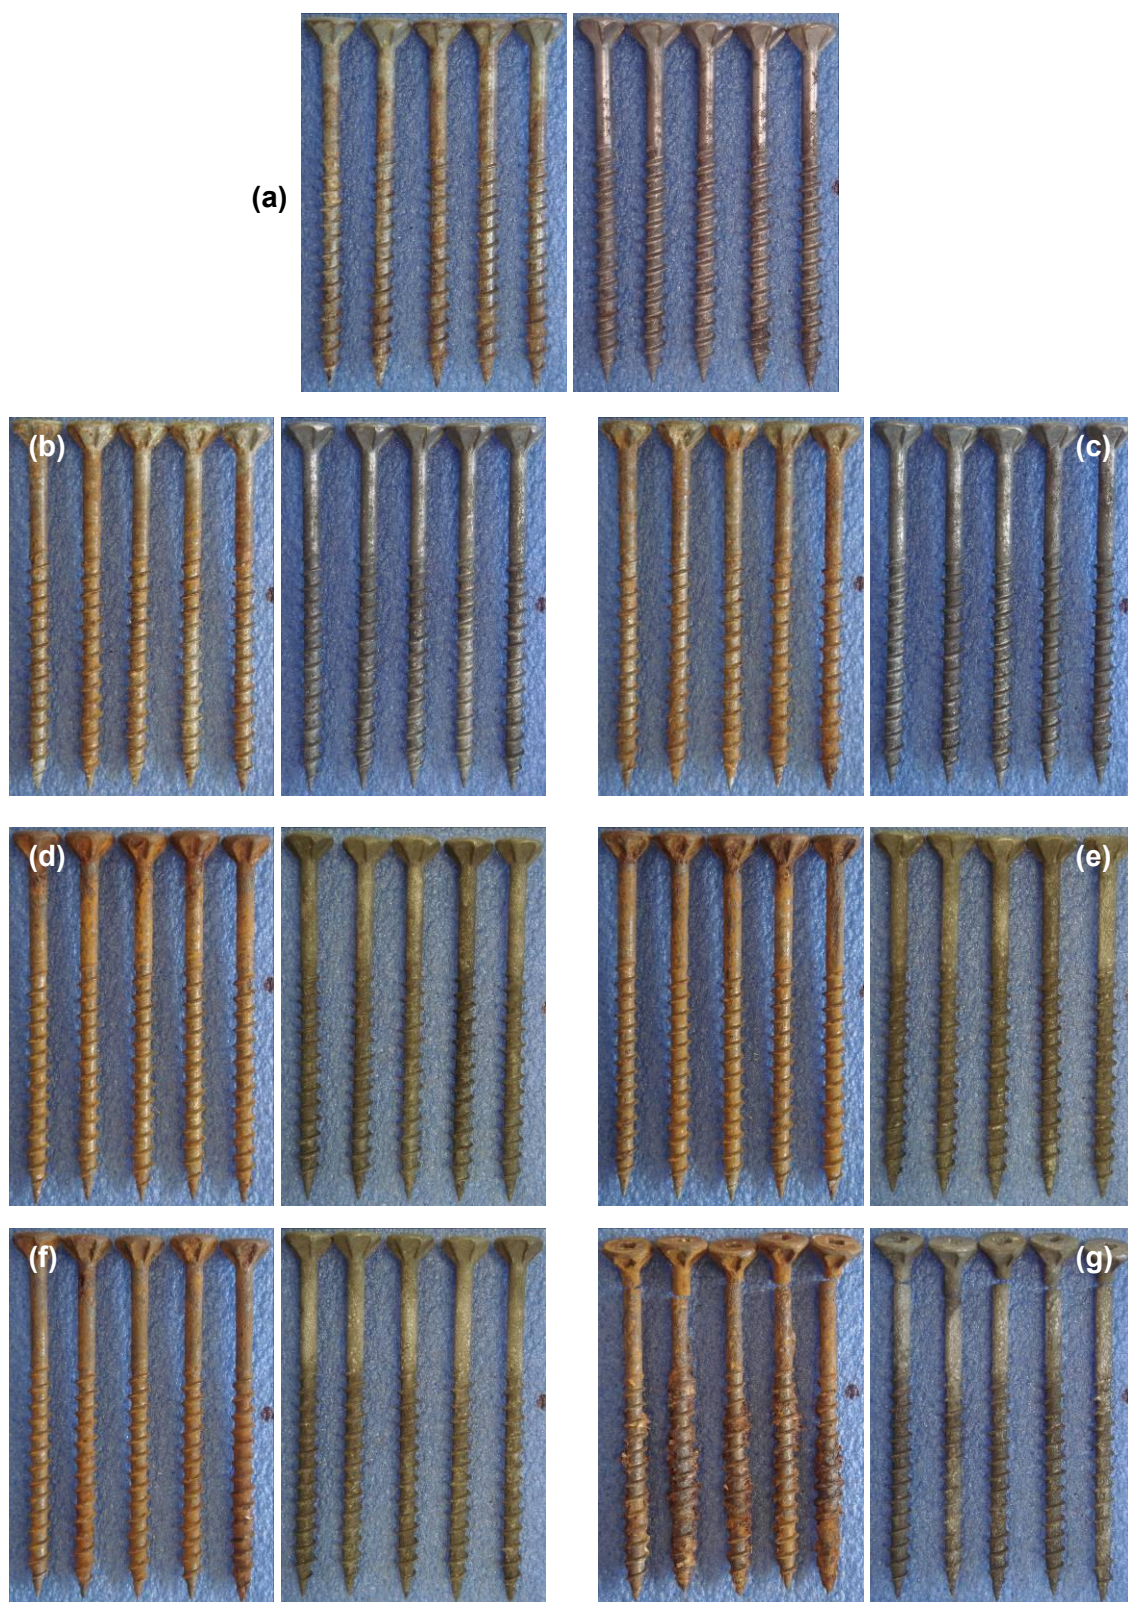
Limited zinc coating still remained on the body section (particularly on the smooth section between the head and the spiral) of the screws retrieved from untreated, H3 and H4 CCA treated timbers. This condition was better than that of the screws removed from the timbers with the same treatment but located on the top part of the gate structure. However, corrosion on the screws inserted into CuAz and ACQ treated timbers was again quite serious, shown by the formation of heavy iron-rich red rust on their whole body sections. Significant consumption of metal (high density pits and incomplete spiral burrs) could be easily observed on the cleaned samples (Figure 28). All screws inserted into CuAz and ACQ treated timbers had heads that were completely rusted. Only 10 screws in untreated and CCA treated timbers had their heads still protected by the zinc coating.

**Figure 28:** Surface morphology of mechanically-plated screws retrieved from the lower (side) part of the timber gate structure exposed at Judgeford site for three years – (a) untreated, (b) H3 CCA, (c) H4 CCA, (d) H3 CuAz, (e) H4 CuAz, (f) H3 ACQ and (g) H4 ACQ

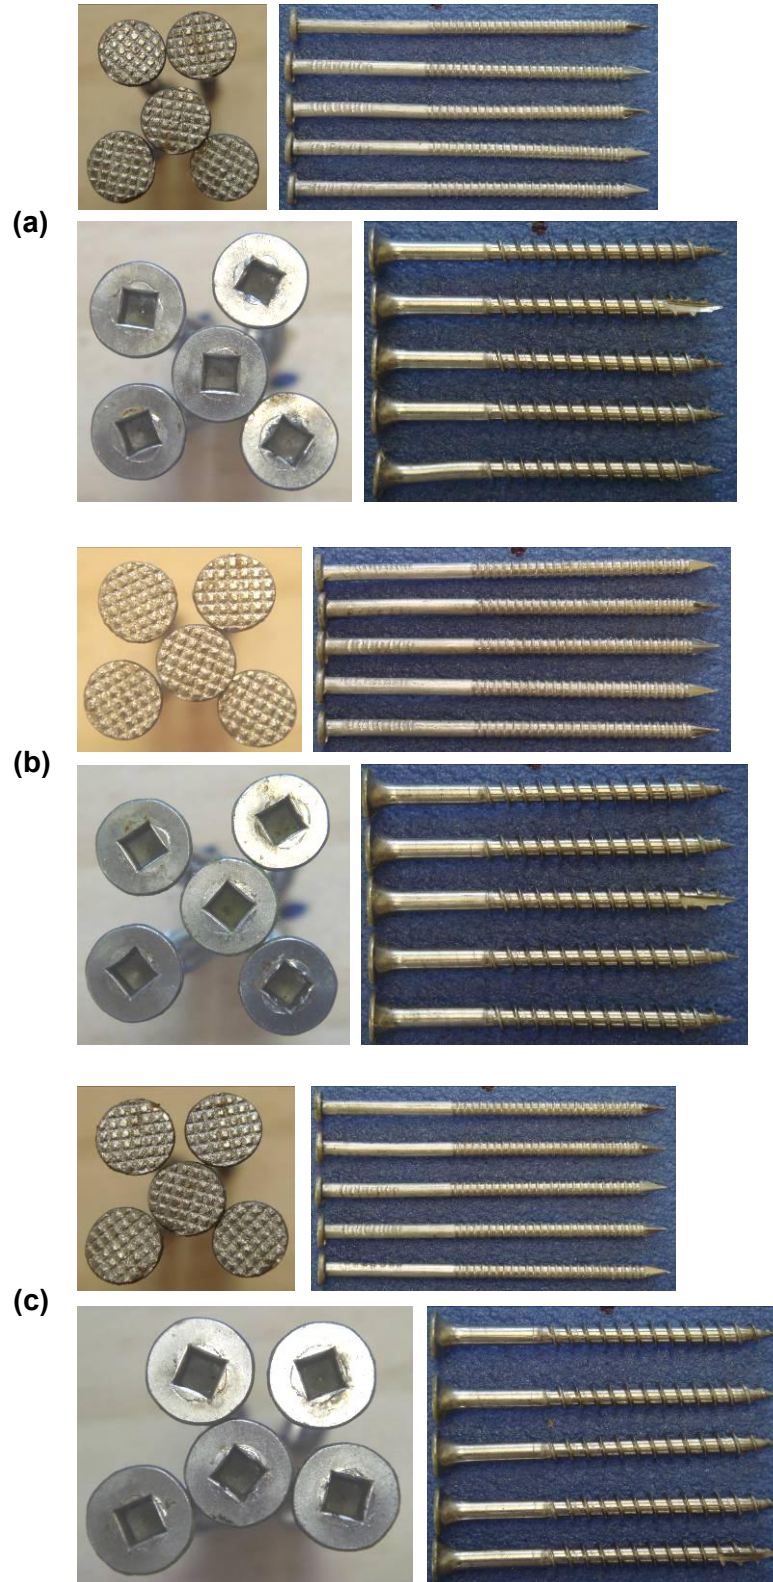
All stainless steel nails and screws (retrieved from both the top and side parts of the timber structure) performed very well after three years of exposure at the Judgeford site. Material deterioration was only present as extremely limited rust formation on their head top surfaces. Serious damage to their body sections by the corrosive environment inside the timber was not found by either visual or optical characterisations. Since heavy rust was absent from the interface between the fastener and the surrounding timber, it was relatively easy to retrieve these fasteners. This ease of extraction would certainly benefit any maintenance and/or retrofitting activities.

**Figure 29:** Typical surface morphology of stainless steel fasteners retrieved from the top part of the timber gate structure exposed at Judgeford site for three years – (a) H4 CCA, (b) H4 CuAz and (c) H4 ACQ

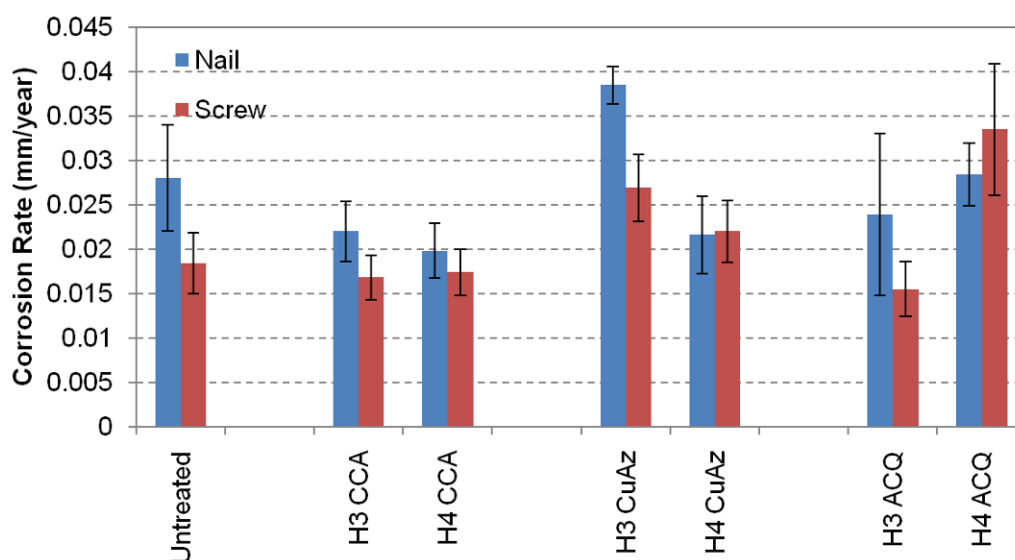
Average corrosion rates measured for the mild steel fasteners retrieved from the top part of the gate-shaped timber structures after three years of exposure at the Judgeford site showed that the degradation behaviours of these fasteners in timbers of different preservation treatments were somewhat similar (Figure 30).

**Figure 30:** Corrosion rates of mild steel fasteners embedded into timbers exposed at Judgeford site for three years (these fasteners were retrieved from the top part of the gate-shaped timber structure i.e. their longitudinal orientation was vertical to the ground)

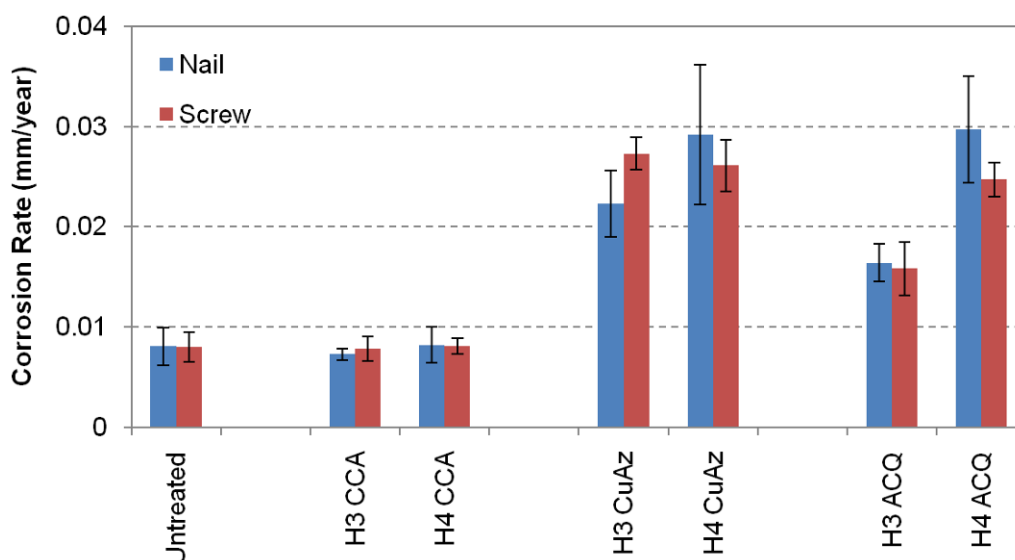
**Figure 31:** Corrosion rates of zinc-coated fasteners embedded into timbers exposed at Judgeford site for three years (these fasteners were retrieved from the top part of the gate-shaped timber structure i.e. their longitudinal orientation was vertical to the ground)

Hot dip galvanised nails and mechanically-plated screws performed slightly better than their mild steel counterparts, particularly in untreated and CCA treated timbers. This might be due to the cathodic protection of the zinc coating (Figure 31). When inserted into either CuAz or ACQ treated timbers, these fasteners still exhibited high corrosion rates, similar to the levels measured with mild steel fasteners. H4 ACQ treatment was found to be 3.6 times as corrosive as H4 CCA treatment. This corrosion acceleration factor is much larger than that observed with mild steel components. This finding from mass loss measurements was fully supported by surface morphological characterisations; most of the zinc coating was consumed and extensive red iron-rich rust was developed. This result again showed that CuAz and ACQ treated timbers exhibited a much higher aggressivity towards zinc-coated components than untreated and CCA treated timbers under identical exposure conditions.

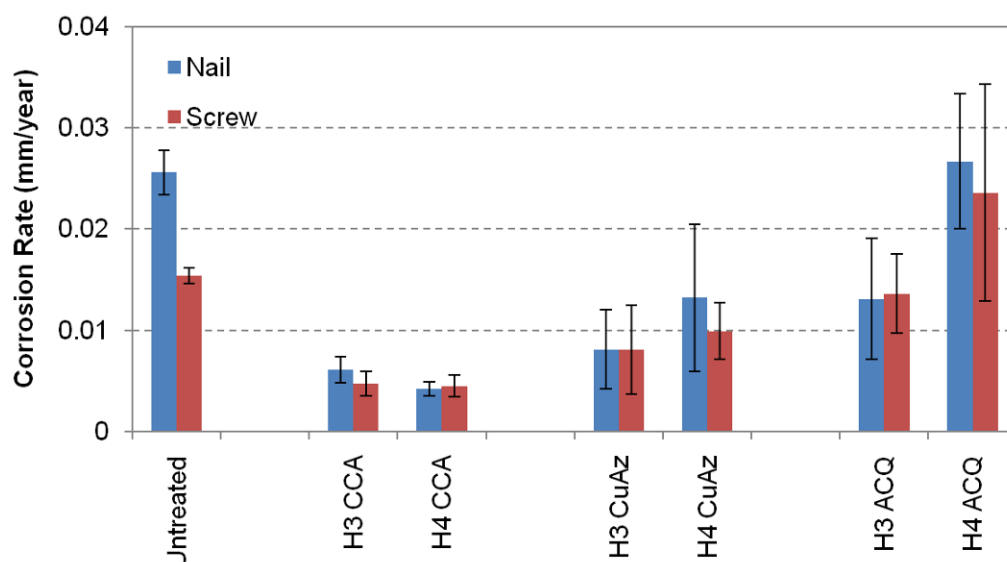
Corrosion rates of the fasteners inserted into the lower (side) part of the gate-shaped timber structures were, in general, lower than those of the fasteners in the top part (Figures 32 and 33). The corrosivity of timbers treated with different preservation chemicals could be clearly distinguished. It is quite obvious that the CCA treated timbers were the least aggressive while the ACQ treated timbers were the most aggressive. For example, H4 ACQ treatment was found to be 6.4 and 3.8 times as corrosive as H4 CCA treatment for mild steel and galvanised steel fasteners, respectively. In addition, an increase of the nominal preservative retention level increased the corrosivity as well.

**Figure 32:** Corrosion rates of mild steel fasteners embedded into timbers exposed at Judgeford site for three years (these fasteners were retrieved from the lower (side) part of the gate-shaped timber structure i.e. their longitudinal orientation was parallel to the ground)

One slightly unexpected observation was that the mild steel fasteners exhibited very high corrosion rates when embedded into untreated timber, comparable to those measured within H4 ACQ treated timbers. During sample retrieval, it was observed that these untreated timber blocks showed serious deterioration and had lots of physical cracks. These surface defects could provide more easy pathways for moisture. This may promote hydrolysis of wood cellular components, resulting in a corrosive micro-environment for fast metal corrosion.

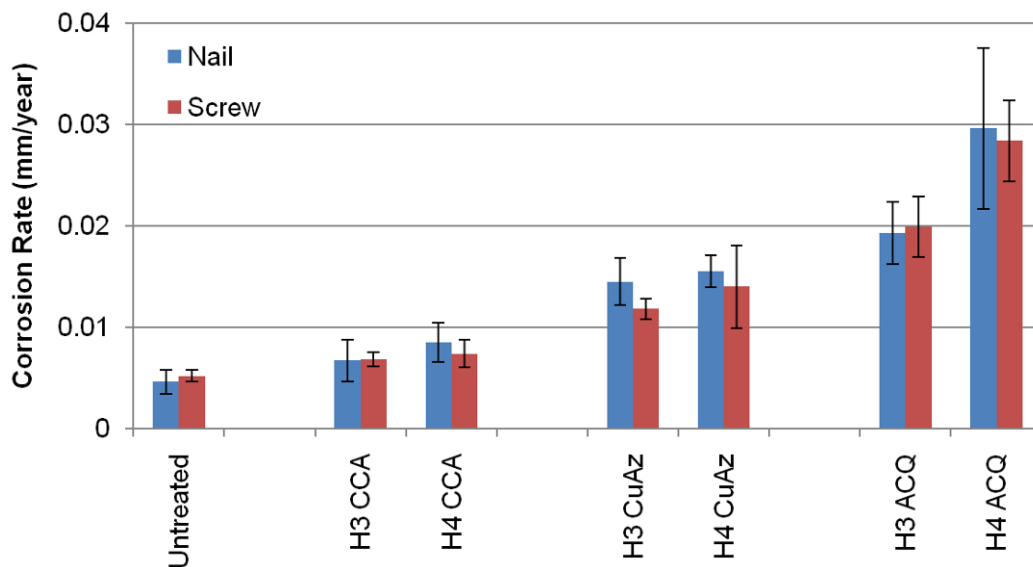
**Figure 33:** Corrosion rates of zinc-coated fasteners embedded into timbers exposed at Judgeford site for three years (these fasteners were retrieved from the lower (side) part of the gate-shaped timber structure i.e. their longitudinal orientation was parallel to the ground)

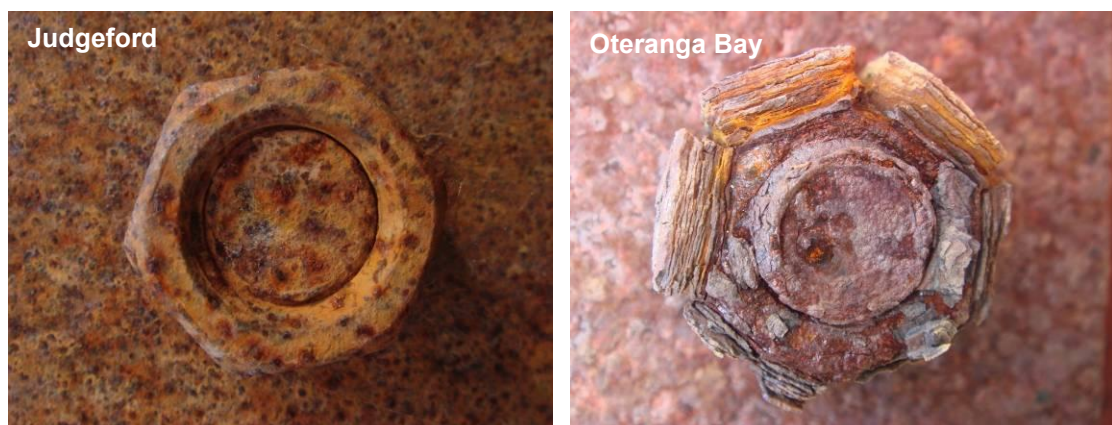
Oteranga Bay is severely marine-influenced. The exposure site is located only a few metres away from the breaking surf. The much higher environmental corrosivity of this site can be simply demonstrated by the surface condition of two mild steel nuts exposed at Oteranga Bay and Judgeford for three years (Figure 34).

**Figure 34:** Mild steel nuts exposed at Judgeford and Oteranga Bay for three years

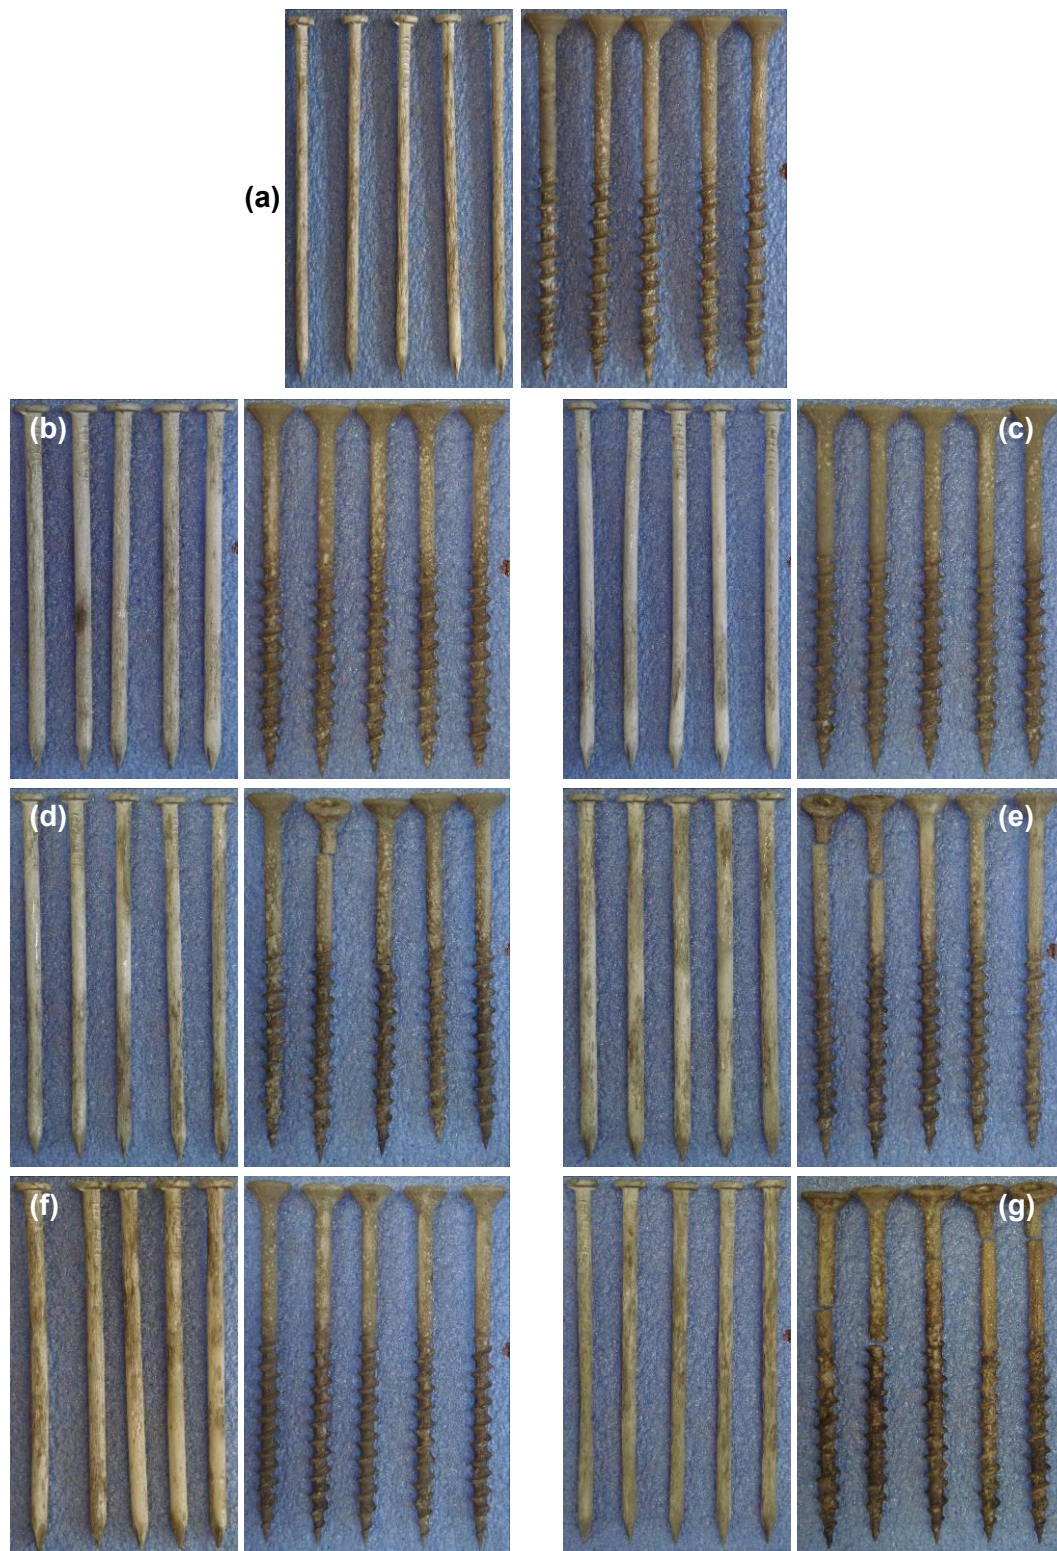
Mild steel fasteners suffered from severe but relatively uniform attack when inserted into all types of timbers. After chemical cleaning, shaft diameter reduction of nails, partial loss of spiral burr and formation of numerous pits of diverse morphologies on screws could be clearly identified (Figure 35). It also appeared that the corrosive attack to these fasteners was more severe than those exposed at the Judgeford site.

**Figure 35:** Surface morphology of mild steel fasteners retrieved from the top part of the timber gate structure exposed at Oteranga Bay for three years – (a) untreated, (b) H3 CCA, (c) H4 CCA, (d) H3 CuAz, (e) H4 CuAz, (f) H3 ACQ and (g) H4 ACQ

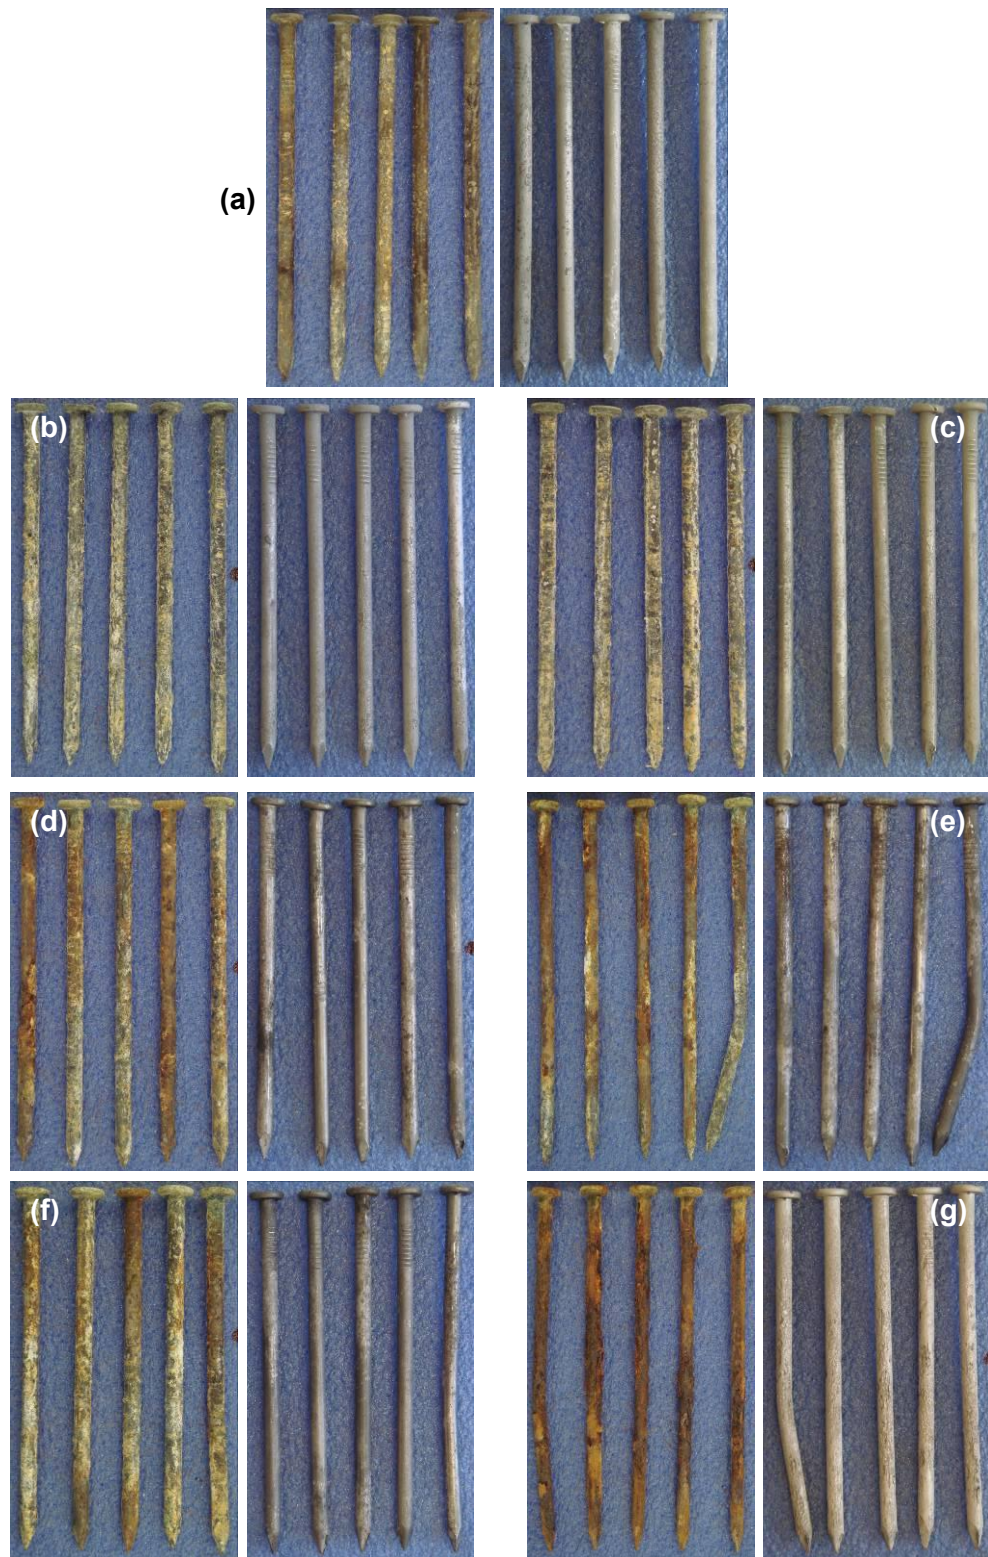
On the surface of the hot dip galvanised nails inserted into untreated and CCA treated timbers, iron-rich red rust was not observed, indicating that the zinc coating was still complete and protecting the steel substrate from the aggressive timber environment (Figure 36). Deterioration of the zinc coating on these nails was mainly shown as darkening, i.e. oxidation of zinc, and formation of white zinc-rich rust (probably a mixture of zinc oxide and hydroxide due to interactions between zinc and moisture). On some samples, partial detachment of zinc coating was found during the retrieval process, indicating degradation of its mechanical properties.

Red iron-rich rust together with heavy white zinc-rich rust appeared on the nails inserted into the H3 CuAz treated timbers. For the nails retrieved from H4 ACQ treated timbers, their whole body section was covered with thick rust, implying the complete consumption of the zinc coating and then direct corrosion attack to the underlying steel substrate of lower resistance.

The heads of most hot dip galvanised nails (23 of 35) were still protected by zinc coating and showed no obvious sign of iron-rich rust formation. However, it was apparent that those nails inserted into CuAz and ACQ treated timbers tended to lose zinc coating from their heads quickly. This was probably related to degradation induced by corrosive chemicals released from these timbers.

**Figure 36:** Surface morphology of hot dip galvanised nails retrieved from the top part of the timber gate structure exposed at Oteranga Bay for three years – (a) untreated, (b) H3 CCA, (c) H4 CCA, (d) H3 CuAz, (e) H4 CuAz, (f) H3 ACQ and (g) H4 ACQ

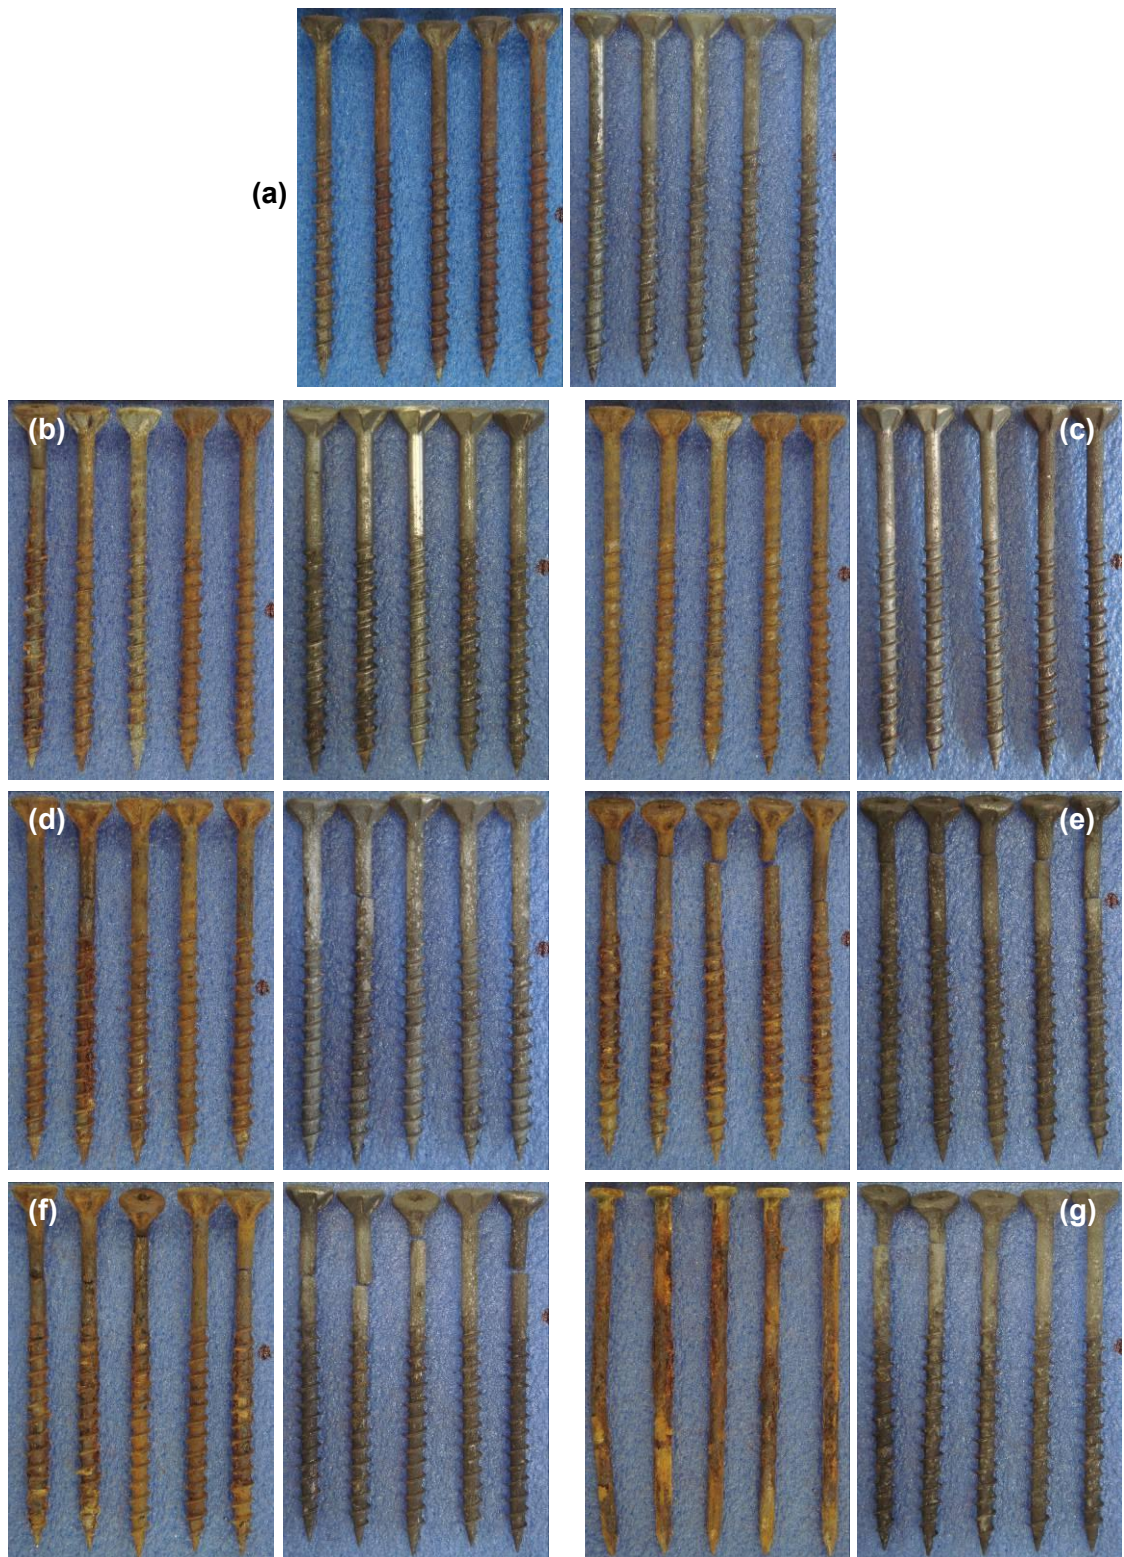
In comparison, the situation on the mechanically-plated (zinc) screws was worse, manifesting as red rust formation on most areas even in untreated timbers (Figure 37). In addition, no screw heads retained a good coating and all heads were heavily rusted. This observation implies that the corrosion performance of the zinc coating on the screws was not as good as that of the hot dip galvanised coating on the nails when they were exposed to a harsh environment.

**Figure 37:** Surface morphology of mechanically-plated screws retrieved from the top part of the timber gate structure exposed at Oteranga Bay for three years – (a) untreated, (b) H3 CCA, (c) H4 CCA, (d) H3 CuAz, (e) H4 CuAz, (f) H3 ACQ and (g) H4 ACQ

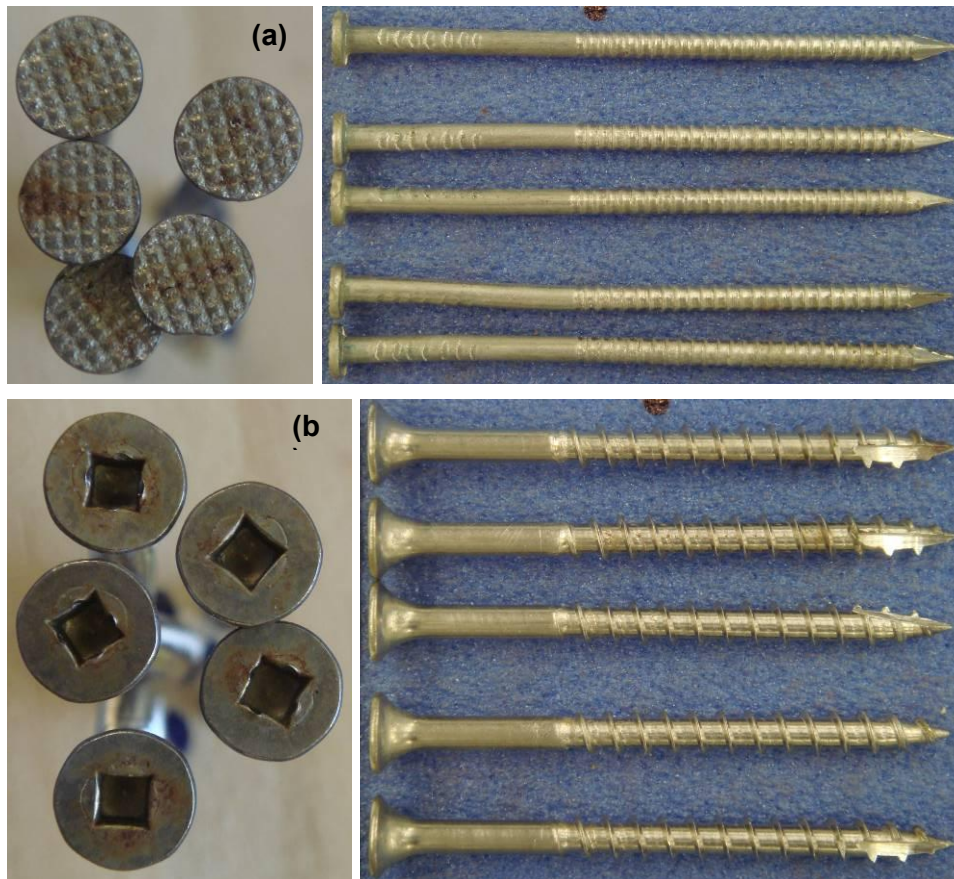
Unsurprisingly, all stainless steel fasteners were performing much better than mild steel and galvanised steel ones. On their body sections, i.e. the parts fully embedded into the timber, no sign of corrosion was observed by either visual or optical characterisations (Figure 37). This further confirmed that stainless steel has superior resistance to corrosion even in timbers exposed to a severe marine environment for a period of three years.

However, more stainless steel fasteners exposed at Oteranga Bay showed slightly serious rust formation on their head top surfaces when compared with the fasteners exposed at the Judgeford site. The situation was slightly worse for the screws that had a rectangular drive mortise in their heads. It is believed that the surface deposition of airborne chloride enhanced corrosion attack to the fastener heads with a locally damaged passive film. Further, mortises like those on the screws tend to collect airborne salt particles more easily than the flat head surface of the nails.

However it must be noted that the extent of this corrosion was still very limited both in affected area and intensity even after three years of exposure. It was not decreasing the corrosion performance of the fastener and/or the mechanical property of the timber-metal joint. It is also believed that this is unlikely to exert any significant negative effects on the joint in the near future.

**Figure 38:** Typical surface morphology of stainless steel fasteners retrieved from the top part of the H4 ACQ treated timber gate structure exposed at Oteranga Bay for three years

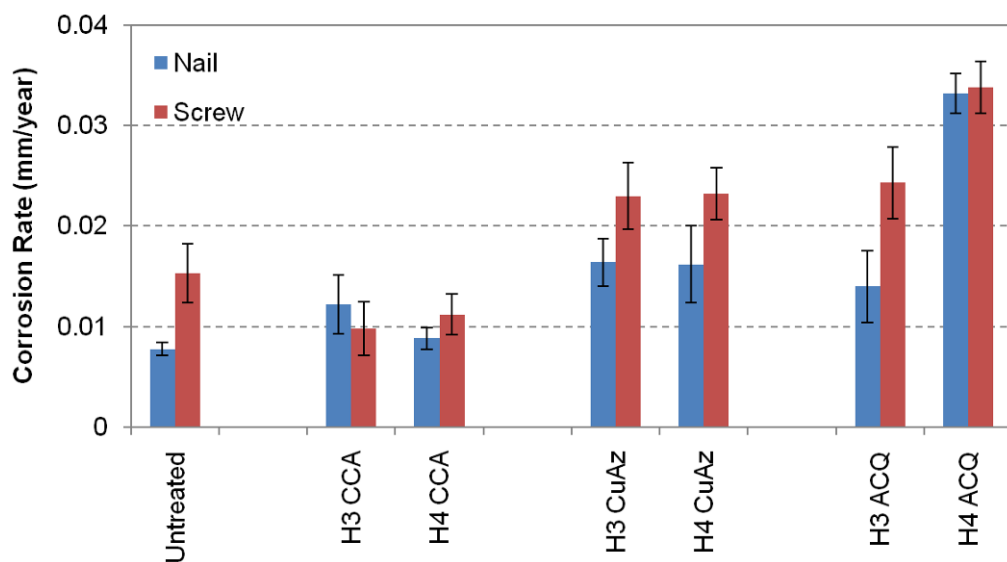
Certainly, zinc coatings applied on the fasteners were providing protection, supported by the lower corrosion rates measured for all galvanised samples. These measurements also showed a relatively clear trend for the aggressivity of timber towards galvanised fastening products:

The corrosion acceleration imposed by H4 ACQ can be as high as 3.8 times greater than that of H4 CCA.

**Figure 40:** Corrosion rates of zinc-coated fasteners embedded into timbers exposed at Oteranga Bay for three years (these fasteners were retrieved from the top part of the gate-shaped timber structure i.e. their longitudinal orientation was vertical to the ground)

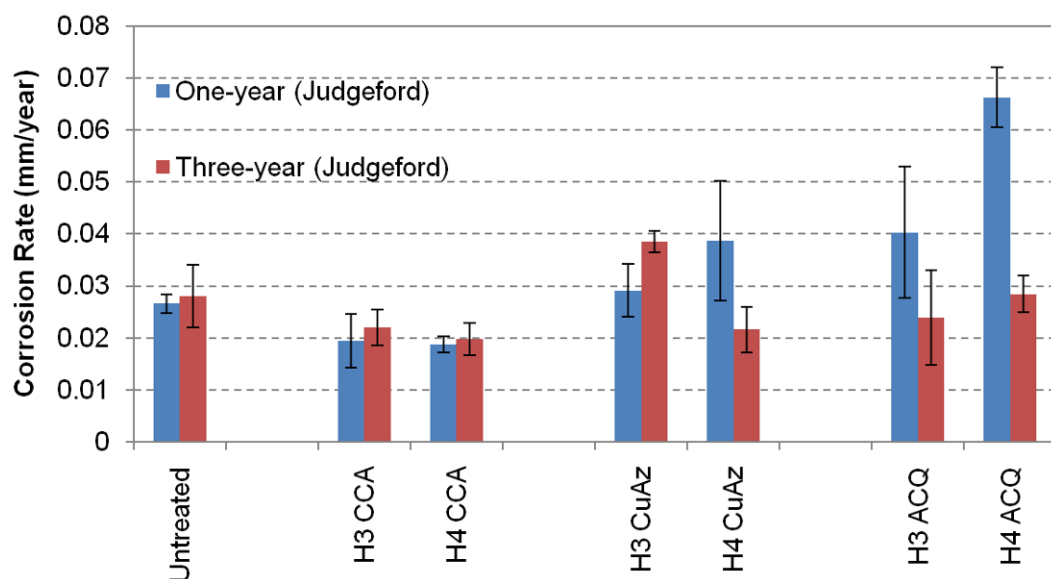
**Figure 41:** Corrosion rates of mild steel nails measured after one year and three years of exposure at Judgeford site (these fasteners were retrieved from the top part of the gate-shaped timber structure i.e. their longitudinal orientation was vertical to the ground)

However, the corrosivity of timbers treated with H4 CuAz and H3 and H4 ACQ appeared to decrease within extended exposure. The averaged three-year corrosion rates of mild steel nails were 55.8%, 59.3% and 42.8% of the first-year corrosion rates in H4 CuAz, H3 ACQ and H4 ACQ treated timbers, respectively (Figure 41).

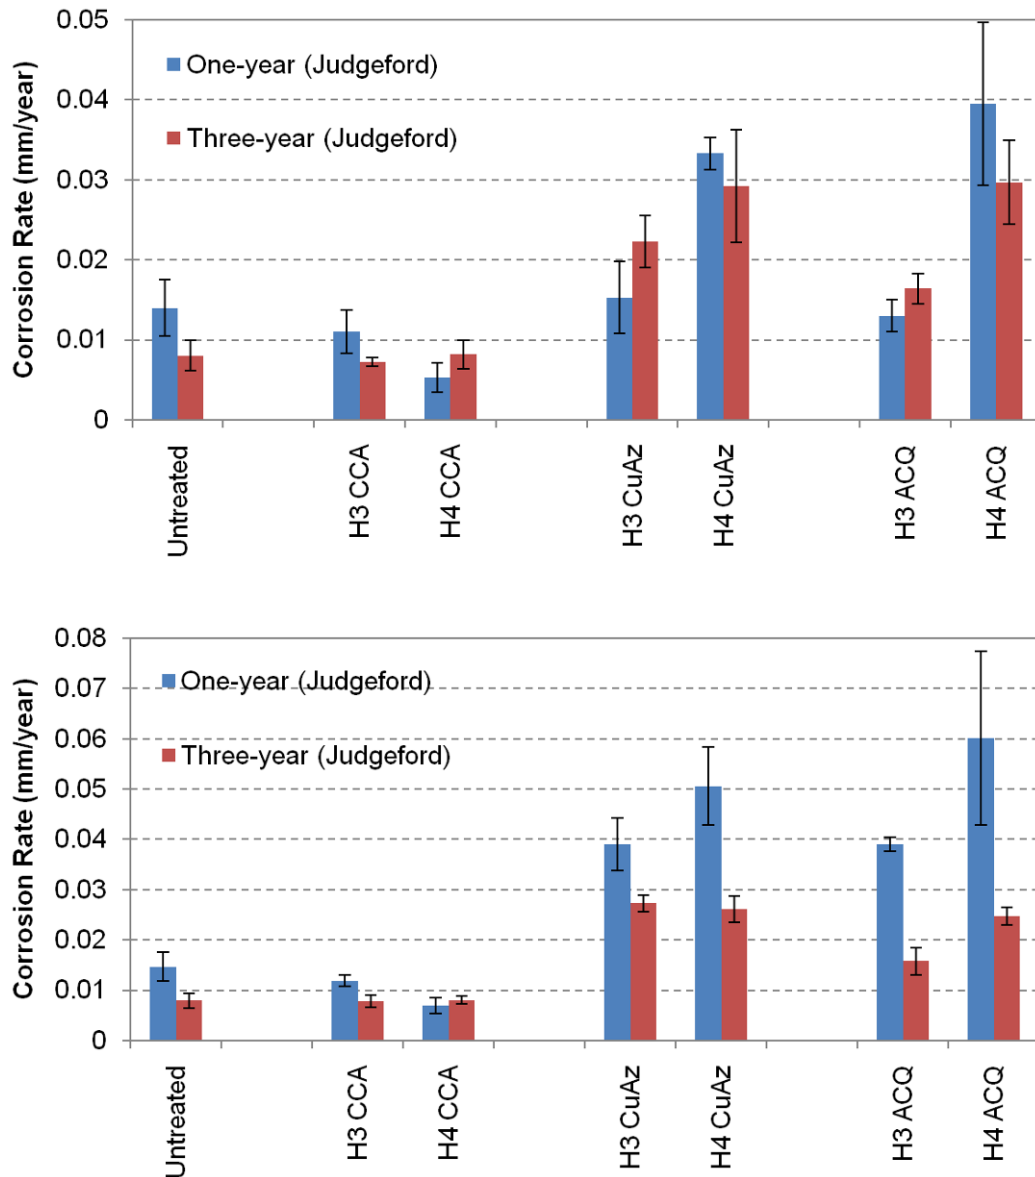
For hot dip galvanised nails, the corrosion rates measured after three years of exposure were similar with those after one year of exposure. Although the averaged

three-year corrosion rate was 75.2% of the first-year rate in H4 ACQ treated timber, it could be up to 1.5 times higher than the first-year rate in H3 CuAz treated timber. For mechanically-plated screws, the averaged three-year corrosion rates were normally lower than the first-year rates. For example, in ACQ treated timbers, the third-year rate was about 40% of the first-year measurement (Figure 42). This trend was similar to that observed for the mild steel fasteners.

**Figure 42:** Corrosion rates of hot dip galvanised (zinc) nails (top) and mechanically-plated screws (bottom) measured after one-year and three-year exposures at Judgeford site (these fasteners were retrieved from the top part of the gate-shaped timber structure i.e. their longitudinal orientation was vertical to the ground)

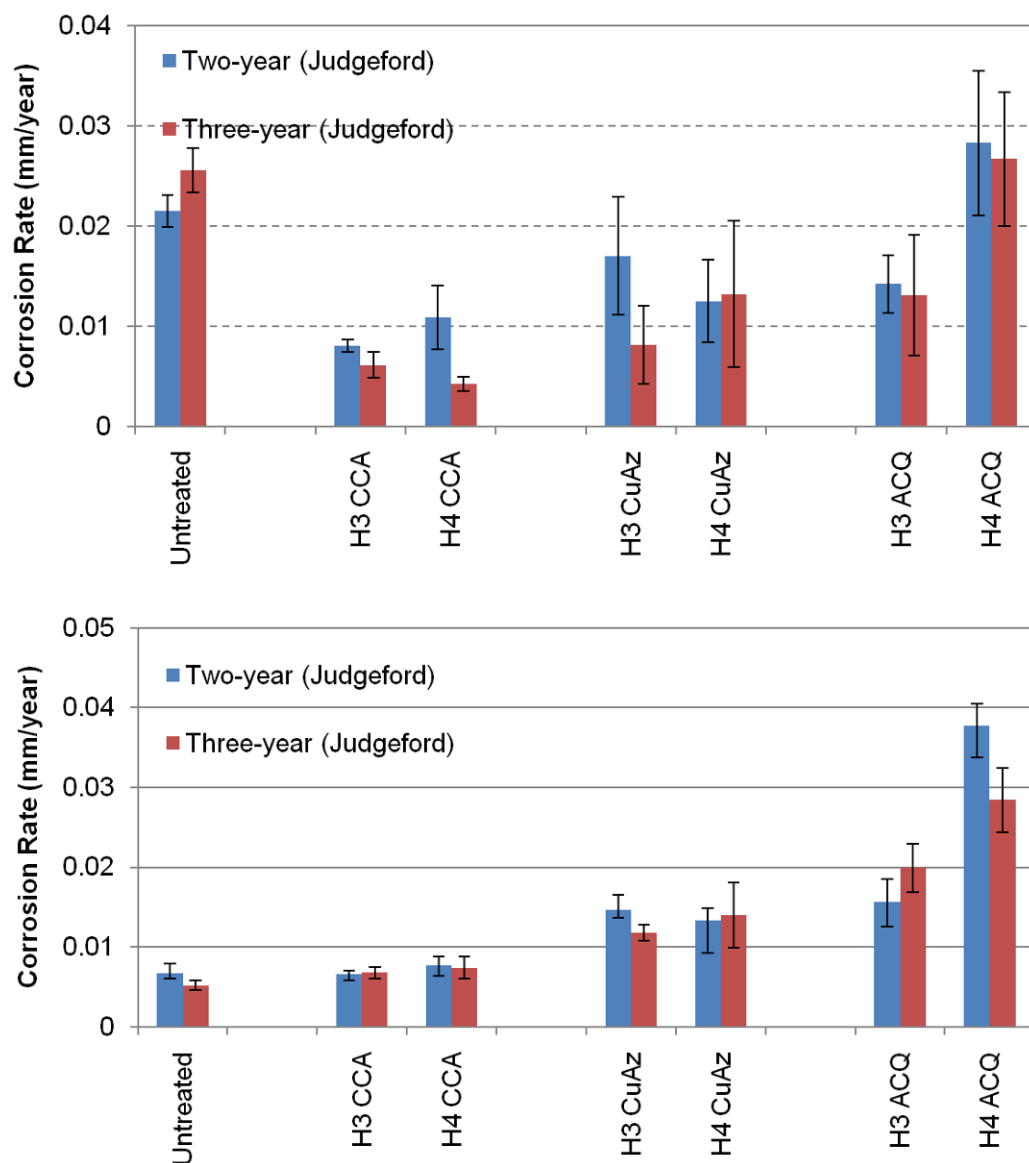
Measurements with fasteners inserted into the side part of the gate-shaped timber structures generally showed that the averaged two-year and three-year corrosion rates were not quite different in all these timbers. The exceptions were mild steel nails inserted into H4 CCA and H3 CuAz treated timbers and mechanically-plated screws in

H4 ACQ treated timbers (Figure 43). These results also indicated that the corrosion rate of metal in CCA treated timbers was not changing markedly within the timeframe of this field exposure test.

**Figure 43:** Corrosion rates of mild steel nails (top) and mechanically-plated screws (bottom) measured after two-year and three-year exposures at Judgeford site (these fasteners were retrieved from the lower (side) part of the gate-shaped timber structure i.e. their longitudinal orientation was parallel to the ground)

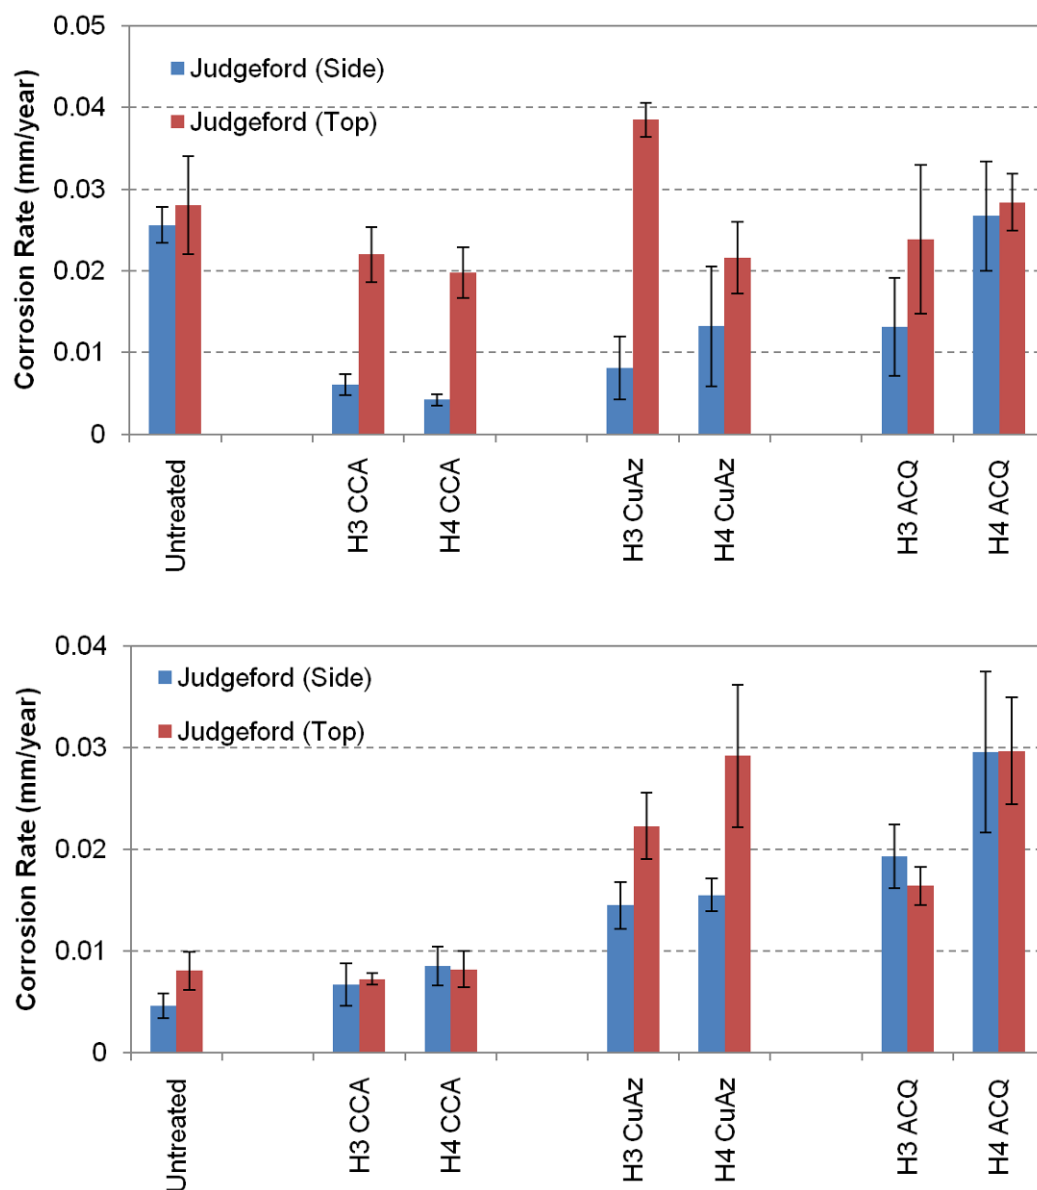
**Figure 44:** Corrosion rates of mild steel (top) and hot dip galvanised (bottom) nails measured after three years of exposure at Judgeford site

However, current measurements did show that the fasteners inserted into the lower (side) part of the timber gate structure were generally performing better than those inserted into the top part, evidenced by their lower corrosion rates and thinner corrosion product scales (Figure 44). The most obvious difference was found with mild steel fasteners in CCA and CuAz treated timbers. For example, within H3 CuAz treatment, the corrosion rate of the nails on the side was only 21% of the corrosion rate of the nails on the top. The opposite was also found, especially with zinc-coated fasteners. Table 4 details the percentage results obtained.
