# **STUDY REPORT**

**SR 241 (2011)**

## **Corrosion of Fasteners in Treated Timber**

**Z.W. Li, N.J. Marston and M.S. Jones**

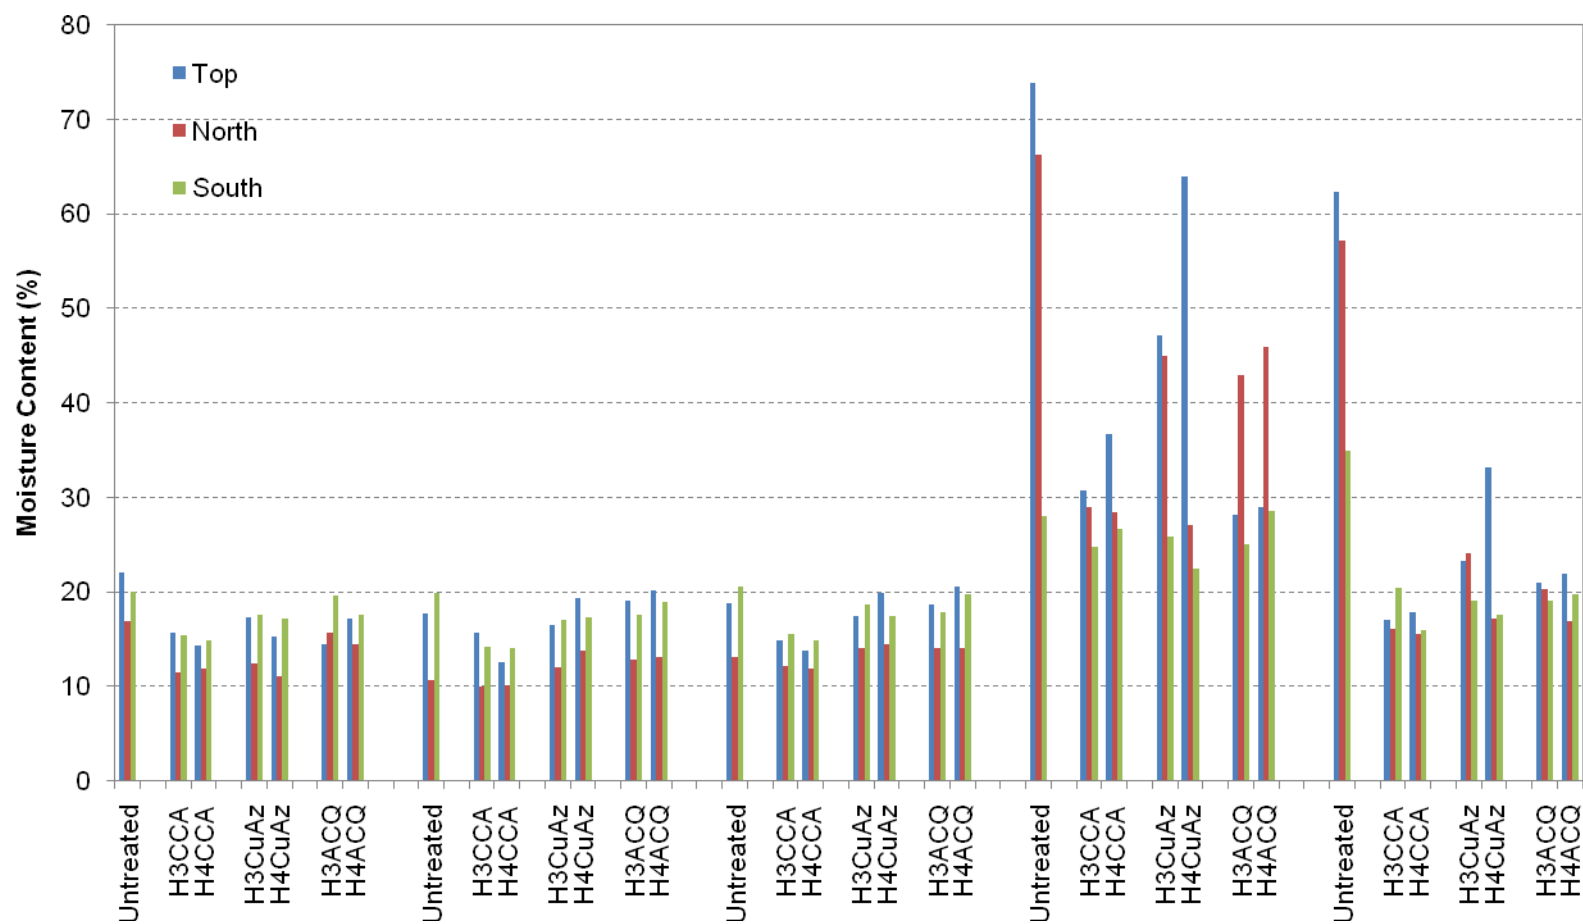
From Figures 45 and 46, it can be seen that the timber blocks at the top of the gate had a higher moisture content than the blocks at the side. In addition, the south side is generally wetter than the north side. This might be a result of different times of heating by solar irradiation. Actually, the surface temperature of the timber on the south side was measured to be about 2°C lower than that on the north side.

However, these observations cannot explain why zinc-coated fasteners on the north side did not exhibit a lower corrosion rate than those on the top, particularly when inserted into CCA and ACQ treated timbers. This would be expected since the timber moisture content on the north is much lower than that on the top. Obviously corrosion in timbers is governed by many factors and moisture content is just one of them. Moisture can influence acid release and leaching of preservation chemicals, and then the corrosion process. However, the exact influences of moisture content and the contribution of other factors are not completely understood at this moment.

**Figure 45:** Moisture content of timber blocks exposed at Judgeford site – the date for test is (from left to right): 01/April, 12/April, 13/April, 14/April and 15/April/2010

In addition, measurements shown in Figures 45 and 46 imply that CuAz and ACQ treated timbers tend to have slightly higher moisture content than CCA treatment, although the mechanism behind this is not known (and the results need to be confirmed).

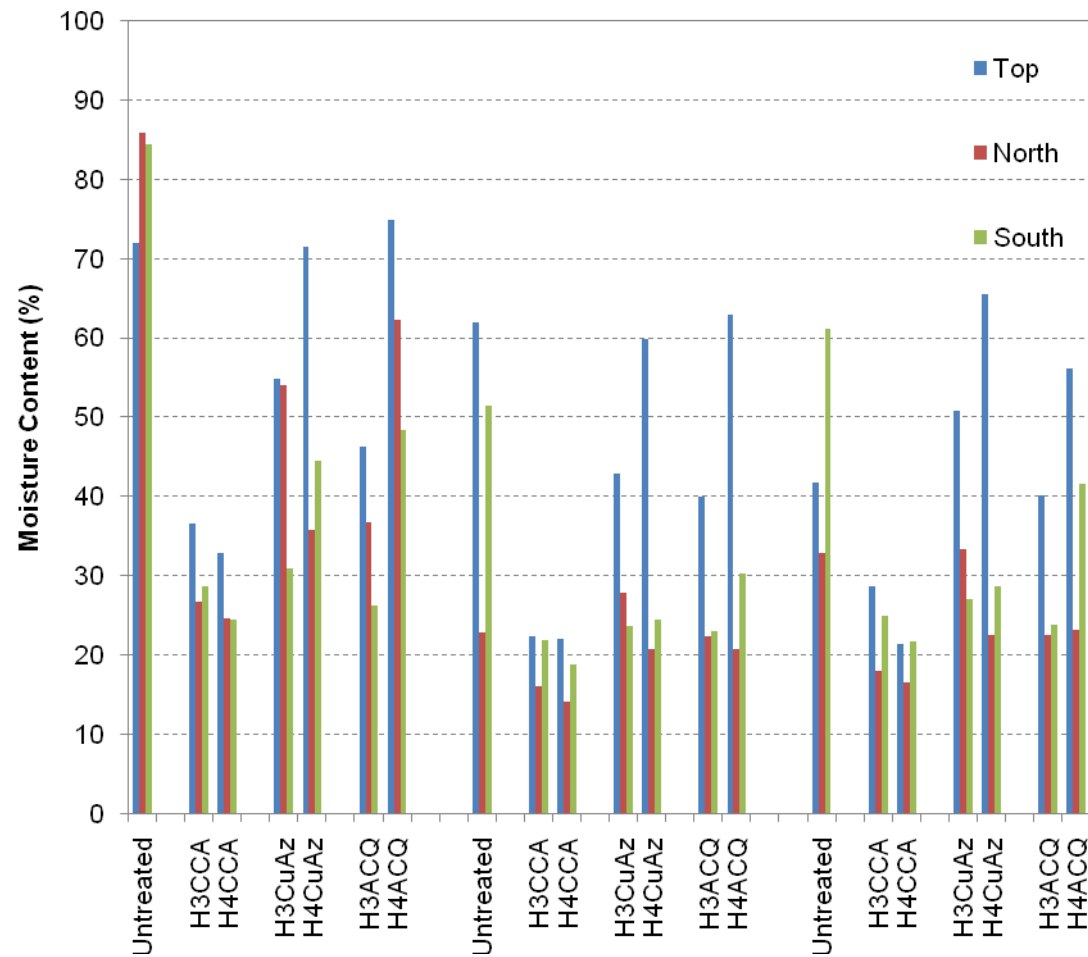
**Figure 46:** Moisture content of timber blocks exposed at Judgeford site – the date for test is (from left to right): 01/July, 05/July and 14/July/2010

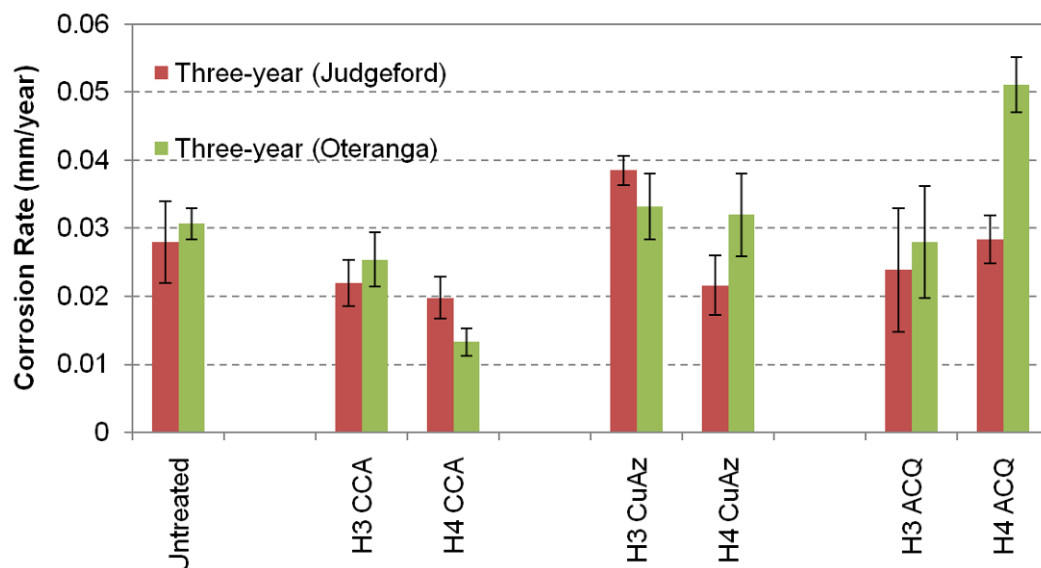
A comparison between the corrosion rates and surface morphologies of the fasteners embedded into the timbers exposed at these two sites showed that the macro-environment was affecting the corrosion process. Mild steel fasteners (including nails and screws) and mechanically-plated screws inserted into the timbers exposed at Oteranga Bay generally had a slightly higher corrosion rate than those inserted into the timbers exposed at Judgeford. However, corrosion rates measured with the hot dip galvanised nails exposed at Oteranga Bay were not always higher than those at Judgeford. Actually, lower corrosion rates were even observed with galvanised nails inserted into H3 and H4 CuAz treated timbers exposed at Oteranga Bay. Those were 56-74% of the rates obtained from the Judgeford site (see Figures 47 through 49).

Mild steel has very low resistance to corrosion. Its mass loss in a severe marine environment (i.e. Oteranga Bay) could be at least two to four times greater than that in a moderate environment (i.e. Judgeford). Mild steel fasteners would then experience a faster corrosion on their head areas, contributing to a slightly higher corrosion rate when averaged by the whole surface area. This agrees well with the current measurement results.

**Figure 47:** Corrosion rates of mild steel nails measured after three years of exposure at Judgeford and Oteranga Bay

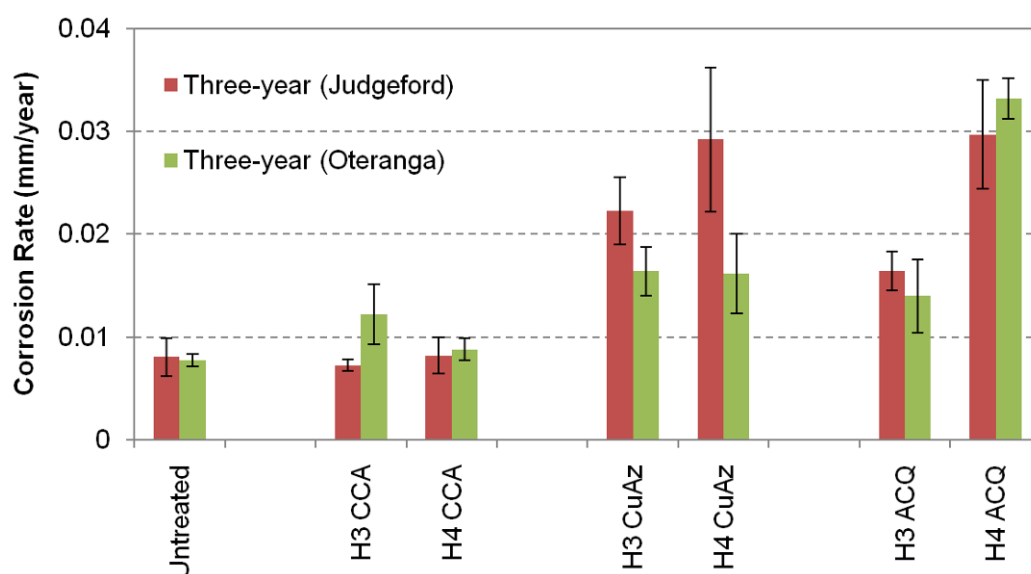
**Figure 48:** Corrosion rates of hot dip galvanised nails measured after three years of exposure at Judgeford and Oteranga Bay

Thus, material deterioration of these hot dip galvanised nails in these timbers was still mainly controlled by the micro-environment inside the timber i.e. the moisture content and the active preservative species. This could partially explain why the hot dip galvanised nails exposed at Oteranaga Bay exhibited a similar corrosion rate to those exposed at Judgeford.

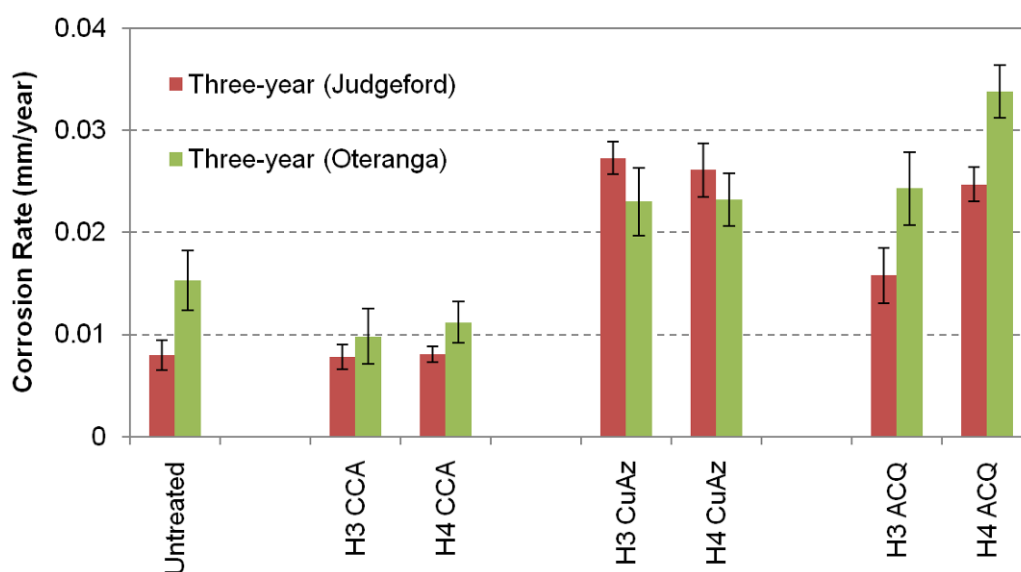
**Figure 49:** Corrosion rates of mechanically-plated screws measured after three years of exposure at Judgeford and Oteranga Bay

Zinc coatings on the screws used in this study were produced by mechanical plating and had more physical defects, thus a lower corrosion resistance [Schweitzer 2007]. Without a doubt, deposition of airborne salt particles on their top surfaces was contributing to their accelerated corrosion. In contrast, hot dip galvanised zinc coating

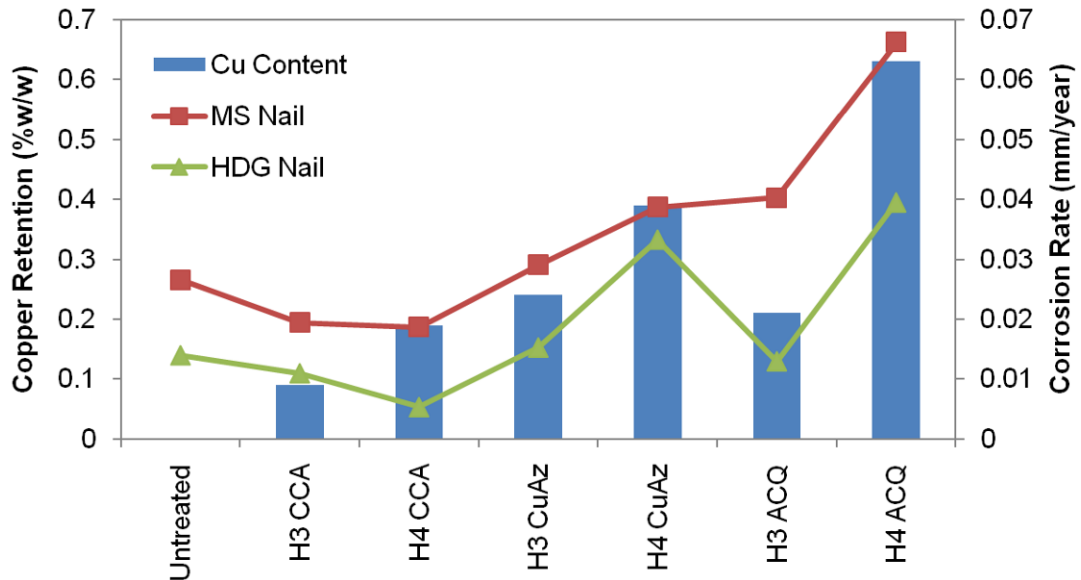
Figures 50, 51 and 52 present the correlation between the retained copper content in the freshly treated timber and the experimentally measured corrosion rate of mild steel and hot dip galvanised nails in this study.

In general, the corrosion rate of mild steel and/or galvanised steel fasteners increases with the copper content in the treated timber. For example, nails and screws in CuAz and ACQ treated timbers have a higher mass loss rate than those in CCA treated timbers, where CuAz and ACQ treated timbers do have a higher copper content than CCA treated timbers. This trend is quite obvious for mild steel fasteners in timbers after one year of exposure and hot dip galvanised nails in timbers after three years of exposure. Different behaviours had also been noticed:

**Figure 50:** Correlation between copper retention in the freshly treated timbers and corrosion rate of nails embedded in the timbers exposed at Judgeford site for one year

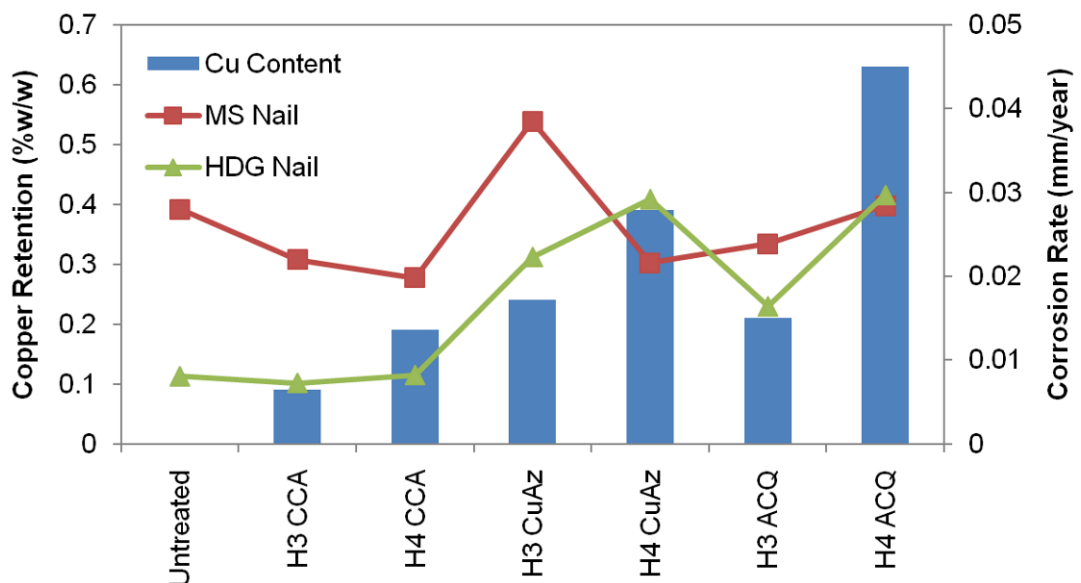
**Figure 51:** Correlation between copper retention in the freshly treated timbers and corrosion rate of nails embedded in the timbers exposed at Judgeford site for three years

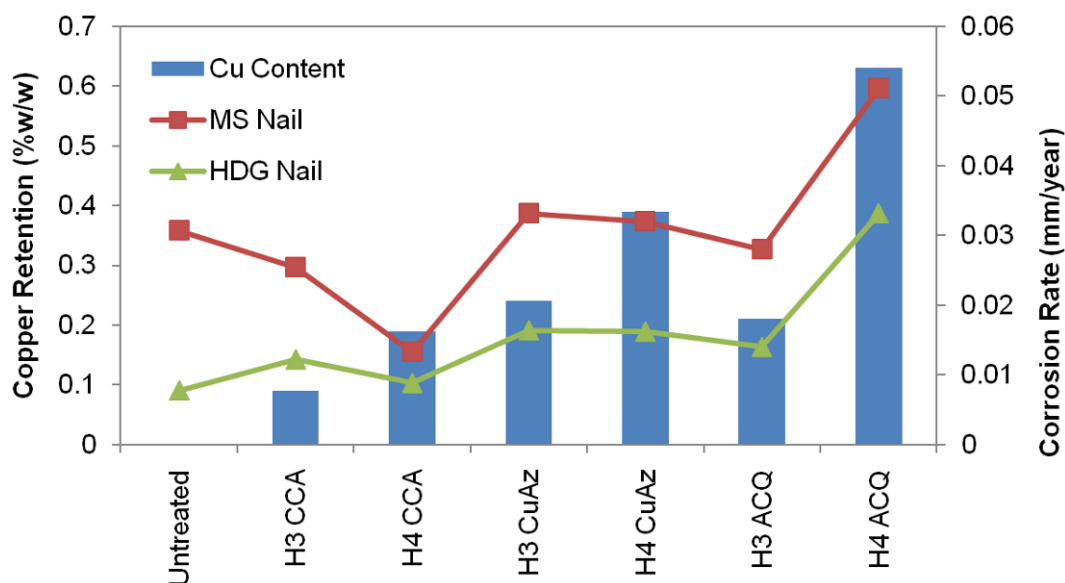
**Figure 52:** Correlation between copper retention in the freshly treated timbers and corrosion rate of nails embedded in the timbers exposed at Oteranga Bay for three years
