# **STUDY REPORT**

**SR 327 (2015)**

## **Structural Performance of Houses in the Canterbury Earthquake Series**

**G.J. Beattie, R.H. Shelton and G.C. Thomas**

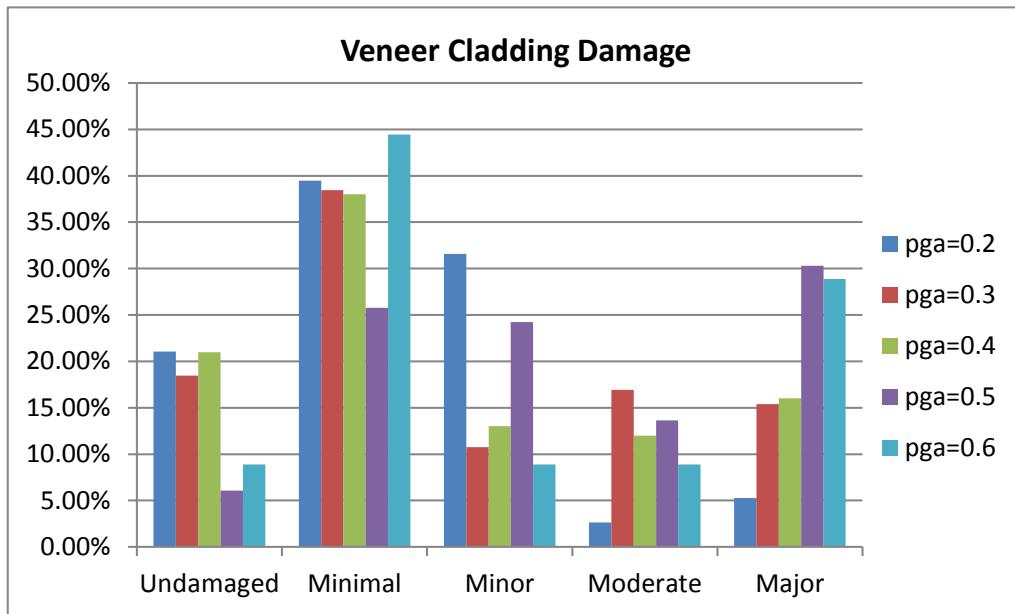
Figure 11. Veneer damage as a function of peak ground acceleration

It was intended that the damage to claddings be compared against the highest peak ground acceleration (PGA) from either the February 2011 or the June 2011 event. However, from the PGA contour maps, none of the houses surveyed underwent a higher PGA in June than February, so only February values were used for comparison. Figure 11 compares PGA against damage to veneer claddings. The expected result would be that damage would generally increase with increased PGA for claddings, which would show up as higher percentages for the lower PGA for undamaged and minimal damage observations. As the PGA increased, higher percentages would be expected for the major damage observations. This expectation was met, which gives confidence in the accuracy of the survey, but there were some anomalies. There was a slightly lower proportion of houses subjected to a PGA of 0.2 and 0.3 in the undamaged category than those subjected to a PGA of 0.4. There were more in this category subjected to a PGA

of 0.6 than a PGA of 0.5. There is some variation due to statistical variation, but an obvious explanation for this discrepancy is the effect of liquefaction on damage to houses on sites that experienced a lower PGA.

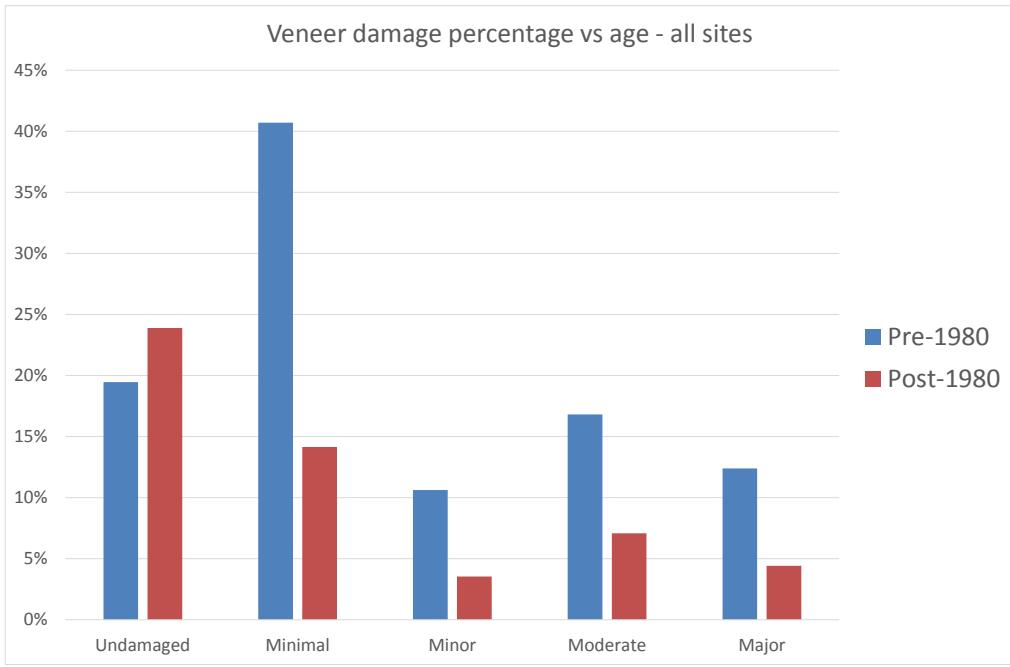
**Figure 12. Veneer damage as a function of house age (all ground conditions)**

House age was divided into pre-1980 and post-1980. This corresponds with the introduction of NZS 3604 *Code of practice for light timber frame buildings not requiring specific design* in 1978, with some allowance for uptake of the new standard. Figure 12 shows a comparison of veneer cladding damage against house age for all houses where veneer was present.

The percentage of post-1980 houses with damage was always significantly less than the pre-1980 house sample, across the range of damage levels. In the mid-1990s, changes were made to the standardised requirements for tying brick veneers to the framing. It was therefore expected that the performance of these veneers would be significantly better than veneers installed earlier. However, observations immediately after the earthquakes (Buchanan et al. 2011) indicated there were often bond issues between the mortar and the bricks in relatively new construction, leading to collapse of the veneer.

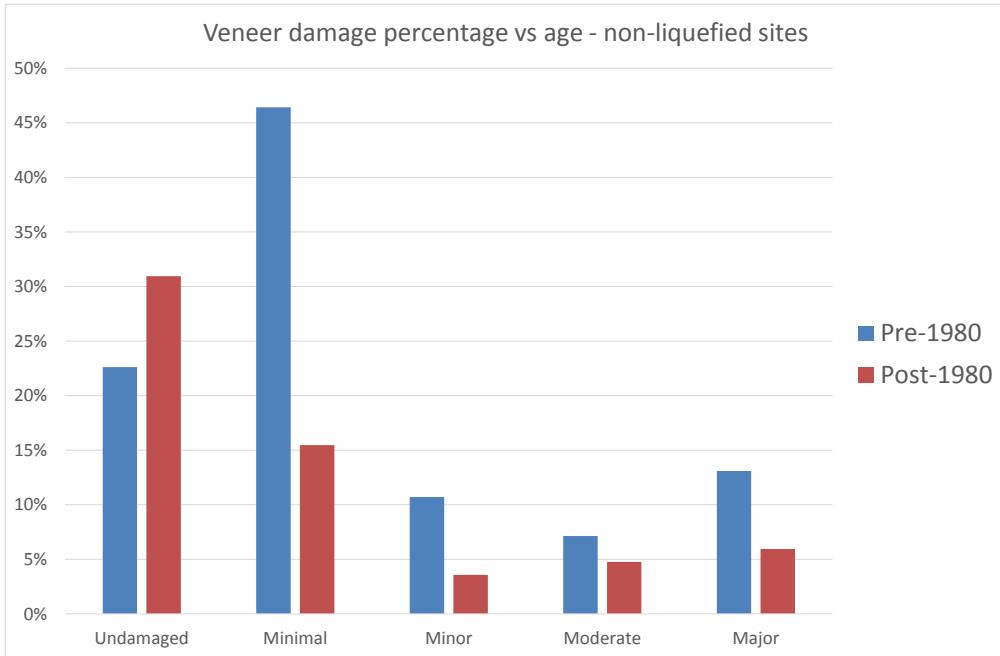
**Figure 13. Veneer damage as a function of house age (non-liquefied ground)**

Approximately 80% of the surveyed houses with veneers were on sites where no liquefaction had occurred. Shaking was therefore the major cause of any damage to the veneer. Figure 13 presents similar data to Figure 12 for these houses. There is no major difference between the trends except that the proportion of veneers with moderate damage has lessened for both age groups. The reason for this difference is not obvious.

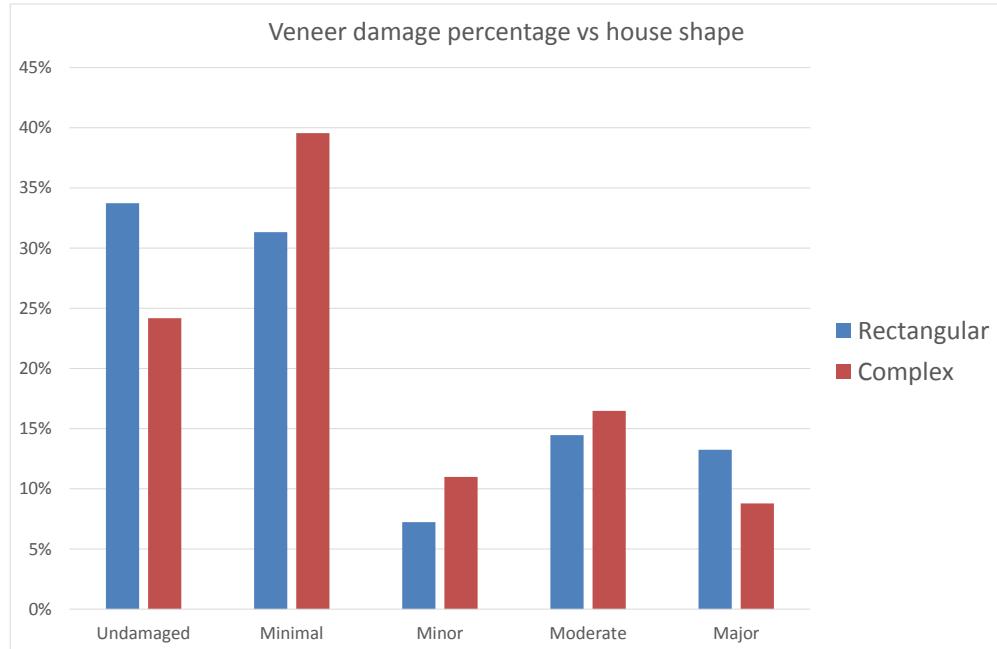
**Figure 14. Veneer damage as a function of house shape**

Of the houses in the sample, 57% were mostly rectangular (see section 4.5 for a definition). Non-rectangular (complex) houses had more damage overall to claddings (Figure 14). Mostly rectangular houses are more likely to be in the undamaged or minimal categories for veneer damage, and this is confirmed by Figure 14. Close to 35% of the rectangular houses had no veneer damage compared to less than 25% of the non-

rectangular houses. When damage did occur, with the exception of the major damage band, the non-rectangular houses had greater percentages of the sample. There is likely to be significant differential movement between two planes of cladding meeting at a re-entrant corner with confinement by the other plane of cladding and wall framing limiting differential movement. Therefore the cladding can generally only crack, displace or fall off, which could explain some of the additional damage.

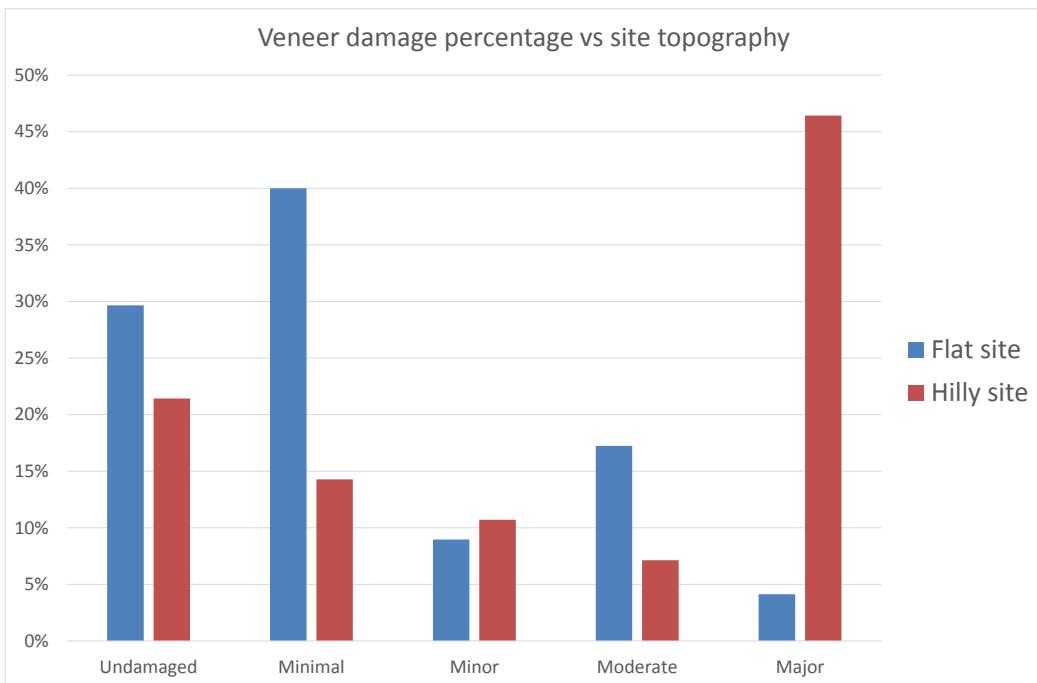
**Figure 15. Veneer damage as a function of site topography**

The effect of topography on damage is marked. Figure 15 shows that a large proportion of houses on hilly (sloping or hilltop) sites had some veneer cladding damage. Although the percentage of the sample reduces as the damage level increases, there is a marked jump at the major damage level to 46%. In comparison, 70% of the houses on the flat had either minimal damage or were undamaged and had a very low proportion of major damage. This finding aligns with the fact that the level of shaking was higher in hill suburbs, with some particularly high vertical accelerations recorded.

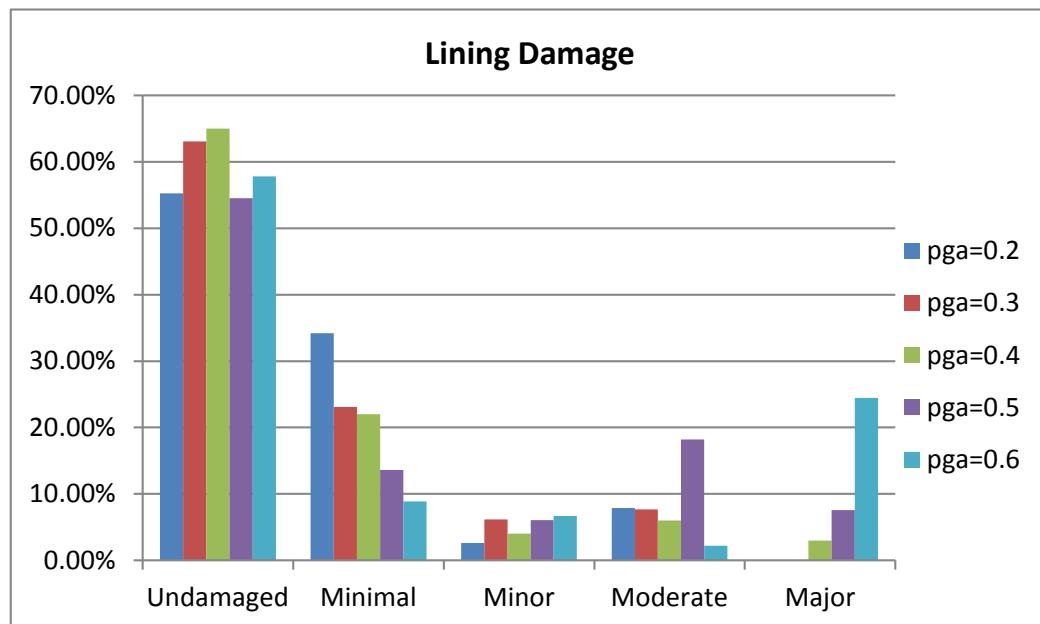
Figure 16. Lining damage as a function of peak ground acceleration

As reported above, 79% of the houses were lined with plasterboard. Figure 16 gives a plot of damage to all linings versus peak ground acceleration (PGA). Of the 57 properties that had major damage recorded, one-third had linings that were other than plasterboard, a figure disproportionate to the material proportions in the sample. However, this skewing is to be expected because the majority of non-plasterboard linings were either lathe and plaster or fibrous plaster. The first of these is very brittle and the second cracks easily, resulting in high damage levels.

It is worth noting that quite a high proportion of the sample (approximately 55%) sustained no damage, regardless of the PGA. While not so clear for the minor and moderate damage categories, the trend to fewer instances of minimal damage and more instances of major damage as the PGA increases is obvious.

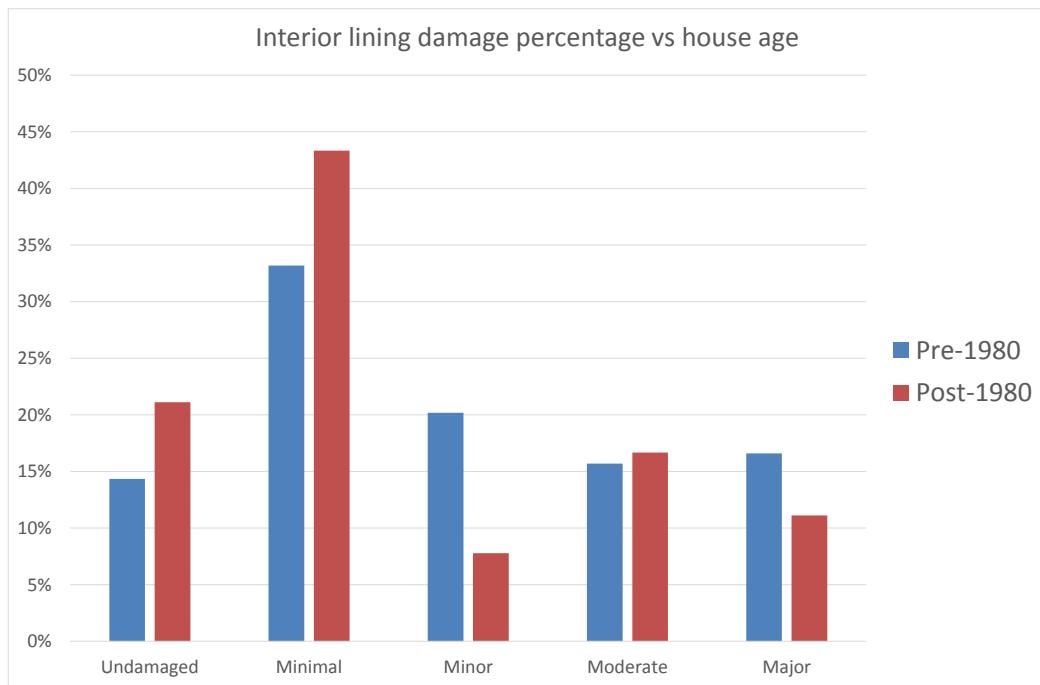
**Figure 17. Comparison of interior lining damage with house age**

Figure 17 presents a plot of recorded lining damage against age. Although older and newer houses had a similar proportion in the moderate category, overall, the older houses performed slightly worse, with more in the minor and major category. Pre-1980s houses had slightly fewer openings. More importantly, the location of openings around the houses, as measured by the relative proportions of windows recorded in the survey on each side, is more even. It can be inferred that improvement in bracing performance with NZS 3604 has been largely countered by a trend for dominant openings on one or two adjacent sides of a house. An increase in the overall amount of openings has contributed to a lesser extent.

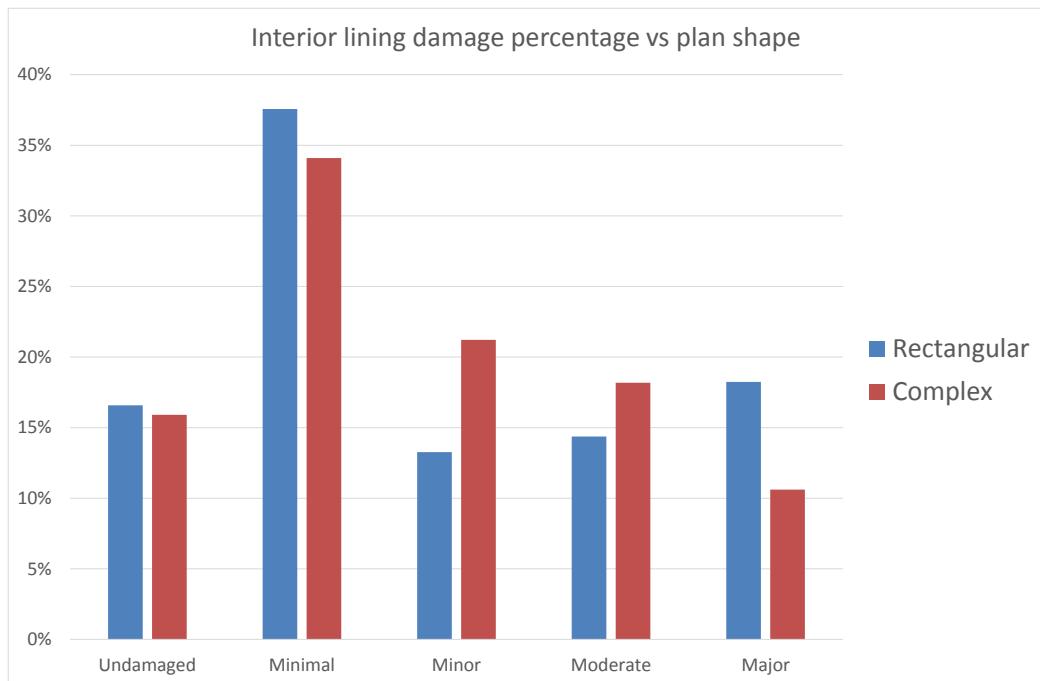
**Figure 18. Comparison of interior lining damage against plan shape**

A complex plan shape is expected to result in more damage to interior linings because of potential movement at junctions between the various parts of the building. Figure 18 presents a comparison between the damage sustained by the two shapes (57% of the houses in the sample were rectangular). The expectation is largely justified – a greater proportion of the complex properties experienced minor and moderate damage whereas a greater proportion of the rectangular houses had either no or minimal damage.

The exception was the major damage category where the rectangular-shaped dwellings fared worse than the complex ones. A visual inspection of the survey records did not identify any particular reason for this anomaly. One possible reason for the greater

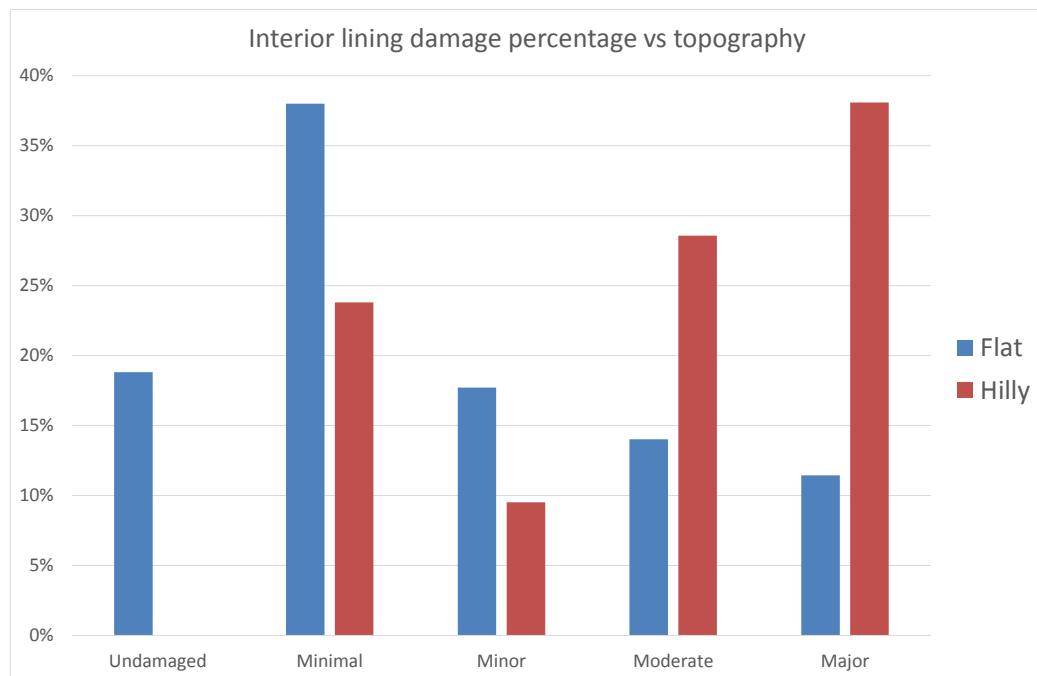
**Figure 19. Comparison of interior lining damage against topography**

Figure 19 presents a plot of lining damage with topography. The effect of topography on damage is marked. All houses on hilly (sloping or hilltop) sites had some lining damage. In the minimal and minor categories, a higher proportion of houses were on the flat, but 66% of the houses on hilly sites had moderate or major damage to linings. This should be compared to only 25% of the houses on the flat with moderate or major damage. This observation appears to confirm that, unless houses were badly damaged by liquefaction settlement on the flat, the performance of their linings was significantly better than those in houses on the hills.

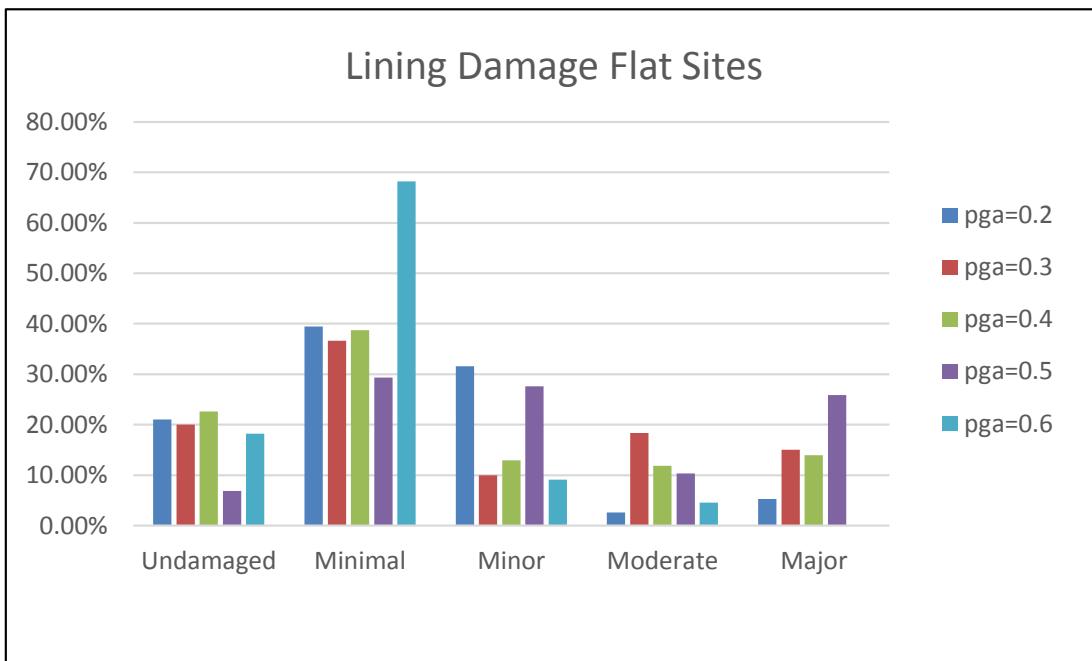
**Figure 20.** Lining damage as a function of PGA for flat sites

Figure 20 and Figure 21 provide a breakdown of the damage to linings on flat and hilly sites respectively, versus peak ground acceleration (PGA). Figure 21 shows that all houses on hilly (sloping or hilltop) sites had some lining damage. Although in the minimal and minor categories a higher proportion of houses were on the flat, over 50% of houses on hilly sites had major damage to linings. The same trend, although less marked, is apparent for veneer damage, with over 30% of the houses on hilly sites having major damage to veneer claddings. This finding is complicated by the fact that the level of shaking was higher in hill suburbs.

It is difficult to draw general conclusions from the middle of the range of lining damage, but at the extremes, findings are more obvious. No houses on hilly sites had linings that were undamaged, regardless of the PGA, but on flat sites, about 17% were undamaged. In the major category, there are a much higher proportion of houses, regardless of PGA, on hilly sites.

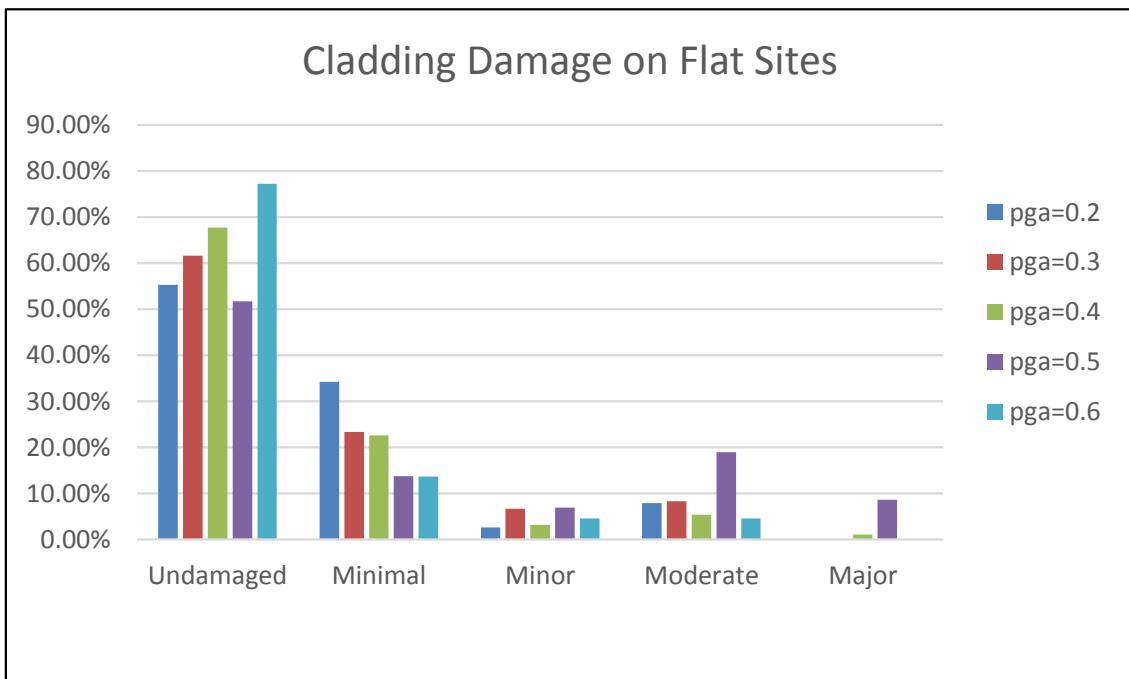
Figure 22. Veneer cladding damage as a function of PGA for flat sites

For cladding damage, because of the smaller sample size for both hilly and flat sites, there is more scatter in the data. However, there appears to be some evidence of a trend of more damage in hilly sites regardless of PGA. The effect of site topography on shaking damage would likely be more marked if the properties with liquefaction effects were removed from the sample.

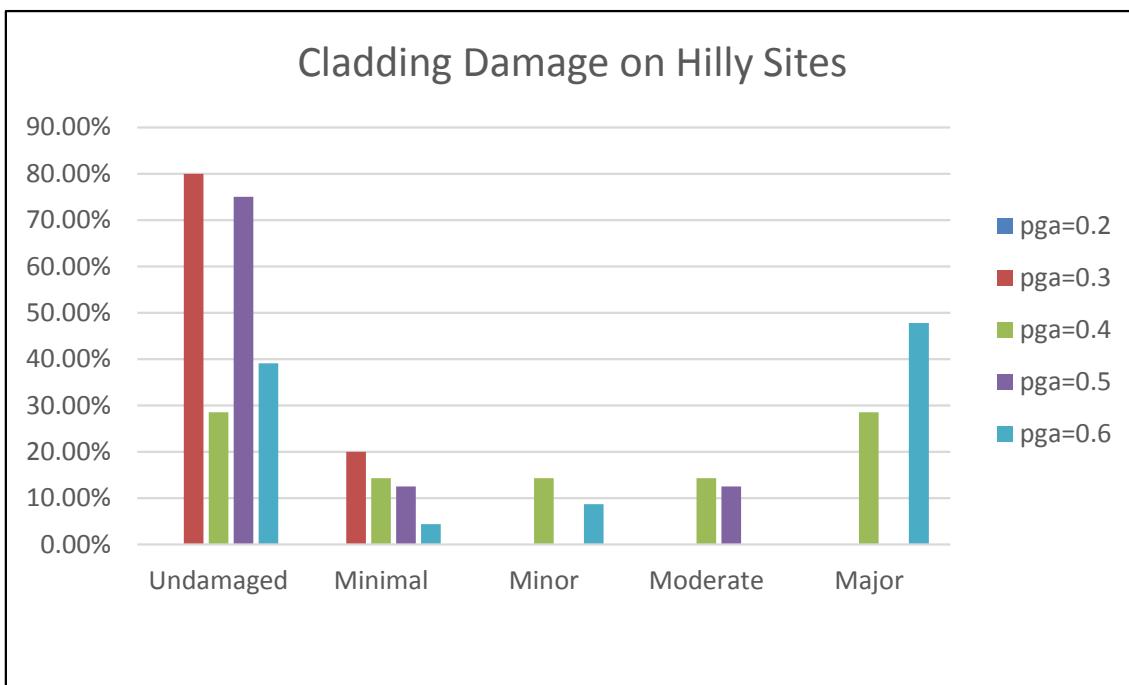
Figure 23. Veneer cladding damage as a function of PGA for hilly sites
