ISSUE 631 **BULLETIN**

HOW MICRO-ENVIRONMENTS AFFECT MATERIAL PERFORMANCE

December 2018

■ This bulletin reports on the first monitoring of how micro-environments affect material performance on a BRANZ test building near Wellington.

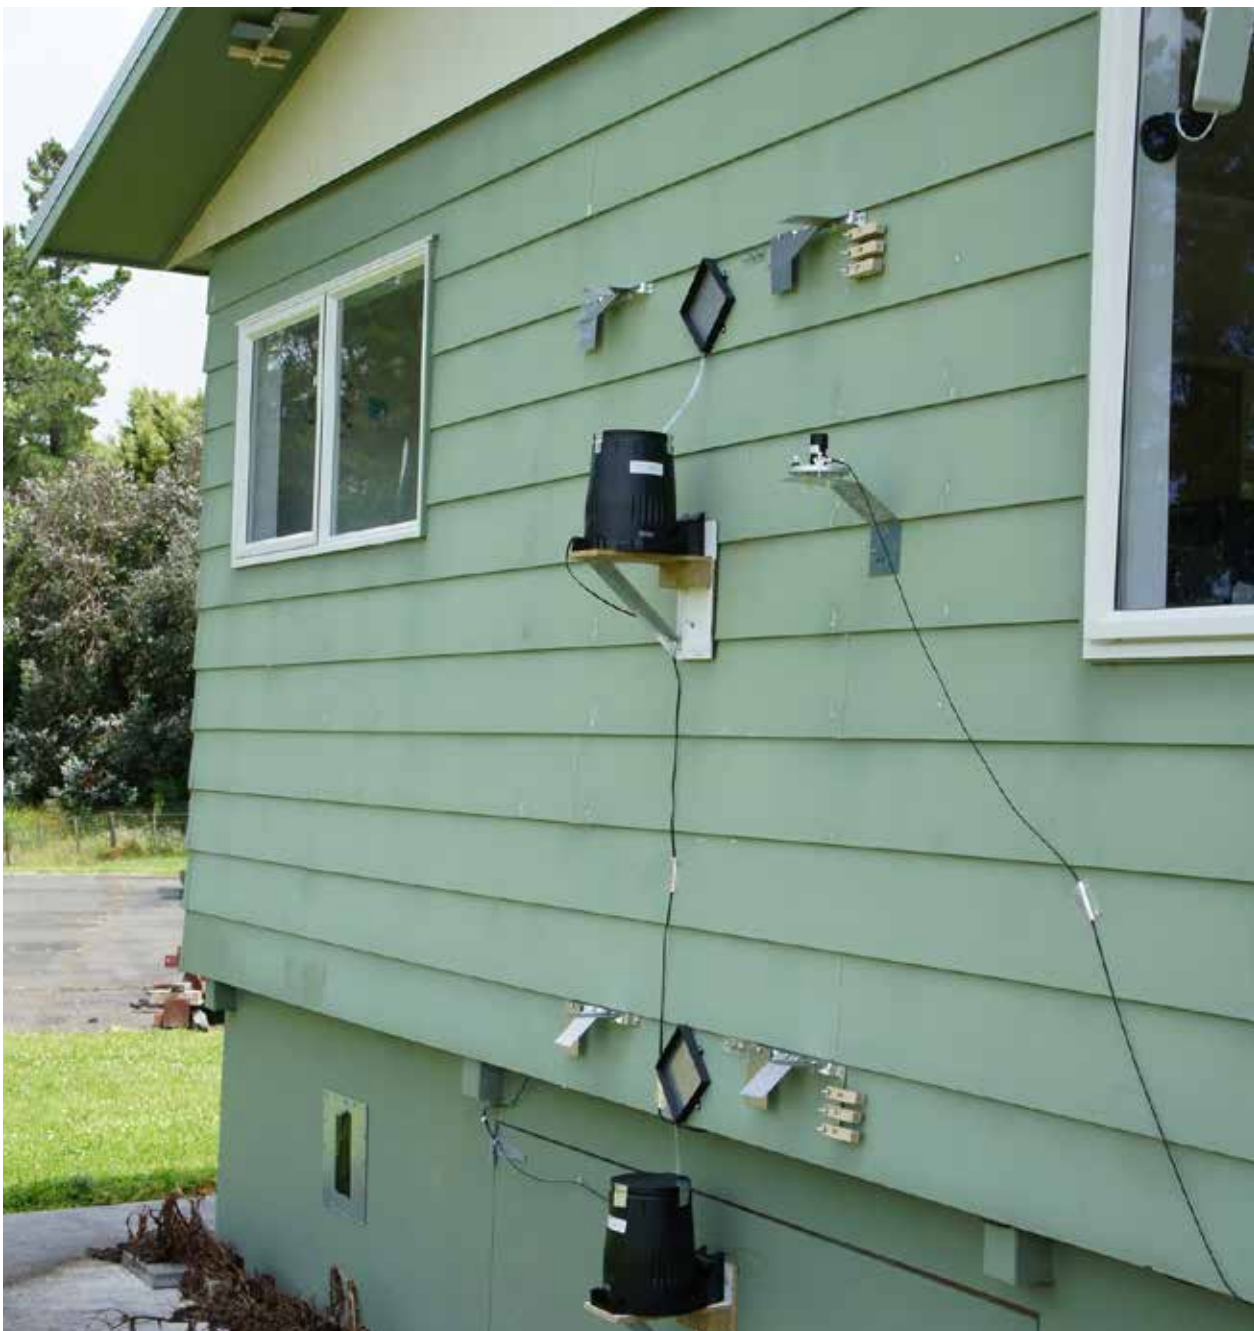
The BRANZ test house at Judgeford, Porirua.

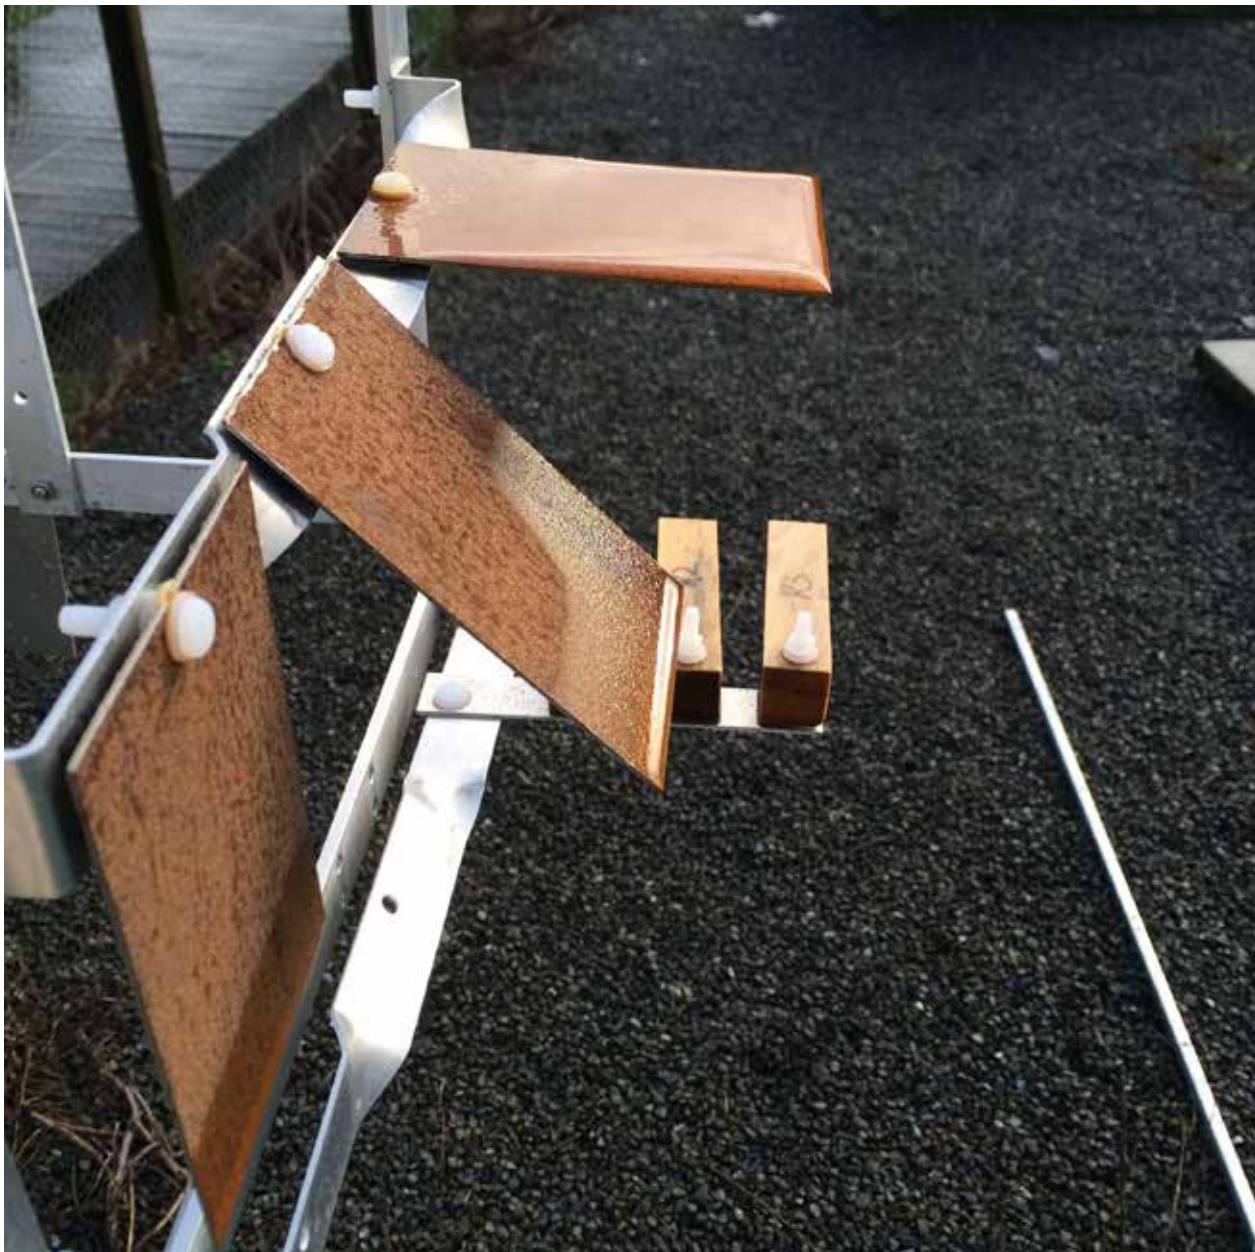
Mild steel coupons were installed in an exposed location away from the BRANZ test house.

8.0.2 The first-year corrosion rates of mild steel coupons (Table 2) available on this test building show the following:

- Samples on the building generally had a lower corrosion rate than those fully exposed to the atmosphere.
- In most cases, the horizontal samples on the building had the highest corrosion, followed by the 45° inclined samples and then the vertical samples. The biggest difference was between these last two – the 45° inclined samples could corrode 2–3 times faster than the vertical samples.
- On the north wall, the horizontal sample in the exposed position showed significantly greater corrosion than that in the sheltered position. With the vertical sample, there was little difference. For the 45° inclined sample, the sheltered position showed a greater corrosion than the exposed position.
- On the south wall, all the exposed samples showed significantly greater corrosion than the sheltered samples.
