Corrosion over the building envelope

The risk of corrosion is different on different parts of the building envelope. Understanding this and specifying the appropriate metals and protective measures for the different locations will help ensure buildings and building materials have significantly greater durability and longer service lives.

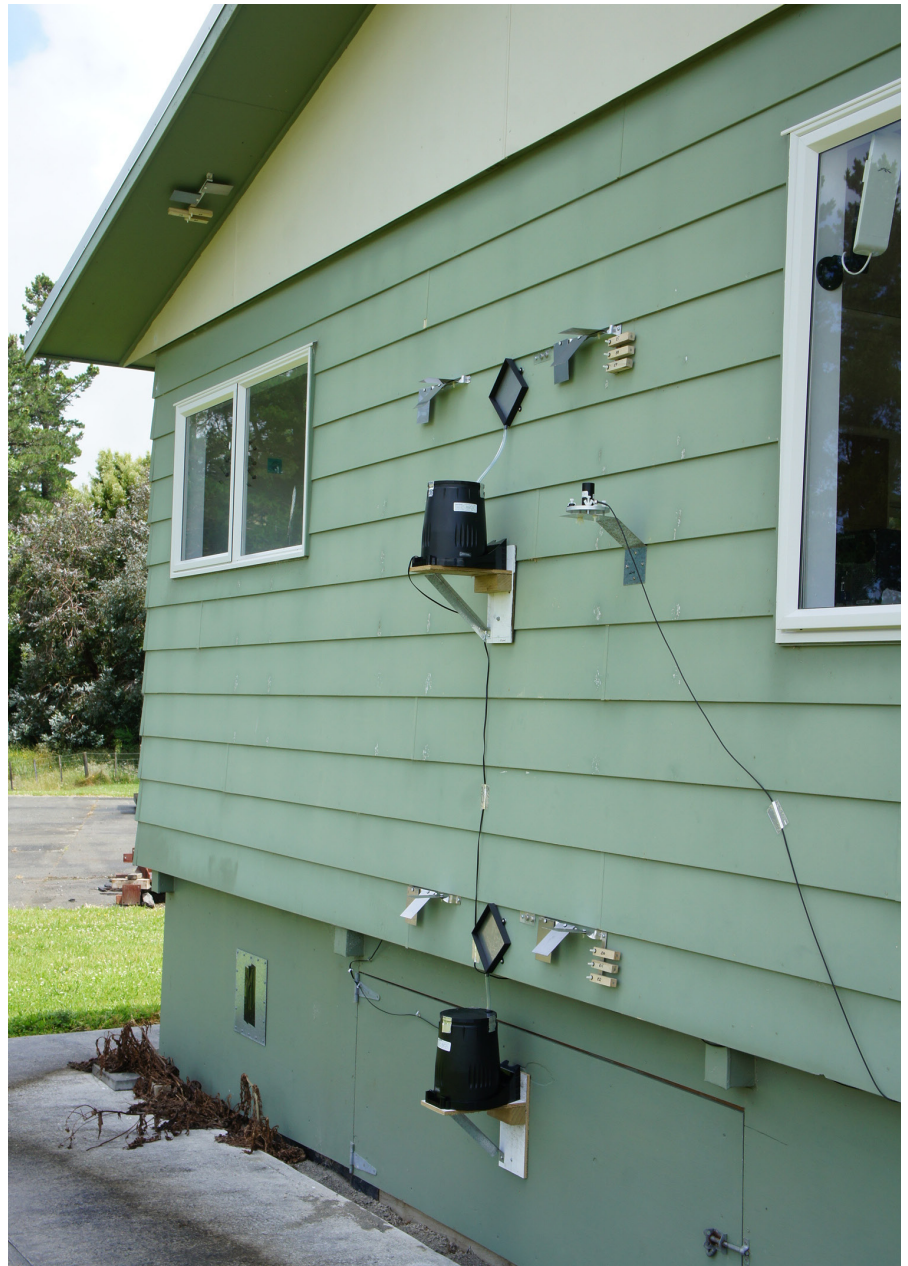
Figure 2. Measuring equipment installed on the BRANZ test building at Judgeford (semi-rural environment).

A test building in BRANZ's semi-rural Judgeford campus (approximately 5 km from a saltwater estuary) was used for one trial (Figure 2), with the following findings:

- As might be expected, the lower position on each wall generally received more wind-driven rain – up to 3–5 times more – than the higher position. Roof eaves restrained rain access to the area immediately below.
- Sheltered wall areas (which receive less rain washing) often collected the most salt, and higher positions on a wall collected more salt than lower positions.
- On the north wall, a steel plate sample fixed horizontally in the exposed position showed significantly greater corrosion than that in the sheltered position. With a sample fixed vertically, there was little difference. For a steel plate sample inclined at a 45° angle, the sheltered position showed a greater corrosion than the exposed position.

- On the south wall, all the exposed samples showed significantly greater corrosion than the sheltered samples.
- Corrosion rates of mild steel nails in H3.2 CCA-treated timber blocks installed at different locations on the building were also measured after 1 year's exposure. On both north and south walls, the nails in the exposed position showed significantly more corrosion than the nails in the sheltered position. Higher moisture levels were clearly the dominant factor.
