# **STUDY REPORT**

**No. 154 (2006)**

## **Racking Tests on Rooms and Isolated Walls to Investigate Uplift Restraint and Systems Effects**

**SJ Thurston**

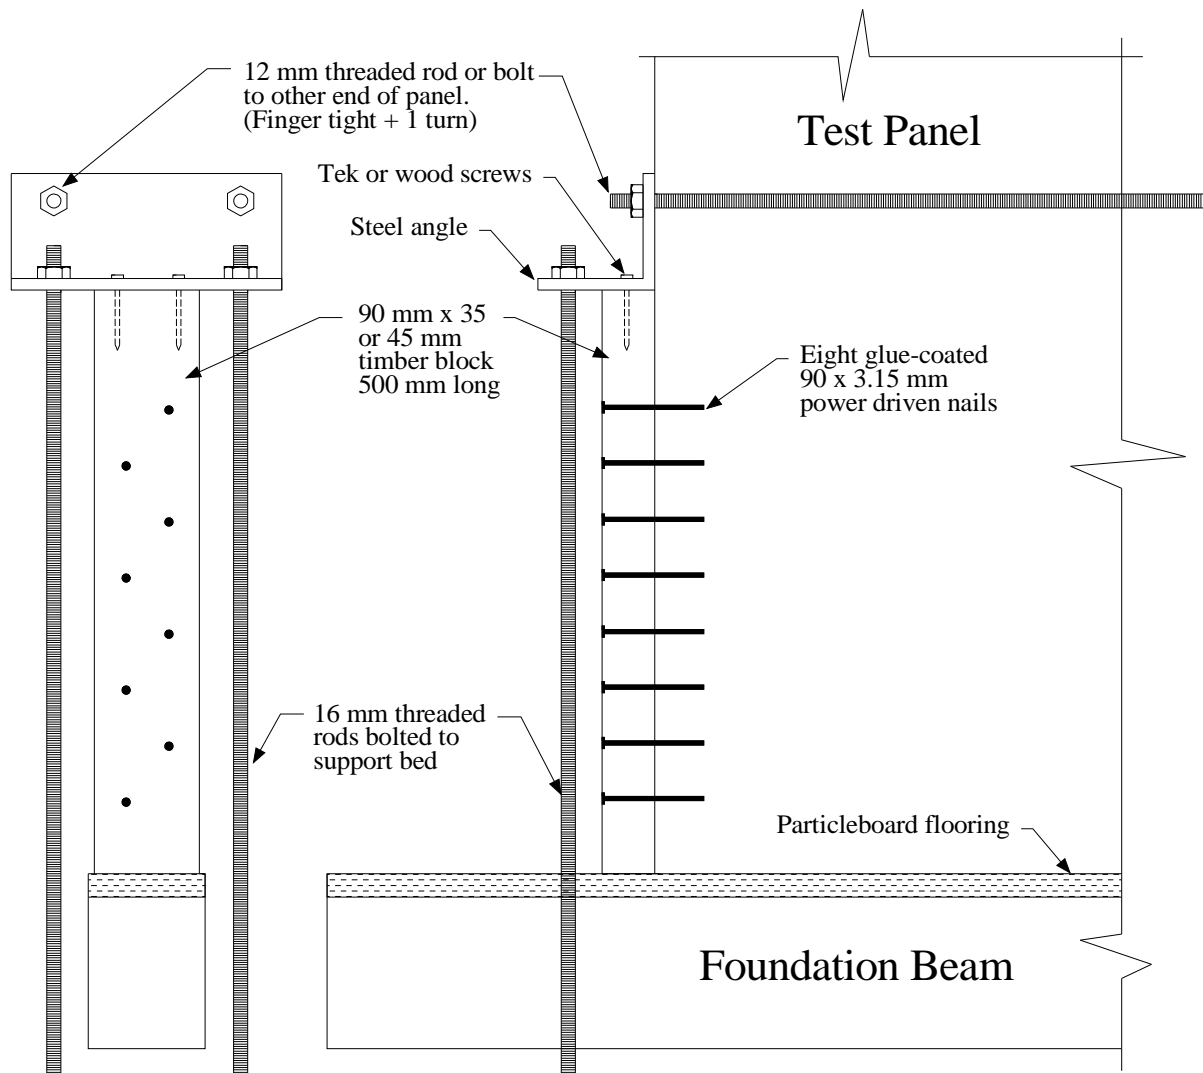
**Figure 3. EM3 '8-nail' contrived end uplift restraint**

Most wall racking test procedures used around the world do not simulate the effect of continuity of construction. On the other hand, some use additional restraints to completely resist 'rocking' action. The BRANZ P21 test (Cooney and Collins 1979) is an exception in that it provides partial end restraints. This is a '3-nail' end uplift restraint. It is proposed that this test procedure is replaced by the EM3 test procedure (Thurston 2004) which is similar but increases the end restraint to an '8-nail' end restraint (see Figure 3). However, the final conclusion of this report was that a '6-nail' end restraint was more appropriate.

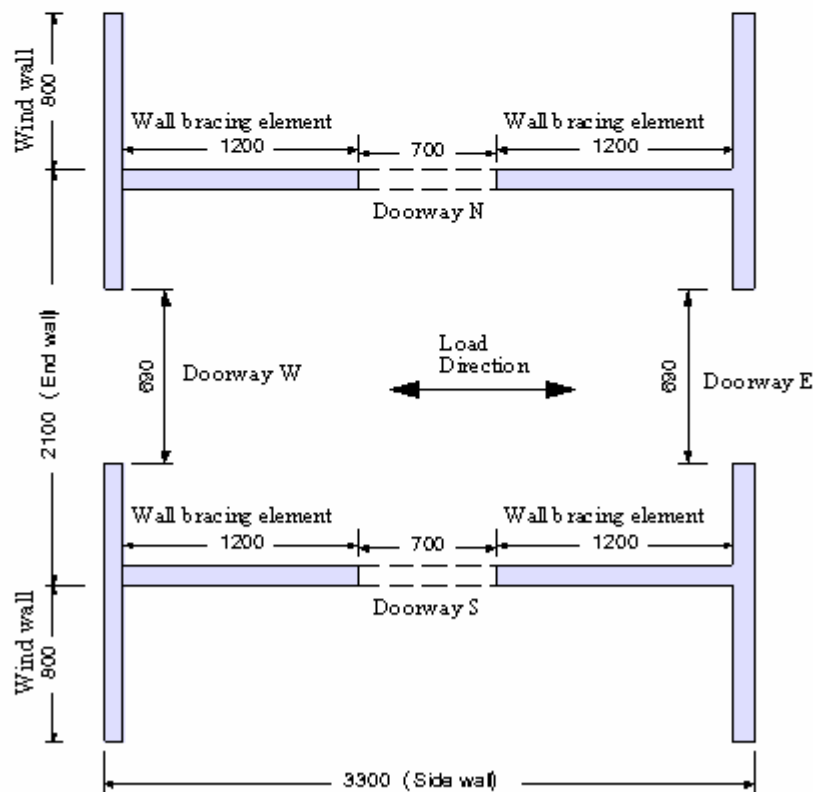
**(b) Plan of interior wall construction  
(with wing walls).  
Tests R5, R6 and R7**

**Figure 4. Plan view of room tests**

The tested room size was 3.3 m x 2.1 m in plan and 1.2 m high. Four of the rooms used exterior wall type construction (Rooms R1, R2, R3 and R4) as shown in Table 3 and Figure 4(a) and three of the rooms used interior wall type construction (Rooms R5, R6 and R7) as shown in Table 3 and Figure 4(b).

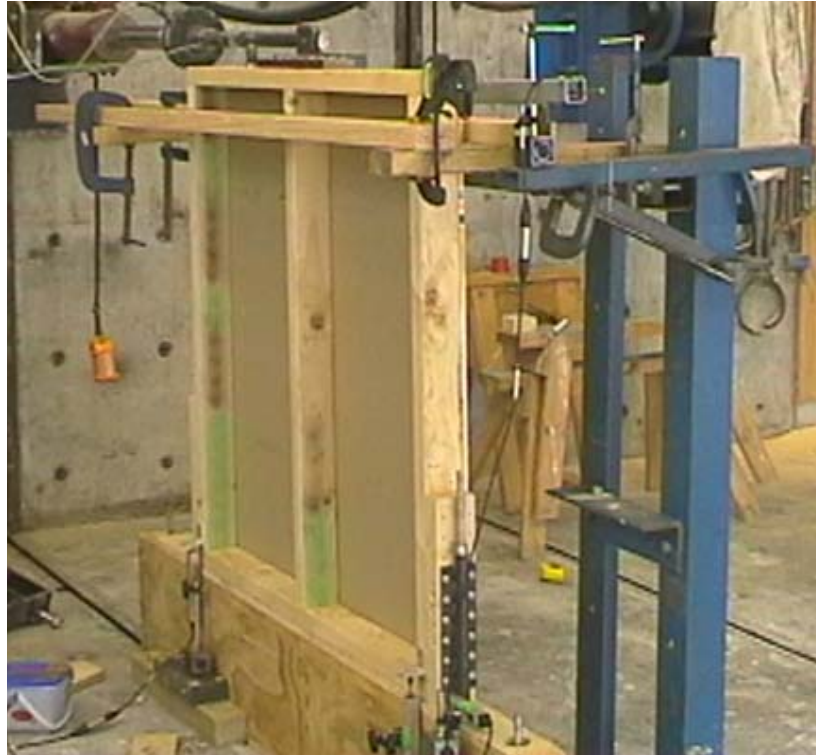
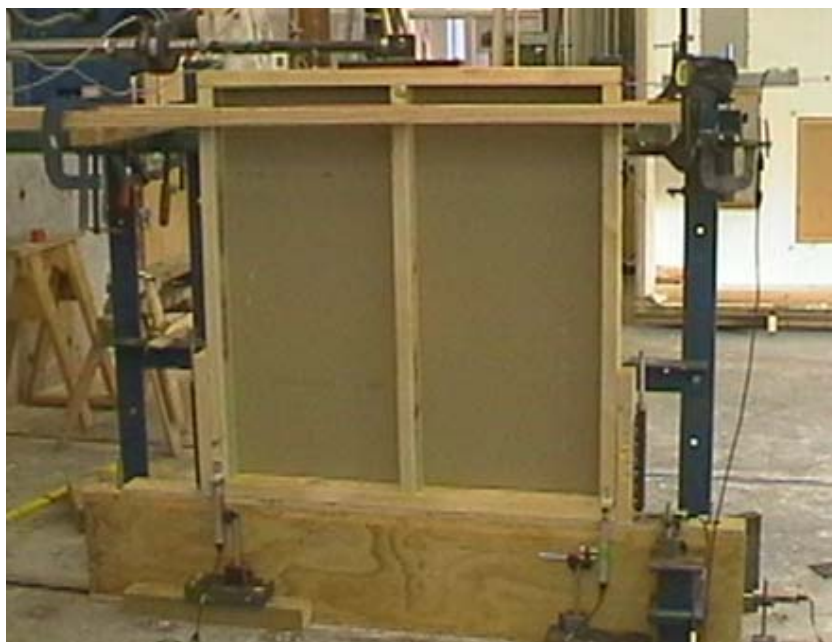
**Figure 5. Photographs of half-scale wall tests**

Racking tests were performed on all walls used in the room tests that were parallel to the loaded direction. See Figure 5 for photographs of the half-scale wall tests and Figure 6 for a photograph of the room tests. Both the room and these isolated walls were constructed at half-scale. They had the same fixings to the foundations and these were placed at the same spacing. To achieve similitude between half-scale and full-scale tests, the '8-nail' end restraint proposed for EM3 tests on isolated walls was replaced with a '4-nail' end restraint. This is discussed further in Section 0. Timber guides were used to preclude lateral deflection.

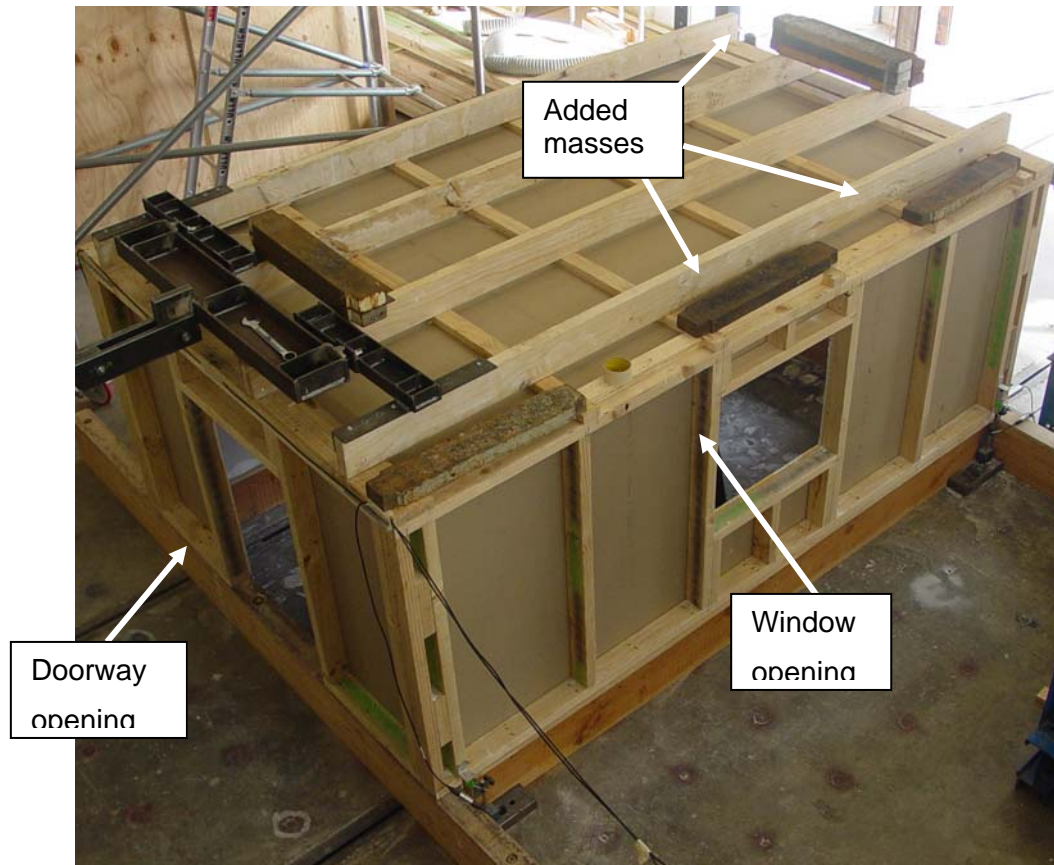
**Figure 6. Photograph of tested half-scale room with exterior wall simulated construction**

Seven 'rooms' (summarised in Table 3) were cyclically racked to failure as shown in Figure 6. The room walls were built on timber foundation beams which themselves were bolted to a strong-floor. In five of the tests the walls were nailed to the foundation beam as shown in Table 3. In the other two tests the walls were bolted to the foundation beam to simulate construction on a concrete floor. All test specimens were a box-like construction consisting of four walls and a ceiling.

A typical room using the exterior wall set-up is shown in Figure 6. Note that there are no wing walls. It had door openings in the end walls and window openings in the side walls. The room interior was lined with PLB plasterboard and the exterior was clad with MDF for some tests and unclad in others (as defined in Table 3). The PLB plasterboard joints were fully taped and stopped (i.e. plastered) in all tests except Room R1 where joints were not plastered.

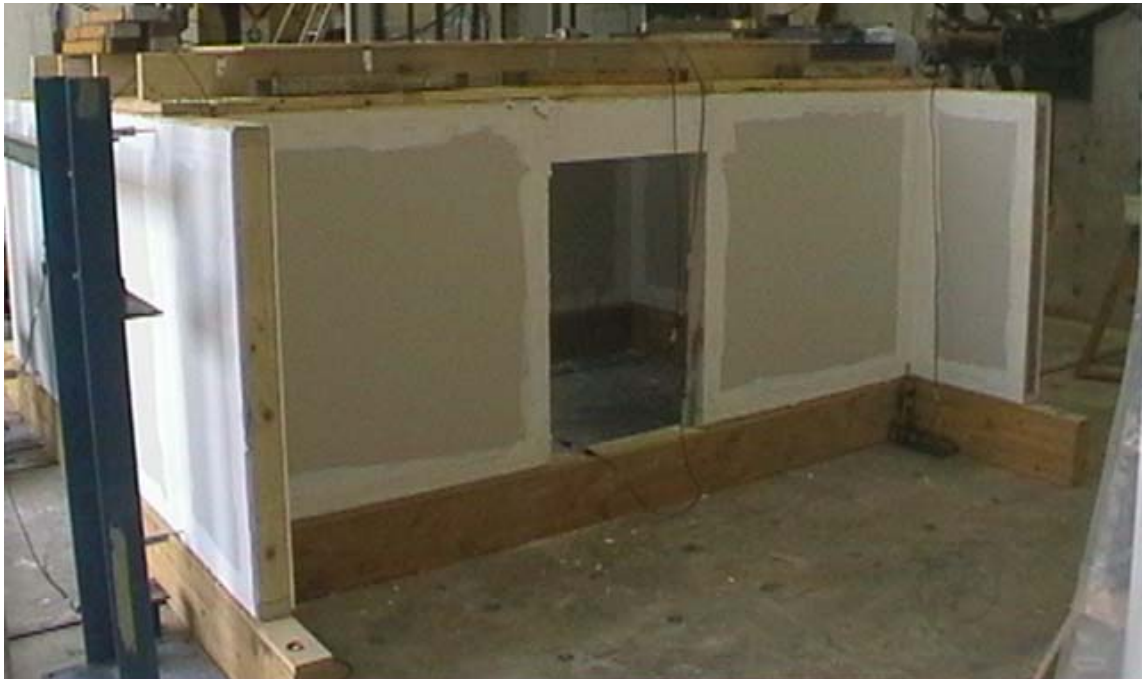
**Figure 7. Photograph of tested half-scale room with interior wall simulated construction**

A typical room using the interior wall set-up is shown in Figure 7. It had door openings in both the end and side walls. It also included wing walls at each end. Both the interior and exterior of the rooms were lined with plasterboard. In one instance, Room R6, straps were added to hold the wall down to the foundation on both sides of these doorway openings. The PLB plasterboard joints were always fully taped and stopped

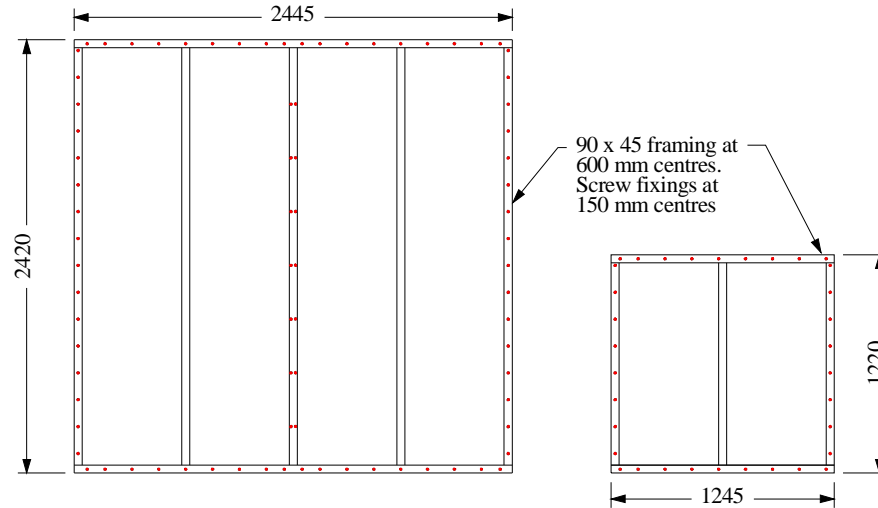
(a) Timber framing for half and full-scale construction

**Figure 8. Comparison of half and full-scale wall framing and shear flow**

Both full and half-scale walls used 90 x 45 mm timber framing (see Figure 8). Studs were at 600 mm centres and thus every second stud of the full-scale walls was omitted. Hence, half-scale modelling was not applied to the wall framing. However, this is not expected to significantly affect half-scale wall bracing strength and stiffness as bracing behaviour is usually a function of the sheathing-to-framing fixing and wall tie-down details. This is considered in detail below.

If a full-scale wall shown in Figure 8(a) is racked with a force of  $2P$  and the corresponding half-scale wall racked with a force of  $P$ , then both half and full-scale walls will have the same shear flow,  $v = P/L$ , around the perimeter of the sheets. See Figure 8(b) for definition of  $P$  and  $L$  and sketch of the forces. Because the same fastener type and spacing is used at the same shear flow, the force per fastener and the slip between sheathing and framing will be the same in both the half and full-scale walls.

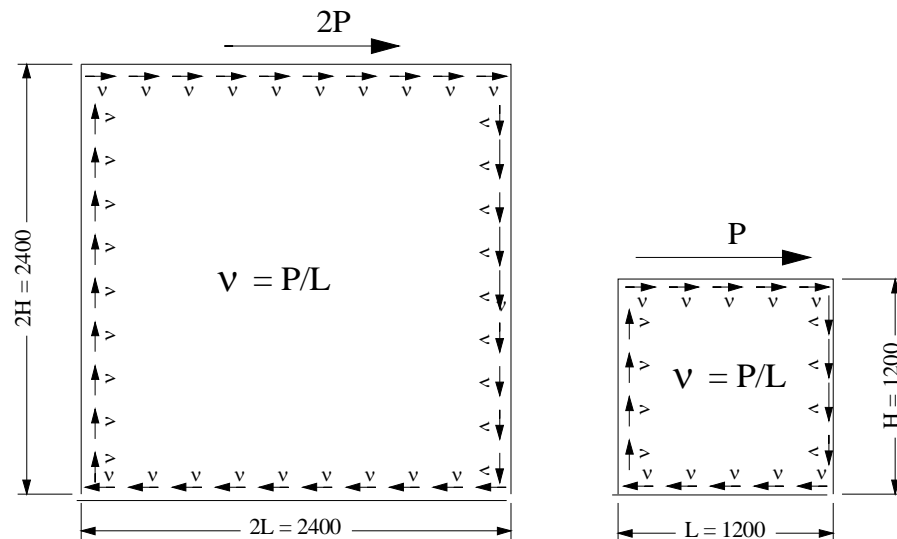
(b) Shear flow around sheet

With reference to Figure 8(b), it can be seen that when the full-scale wall is racked with a force of  $2P$  then the overturning moment =  $2P \times 2H$ . When the half-scale wall is

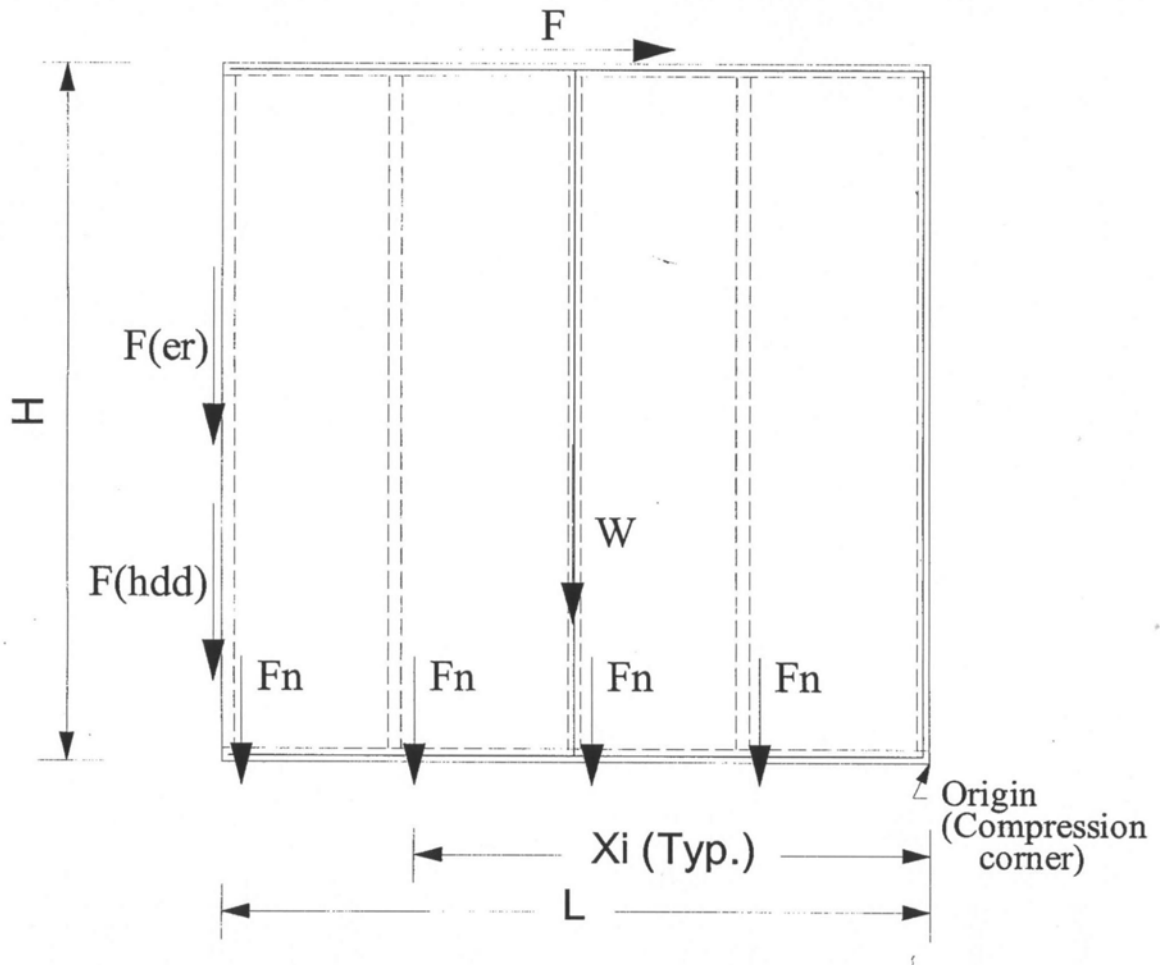
**Figure 9. Forces to resist wall 'rocking' motion on a timber foundation**  
(Free body includes bottom plate)

Figure 9 shows the forces on a wall, from a building, where the 'rocking' mechanism is 'bottom plate uplift'. The end restraint force,  $F(er)$ , shown in Figure 9, is the force exerted from the adjacent structure to resist 'rocking' of the isolated panel. This is simulated in a P21 test with a '3-nail' end hold down system as shown in Figure 1(b). In addition, the panel may have an end hold down device to resist uplift and this is designated  $F(hdd)$  in Figure 9. An example is a steel strap from the end stud to the floor joists. The panel self-weight and axial load on the wall is designated as  $W$ .

The racking force,  $F$ , as shown in Figure 9, tends to 'rock' the wall about the bottom compression corner marked as the origin in Figure 9. This is resisted by  $W$ ,  $F(er)$ ,  $F(hdd)$  and the nail fixings force ( $F_n$ ) between bottom plate and timber foundation beam. Each of these nails is taken as having a pull-out strength of  $F_n$  which acts at a variable distance from the compression corner – taken as distance  $X_i$  – where  $X_i$  is the distance from the origin to each nail location.

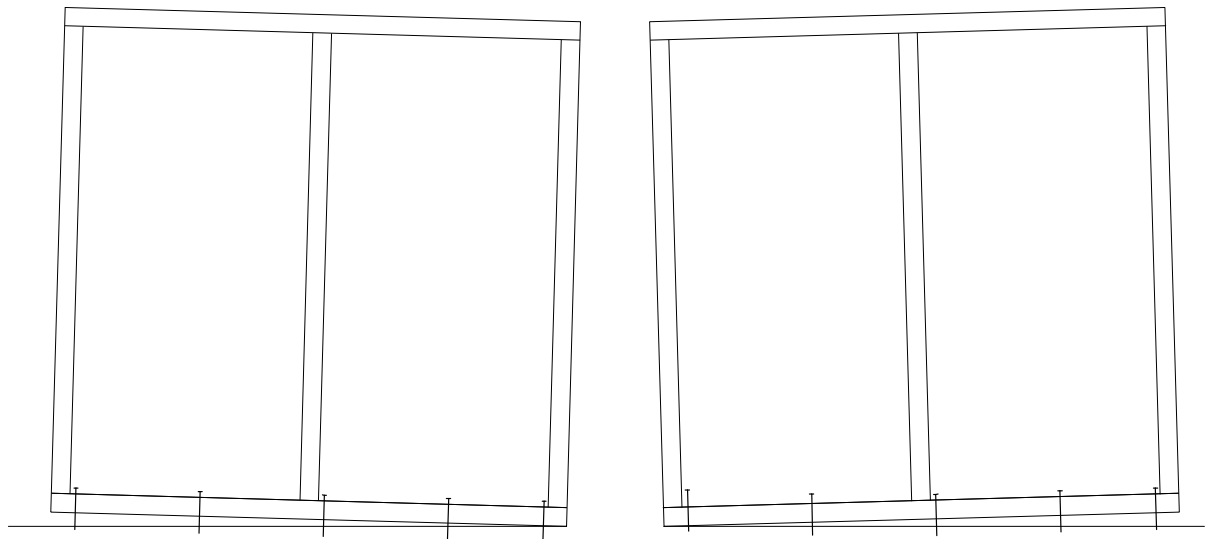
(a) Bottom plate lifting from LH end      (b) Bottom plate lifting from RH end

**Figure 10. 'Rocking' action for wall on timber foundations where the mechanism is bottom plate uplift from the foundation beam**

The mechanism of 'bottom plate uplift' is illustrated in Figure 10. The wall effectively rocks about one corner as a unit and the nails between bottom plate and foundation are pulled out as illustrated in Figure 10(a). It is interesting to note that when the wall is racked in the opposite direction, the nails pulled out from the first loading cycle remain protruded as shown in Figure 10(b).

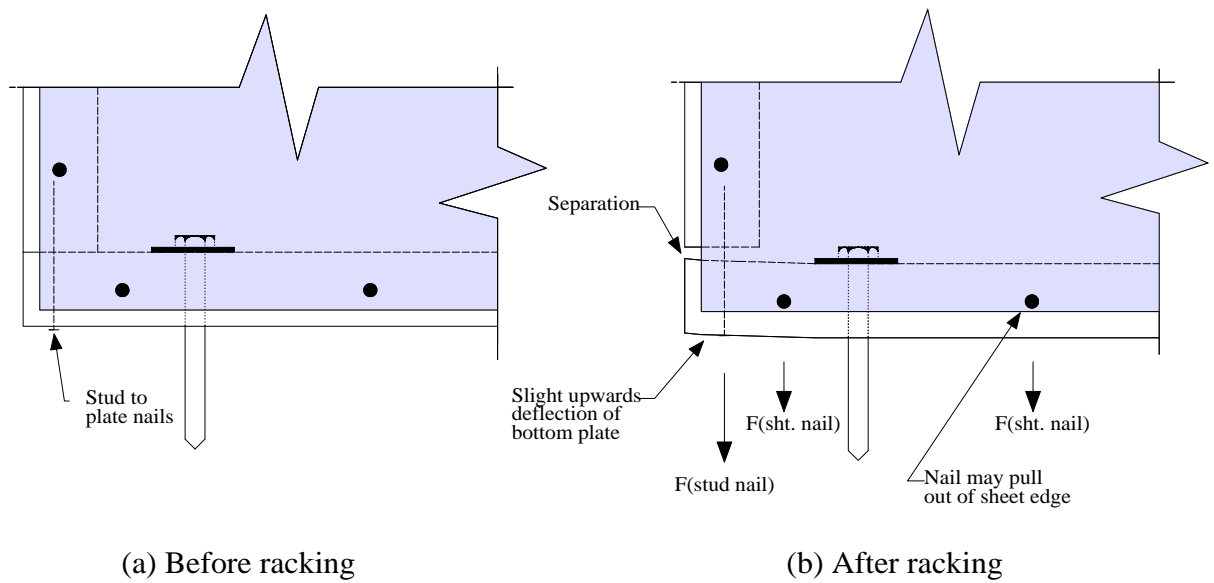
**Figure 11. 'Rocking' action for wall on concrete foundations**

For construction on concrete foundations, the bottom plate is fixed to the foundation by bolts placed at 1200 mm centres in the full-scale walls and 600 mm centres in the half-scale walls. These commence 100 mm inside the wall end studs in the full-scale walls and 50 mm in the half-scale walls. The 'rocking' mechanism is due to a 'stud-uplift' from the bottom plate as shown in Figure 11. For this mechanism to occur there must be a similar movement between the

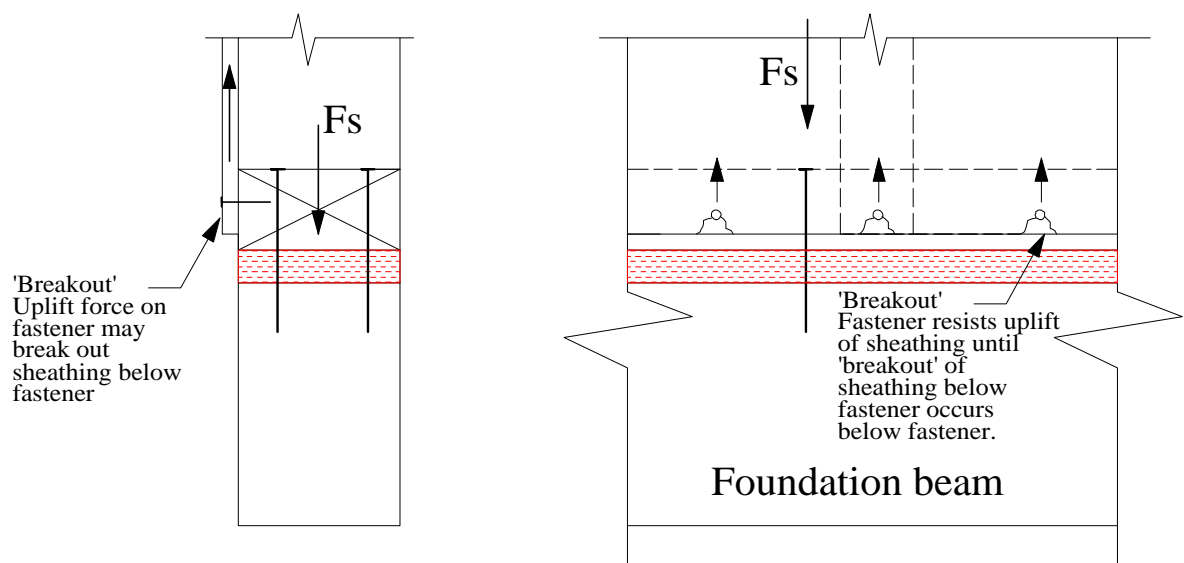
**Figure 12. Transfer of sheathing uplift force to bottom plate via bottom sheathing nail**

sheet and bottom plate fasteners (perpendicular to the sheet edge). The tendency for 'breakout' to occur due to 'stud-uplift' is illustrated in Figure 12.

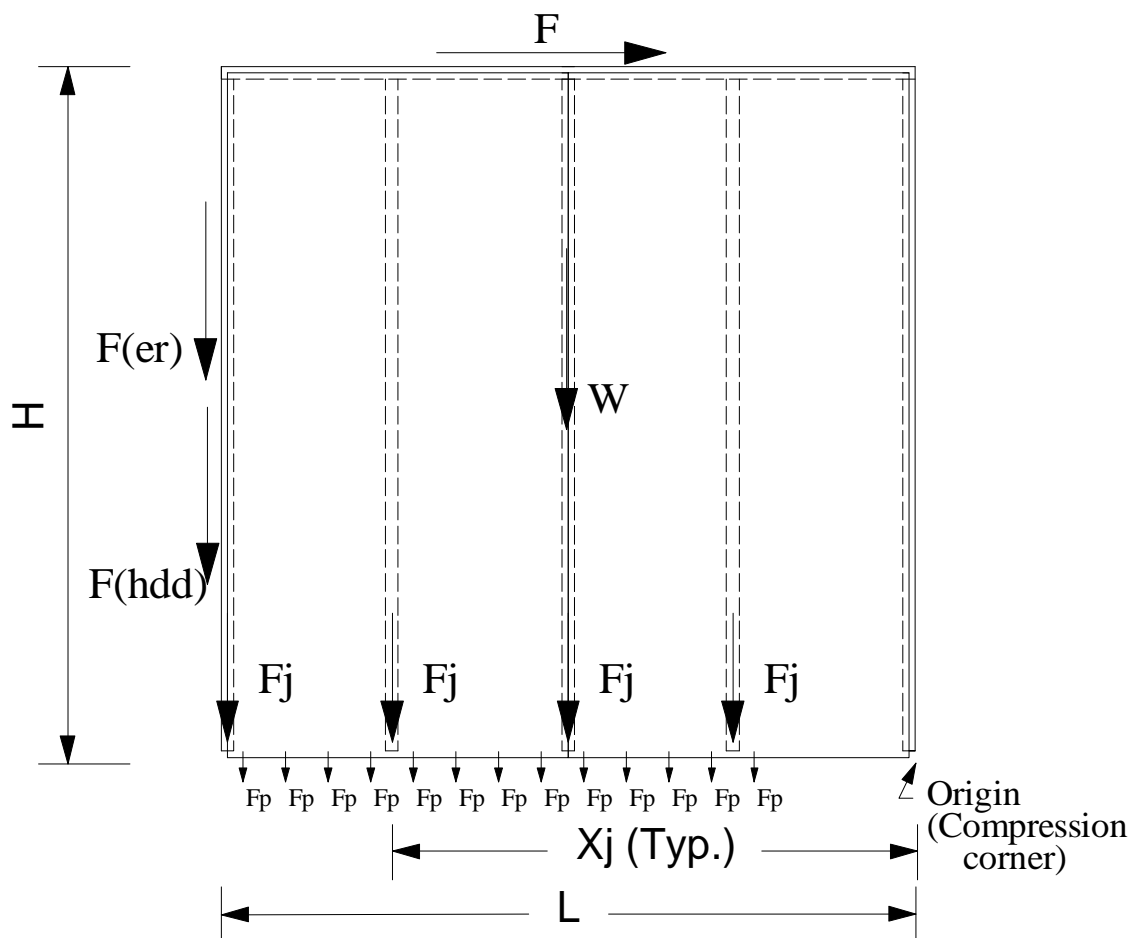
**Figure 13. Forces to resist wall ‘rocking’ motion for a wall on concrete foundations**

(Free body excludes bottom plate)

Rather than the total wall (including bottom plate) lifting from the foundations as a unit, the wall lifts from the bottom plate in this model and the bottom plate remains bolted to the foundation. Figure 13 shows the forces on a free body of the wall excluding the bottom plate:  $F_j$  is the force between studs and the bottom plate; and  $F_p$  is the fixing strength between fasteners and sheathing perpendicular to the sheathing edge. These fasteners also resist uplift of wall from the bottom plate. It is assumed that these fasteners are at a spacing of 's'.

Taking moments about the origin in Figure 13 results in the following equation:

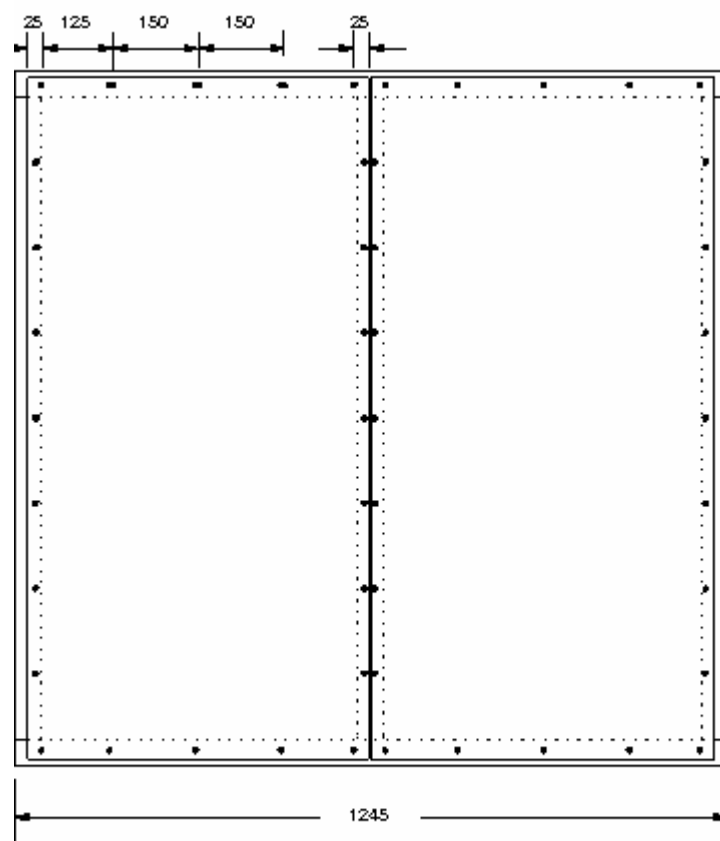
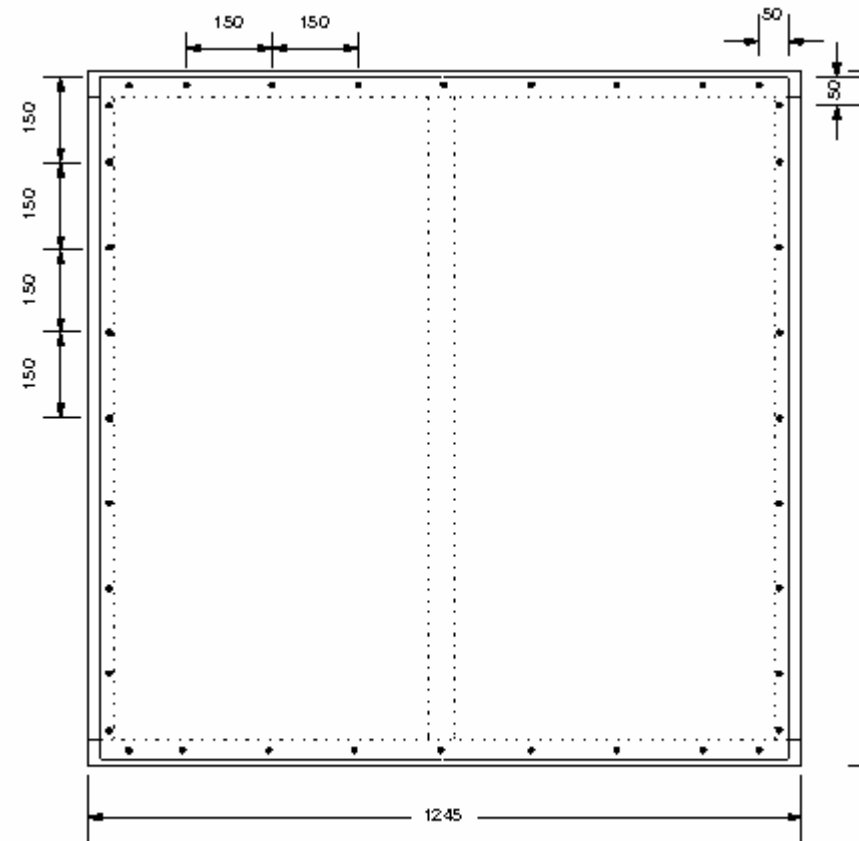
**MDF Fixing**

**PLB Plasterboard Fixing**

**Figure 14. Sheathing fixing and framing of half-scale wall tests**  
(Fastener locations are represented with a black dot)

Five walls were cyclically racked to failure as summarised in Table 1. The walls were 1.245 m wide and 1.22 m high as shown in Figure 14. Specimens were sheathed on either one side or two, and were either nailed or bolted to a timber foundation beam which was itself rigidly fixed to a concrete floor. The sheathings are identified as being PLB or MDF. Appendix A gives a full description of sheathing type for each of these terms.

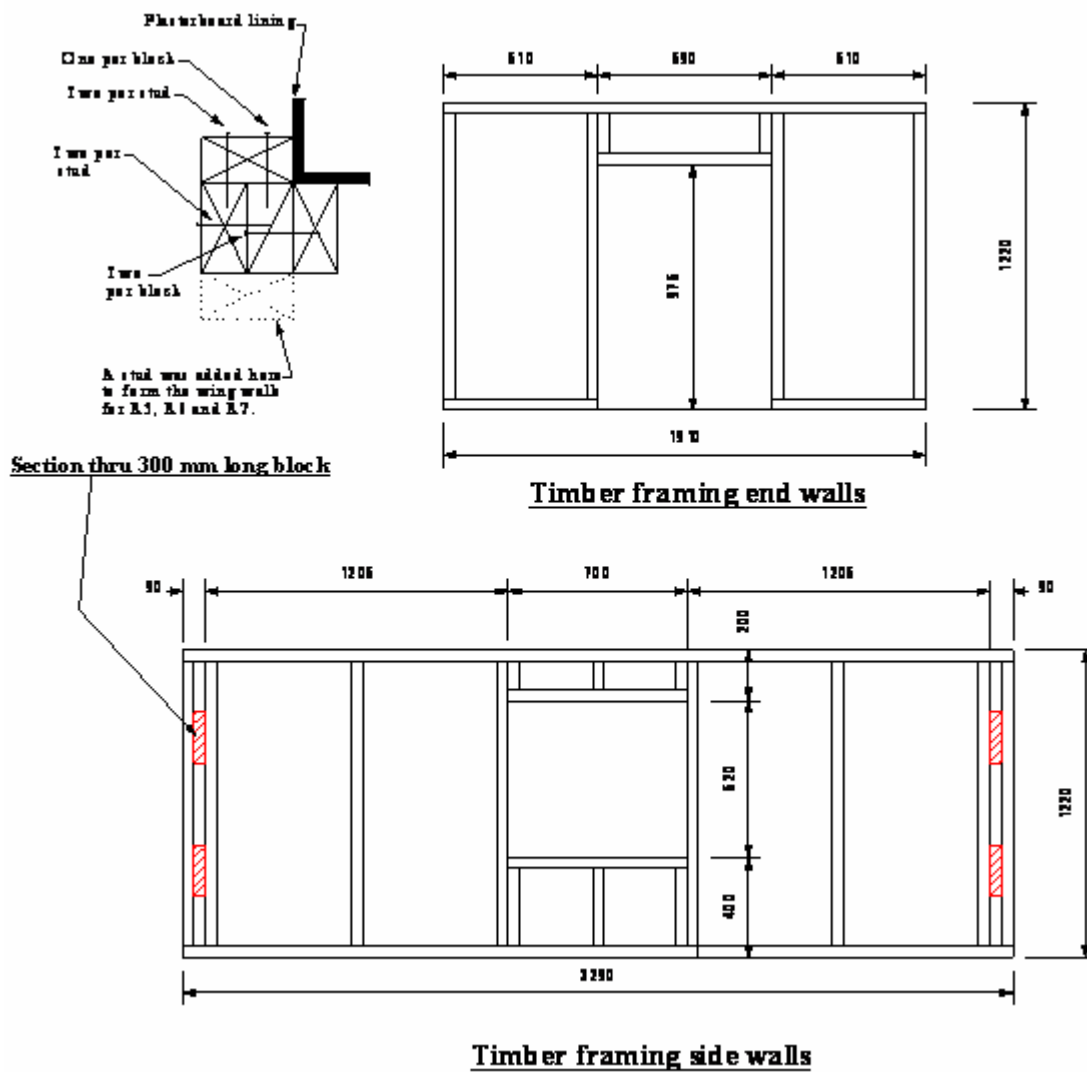
Figure 15. Timber framing for walls R1, R2, R3 and R4

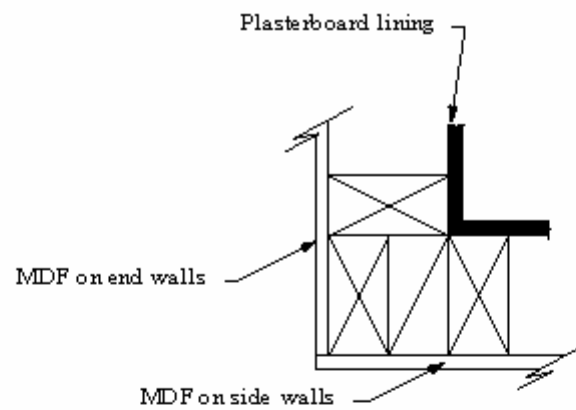
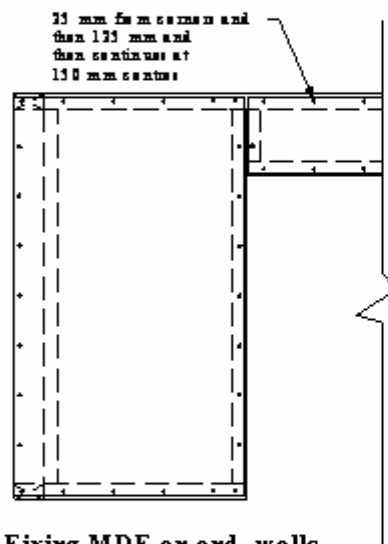
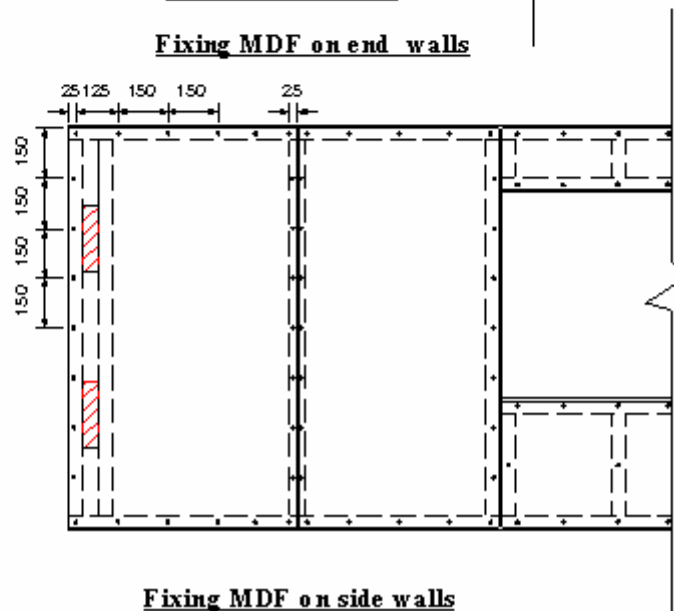
**Corner detail**

**Fixing MDF on end walls**

**Fixing MDF on side walls**

**Figure 16. MDF sheathing fixing for walls R1, R2, R3 and R4**  
(Fastener locations are represented with a black dot)

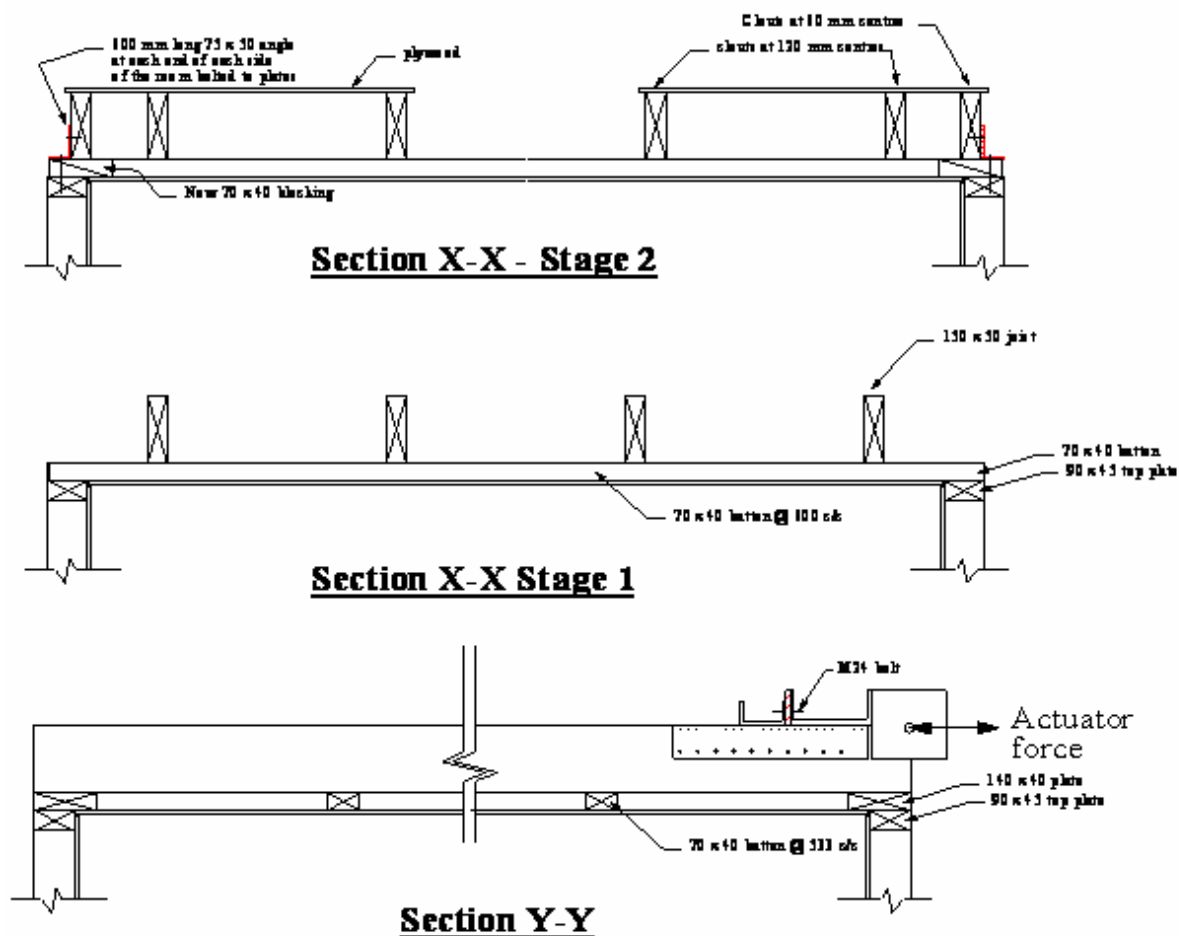
Figure 19. Cross-sections of ceiling framing and loading

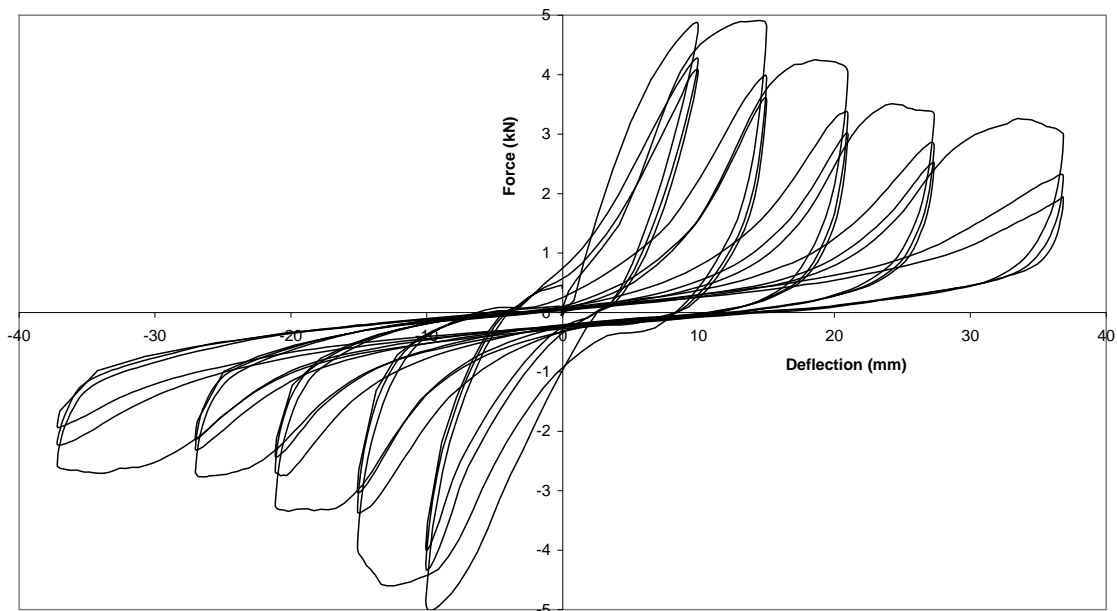
**Figure 21. Wall S1 hysteresis loops**

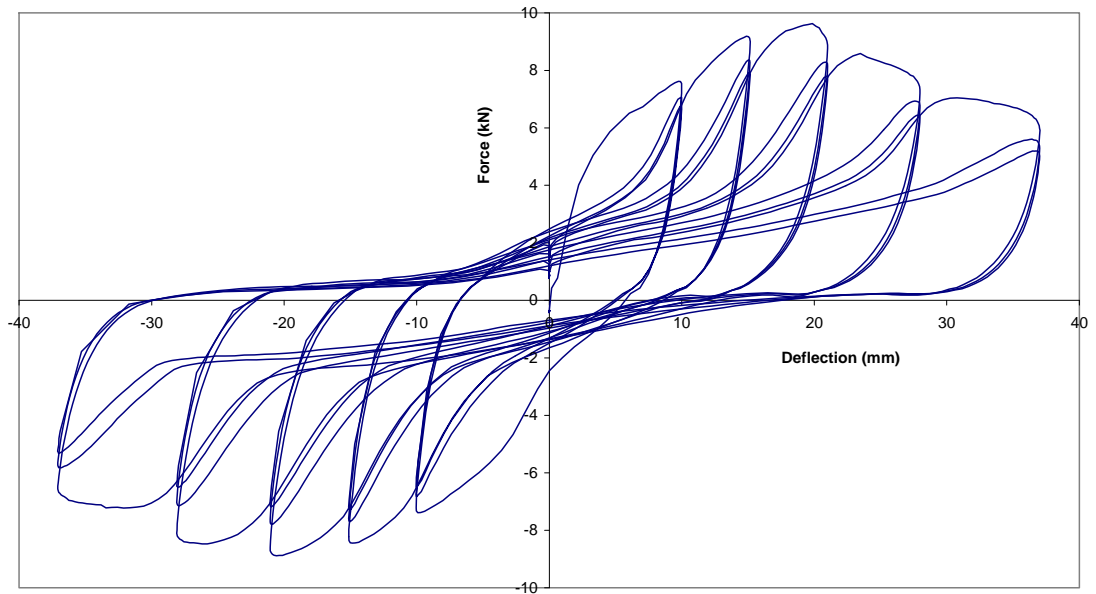
**Figure 22. Wall S2 hysteresis loops**

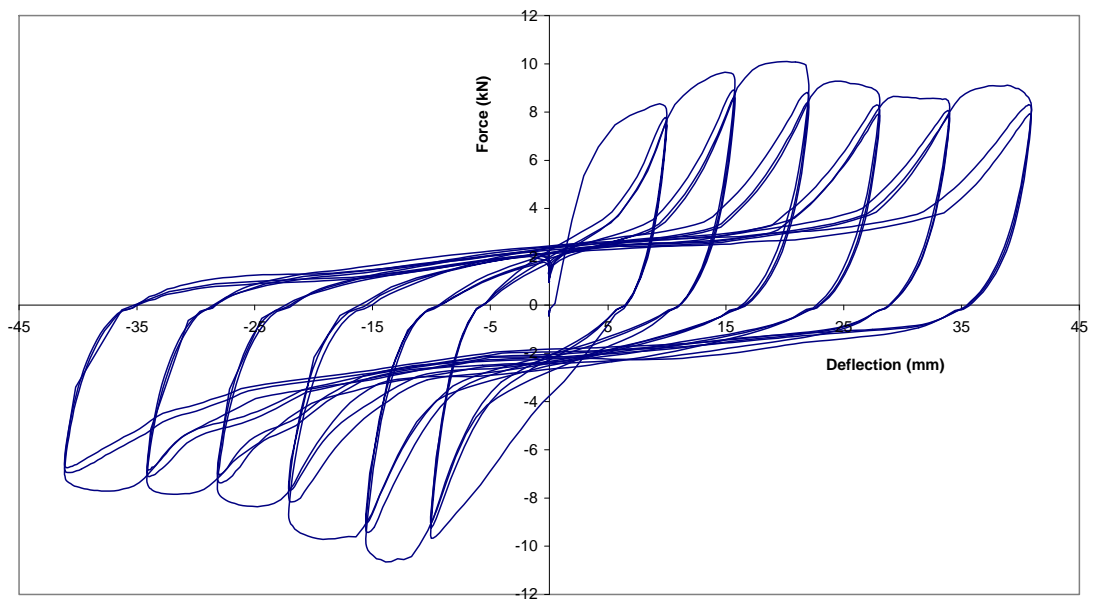
**Figure 23. Wall S3 hysteresis loops**

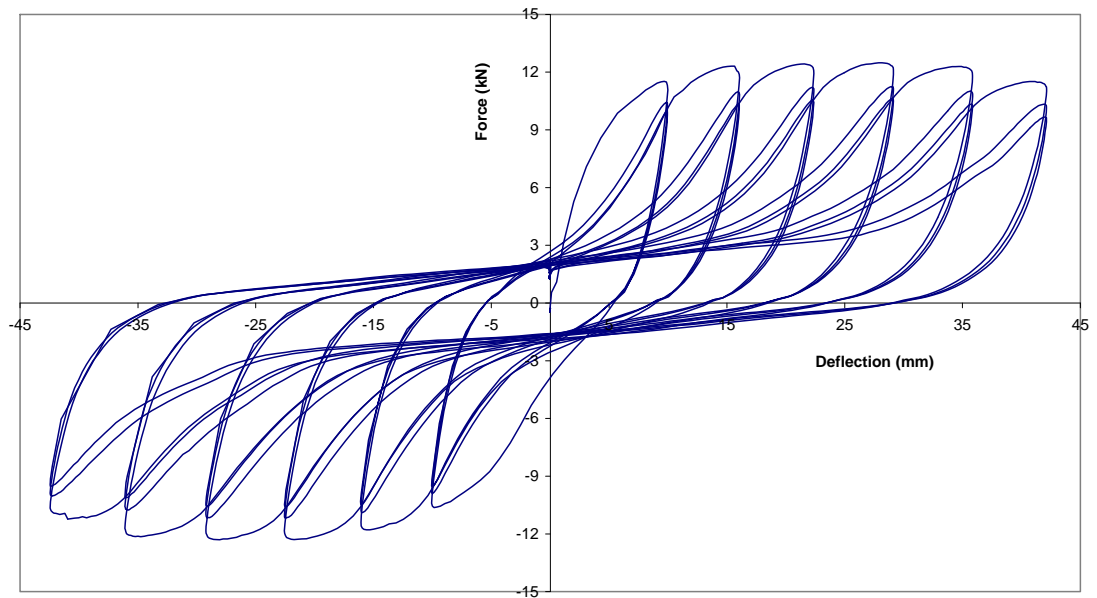
**Figure 24. Wall S4 hysteresis loops**

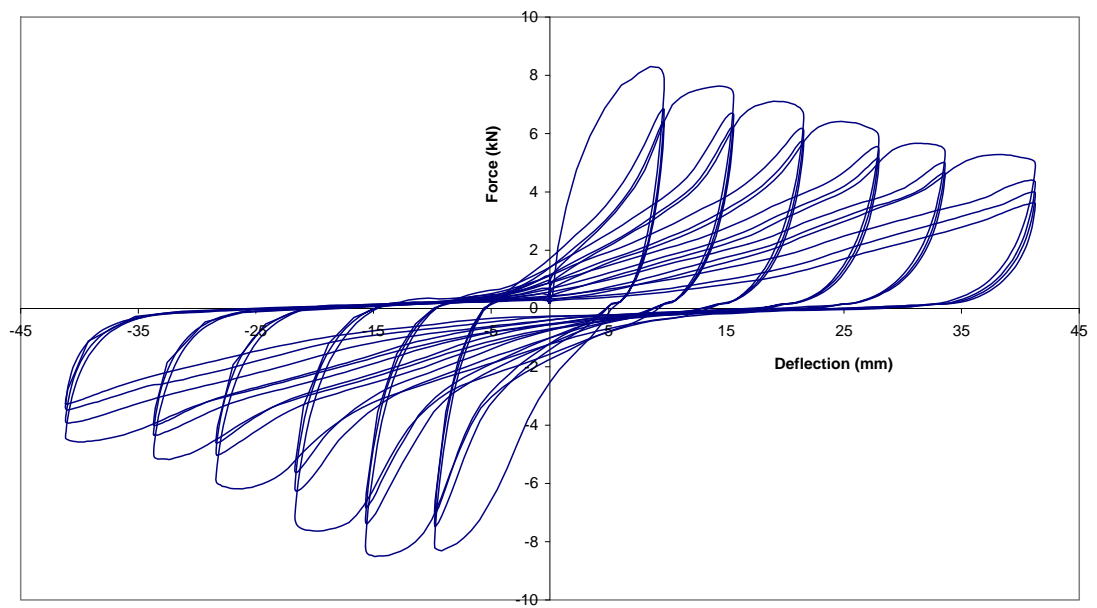
**Figure 25. Wall S5 hysteresis loops**

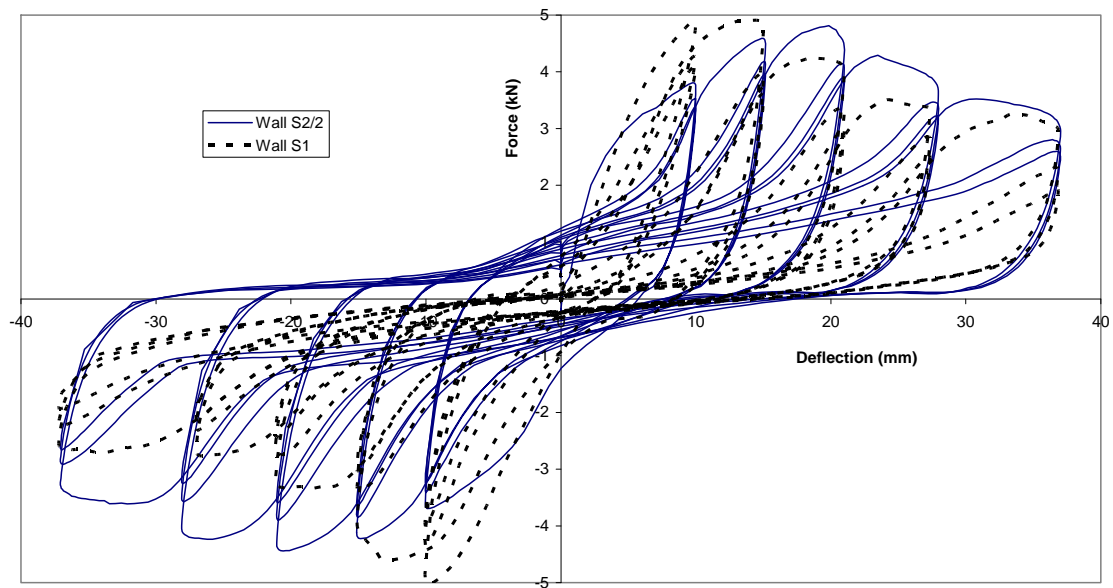
**Figure 26. Comparison of Wall S1 and Wall S2/2 hysteresis loops**

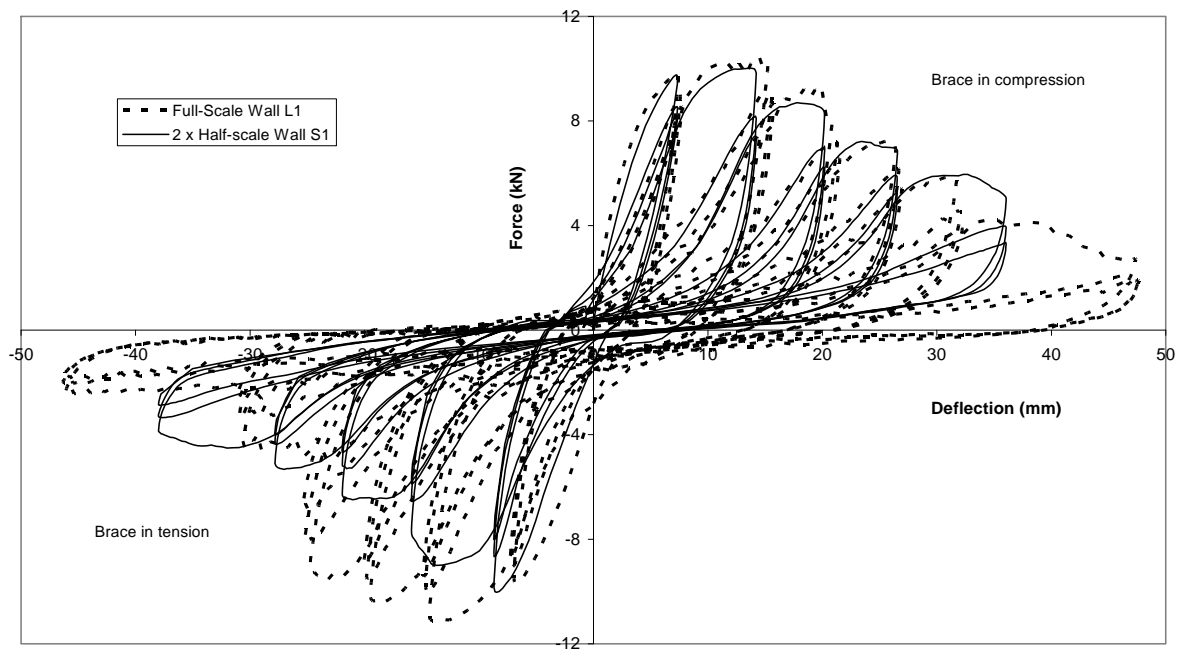
**Figure 27. Comparison of half-scale Wall S1 and full-scale hysteresis loops from an equivalent full-scale test (Wall L1)**

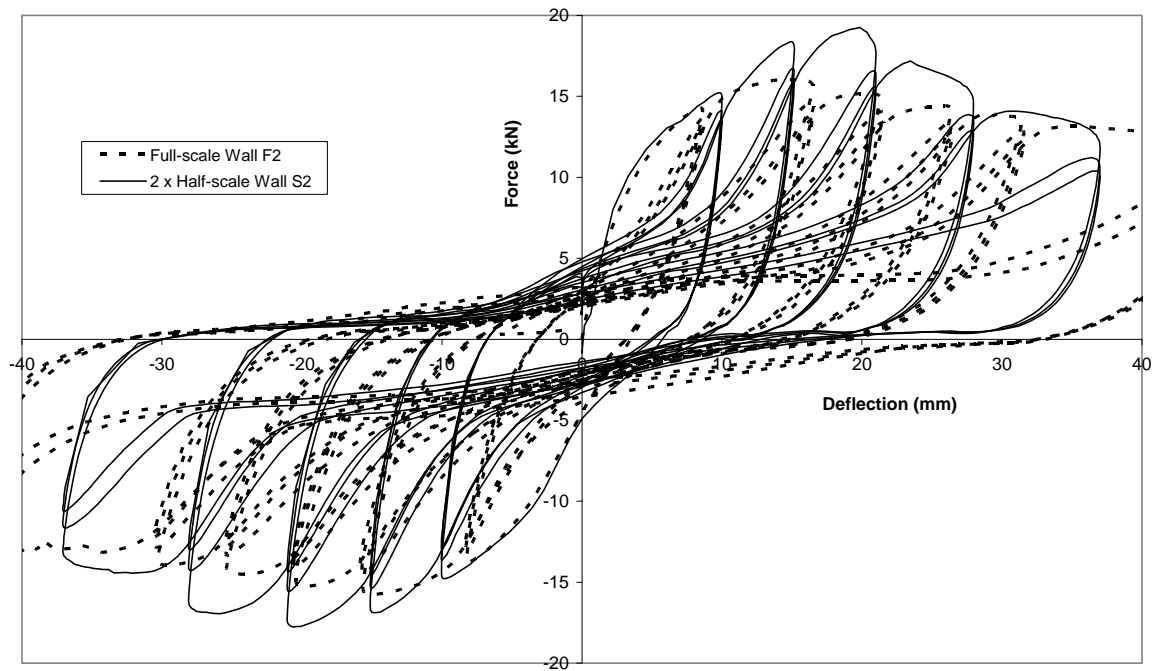
**Figure 28. Comparison of half-scale Wall S2 and hysteresis loops from an equivalent full-scale test (Wall L2)**
