# **STUDY REPORT**

**No. 154 (2006)**

## **Racking Tests on Rooms and Isolated Walls to Investigate Uplift Restraint and Systems Effects**

**SJ Thurston**

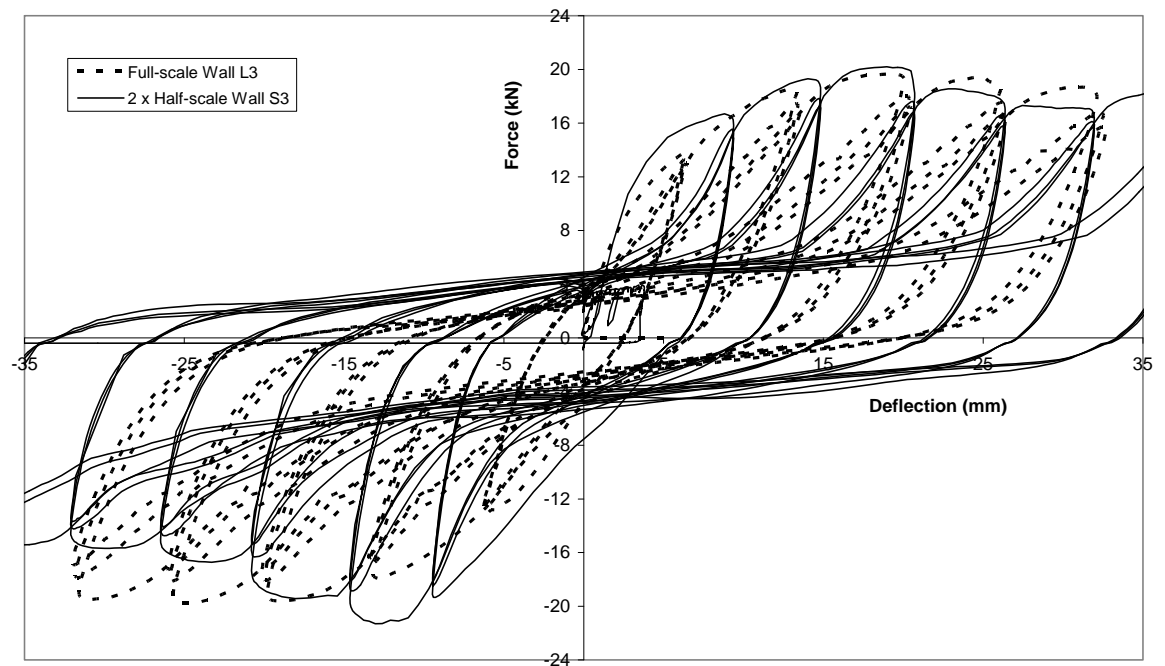
**Figure 29. Comparison of half-scale Wall S3 and hysteresis loops from an equivalent full-scale test (Wall L3)**

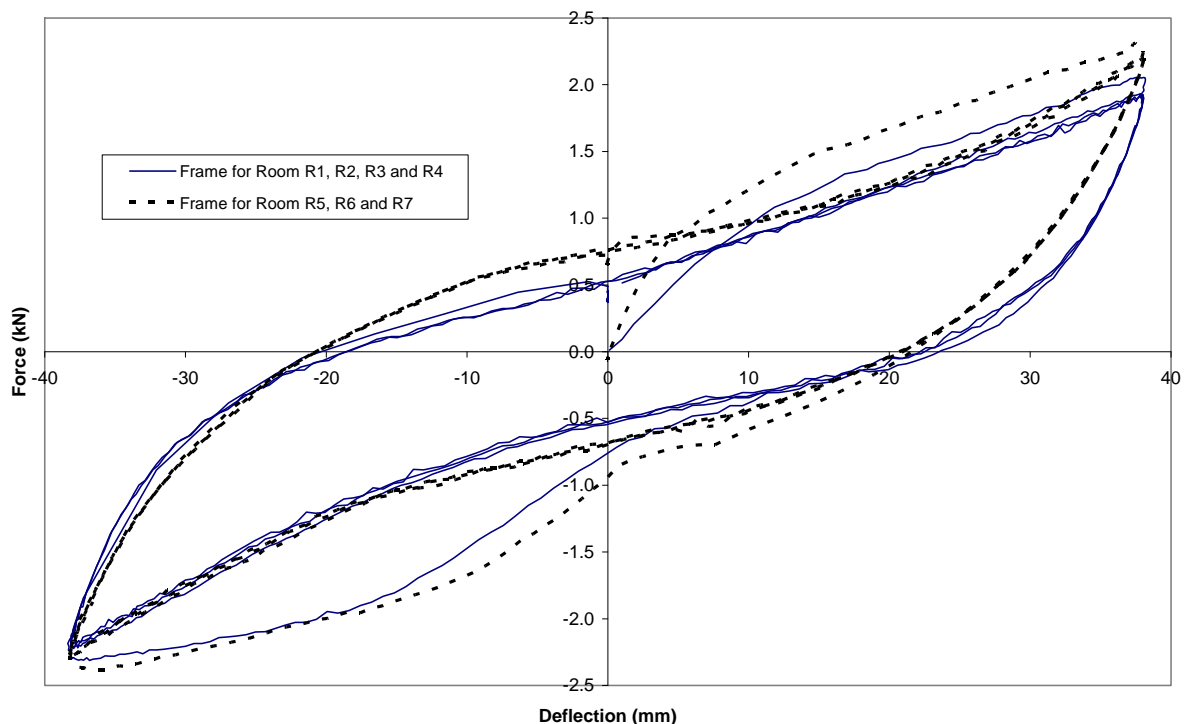
**Figure 30. Hysteresis loops from racking of the bare timber frames used for the half-scale room tests**

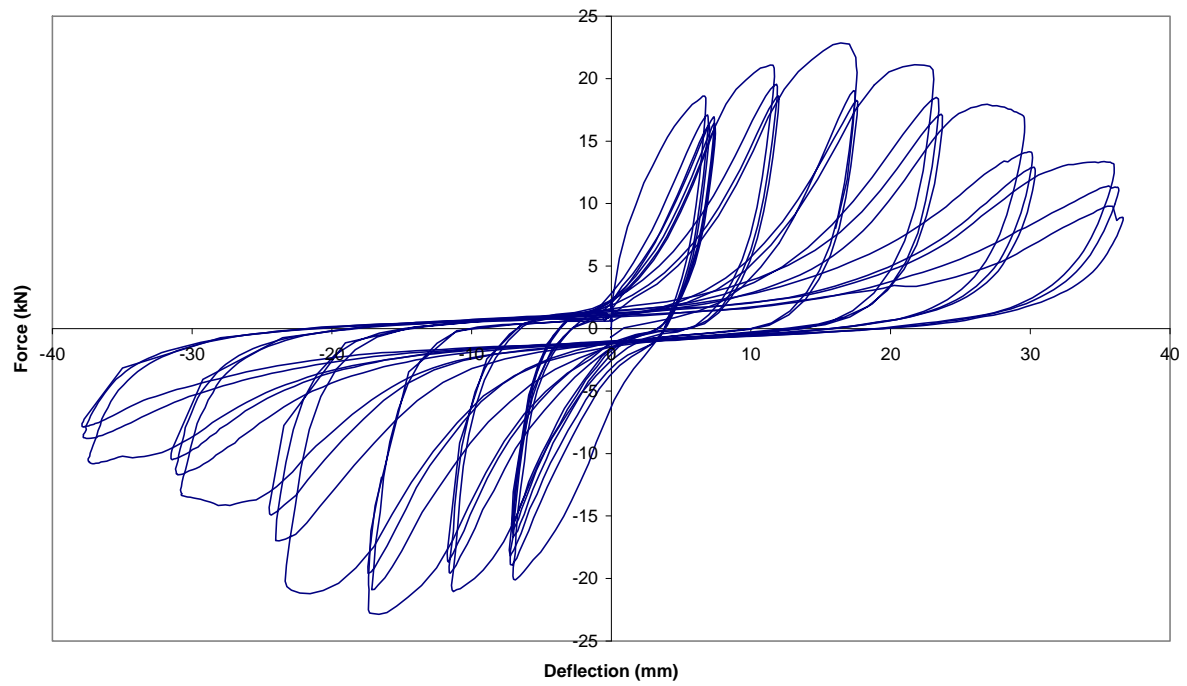
**Figure 31. Room R1 hysteresis loops**

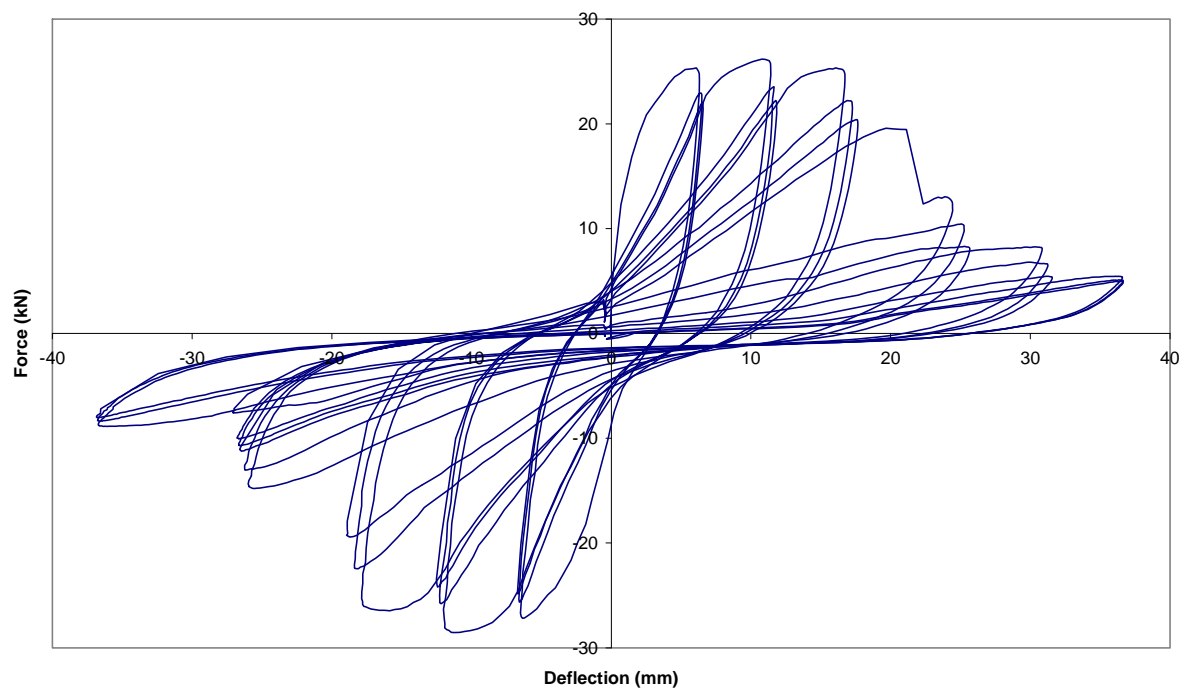
**Figure 32. Room R2 hysteresis loops**

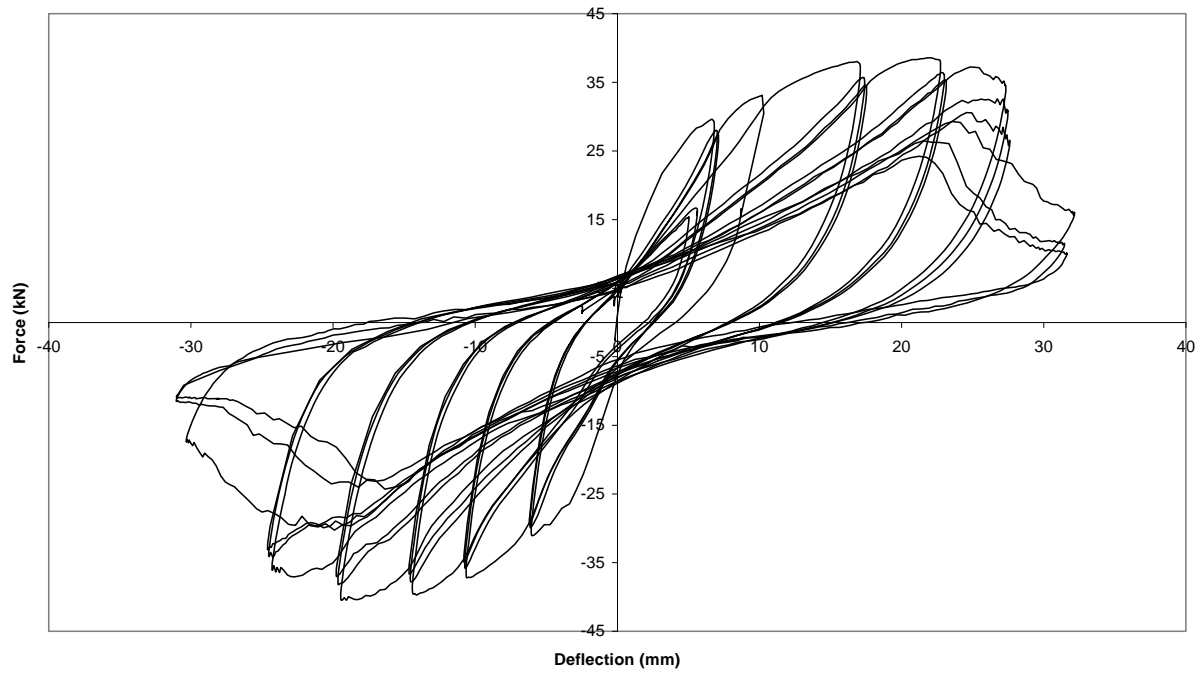
**Figure 33. Room R3 hysteresis loops**

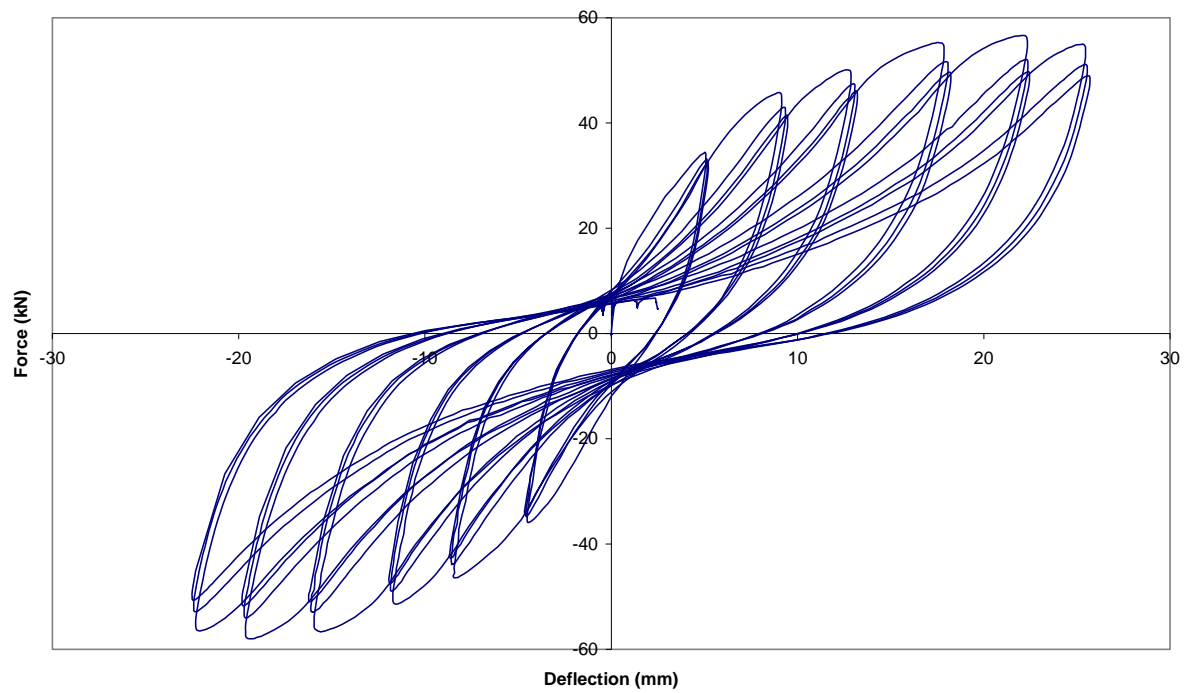
**Figure 34. Room R4 hysteresis loops**

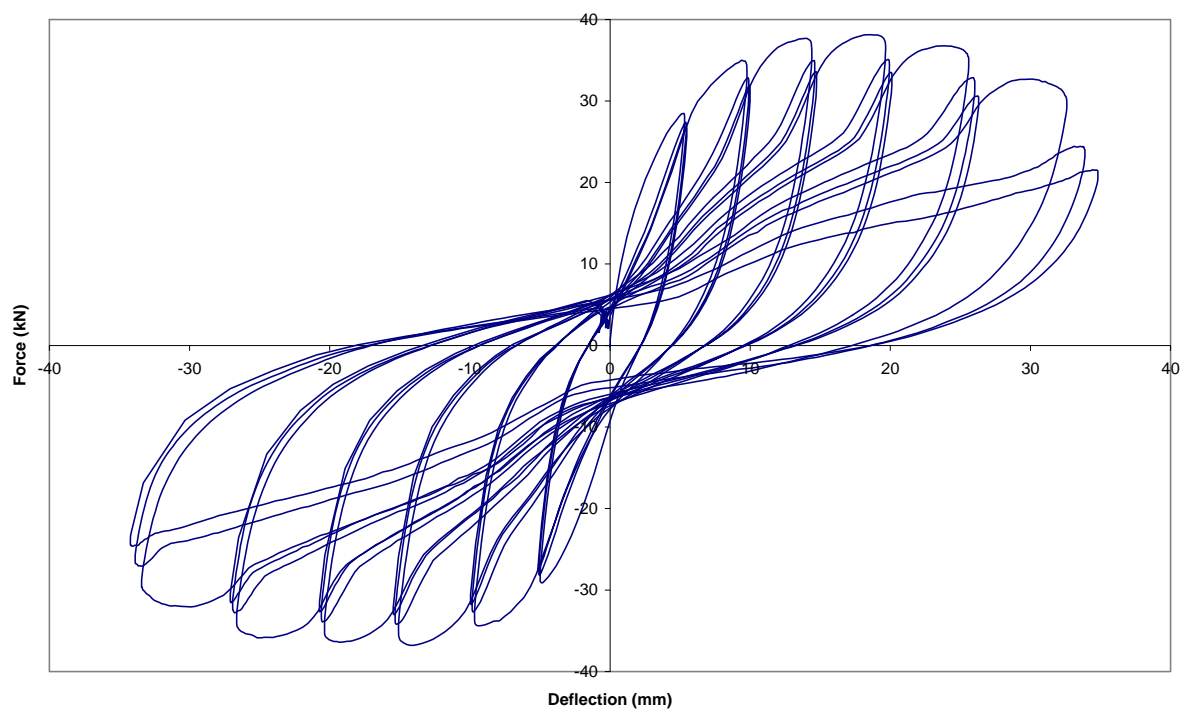
**Figure 35. Room R5 hysteresis loops**

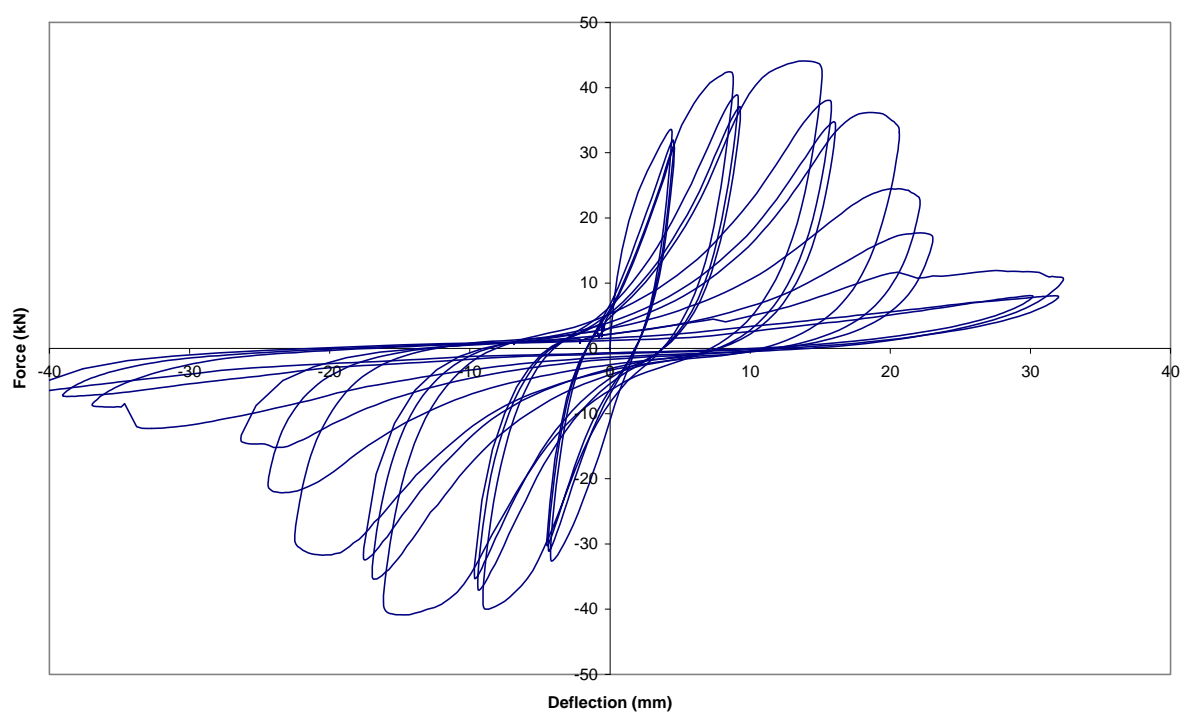
**Figure 36. Room R6 hysteresis loops**

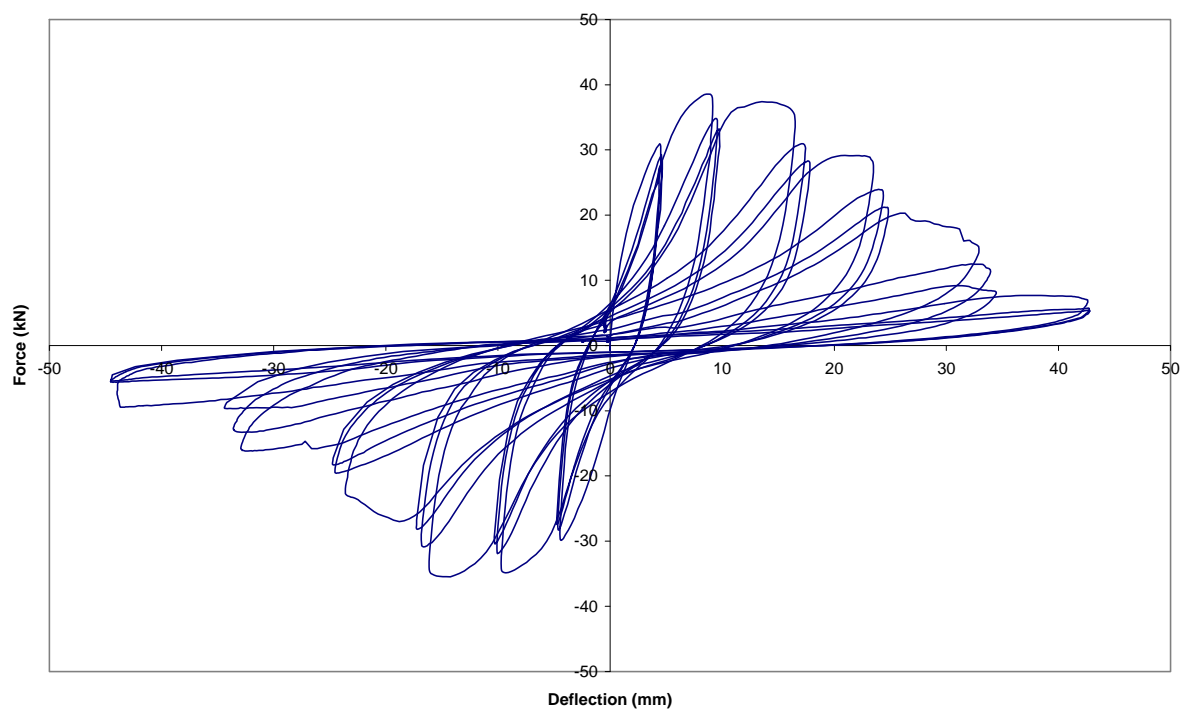
**Figure 37. Room R7 hysteresis loops**

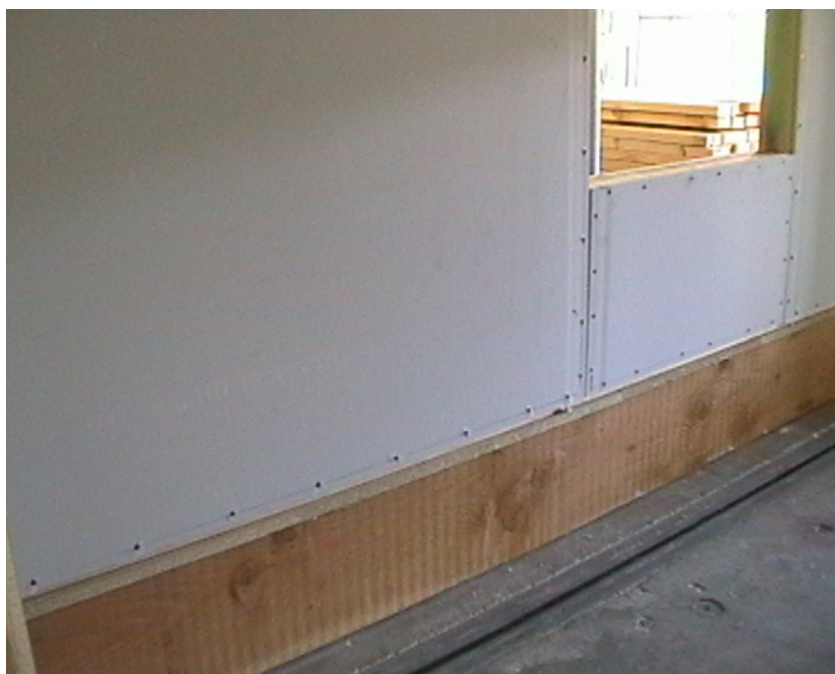
**Figure 38. Room R1 – photograph of damage to the interior plasterboard screw fixings at 7 mm wall deflection on the room long sides at the window openings**

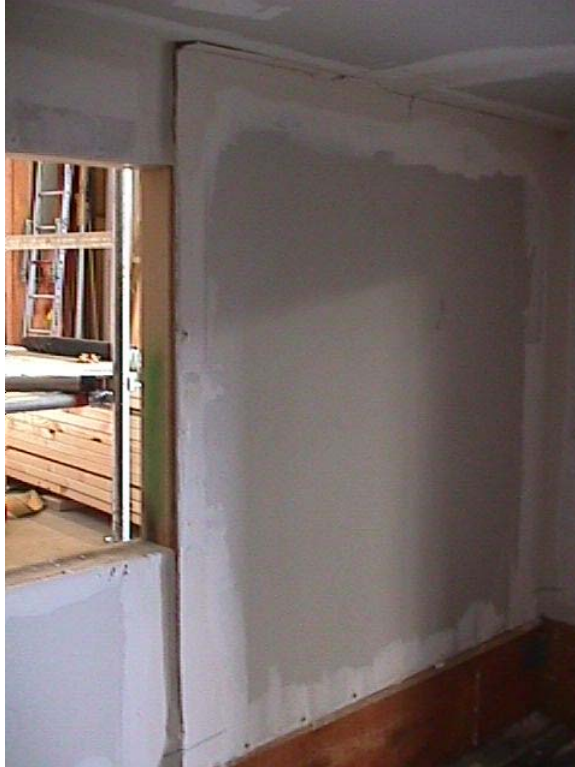
**Figure 39. Room R2 – movement at wall long side doorway opening near test completion**

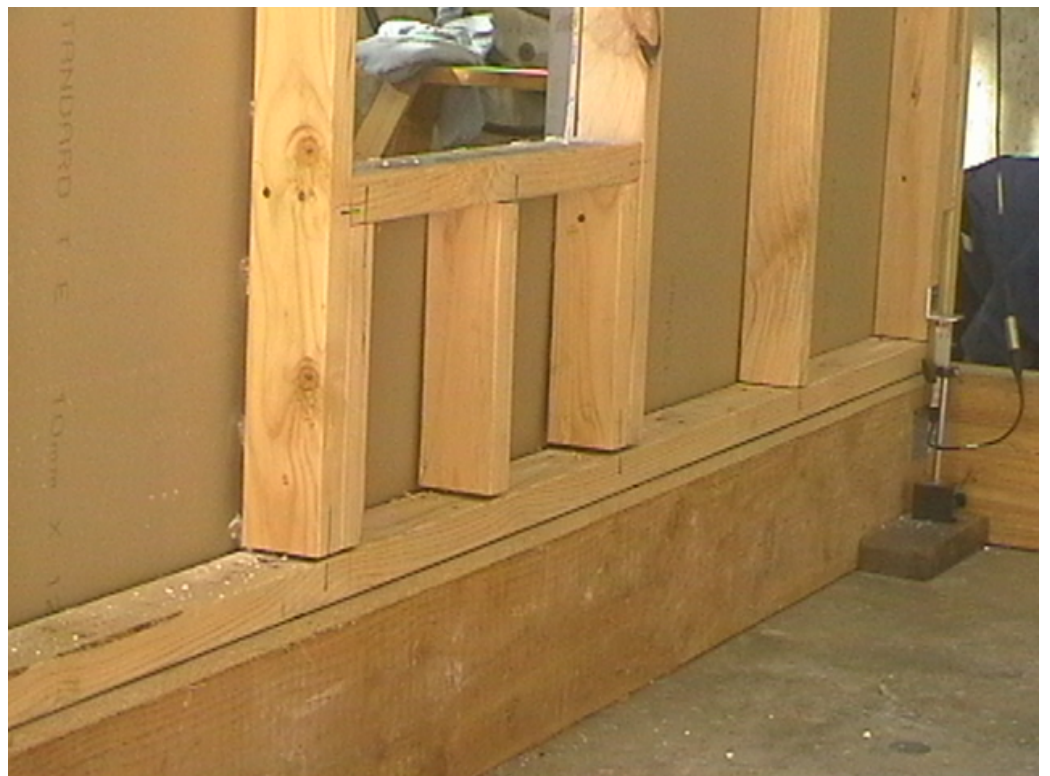
**Figure 40. Room R2 – stud uplift on long side walls**

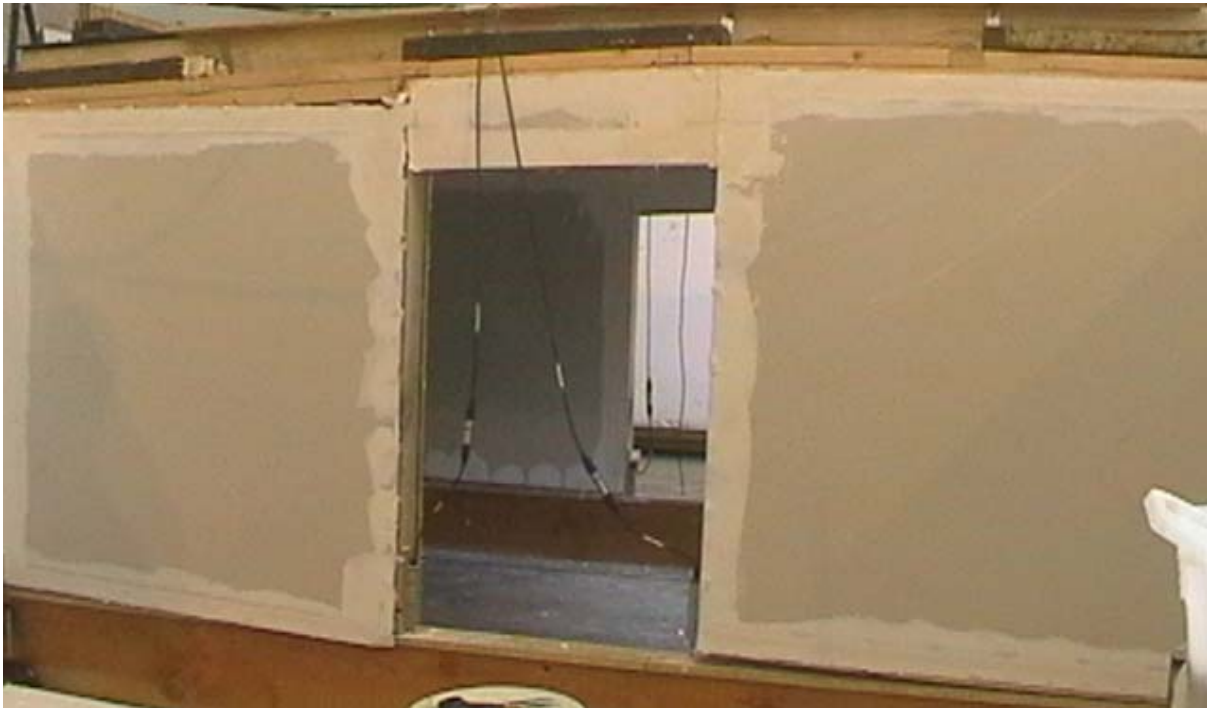
**Figure 41. Room R5 – photograph of vertical movement at wall long side doorway openings**

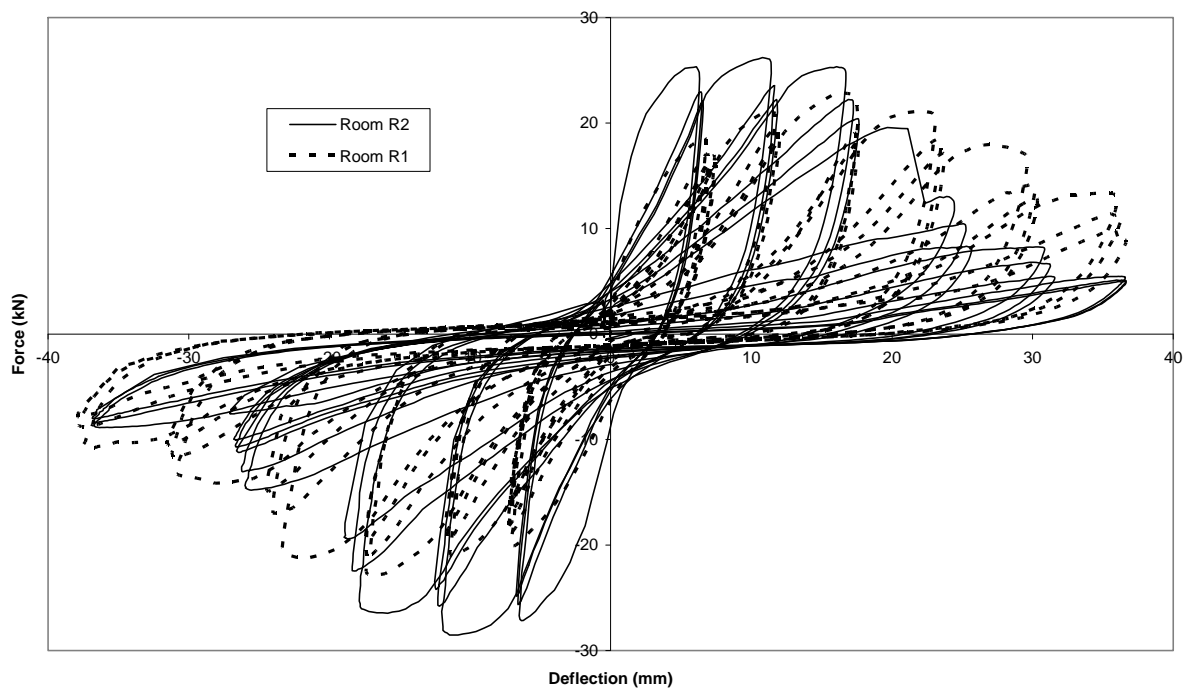
**Figure 42. Comparison of test results for Rooms R1 and R2**

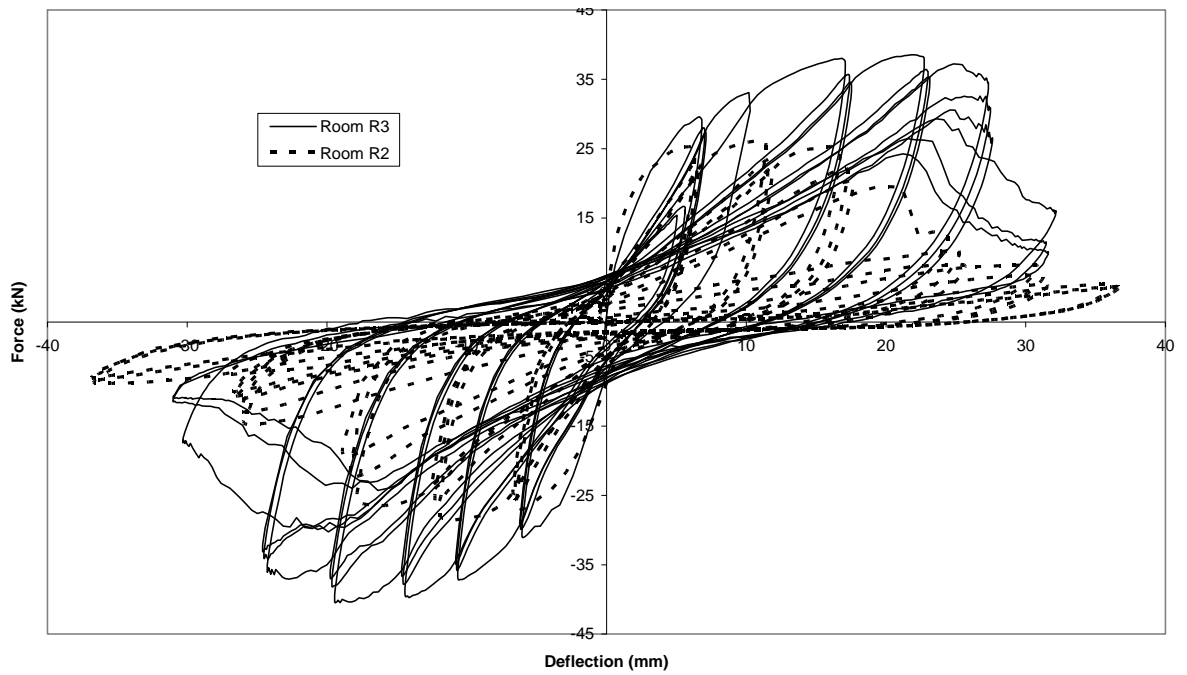
**Figure 43. Comparison of test results for Rooms R2 and R3**

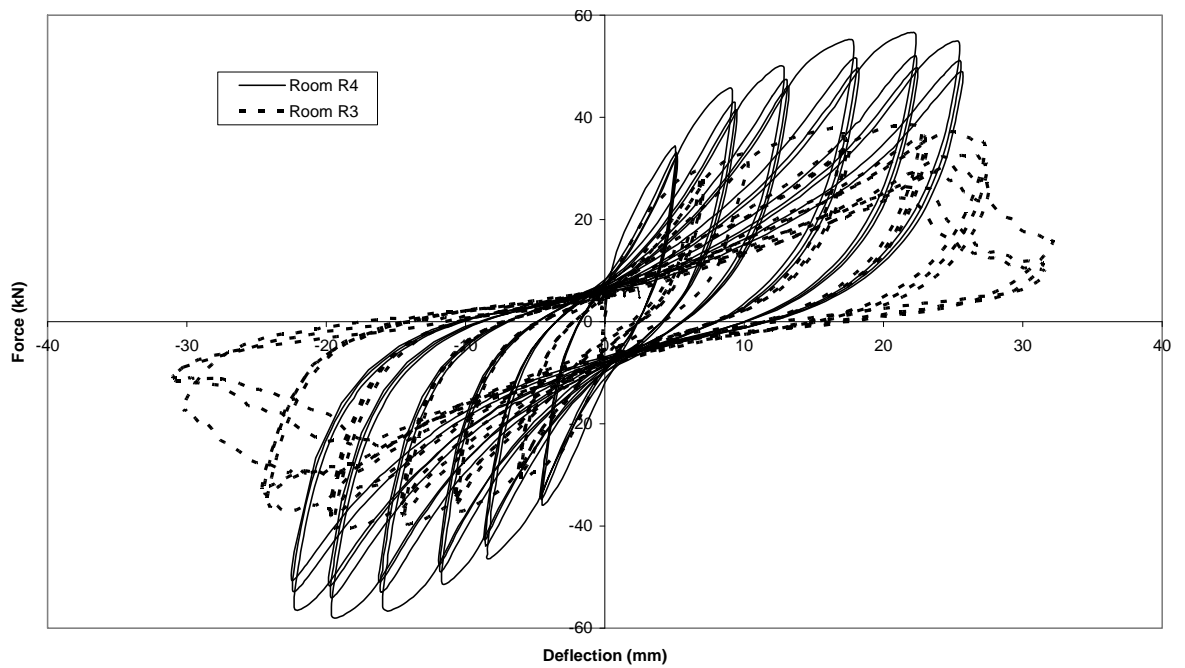
**Figure 44. Comparison of test results for Rooms R3 and R4**

The comparison in Figure 44 shows that Room R4 was both stiffer and stronger than Room R3 and showed no load decay. This was attributed to the bolting fixing preventing the bottom plate lifting. This action limited the strength of Room R3, but added to its flexibility. The strong fixing between MDF and bottom plate limited the stud uplift (only 2-6 mm measured) of Room R4, which is the other 'rocking' mechanism as described in Section 1.11. This is not expected to be the case with only plasterboard lining (see (e) below).

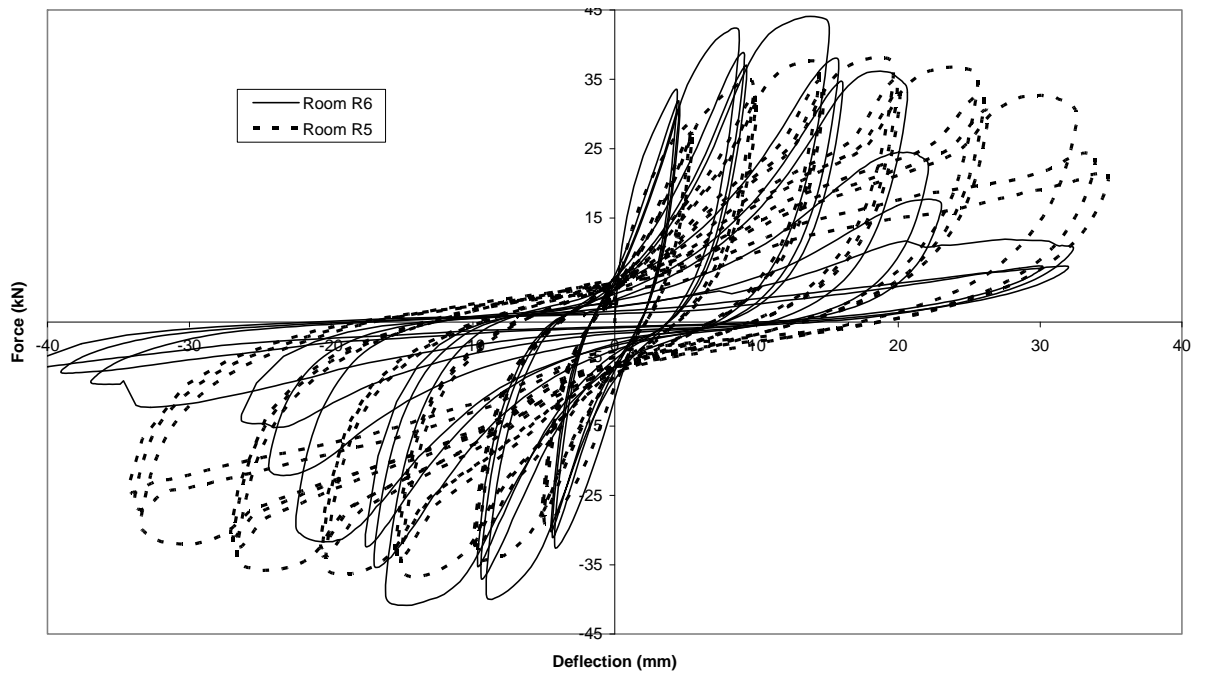
**Figure 45. Comparison of test results for Rooms R5 and R6**

The comparison in Figure 45 shows that at deflections up to  $\pm 15$  mm, the room with end straps (Room R6) was significantly stiffer and reached higher strengths. The surprising result was the subsequent rapid reduction in strength. The straps all remained intact, but there was still moderate uplift at doorway openings. However, the stud uplift at the corners was only 1-2 mm at deflections up to  $\pm 15$  mm. This vertical movement would have weakened the lining fixing along the bottom plate. Note that this was where the damage was observed and where the greatest slip movement occurred. In addition, the greater shear load in Room R6 walls is expected to have induced brittle failure at the lining fixings.

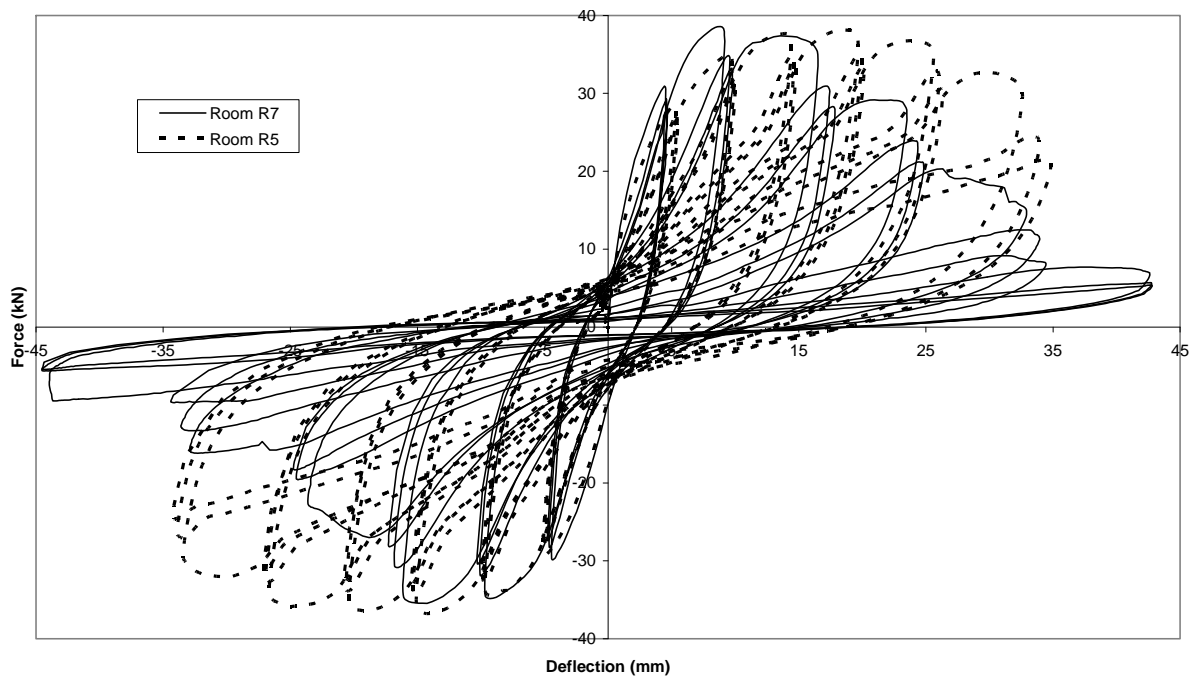
**Figure 46. Comparison of test results for Rooms R5 and R7**

The comparison in Figure 46 shows a similar result up to deflections of approximately  $\pm 15$  mm. From this stage the strength of Room R7 deteriorated, whereas the strength of Room R5 stayed moderately constant. This is in marked contrast to the comparison in (c) above. It is expected that this is due to the strength of the plasterboard linings being inadequate to prevent stud uplift, whereas the MDF was adequate.

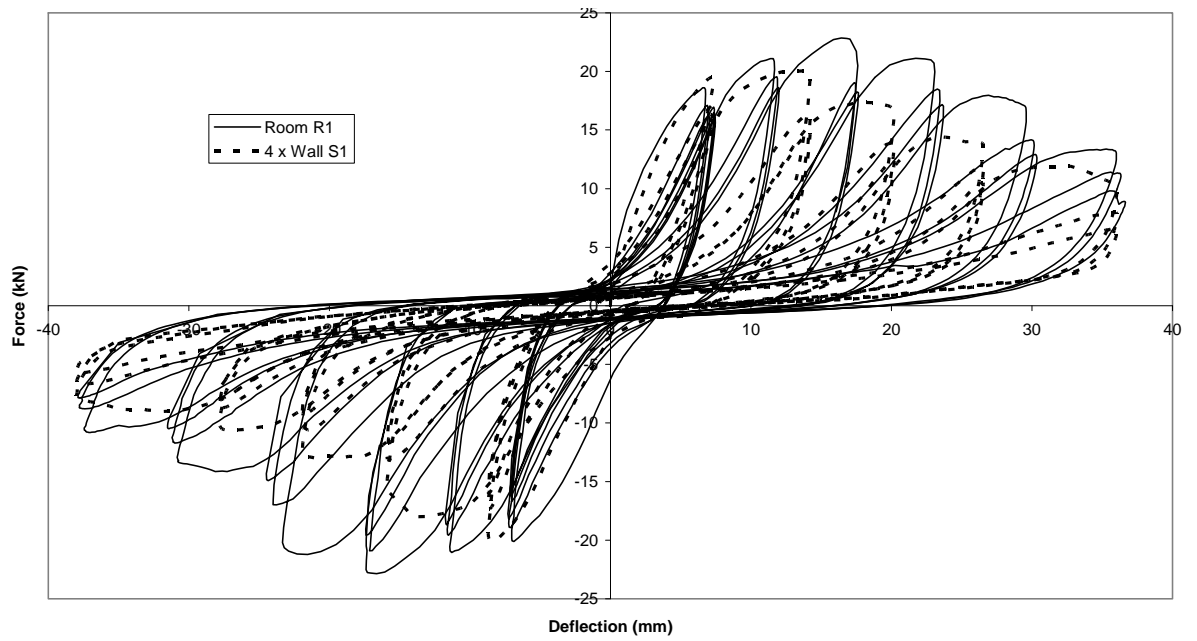
**Figure 47. Comparison of test results for Room R1 and 4 x Wall S1**

The comparison in Figure 47 shows that Room R1 was stronger than 4 x S1 (maximum loads resisted being 14% greater). As both walls were governed by shear strength, rather than rocking, no conclusions can be made about the suitability of the end restraints. It is concluded that the systems effect factor in construction governed by shear where plasterboard joints are not taped and stopped is small, and should be taken as 1.0.

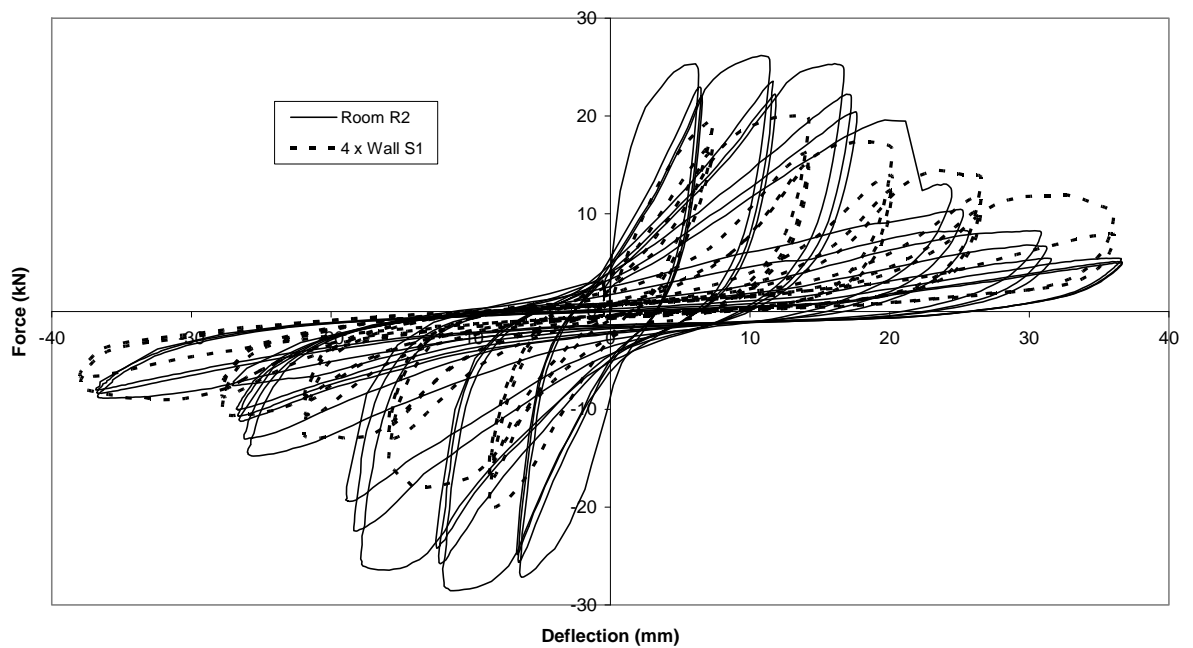
**Figure 48. Comparison of test results for Room R2 and 4 x Wall S1**

The comparison in Figure 48 shows that Room R2 was significantly stiffer and stronger than 4 x S1 (maximum loads resisted being 36% greater). Hence, the systems effect factor can be taken as 1.36, or more conservatively as 1.30. Subsequent to the peak load, Room R2 deteriorated fast for reasons noted in Section 1.17.2 (a).

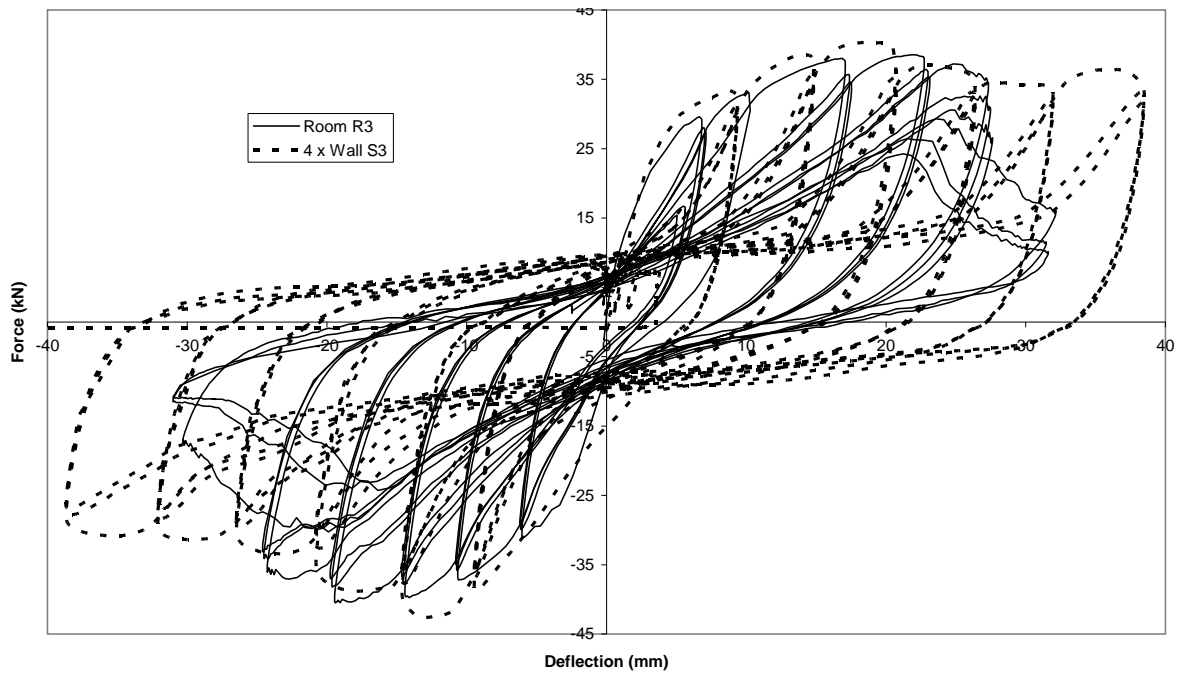
**Figure 49. Comparison of test results for Room R3 and 4 x Wall S3**

The comparison in Figure 49 shows good agreement between Room R3 and 4 x Wall S3 until the end walls lifted in Room R3 at about  $\pm 25$  mm and the load resisted dropped off (see Section 1.17.1).

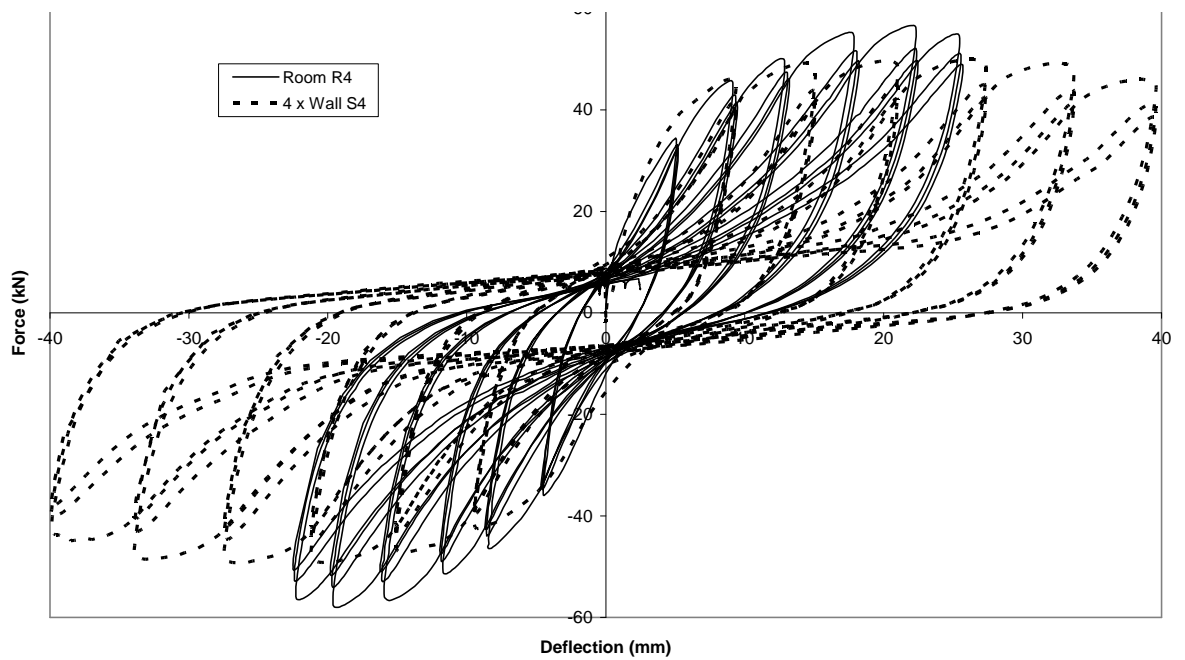
**Figure 50. Comparison of test results for Room R4 and 4 x Wall S4**

The comparison in Figure 50 shows good agreement between Room R4 and 4 x Wall S4 – with Room 4 being slightly stronger. Both constructions had 30-50% of the movement attributed to 'rocking' by stud uplift. From these results it is concluded that the proposal is valid for this construction.

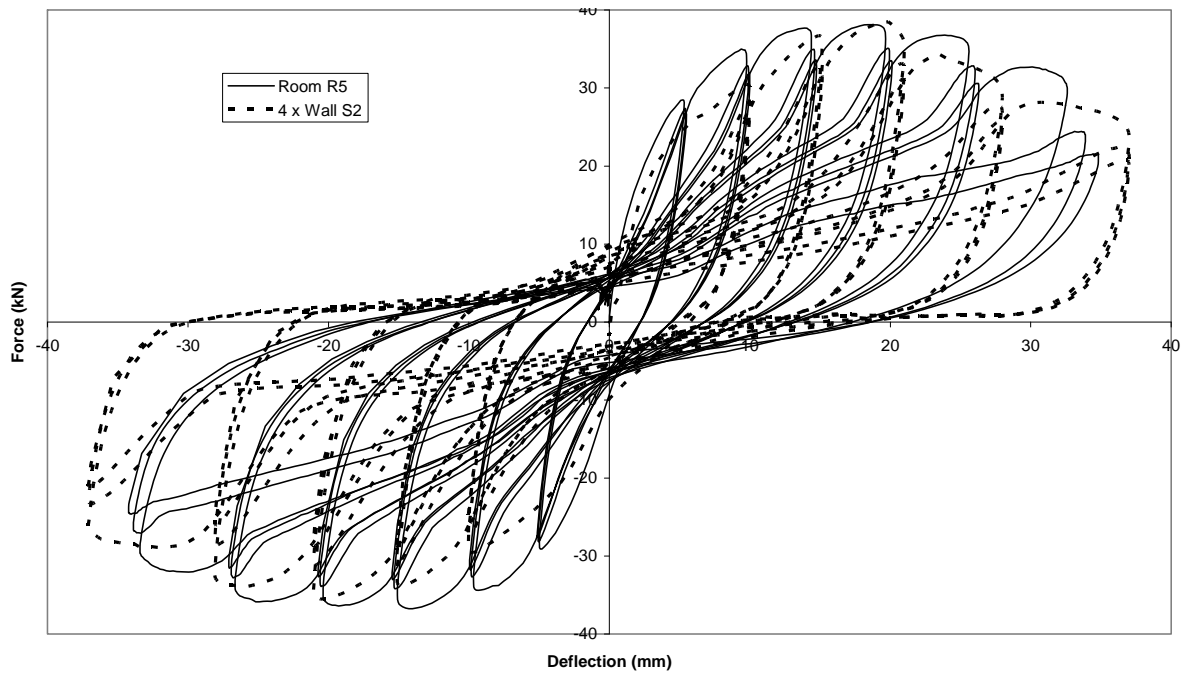
**Figure 51. Comparison of test results for Room R5 and 4 x Wall S2**

The comparison in Figure 51 shows good agreement between Room R5 and 4 x Wall S2. Both constructions had approximately 60% of the movement being due to 'rocking' by bottom plate uplift. From these results it is concluded that the proposal is valid for this construction.

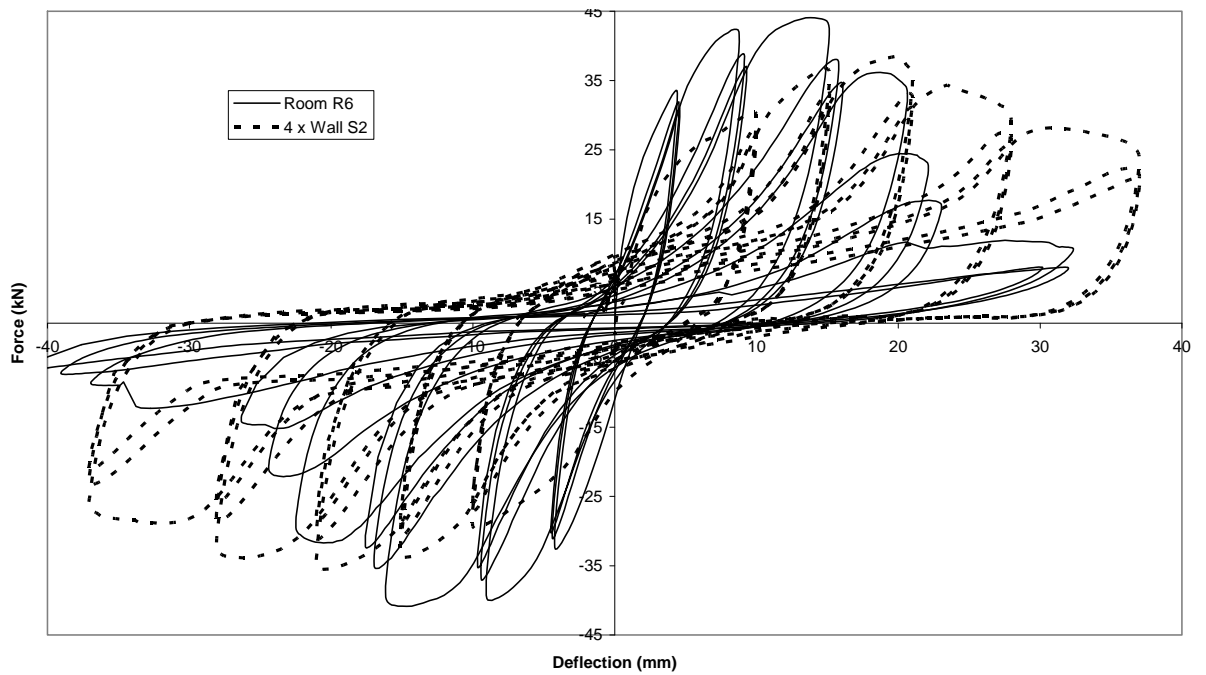
**Figure 52. Comparison of test results for Room R6 and 4 x Wall S2**

The comparison in Figure 52 shows that at low deflections Room R6 was significantly stiffer and stronger than 4 x Wall S2. After reaching peak load it subsequently rapidly deteriorated for reasons given in Section 1.17.2(d). As Wall S2 did not have end straps, no conclusions on the adequacy of the end restraints or systems effects can be made.

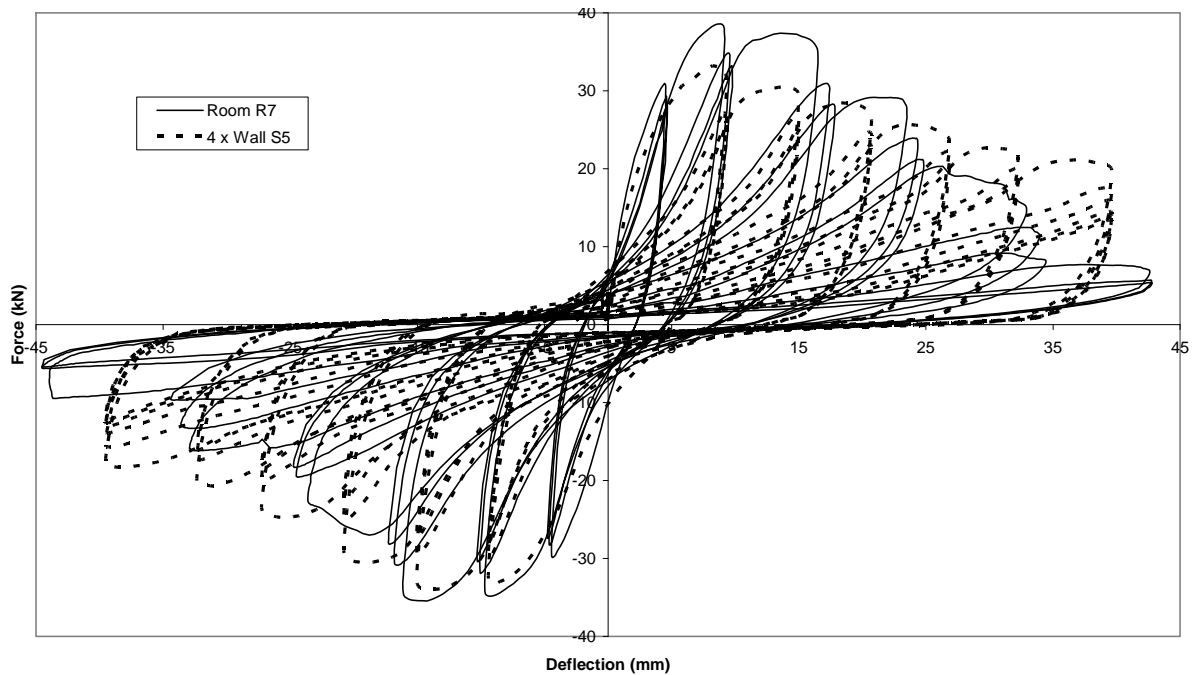
**Figure 53. Comparison of test results for Room R7 and 4 x Wall S5**

The comparison in Figure 53 shows a moderate agreement. Both had a similar initial stiffness. Room R7 reached slightly higher peak loads, but deteriorated faster than Wall S5. From these results, it is concluded that the proposal is valid for this construction.
