Study Report

SR393 [2018]

Materials within geothermal environments

Zhengwei Li, Nick Marston and Kathryn Stokes

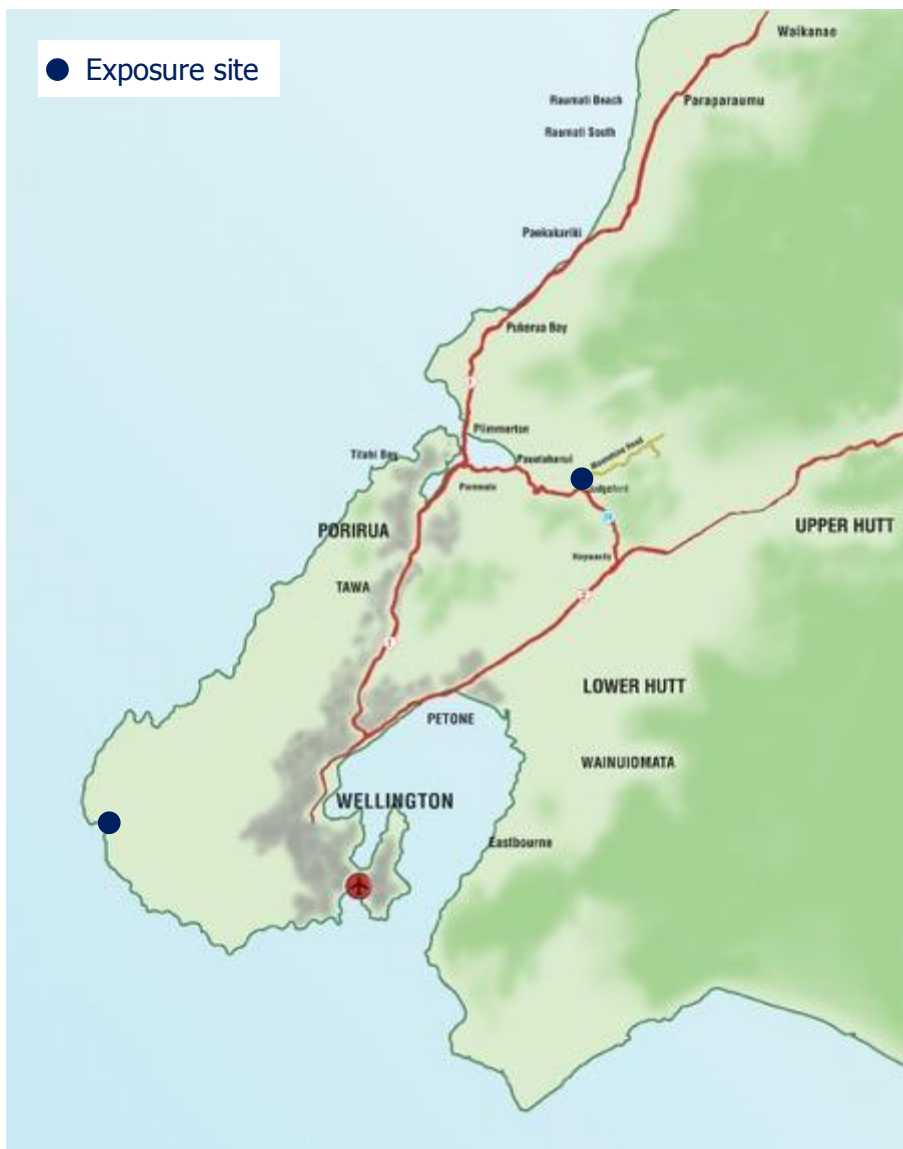
Figure 4. Exposure sites established in Wellington region.

For comparison, two exposure sites were established in the Wellington region (Figure 4). One was within the BRANZ campus at Judgeford, Porirua. This site is in a sheltered semi-rural environment, located approximately 5 km from the nearest salt water, a tidal estuary, and further protected from the open sea by gently rolling hills. It lies within Zone C (or C3 according to ISO 9223:2012) according to the atmospheric corrosivity map shown in the NZS 3604:2011 based on severity of exposure to marine aerosols. However, it is considered a fairly benign example of this classification based upon atmospheric corrosion testing with standardised mild steel and zinc coupons.

The other site was on the beach-front of Oteranga Bay, located at map coordinates 41.30°S and 174.62°W (west coast of Wellington). It is only a few metres away from the breaking surf and can be exposed to extremely strong winds in some seasons. It is considered a typical sea spray zone, i.e. a (very) severe marine environment. Previous

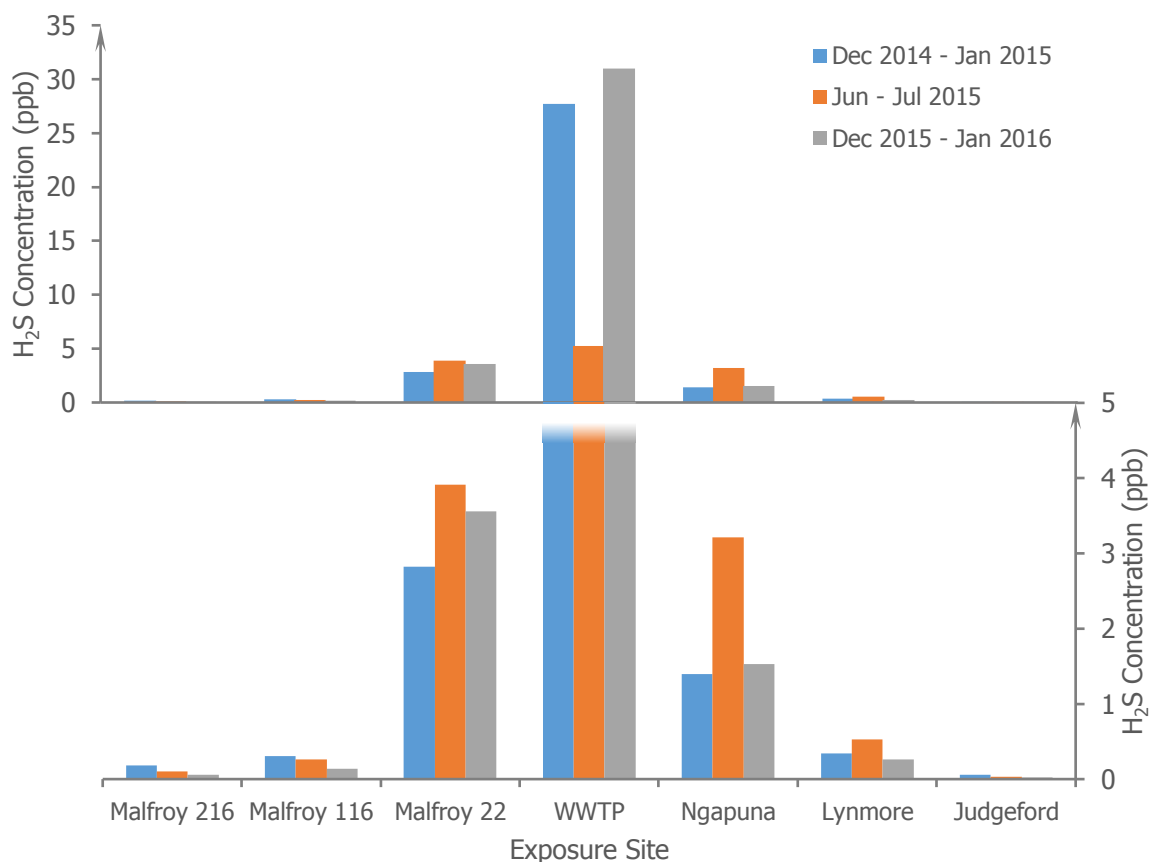
Figure 6. Average H₂S concentration during a 3-week exposure.

The average concentrations of H₂S for a 3-week exposure are shown in Figure 6.

H₂S concentrations in the west and east areas were much lower than that in the central part of Rotorua city. The highest concentration (30.98 ppb) was observed at the wastewater treatment plant site close to Sulphur Bay (started from December 2015). This concentration was ~500 times higher than that measured at the far west location during the same testing period. In addition, H₂S concentration in the east area was slightly higher than that in the west area.

The average 3-week H₂S concentrations varied even at one specific exposure site, relative to the monitoring timing (Figure 6). For example, the H₂S concentration at the wastewater treatment plant site was 5.2 ppb during June–July 2015, ~5–6 times lower than those measured during December 2014 to January 2015 and December 2015 to January 2016. This pattern was also observed at other sites.

The prevailing wind direction could explain two phenomena revealed in Figure 6:

- Geothermal features are located mainly in the central part of Rotorua city. The prevailing wind from the southwest could carry sulphur-containing species to the northeast and east regions, leading to higher H₂S concentrations in the west area.

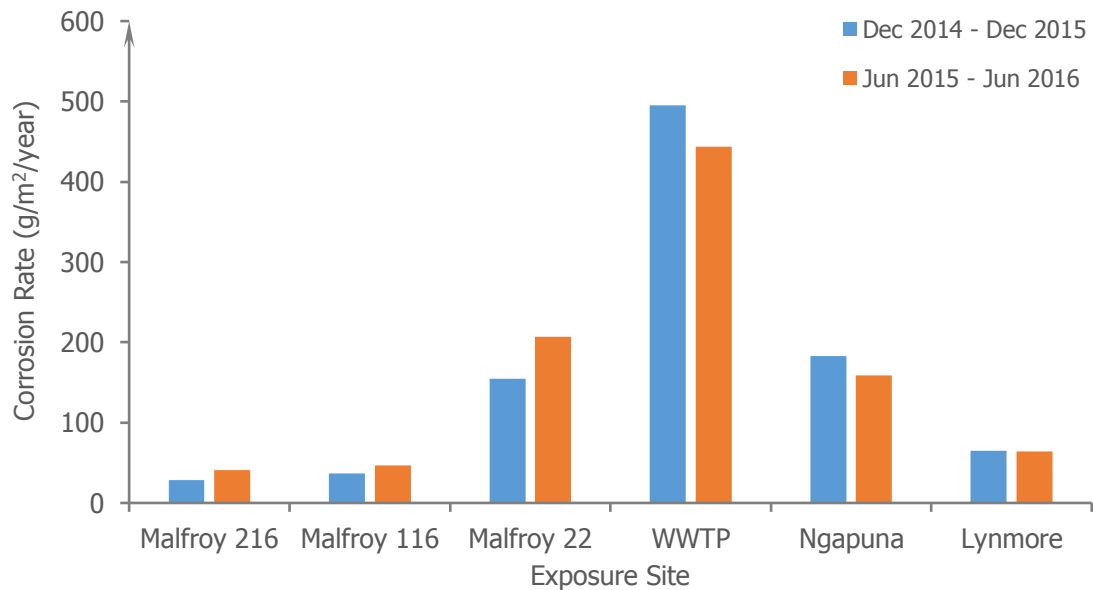
Figure 14. First-year corrosion rates of copper at six exposure sites in Rotorua.

The copper samples exposed at the wastewater treatment plant site had a corrosion rate ranging from 443 g/m²/year to 495 g/m²/year. This extremely high corrosion rate was a direct result of the rapid interactions of copper and sulphur-containing species and poor protection offered by the corrosion products with a large number of defects. Corrosion products on copper samples started to crack and detach partially as flakes after approximately 1 month of exposure at this site, exposing fresh copper substrate to this highly corrosive environment. Microscopic characterisation also revealed a rough surface with a large number of nodules and deep etch-like pit features after a 1-year exposure (Figure 18b). This indicated that the attack to metal was extremely non-uniform and a complete corrosion product layer was unlikely to be present to provide a good protection to the underlying substrate.

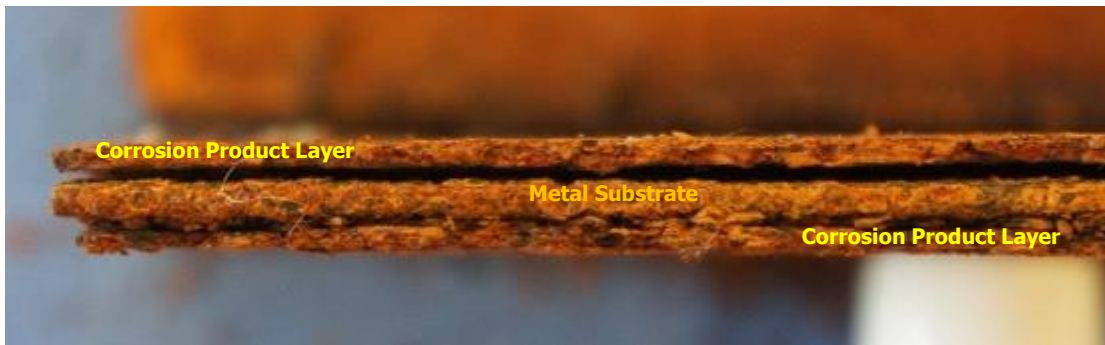
Figure 15. Corrosion products remaining on the mild steel sample exposed at the wastewater treatment plant site for 1 year.

The difference in corrosion rates measured at different exposure sites was strongly supported by the variation in sample surface morphologies. At the wastewater treatment plant site, a thick corrosion product layer was formed on the mild steel sample surface, leading to a significant increase of total sample thickness from 3 mm to ~5–6 mm after a 1-year exposure. This thick corrosion product layer (~1–2 mm thick) on each side could readily detach from the sample surface (Figure 15).

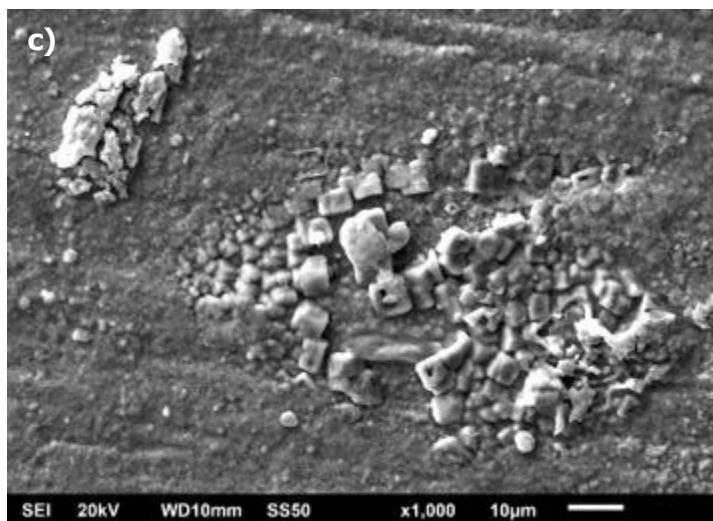
Figure 19. Surface morphology of (a) mild steel, (b) zinc and (c) copper exposed at Judgeford for 1 year.

- The copper corrosion rate measured at Judgeford was lower than those at all six exposure sites in Rotorua. The corrosion product layer on the copper sample exposed at Judgeford was dense and uniform and composed of particles of ~100–200 nm and occasionally some large cubic particles (~3–5 μm) of unknown phase composition (Figure 19c). This morphology is different from that of copper samples exposed in the west and east areas of Rotorua (Figure 18a and c), indicating that very low concentrations of sulphur-containing species in air could still significantly affect copper corrosion.

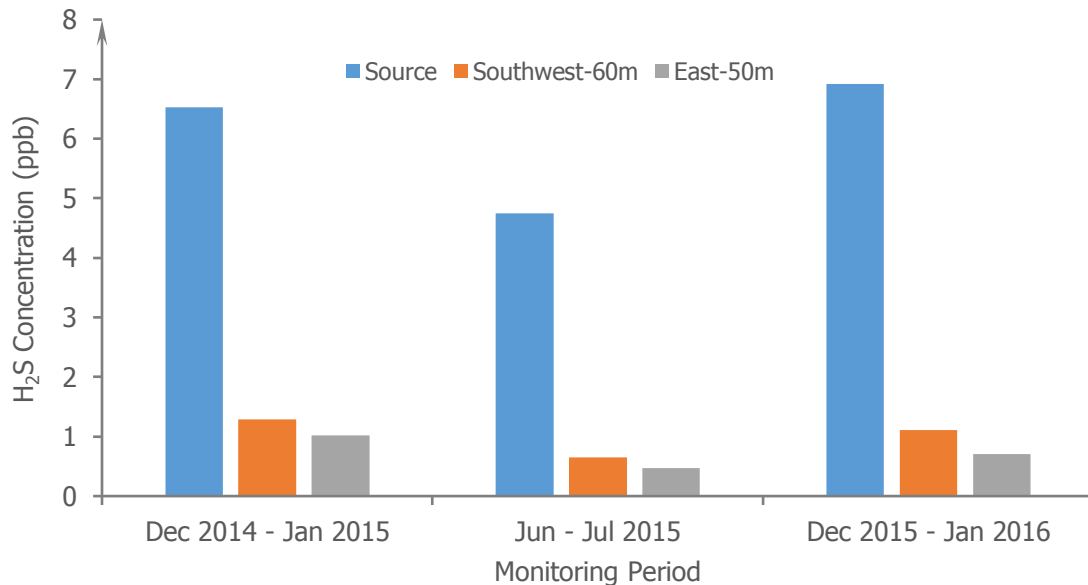
Figure 24. Average H₂S concentrations at three locations around a fumarole.

This is likely related to the concentration decrease of airborne sulphur-containing species (H₂S and/or SO₂). As shown in Figure 24, H₂S concentrations measured at the southwest and east locations approximately 50–60 m away from this fumarole was 5–10 times lower than that at the source. Similarly, SO₂ concentrations measured at these two locations were approximately 3–4 times lower than that at the source (Figure 11b).

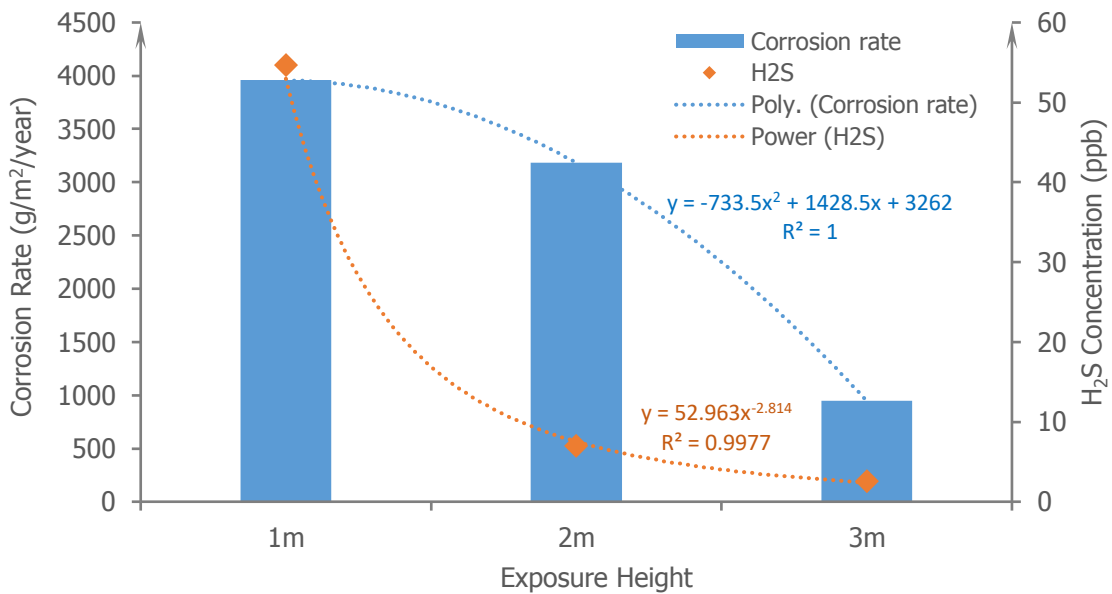
Figure 27. Correlation between mild steel corrosion rate, H₂S concentration and exposure height (mild steel coupon installed at an angle of 45° and faced north).

Although both metal corrosion and airborne H₂S concentration decrease with height, their decreasing behaviours were not the same (Figure 27). H₂S concentration tended to decrease more rapidly with height increase.

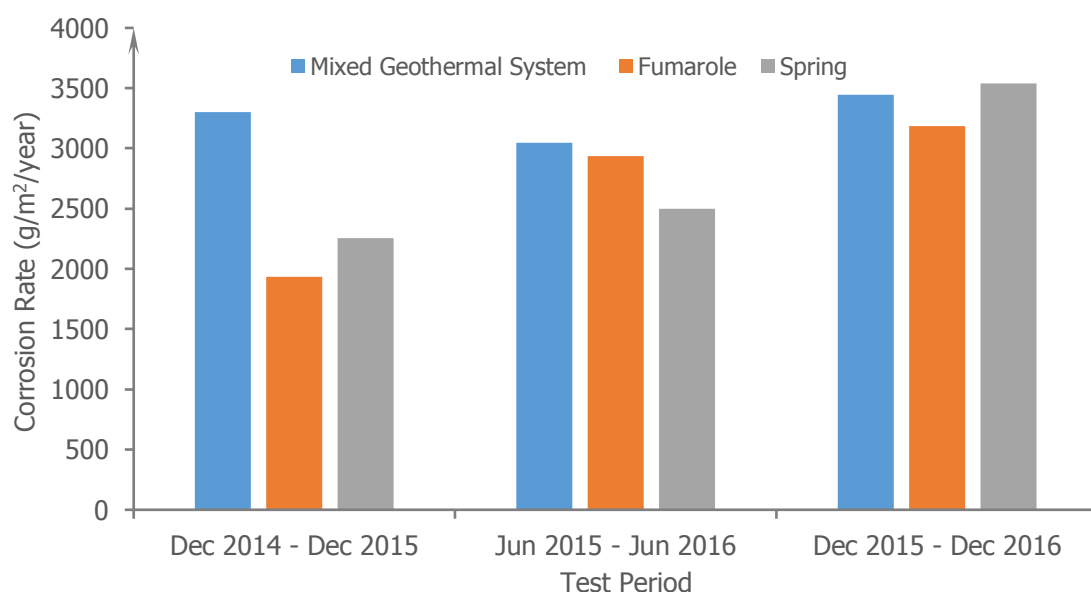
Figure 28. First-year corrosion rates of mild steel coupons exposed to three geothermal features.

Figures 28–30 show the first-year corrosion rates of mild steel, zinc and copper exposed to these three geothermal features. The following corrosion rate orders were roughly derived based on corrosion rate measurements done in three testing periods:

- Mild steel: mixed geothermal system (Sulphur Bay, WWTP) ≥ spring (Whakarewarewa, Scion) ≥ fumarole (Whakarewarewa, Scion).
- Zinc: mixed geothermal system (Sulphur Bay, WWTP) ≥ fumarole (Whakarewarewa, Scion) ≥ spring (Whakarewarewa, Scion).
- Copper: mixed geothermal system (Sulphur Bay, WWTP) > fumarole (Whakarewarewa, Scion) > spring (Whakarewarewa, Scion).

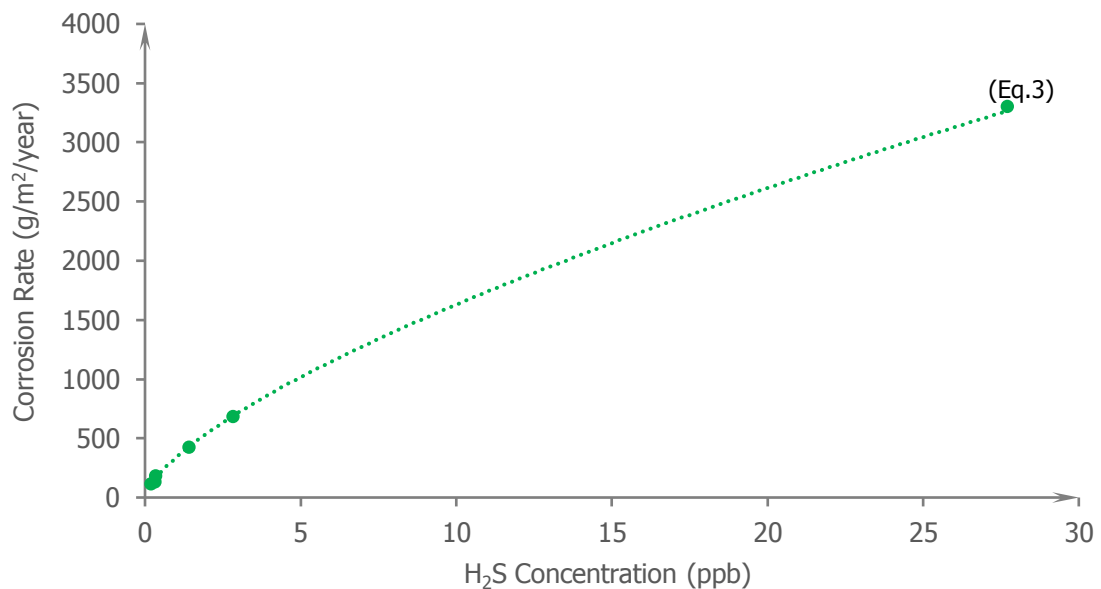
Figure 46. Power fitting of H₂S concentration and first-year corrosion rate of mild steel.

with an R² value of 0.9951 (Figure 46).

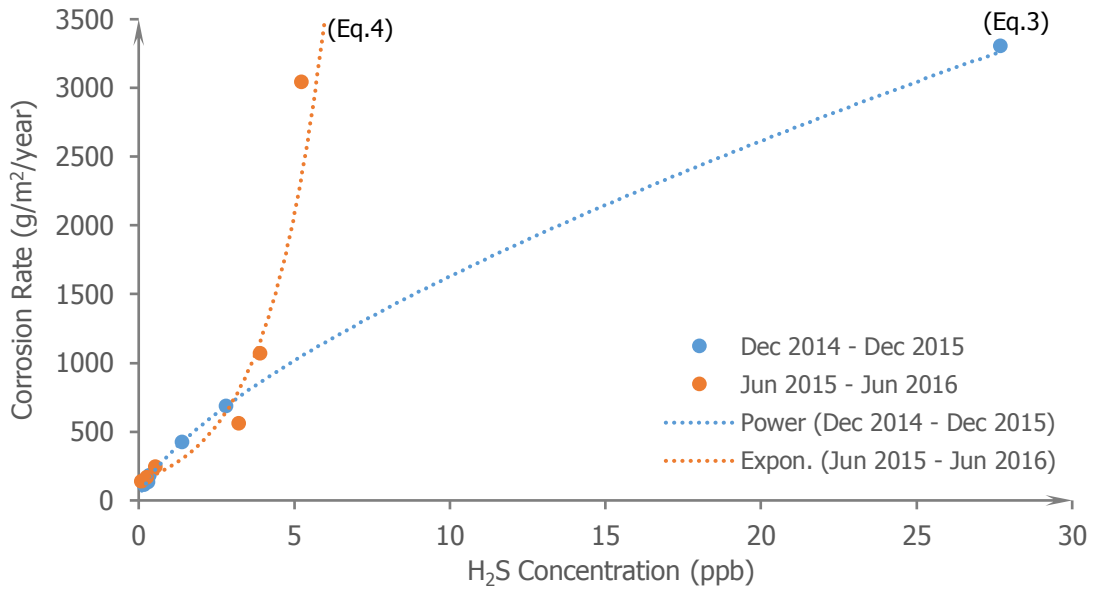
Figure 47. Comparison of trials using H₂S concentration and first-year mild steel corrosion rate collected from different exposure periods.

This trendline was quite different from those derived with the data collected from December 2014 to December 2015 (Figure 47).

- Figure 47 shows that the correlations between airborne H₂S concentration and first-year corrosion rate of mild steel are different for different exposure periods. This indicated that H₂S-induced attack might dominate metal corrosion in a certain concentration range. However, the potential influences of climatic factors on concentration, distribution and deposition of H₂S on a metal surface must be considered for correlation analysis.

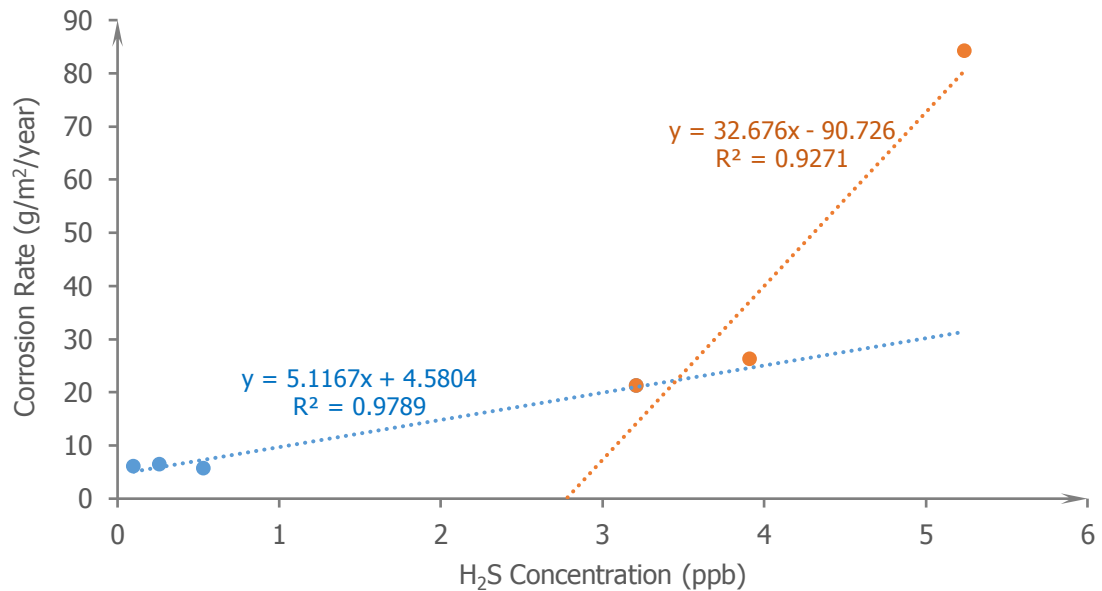
Figure 51. Two-stage fitting of H_2S concentration and first-year zinc corrosion rate data (June 2015 to June 2016).

A two-stage fitting was then trialled with the data used in Figure 50. A linear trendline with an R^2 value of 0.9789 was obtained with H_2S concentration less than 4 ppb and another linear trendline was obtained with H_2S concentration larger than 3 ppb (Figure 51). This gave a better way to interpret data.

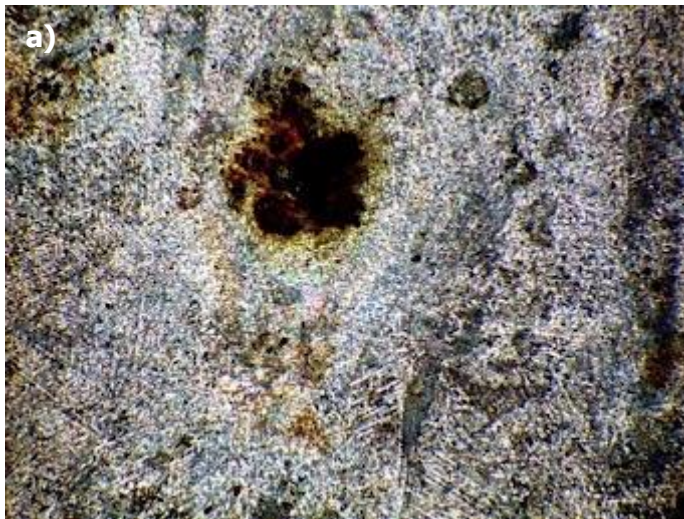
Figure 59. Surface morphology (32×) of 55%Al-Zn alloy coating after a 2-year exposure at (a) a fumarole (Scion campus), (b) the wastewater treatment plant (south of Sulphur Bay – a large, mixed geothermal system) and (c) Oteranga Bay (severe marine).

Heavy rusting was not observed on 55%Al-Zn alloy coating samples in geothermal environments after this 2-year exposure. Instead, a number of small, randomly distributed rust spots were formed (Figure 59a). This indicated that deterioration of this coating was localised, partially exposing steel substrate to the highly aggressive environment. Heavy rusting was observed close to the cutting edges, indicating that the unprotected steel cannot be effectively protected by the cathodic protection effect commonly lent by zinc coating in natural environments (Figure 59b).

Spot rusting was observed only occasionally on the samples exposed to the severe marine environment together with some grey/white patches (Figure 59c). Rusting was limited to small areas close to the bottom cutting edge. Relatively severe damage to the coating was observed in small areas on the skyward surface and identified to be related to mechanical impacts from sand and/or salt particles carried by strong winds.

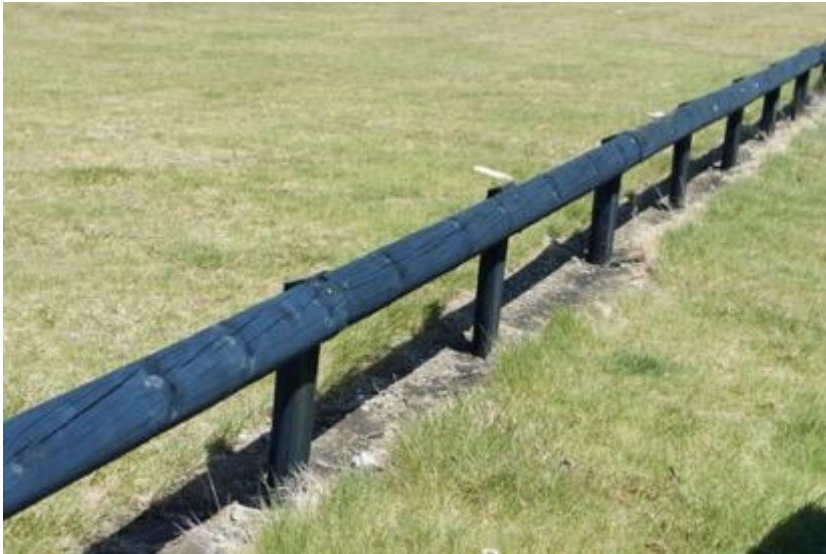
Figure 66. An example of wood discolouration noticed in an area with strong geothermal influences (south of Sulphur Bay).

Discolouration of wood and its products was frequently observed in geothermal environments. For example, in areas close to Sulphur Bay with a number of active geothermal sources, preservative treated woods could turn uniformly blue quickly (Figure 66). This discolouration appears to be somewhat different from the discolouration mentioned above.
