Corrosion of metal in timber and concrete

The rate at which metal elements corrode in timber and concrete depends on things like the type of metal involved, treatment of the timber, concrete strength and cover and the local atmospheric environment. A basic understanding of how corrosion occurs in these materials can help ensure that the right materials and protective measures are specified and building elements meet durability requirements.

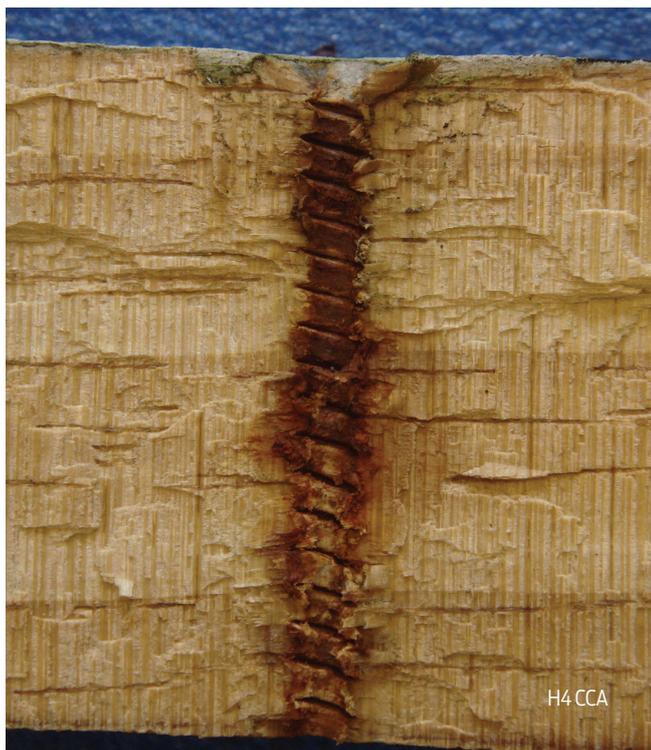
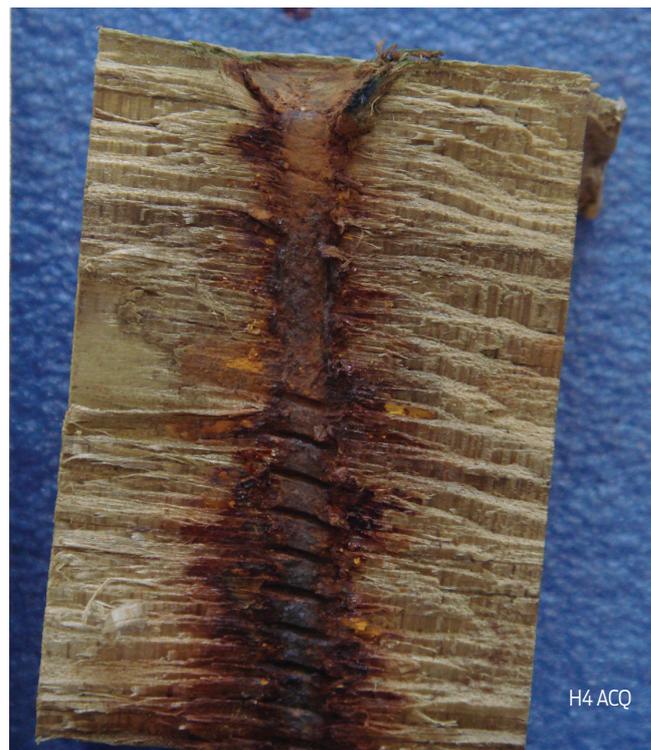
Figure 1. Iron stains formed around zinc-coated screws after just 3 years in H4 CCA and H4 alkaline copper quaternary-treated timbers in an exposed rural environment.

Fastener corrosion may also lead to heavy iron stains forming in the timber treated with copper azole or alkaline copper quaternary at high hazard levels (Figure 1). This made it very difficult to remove the screws. With longer

exposure, the cellulose components of the timber are attacked, causing loss of strength and structural integrity – sometimes referred to as nail sickness.

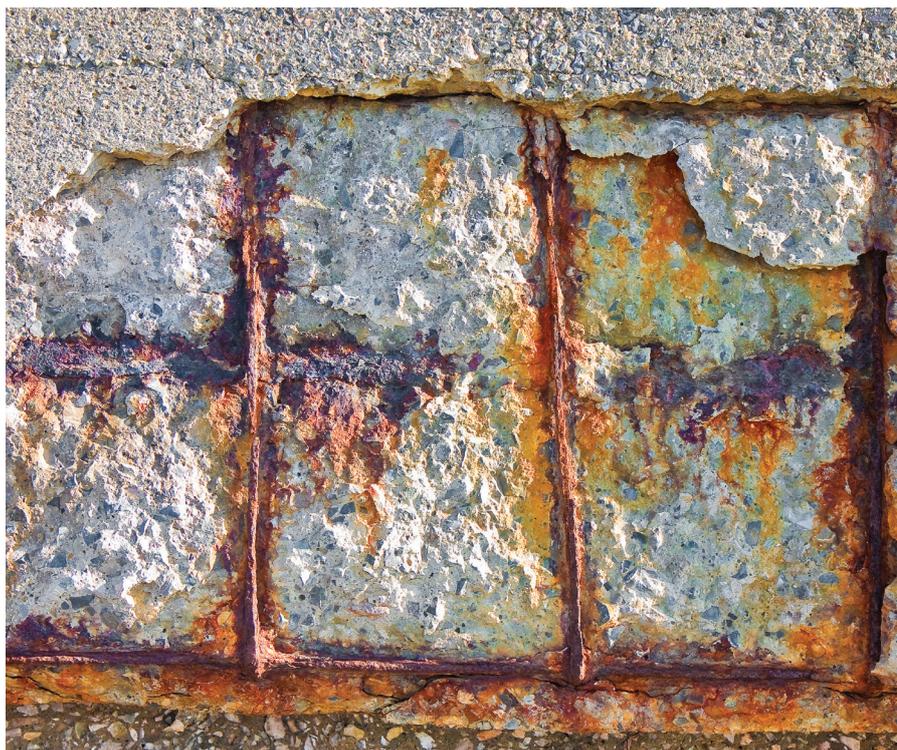
Figure 2. Chlorides in sea salt can lead to serious corrosion of steel reinforcing in concrete structures subject to salt winds and regular wetting.

Rust occupies approximately three times more space than the steel it forms from, so the increasing volume created as the reinforcing steel rusts can lead the concrete cover to spall or flake off (Figure 2). In extreme cases, entire concrete structural elements can fail.
